# John Deere 620 Orchard Tractor

Report and pictures by Chris Wilson

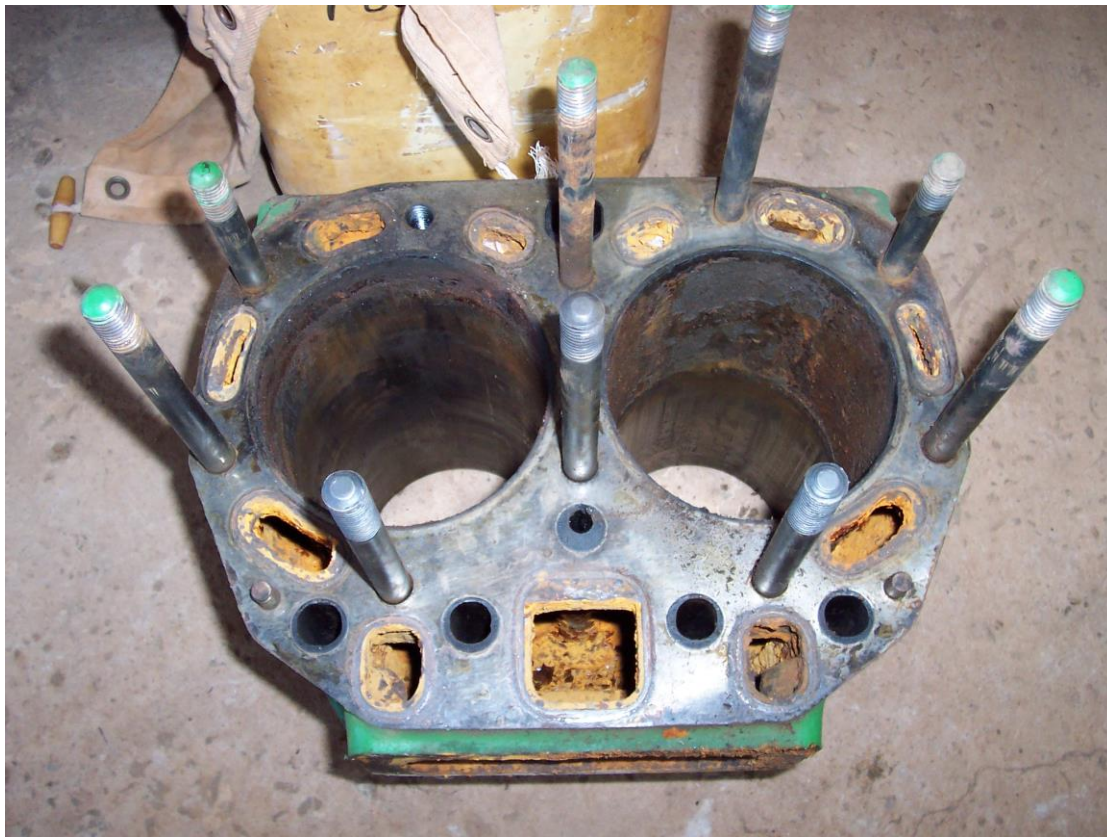
Upon removal, several unexpected problems were discovered. Firstly the engine was seized – which proved to be from water ingress years ago. This of course can be highly destructive, and was unexpected as the exhaust, through which water usually enters an abandoned tractor engine exits sideways, not vertically. Since the carburetor was badly corroded as well water must have found its way in through the inlet system.

*The cylinder bores, rusted but salvageable.*

There was no way of removing the pistons conventionally, so the block was removed from the crankcase and stood vertically. Diesel was poured onto the piston tops and left for a couple of weeks. Slight diesel leakage eventually past the pistons indicated some possibility of pounding the pistons out backwards; and this was achieved with a wooden stake and 14lb hammer. While the bore was not too badly rusted and responded to a good honing, disaster was again encountered when examining the pistons.

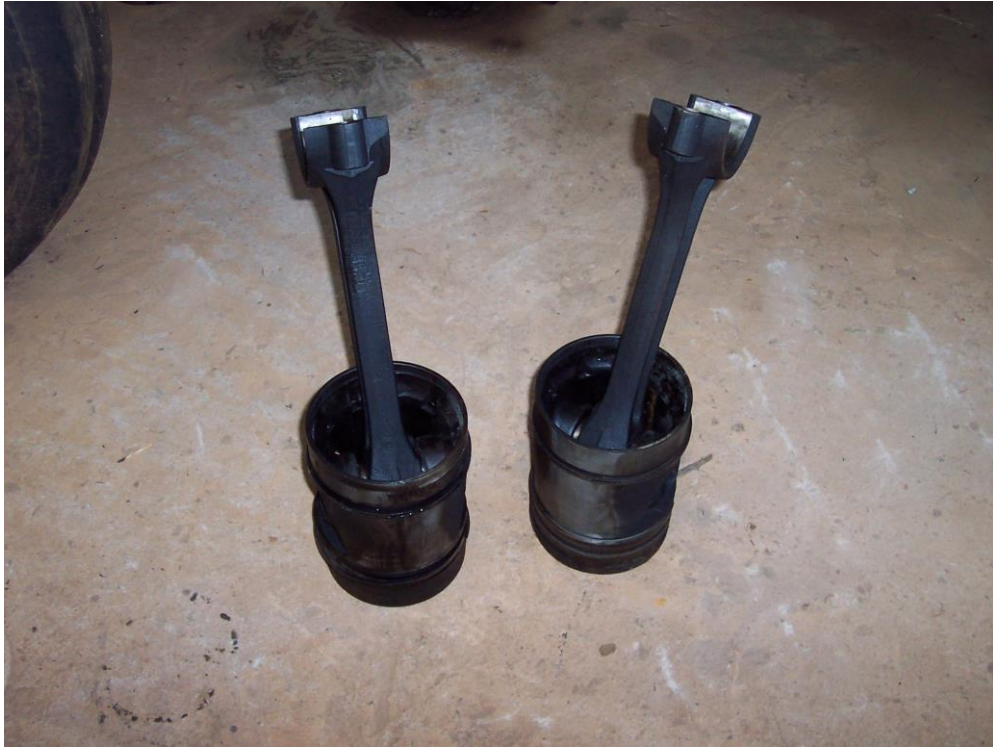
*Initially the forcefully removed pistons looked good – but closer examination showed broken ring lands disguised by hard carbon deposits.*

Obviously at some stage the top rings had broken for whatever reason – but the engine had gone on being used for long after, and the top piston lands had been completely eroded away, through to the crown in places. This was not immediately apparent as the erosion had been filled in with hard carbon – which had probably created enough compression to keep the engine running! It had been expected that new rings would be necessary, but pistons? No good used ones were available, new from John Deere were no longer supplied and even the aftermarket suppliers in the US didn't list them. There is in Merrivale, near Pietermaritzburg, a first class welding business, Euroweld. They took the pistons, welded them and re-cut the grooves.

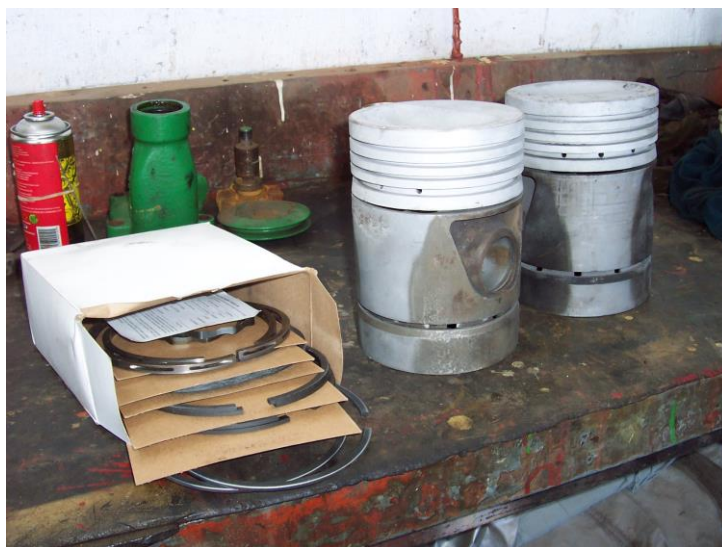
*The pistons repaired with new rings awaiting assembly and the stripped water pump in background.*

Now, with new rings, assembly could begin. Although the valves were badly rusted there was enough “meat” to re-cut them as well as the seats in the head, and a pressure test showed no other damage. A major internal and external clean-up and inspection of the whole tractor showed a healthy transmission, at least. Clutch & brakes, par for the course, were badly worn, but relatively easily overhauled. Steering woes were similarly repaired with a new bearing in the steering box.

The starter also was in need of overhaul, and this was sublet to vintage electrical experts Mason Auto. The radiator had just a small leak, easily repaired, and the water pump had to be stripped and a new seal fitted. The ignition system needed only a good set of points to give a good spark

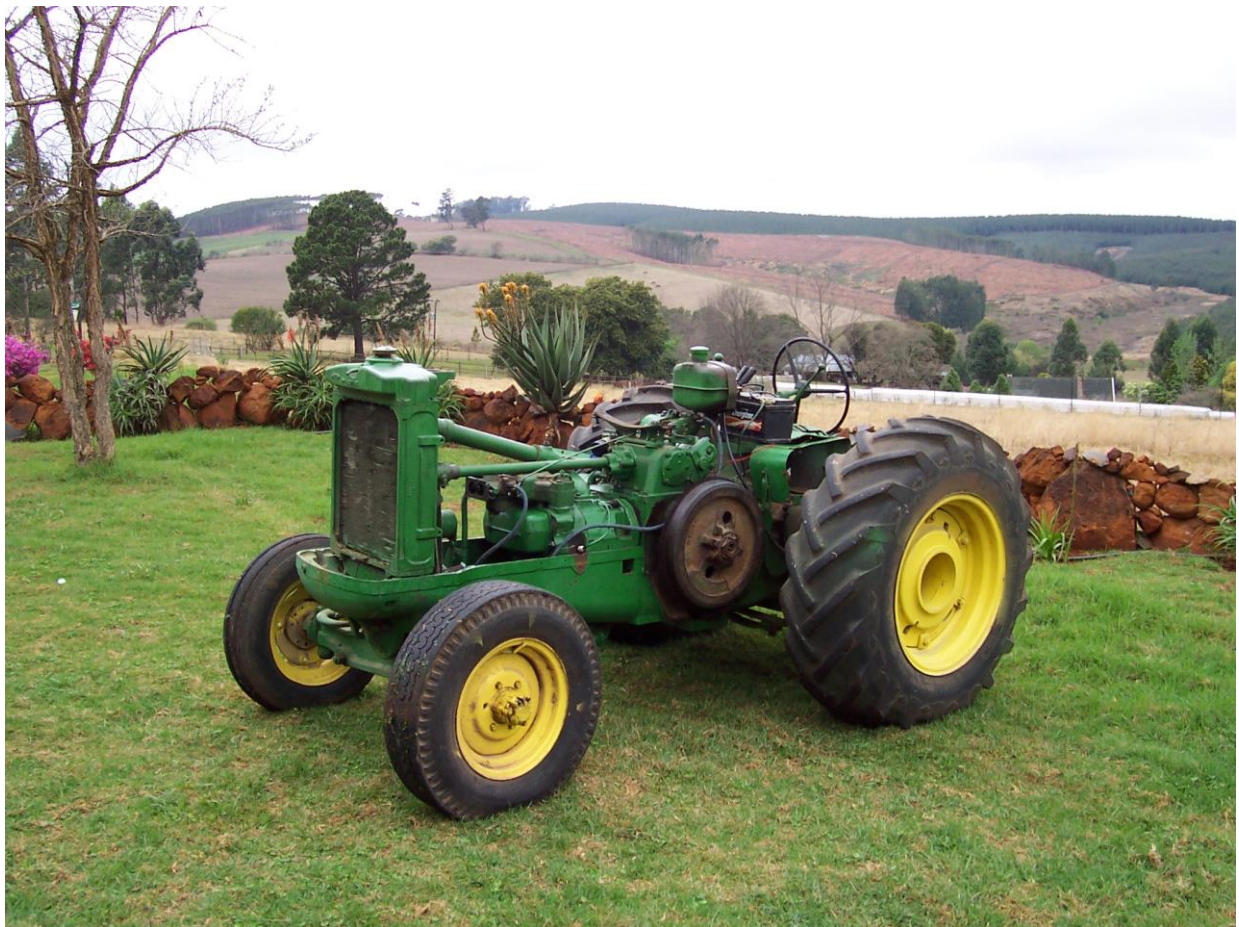
*The 620 after its first test run*

Now the big moment – would she run? After a couple of electrical setbacks she did indeed fire, and after some initial smoking and missing and carb tuning, settled down to the even beat normal to all the numbered series JD's with twin barreled carbs. What a relief!
