# SANDSTONE STEAM RAILWAY

# LOCOMOTIVES

## REPAIRS

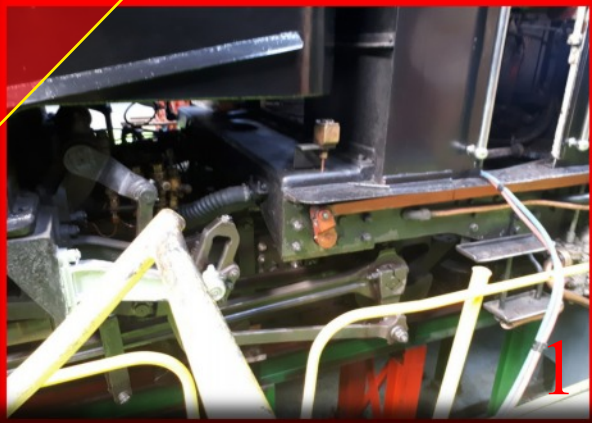
Image 1: NGG 16 number 153 on the inspection pit. Fitting the steam pipes is not a easy task.

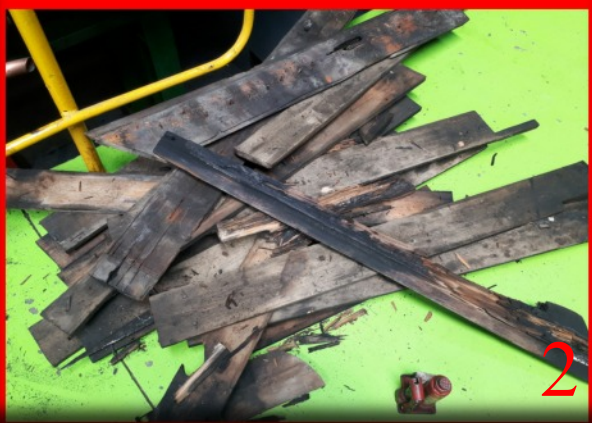
Image 2 : 153's rotten wooden floors removed.

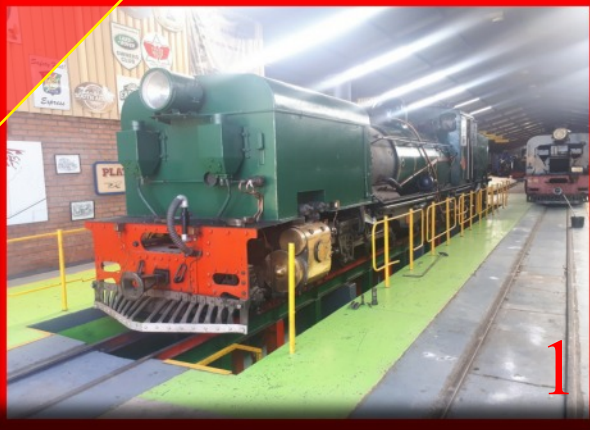
Image 1: Class NGG 16 number 88 on the inspection pit.
