# Boiler Washouts

## Stationary and Traction Engines.

During the last week and a half we have pulled out all the Stationary Boilers and Traction Engines from the Vintage Shed for washouts and same time preparing them for Boiler Inspections.

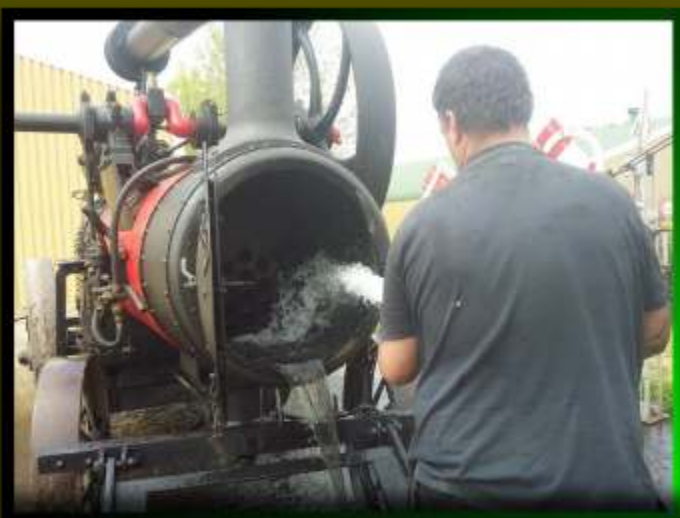
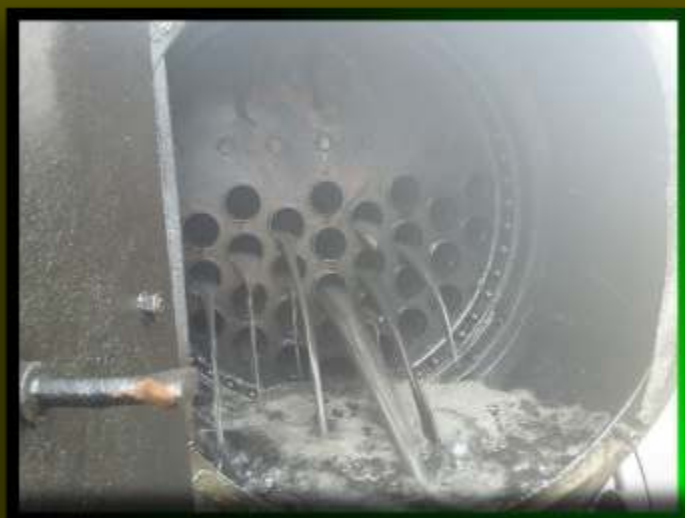
Below left: Washout through the large mud hole cover

After the boiler inside is washed then we wash the smoke box, fire box and tubes.

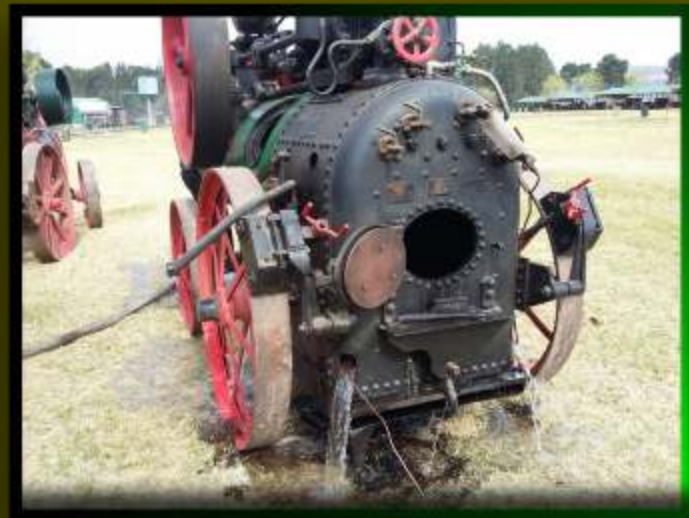
Below: Washing out the Robey Portable.

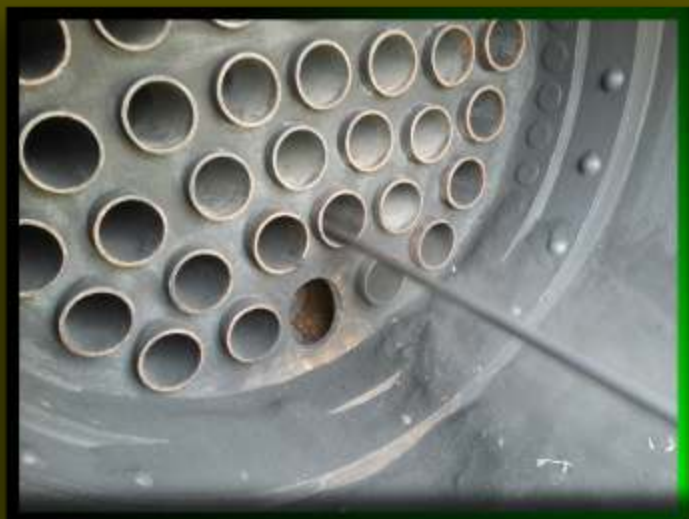
Below right: Cleaning all soot from the tubes with a tube cleaner.

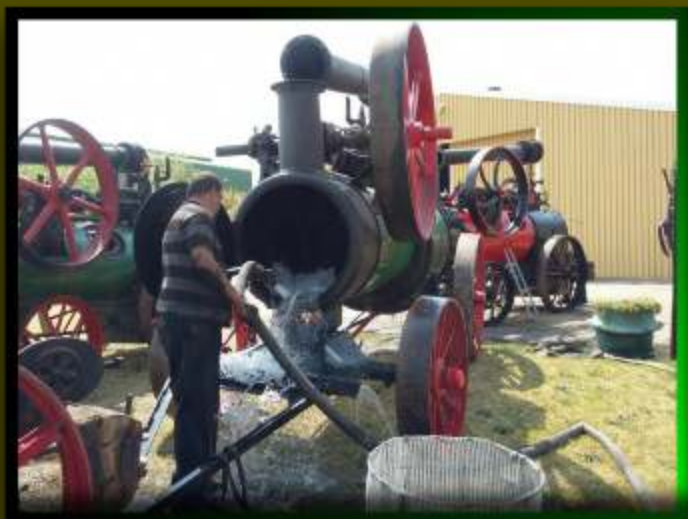
Below: Washout of the Marshall Portable.

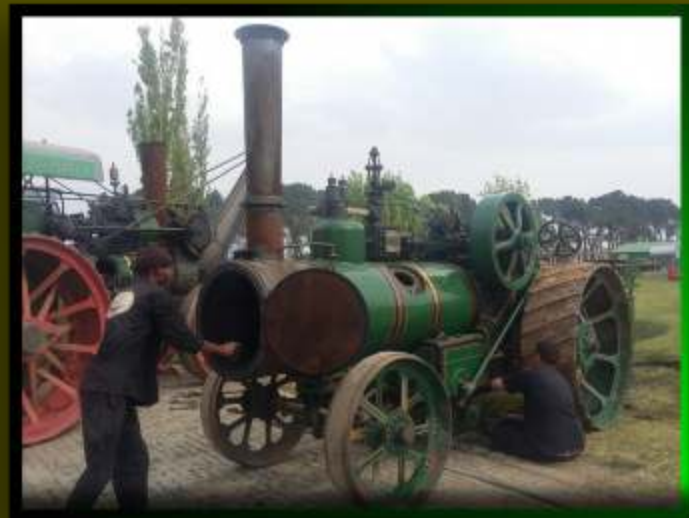
Below right; Preparing the boiler for washout. Wouter took out all the washout plugs and mud hole covers while Split pin cleaned the tubes.

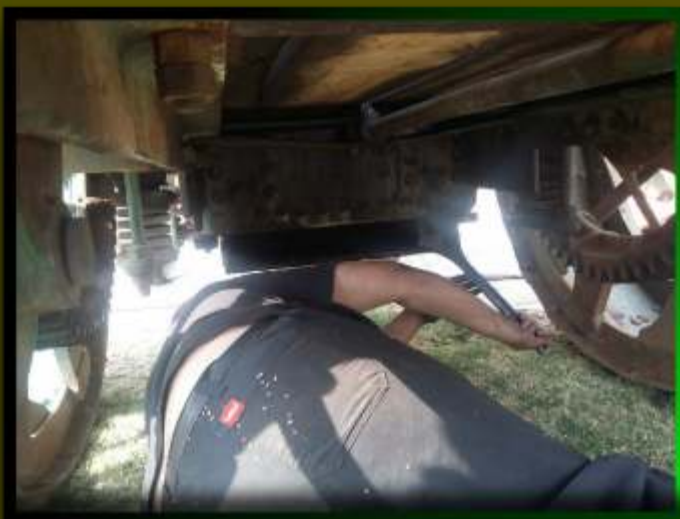
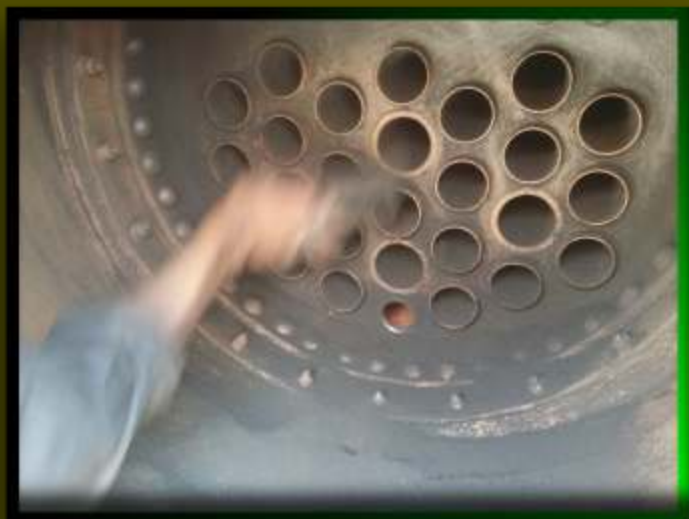
Below right: The smoke box tube plate wire brushed.

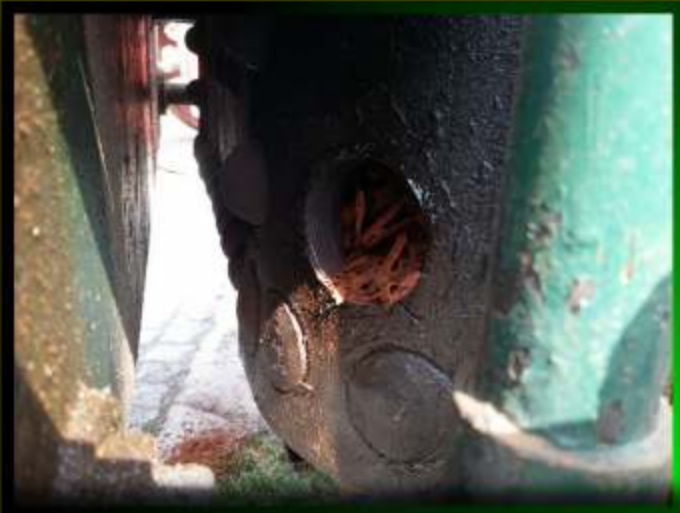
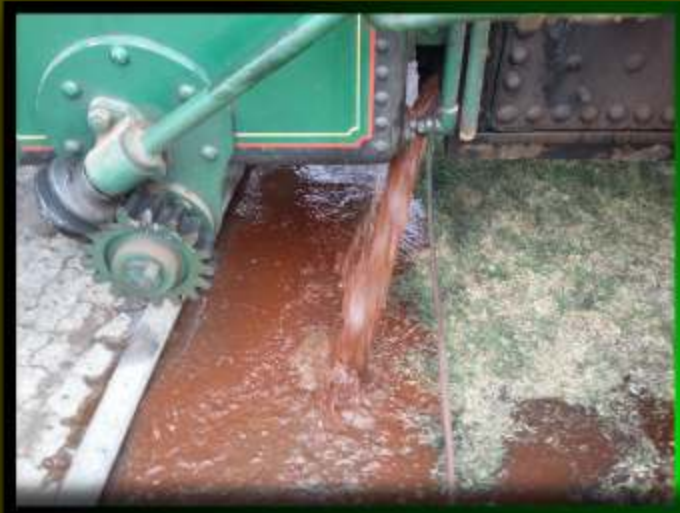
Below left: loose scale laying all around the water space above the foundation ring. These scale only comes Out with the use of the copper rod but this will be eliminated with the use of the new chemicals that we Are going to use in the future.

With the use of these chemicals we will never need to do a washout again, just regular blow downs will keep the Boilers clean but we still will do washouts just to set the mind on ease and to flush out all the scale that are adhering The tubes and stays at the moment. These scale will be broken up by the chemicals and easily be washed out.

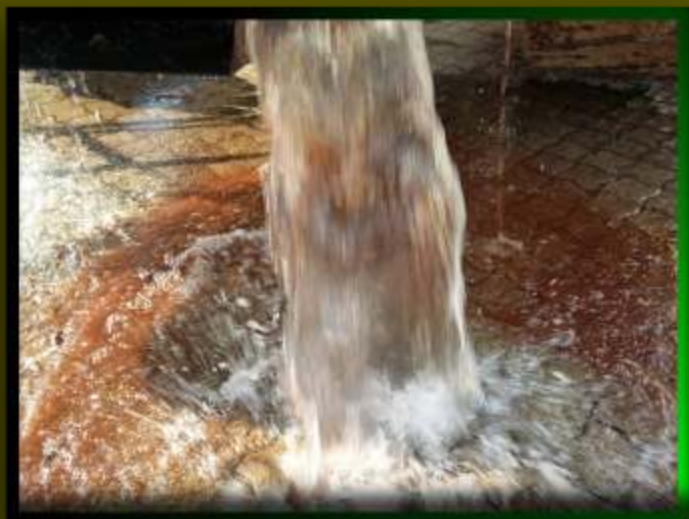
Below left: A view down the water space between the inner and outer fire box. These spaces are very important to be kept clean to prevent boiler explosions. Another critical place sometimes neglected is the barrel and the front tube plates. These are just as important to keep clean.

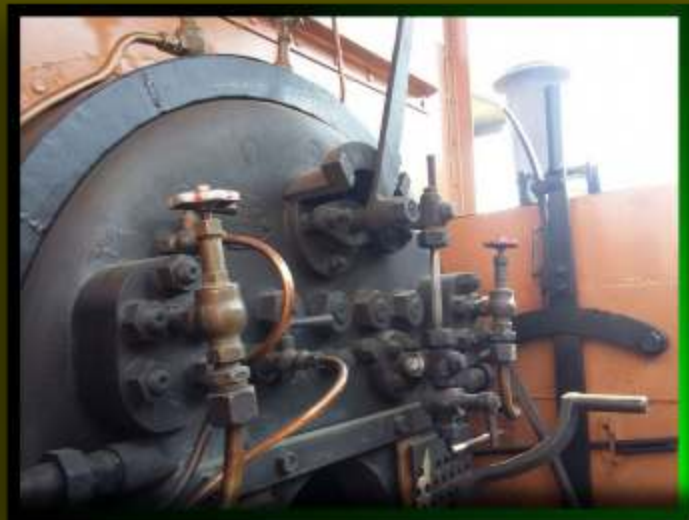
This week we also washed out the last Locomotive Boiler, Tamara number 4063.

This however is not the end yet, we now will attend to the servicing of boiler joints and replace all old gauge glasses. On these boilers over the time to come. Steam and water ports on the gauge columns will be cleaned when the gauge Glasses are renewed.

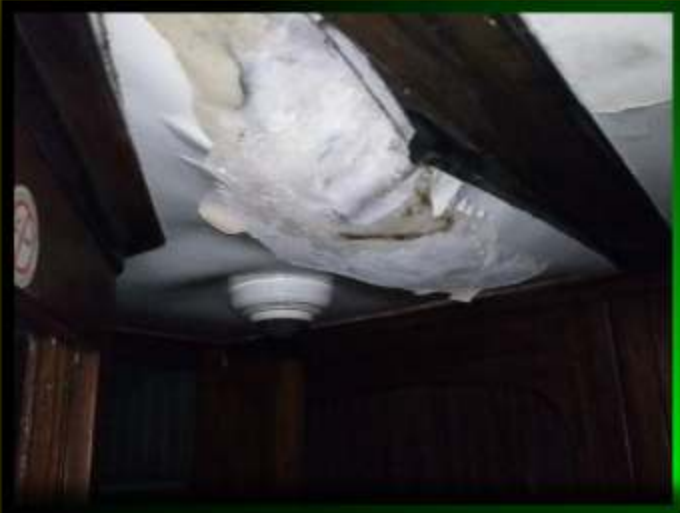
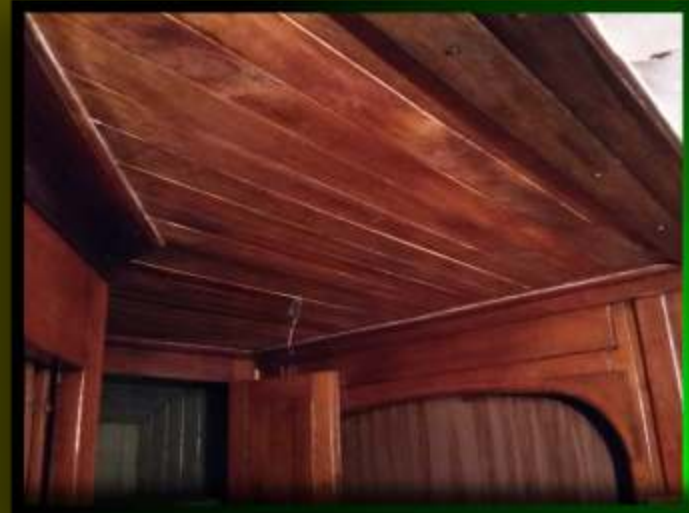
He then went on to the next sleeper coach and fitted 2 new windows and fixed the ceiling that were falling in.  
Below: Before and after.

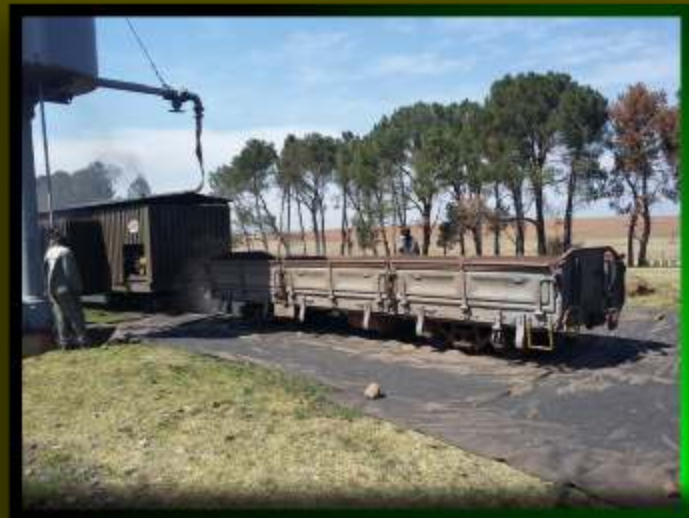
Another 3 DZ wagons the were shunted to the coal stage and were sandblasted.

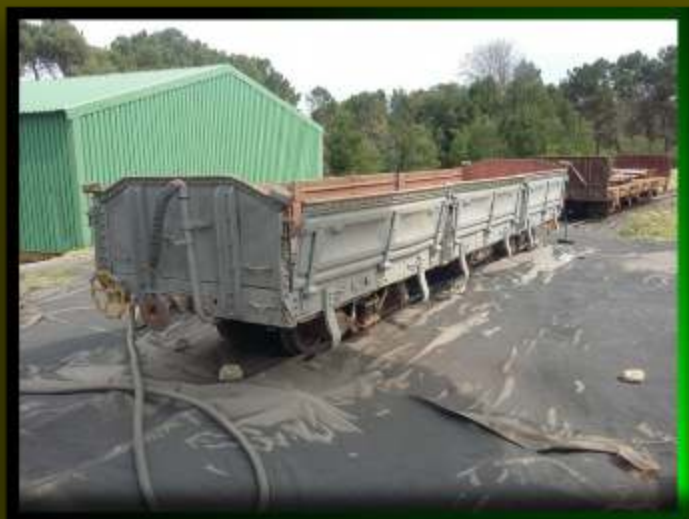
Below left: The DZ with fitted angle iron brackets on the sides.  
Below right: The second DZ being sandblasted.

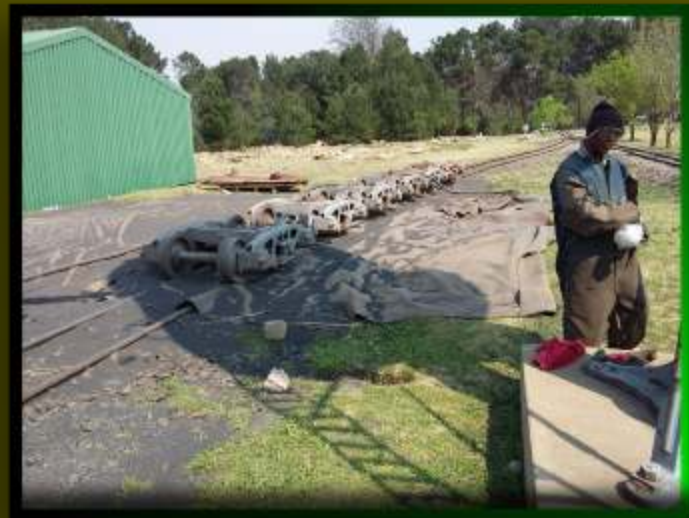
Below: The 6 bogeys being sandblasted.

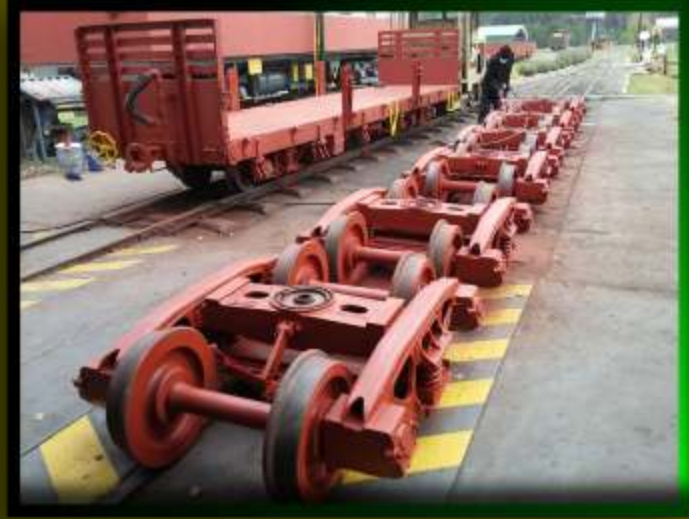
Below: The Bogey restoration in progress.

The centers and side friction plates then were greased and we now are going to fit the wagons back onto the bogeys.

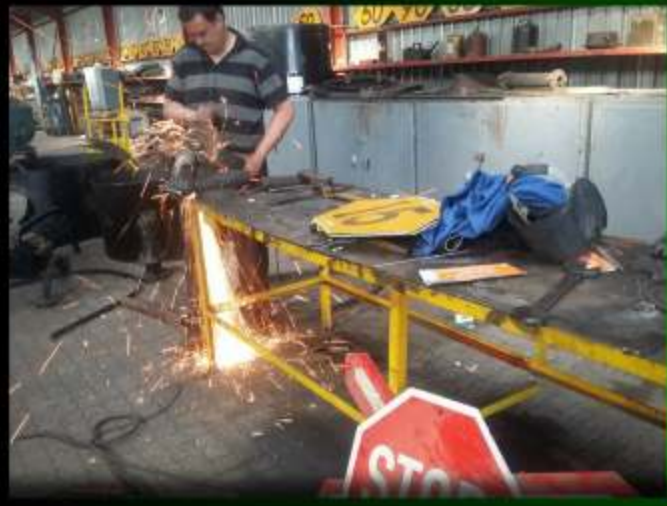
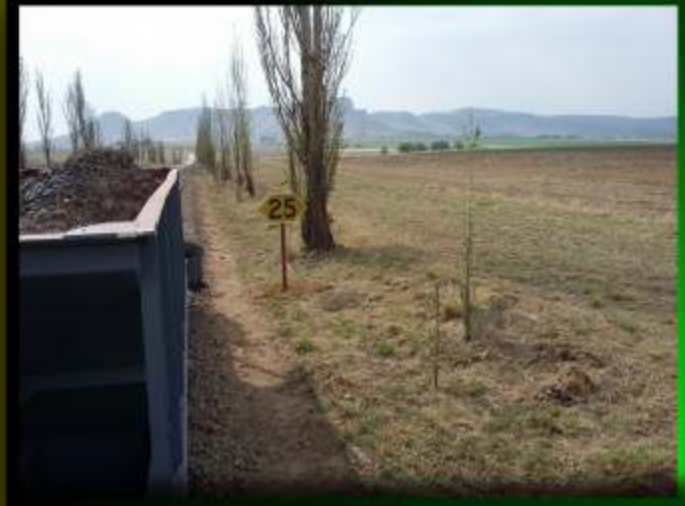
This week Wouter have made 3 new speed posts for our Railway line. One at Grootdraai, one near the Security gate On the section Hoekfontein to Mooihoek and one for just over the Pandora crossing. All 3 are double sided and shows Different speeds for both directions.

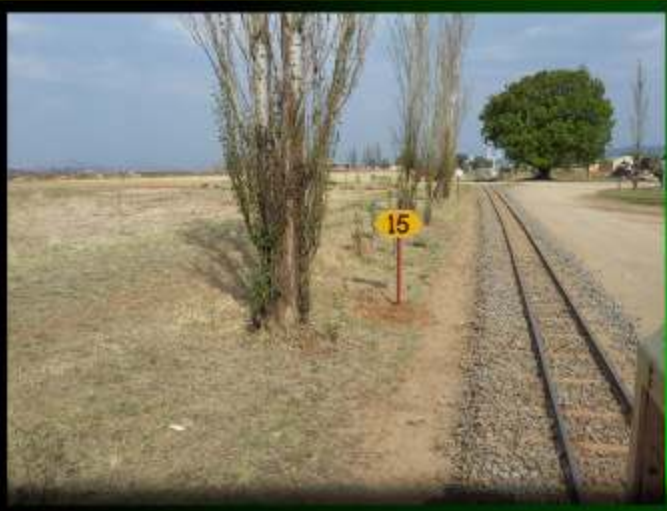
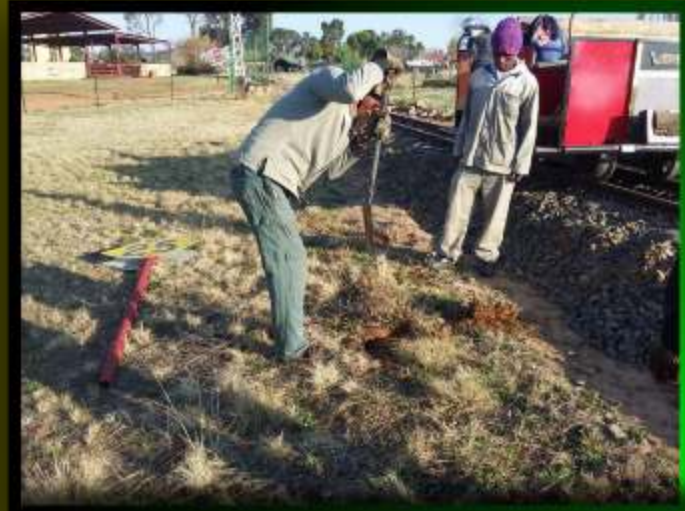
Wouter also made a new whistle signboard that will replace the one near the speed post in the image one the left side Below. Joseph and his team fitted all the signboards.
