## Highlights of the week!

# Boiler Washouts

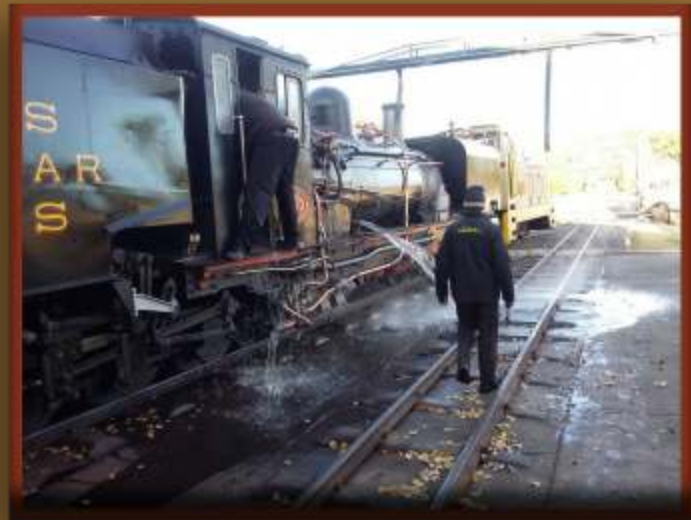
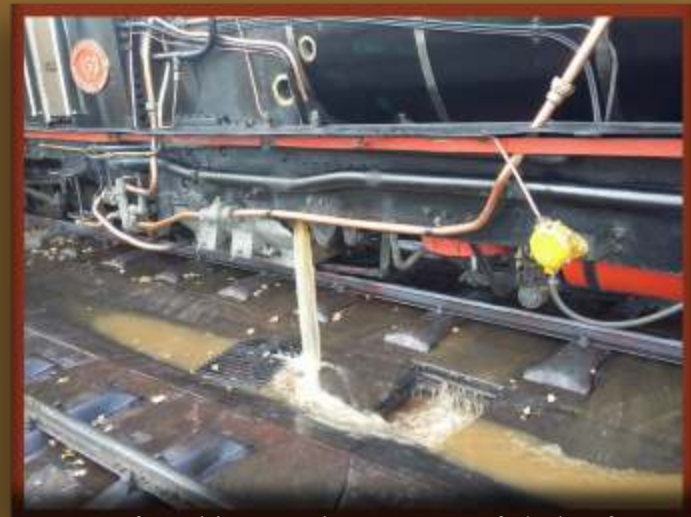
## Class NGG 16 number 153

The past week we have washed out 6 Locomotive boilers, our Class NGG 16 number 153, the Barclay, Peckett, O&K 2510, O&K 4102 and O&K 10311.

Class NGG 16 number 153 is the most used locomotive for it has excellent capabilities on the heavy gradients on the Mountain line and most of our trains are round trips, thus she needs to be washed out more frequently.

The chemicals we use is making live much easier and it is only a matter of washing out the amounts of sludge from The boilers. We now will start using a extra treatment on feed water to speedup the de scaling process in our Boilers To ensure they can reach their full steaming capabilities as designed for.

We only have these boilers and need to take proper care of them to ensure a long life span. It is extremely important To keep them healthy and to keep them clean to minimize stress on the boiler due to scale and when the boilers Are completely clean then it will protect the stays and tubes also which can result in huge expenses if neglected.

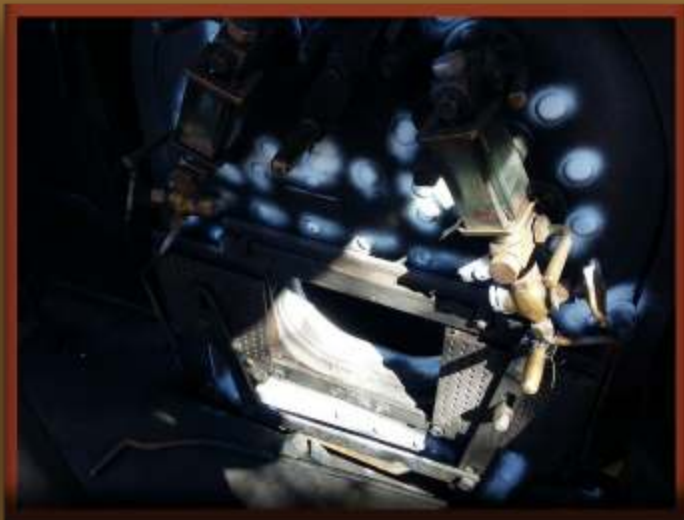
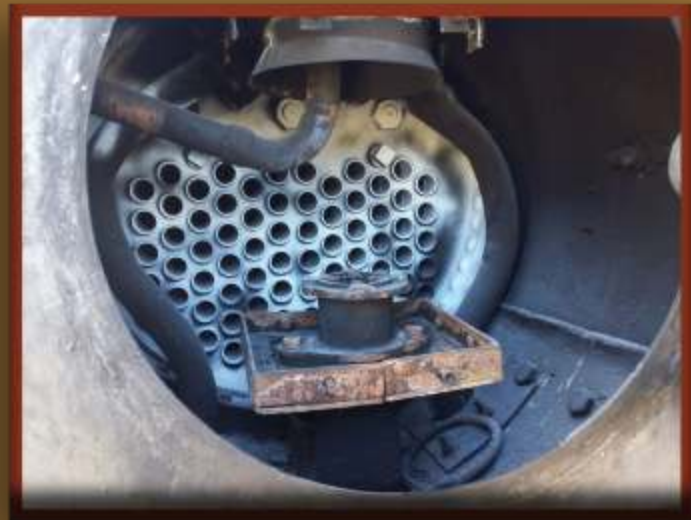
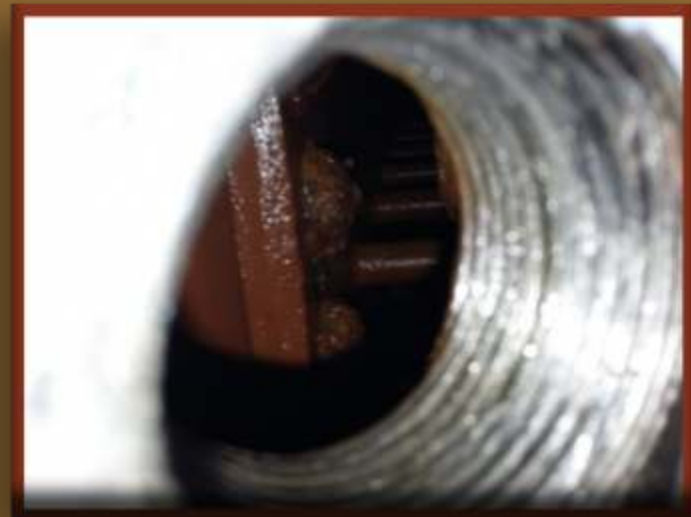
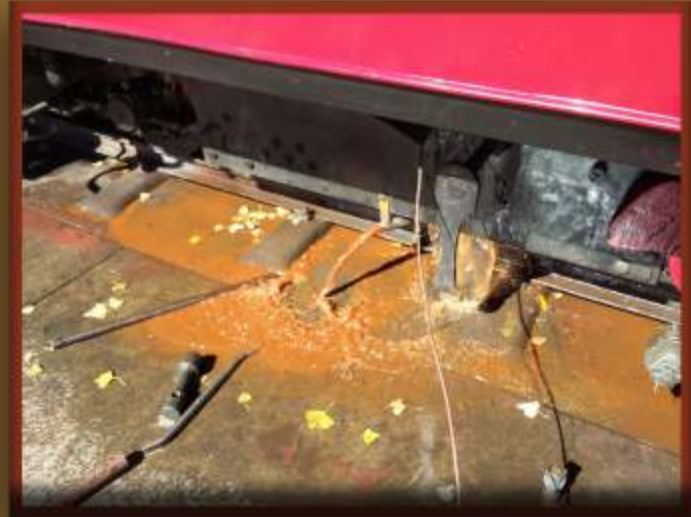
## Barclay

During the last week we did some major rearranging of the NG wagon shed and used the opportunity to shunt out The locomotives due for washout. The Barclay came in first and received a proper washout.

The first washout here was not so easy because we had to wash and remove old hardened scale as this locomotive Did not run recently to allow us to do the treatment to brake up the hardened scale, however she is clean now and

Will be treated next time she is in steam. This is one of the boilers where we will do a shock treatment to remove Scale around all the surfaces inside the boiler.

We use straight and bend nozzles with a great force of water to reach all the spaces inside the boiler but unfortunately we can't get scale off when they've adhered to tubes and inner plates, thus the water treatment will do this task for us.

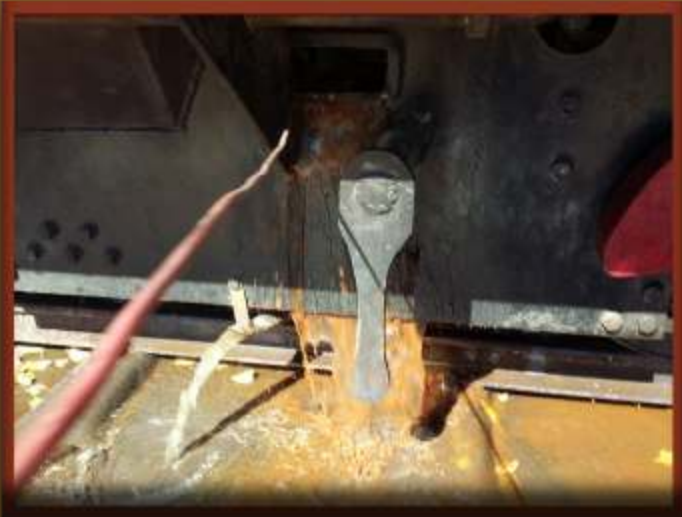
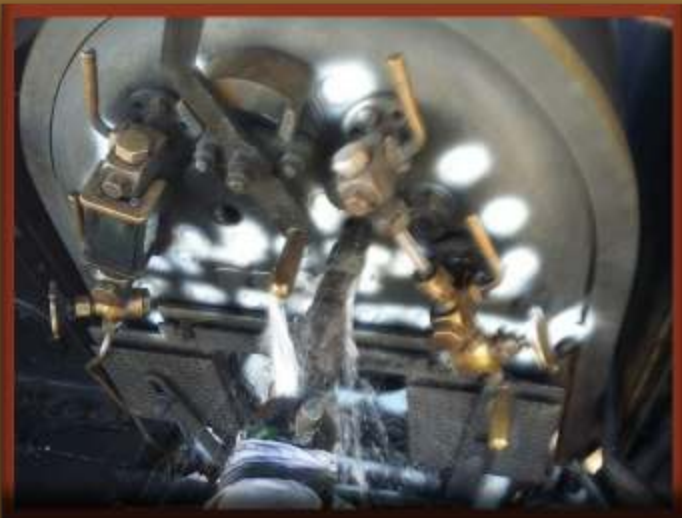
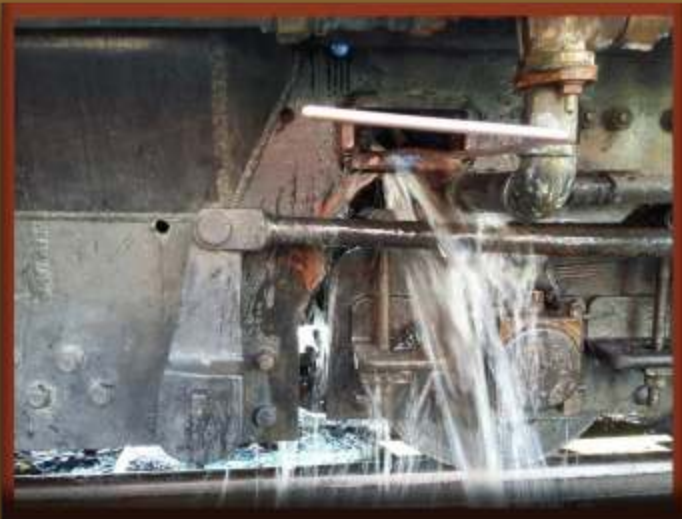
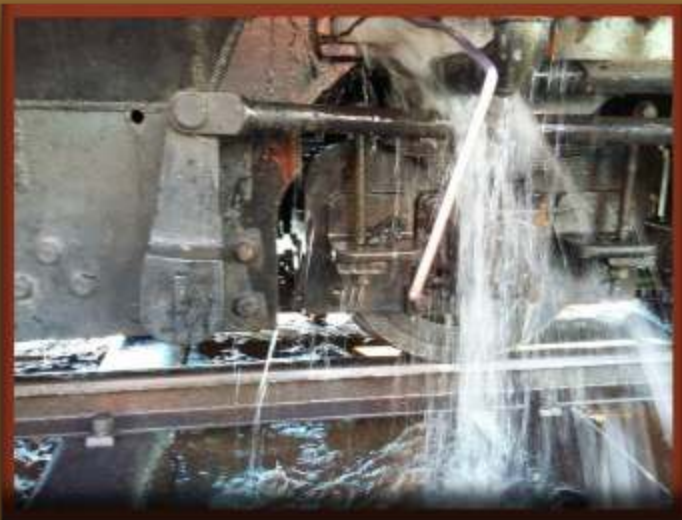
Below: Images of the washout on the Barclay Locomotive.

Finally the boiler was clean and tubes were cleaned as well.

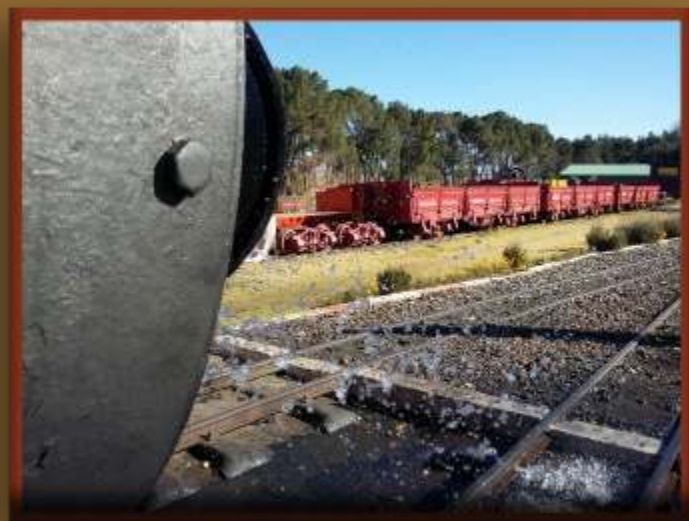
Her gauge glasses will be renewed with general maintenance soon.

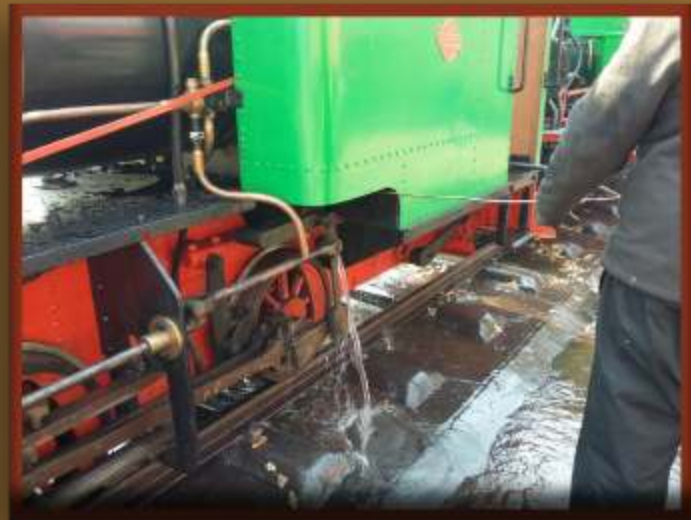
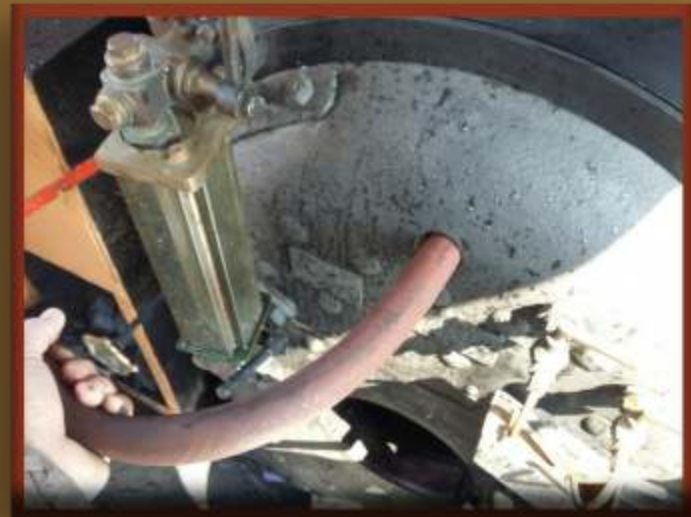
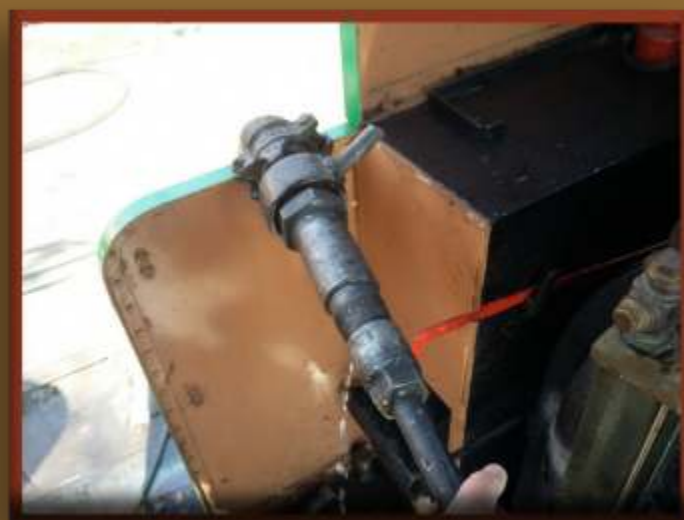
4102, 2510, 10311

The 3 little O&K locomotives also came in for washout and were cleaned properly.

Some washout holes are big enough to take the 2" washout pipe but on some little locomotives we need to use a thick Hose to access the water spaces using the same force of water.

Below: Images of the 3 small locomotives on the washout bay.

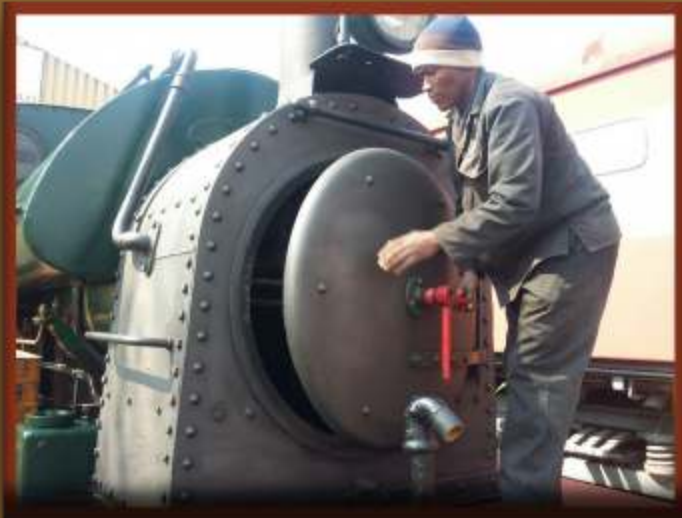
The final locomotive we washed out this week was the very sexy Peckett locomotive and she kept us busy all day. There are a few washout plugs but mostly she have mud hole covers that needs to be removed to access the fire box Area.

We removed quite a large amount of hardened scale from the boiler and she will receive some shock treatment next Time she is in steam to remove the scale adhering tubes and inner plates.

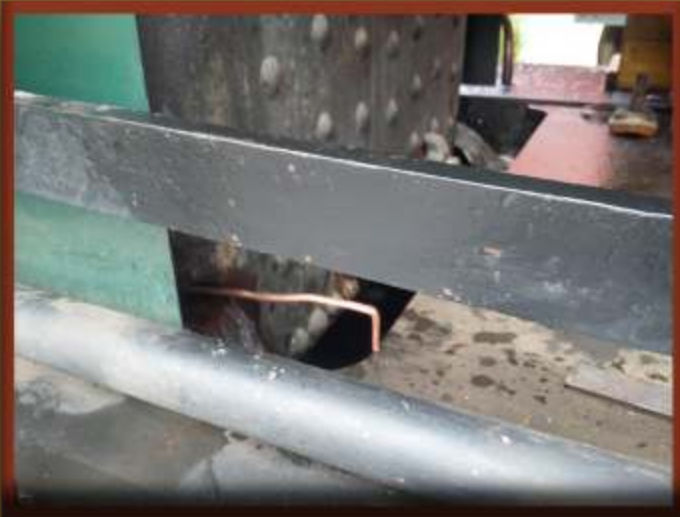
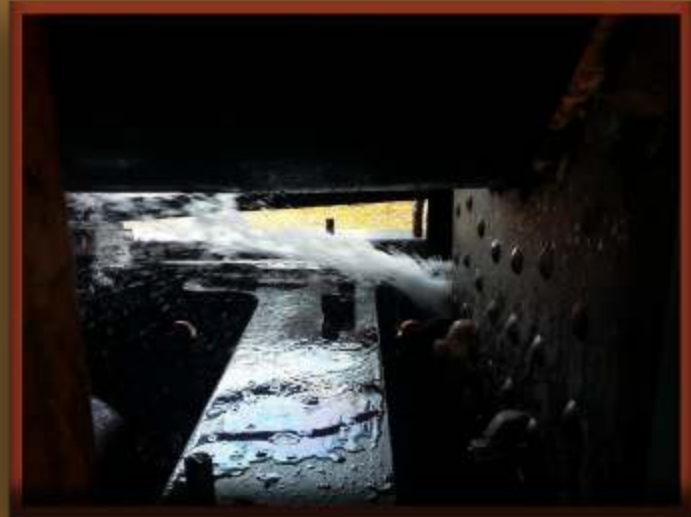
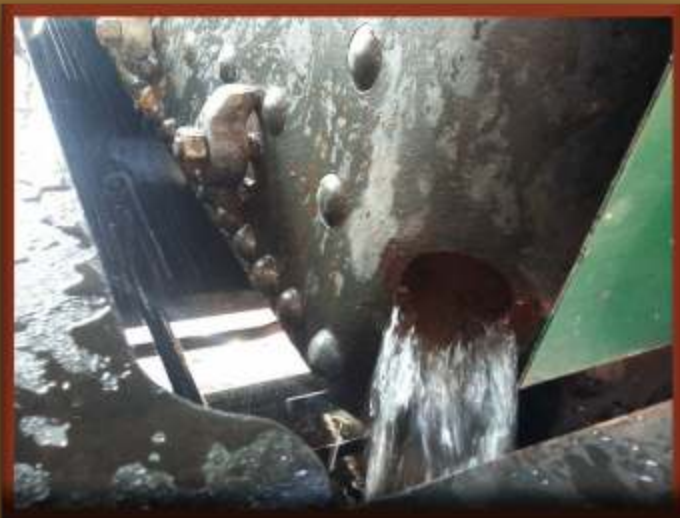
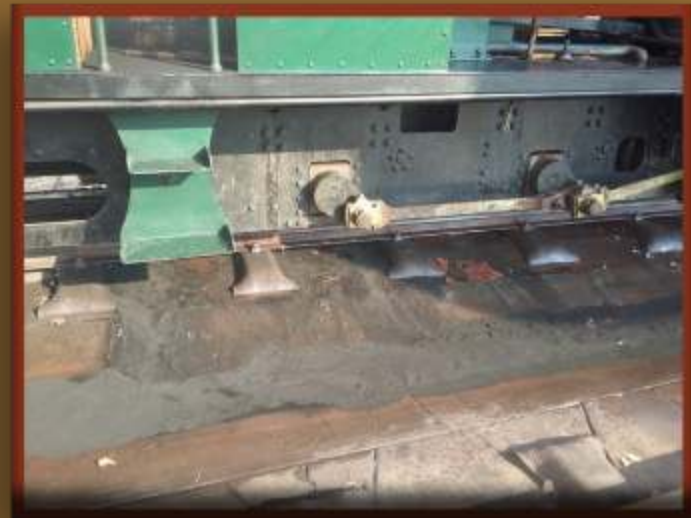
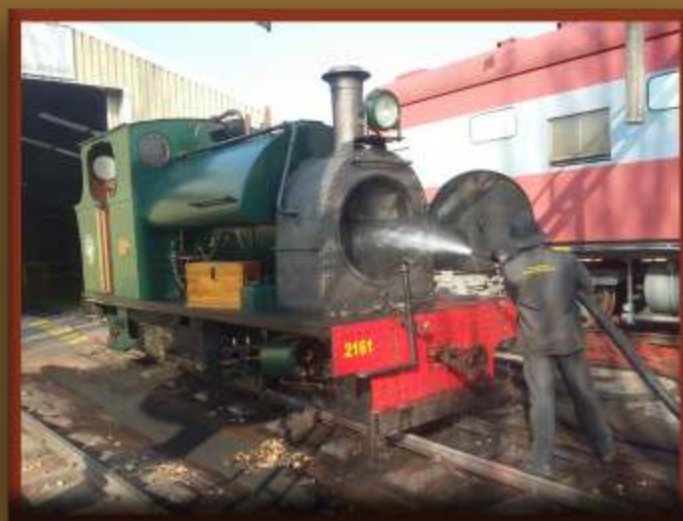
Copper scraper rods are used to scrape out hardened scale from the foundation ring.

Finally her tubes were cleaned and the fine ash washed down from the fire box to prevent damage.

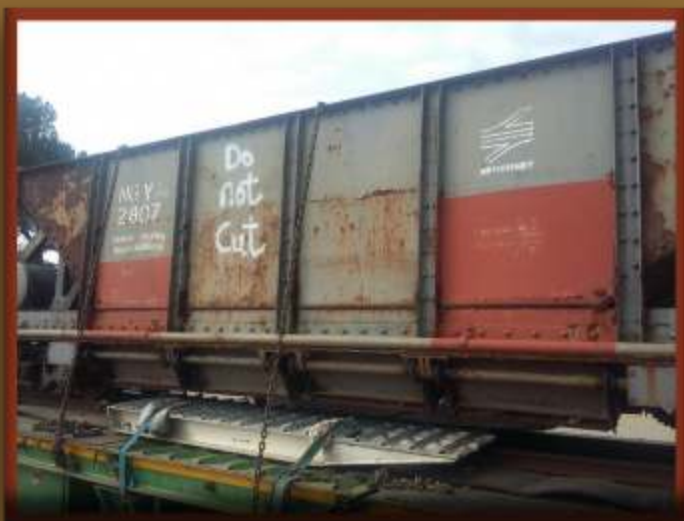
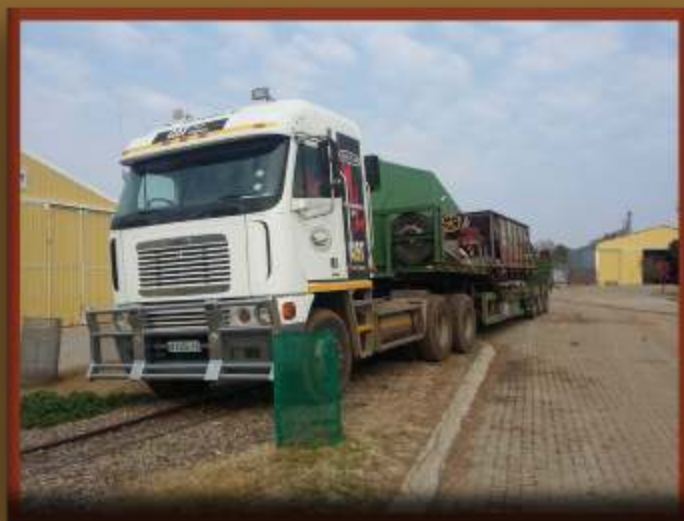
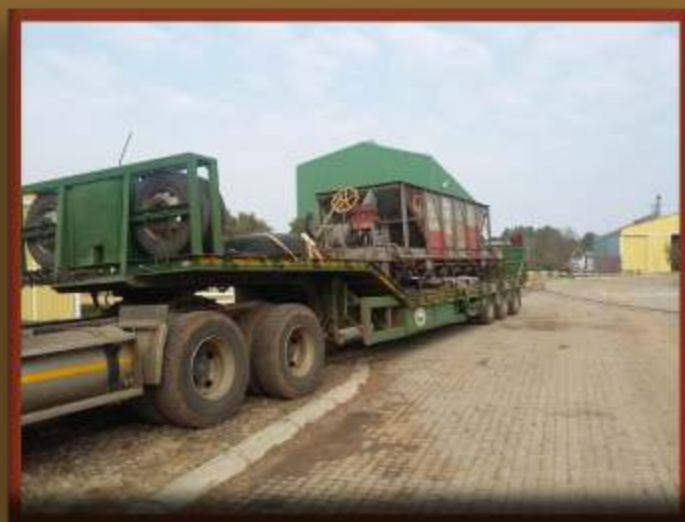
## Ay's numbers 2807 and 2883

This week Mr.Mole send down 2 Trucks to Port Elizabeth and collected another 2 good Ay wagons. The wagons Were offloaded and will await restoration.

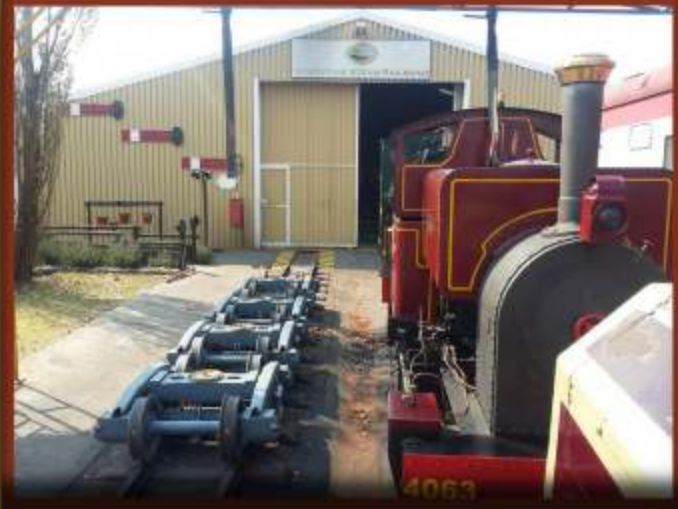
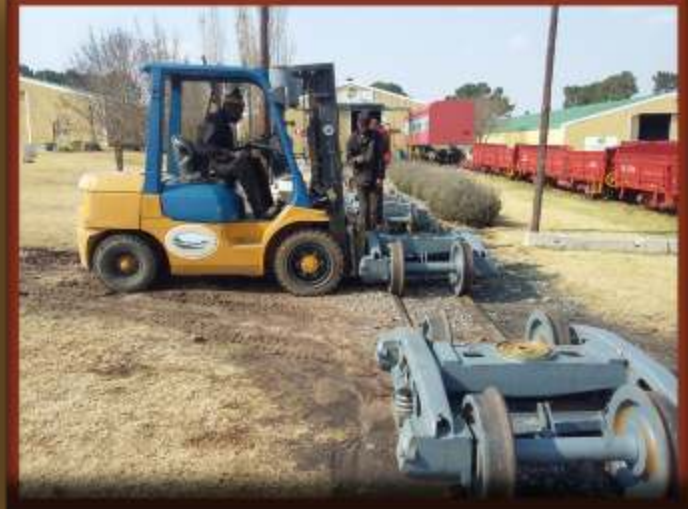
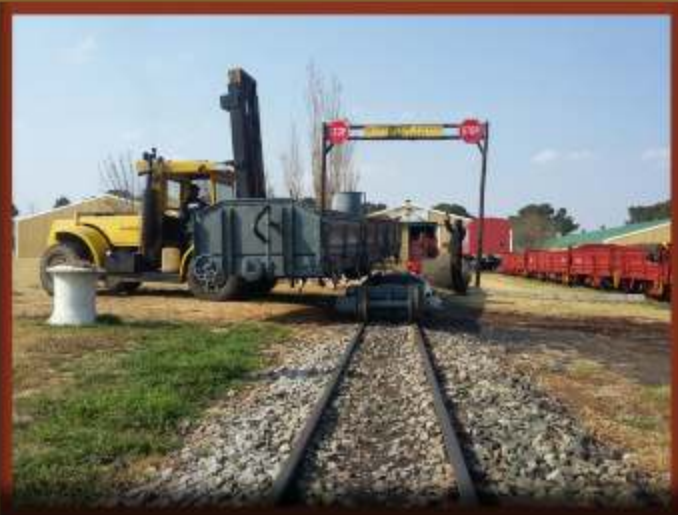
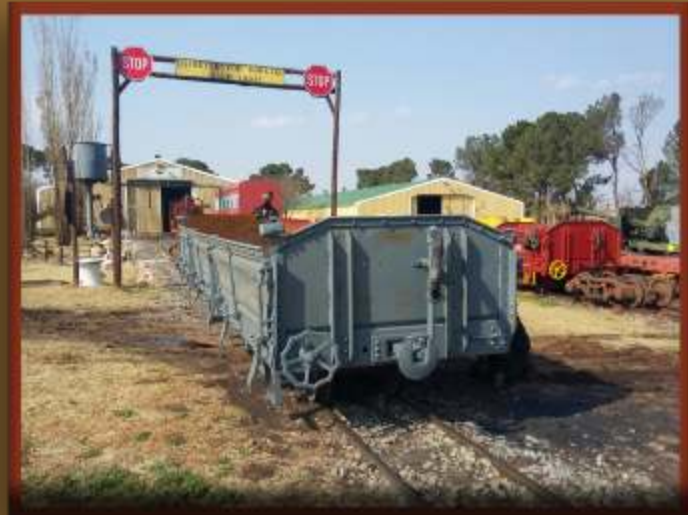
The DZ wagon restoration was side tracked for a few days to enable us to boost the restoration of the second Dining Coach for Hoekfontein Station. Yesterday we lifted back 2 DZ wagons and sand blasted another 4 bogeys. These 4 Will be moved to the shed for for mechanical restoration and will be painted before we lift another 2 DZ wagons.

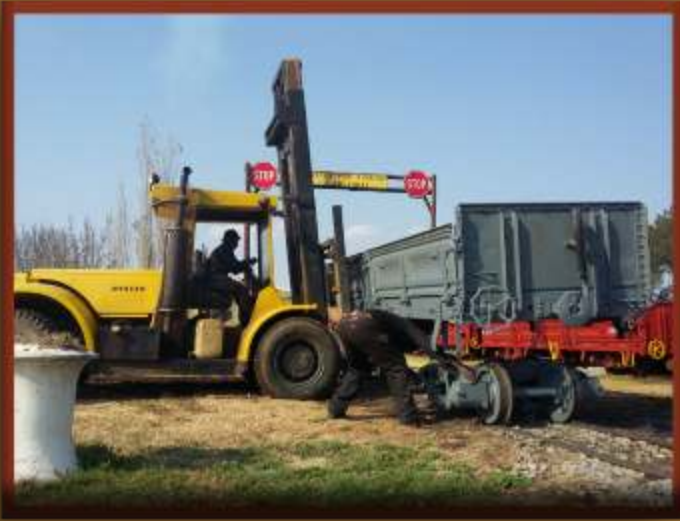
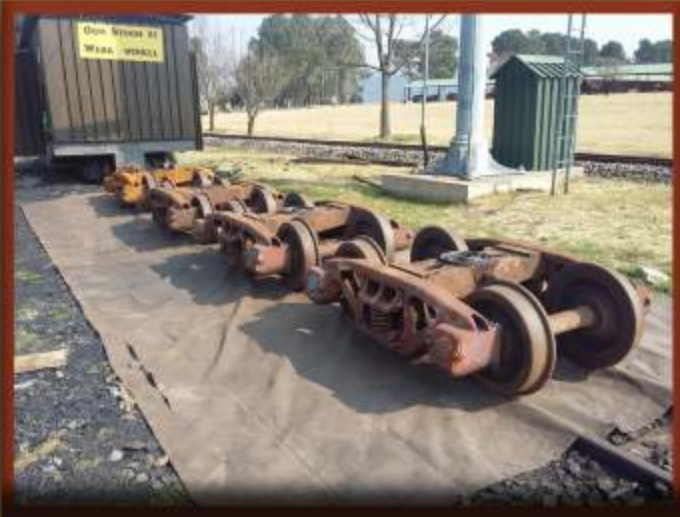
This 2 DZ wagons will now be moved to the Steam shed for bake adjustment and final body work that is needed.

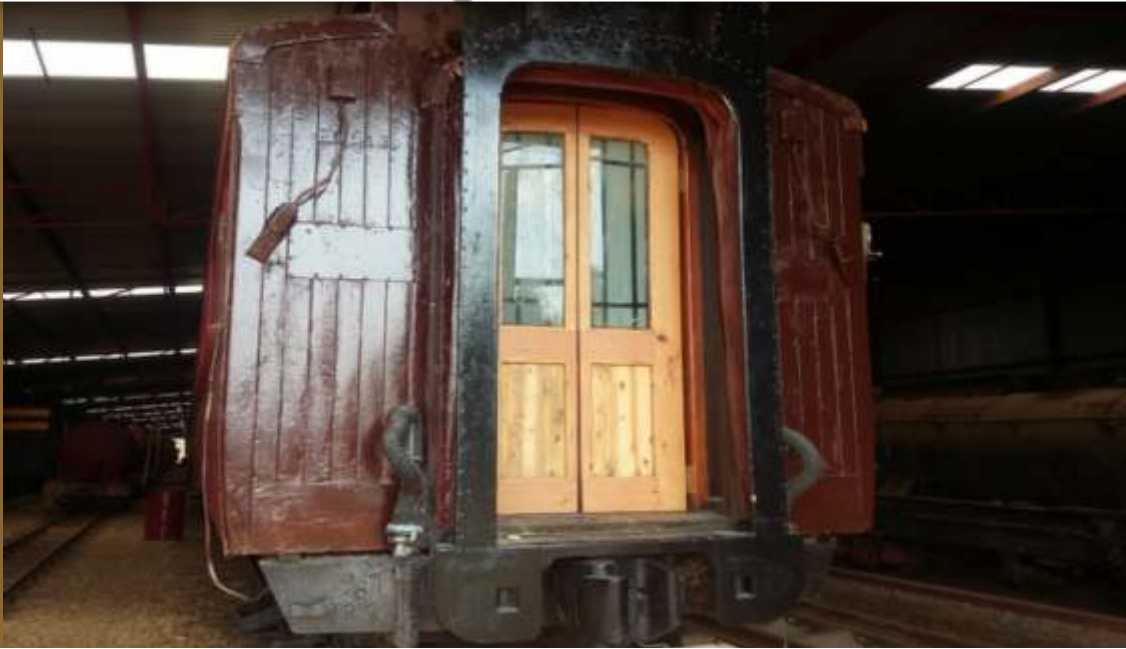
### Riet 218

During the last week we fast track the restoration of this exquisite Dining Coach number 218 called Reit. There are still A few items to attend to before this restoration will be completed. From now on we will spend a day each week to fast Track the restoration of sleeper coaches for Stars 2017.

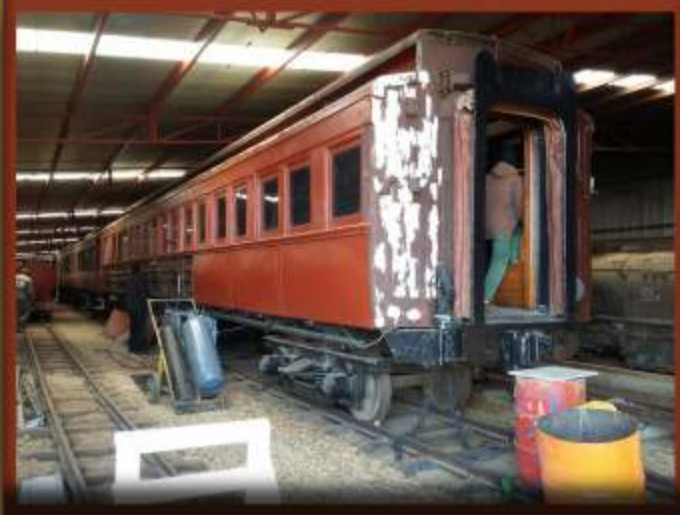
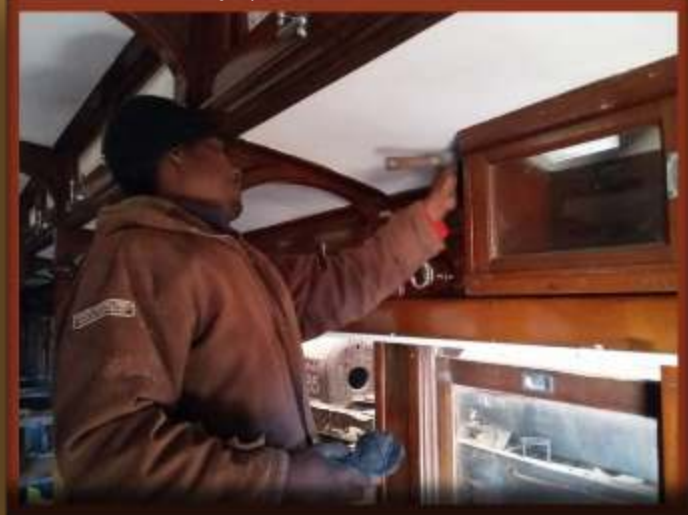
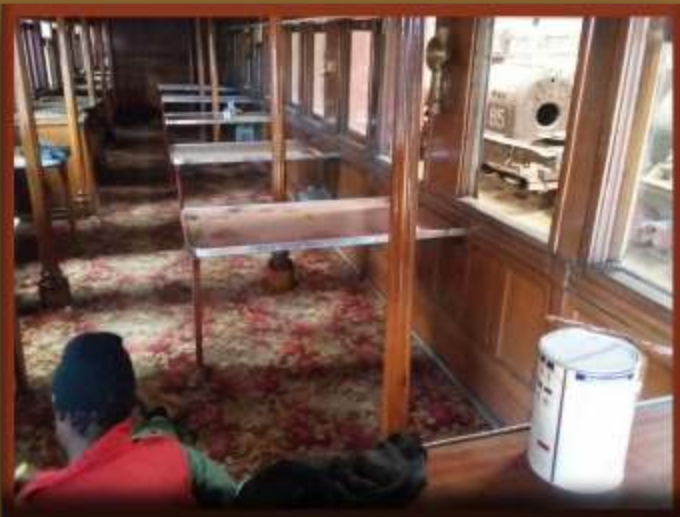
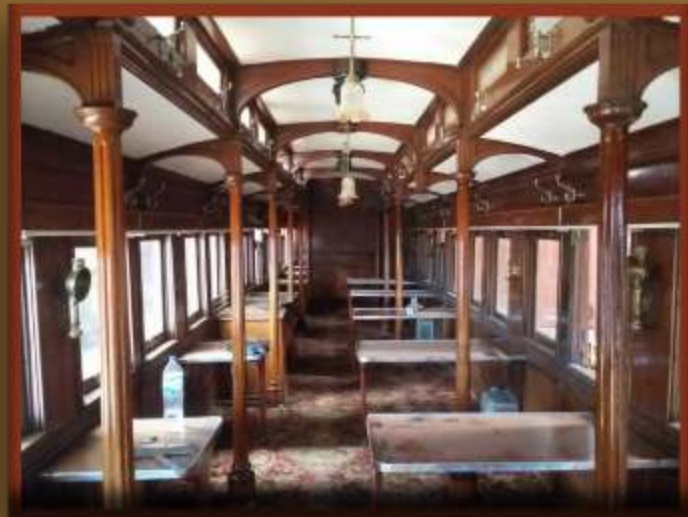
Our team fitted back large and small windows and repaired the inside of the coach. Lamps were repaired and fitted Back while our cleaning ladies did a great job of cleaning carpets and windows.

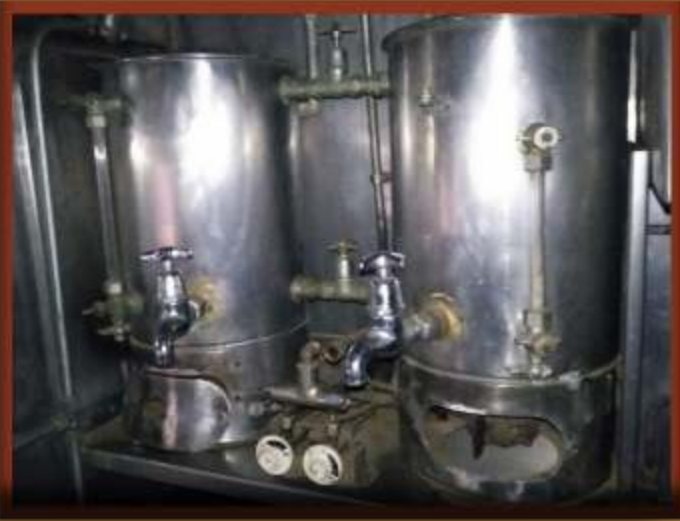
Below left: A interesting kettle inside one of the Kitchen cars, fitted with gauge column glasses to see the level.

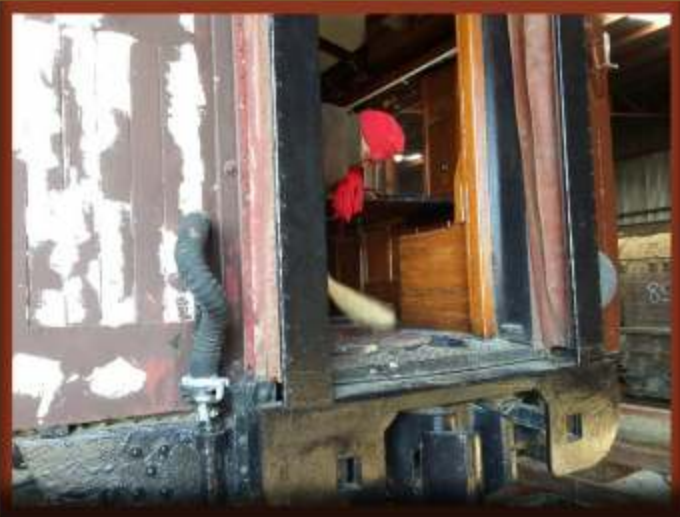
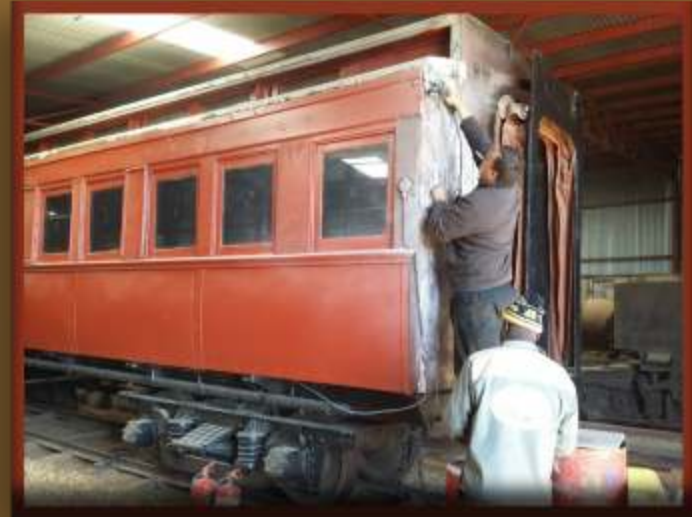
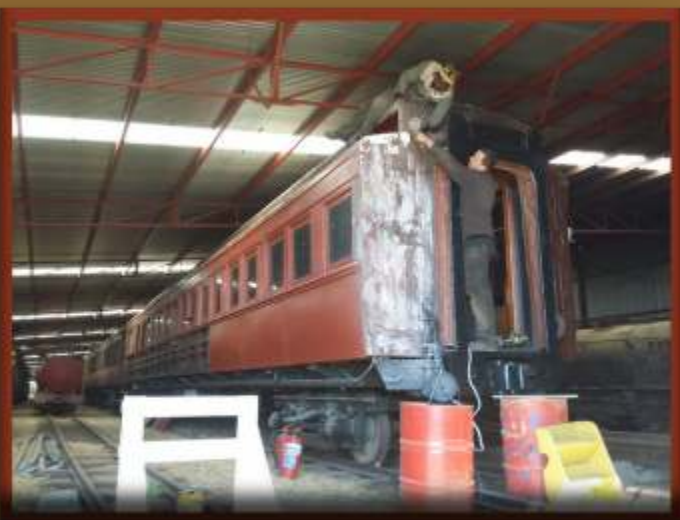
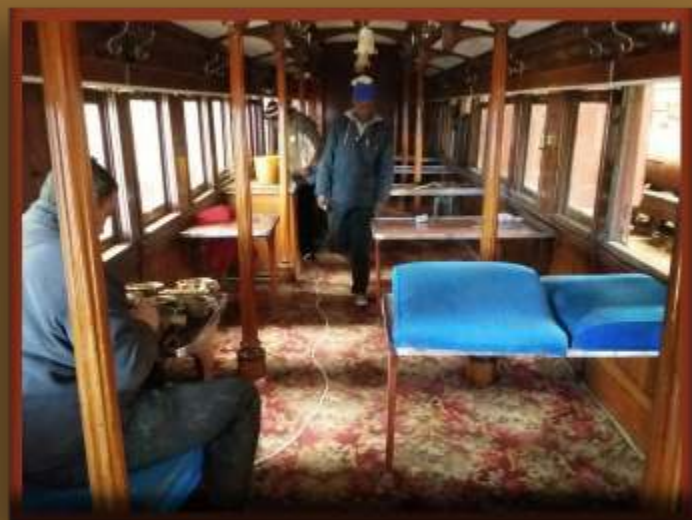
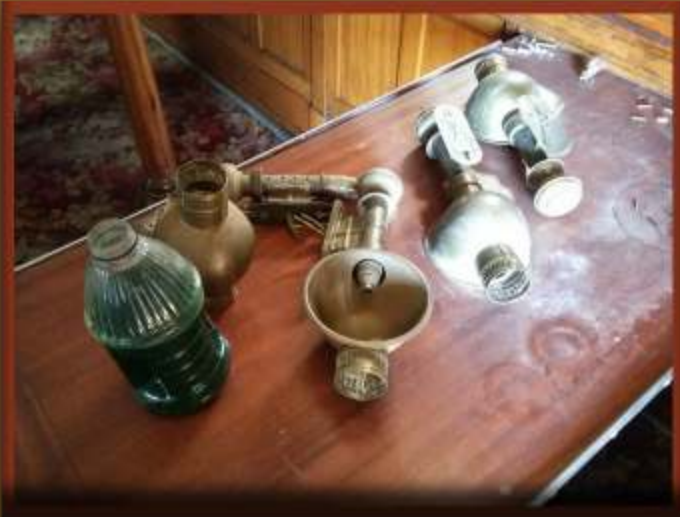
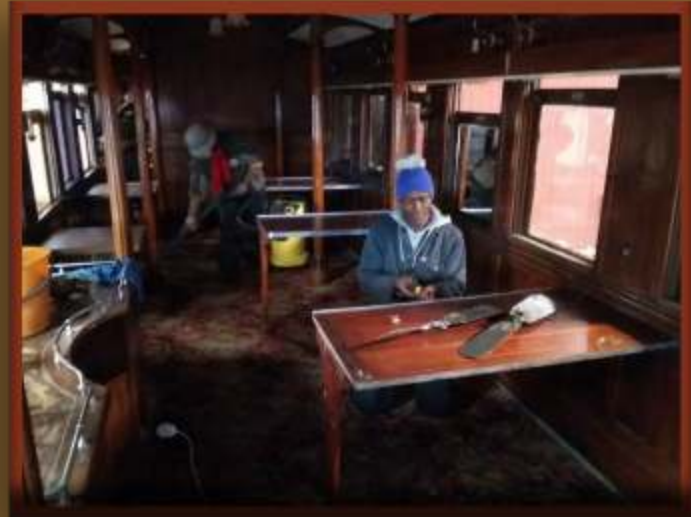
Below: Images of the restoration of the 3'6" Dining coach.

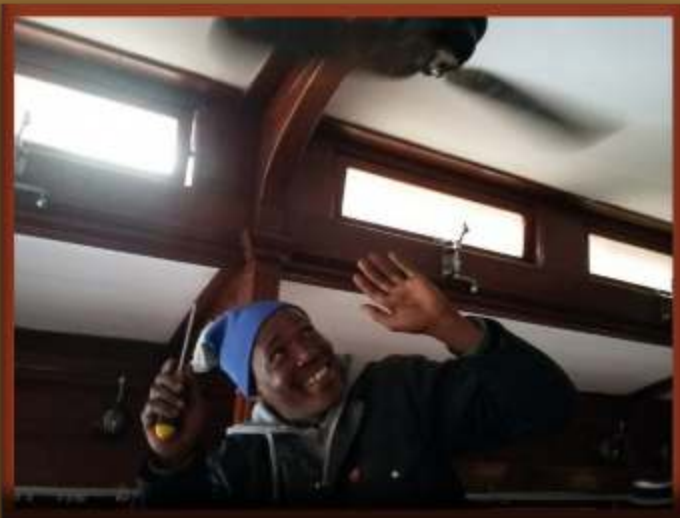
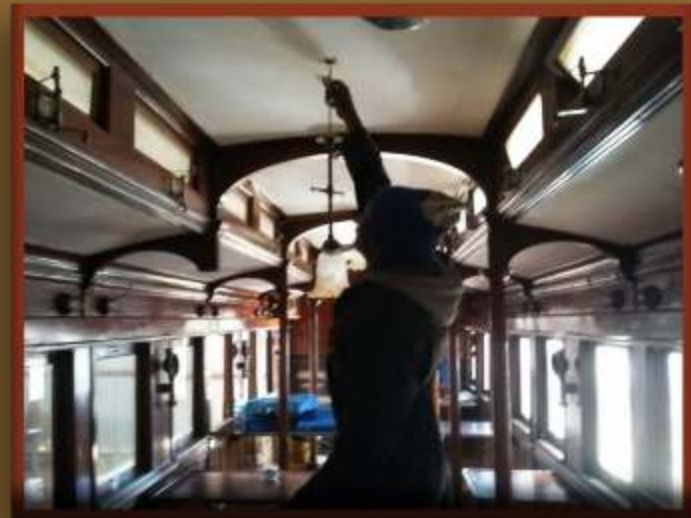
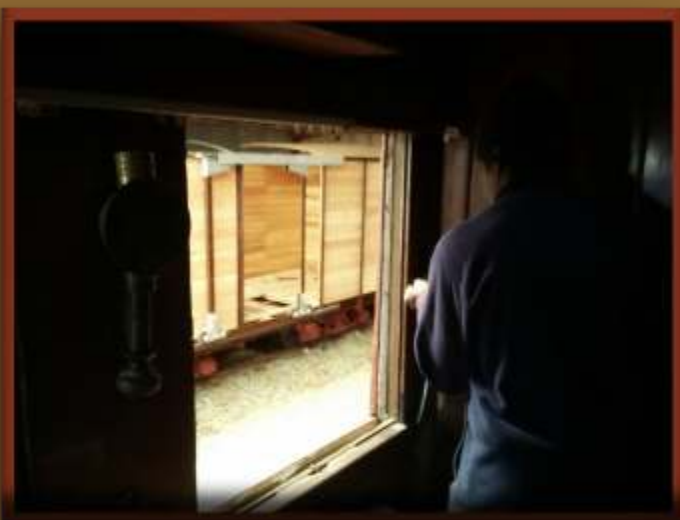
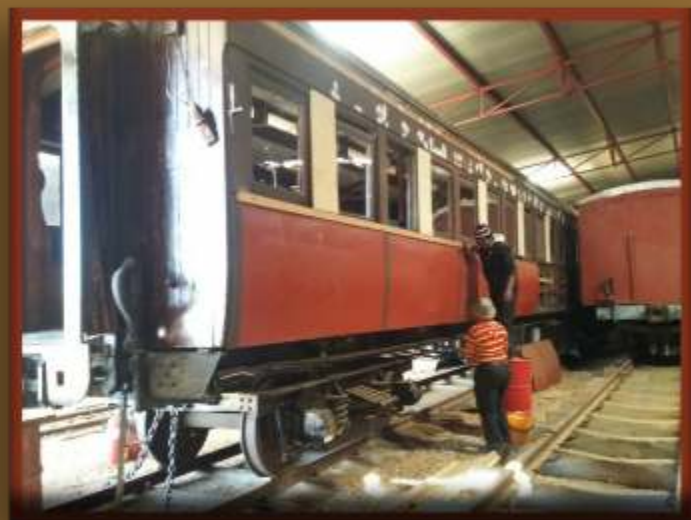
Below left: Brian just fitted 2 ceiling fans and then tested it :-)

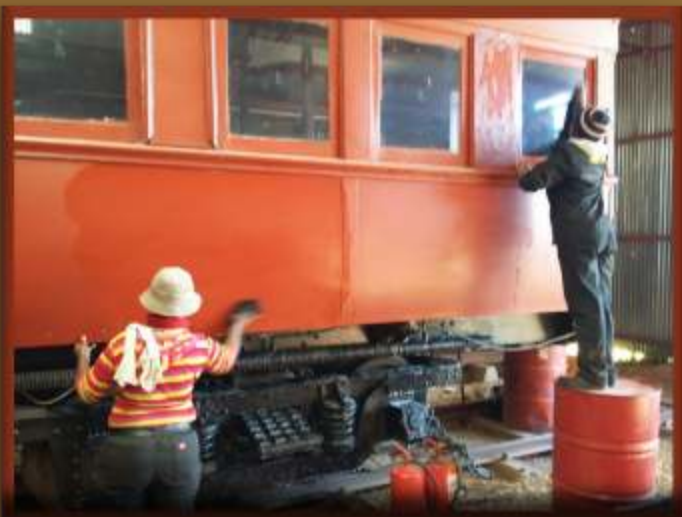
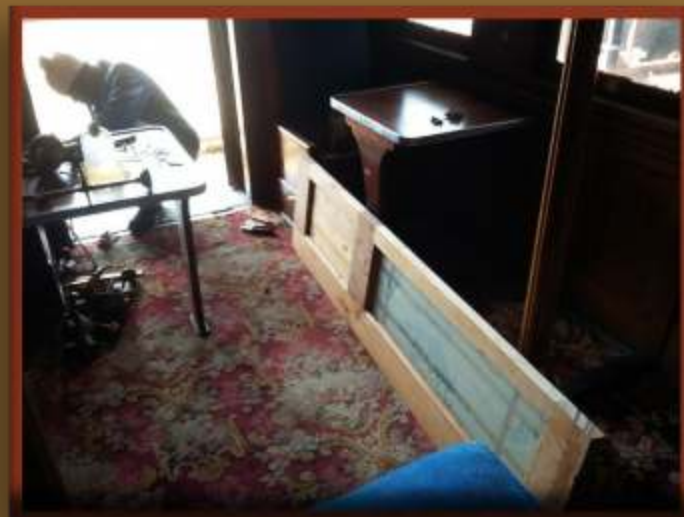
Below right: Ernest busy fitting the doors.

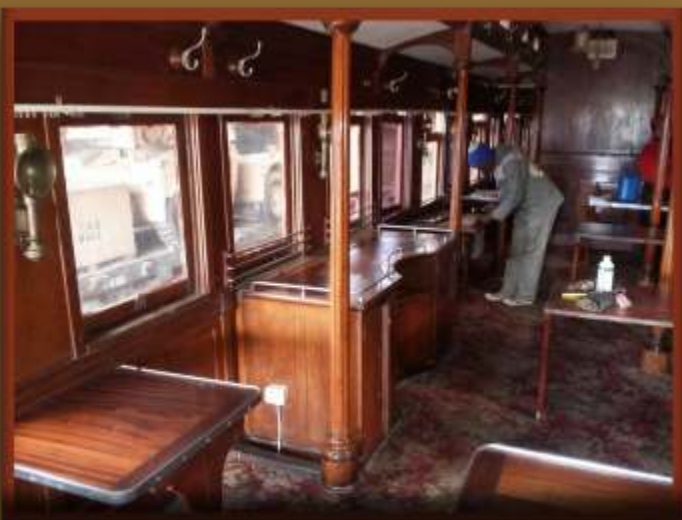
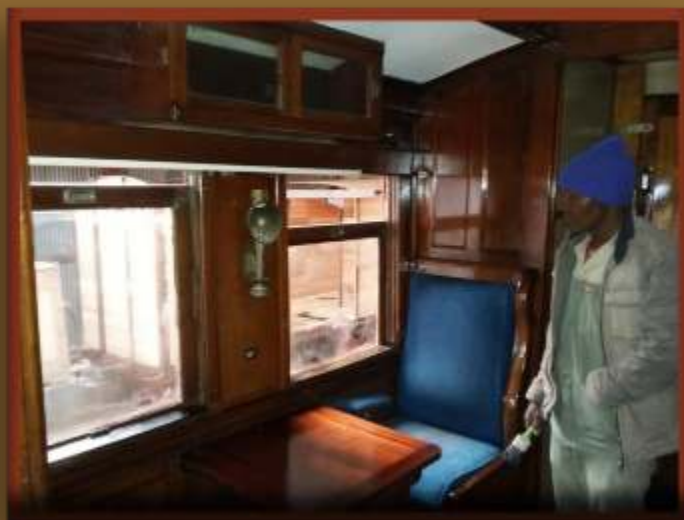
Below right: Brian and Agnus then started and varnished the interior of the Dining coach.

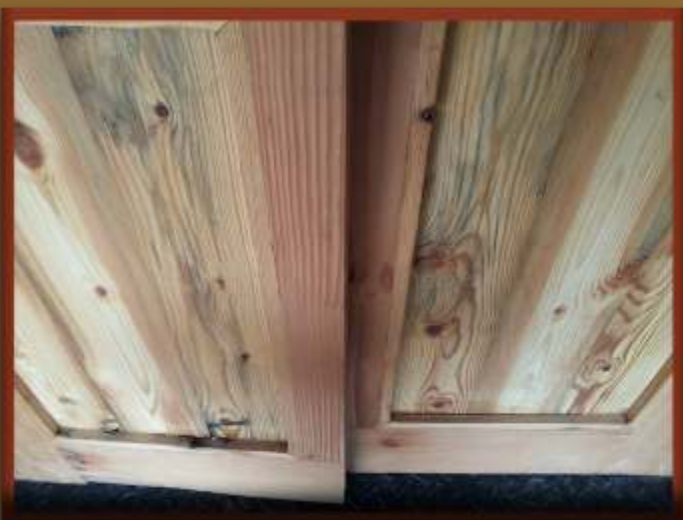
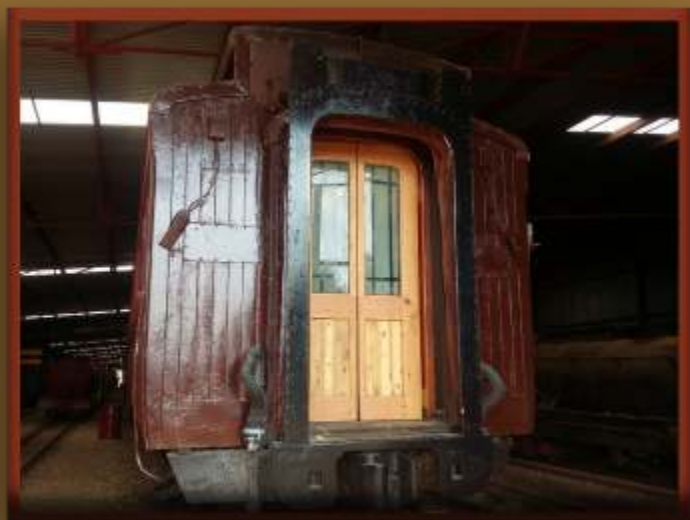
Below: The new origin pine doors fitted.

Ernest will now finish the final work needed on this coach as well as the last work needed on the outside.

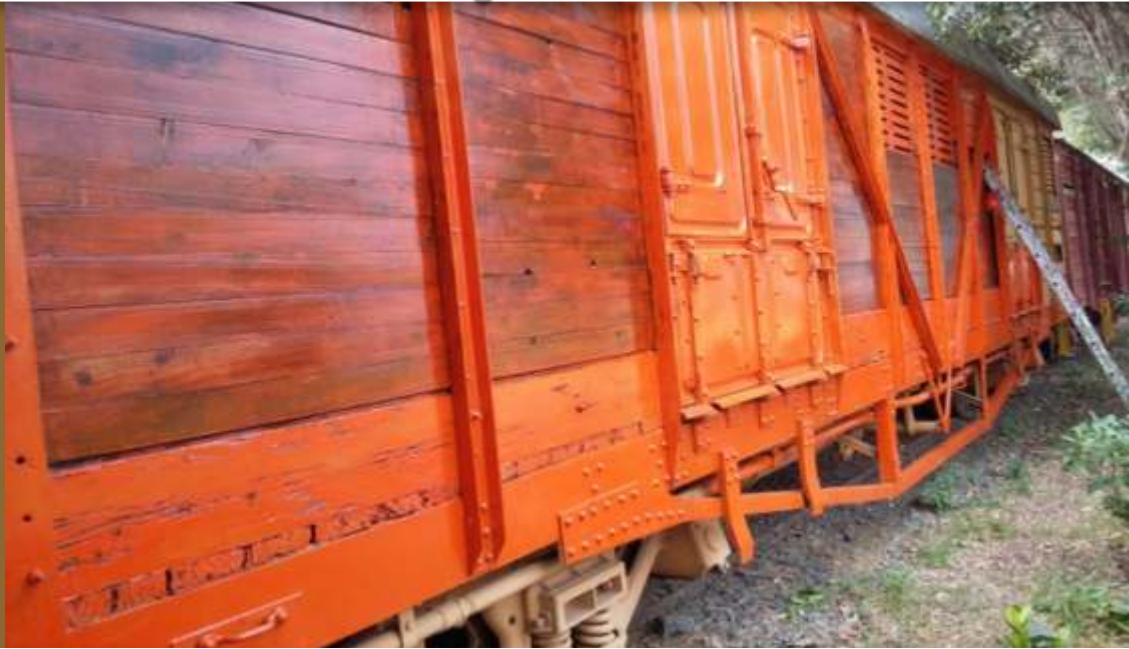
In between the tasks we tackled the cosmetic restoration of the 3'6" goods wagons in Hoekfontein Station. This past Week Petrus and Johannes finished the painting of the Elephant wagon and another orange wagon down the line At the stop block.

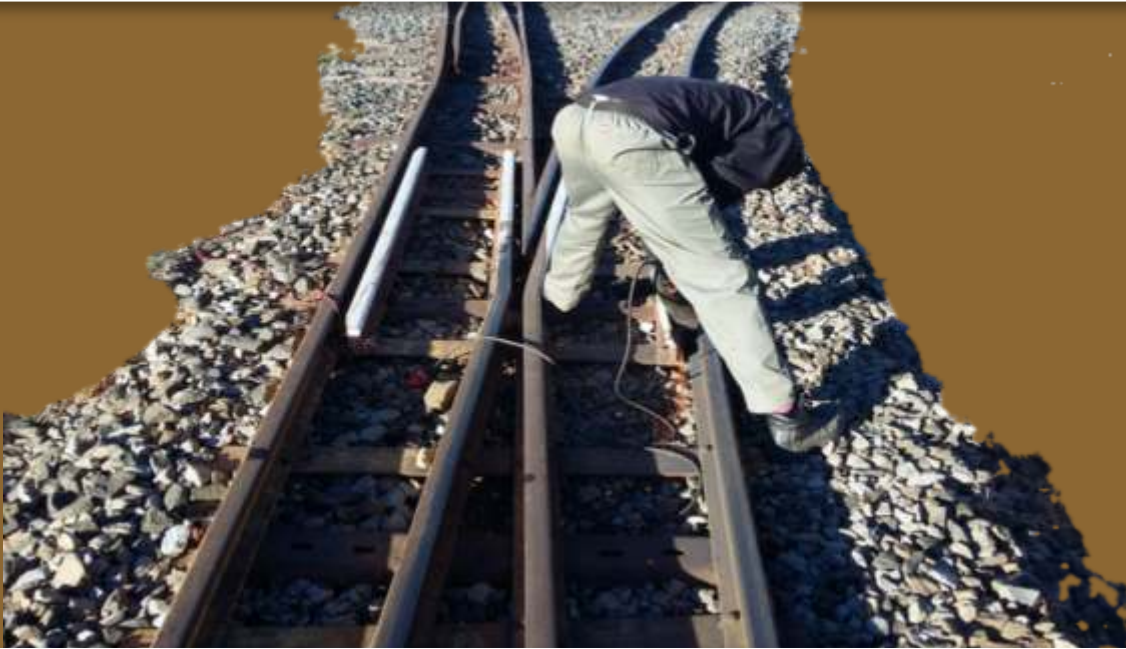
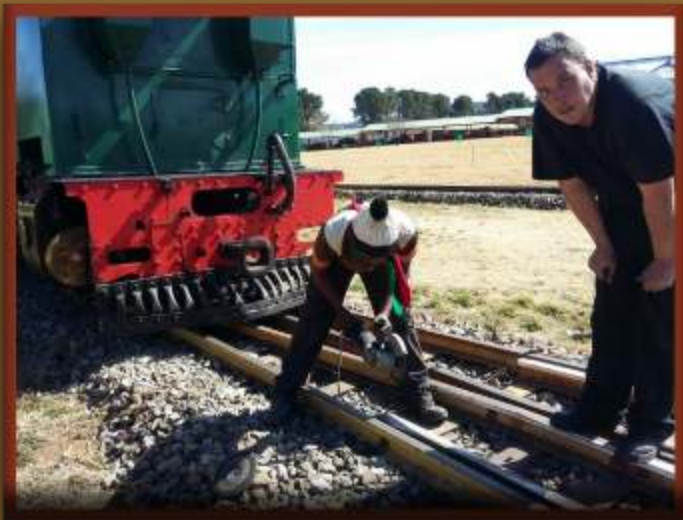
# Track News

The past week our Track Team has worked on the points near the Steam shed removing the rough edges of the check rail. They also are working on the section Hoekfontein towards Mooihoek, lifting out slacks and aligning the line.

The work on this section is taking longer because Joseph and his team have to do lots of screening.
