## Highlights of the week!

# Boiler Washouts

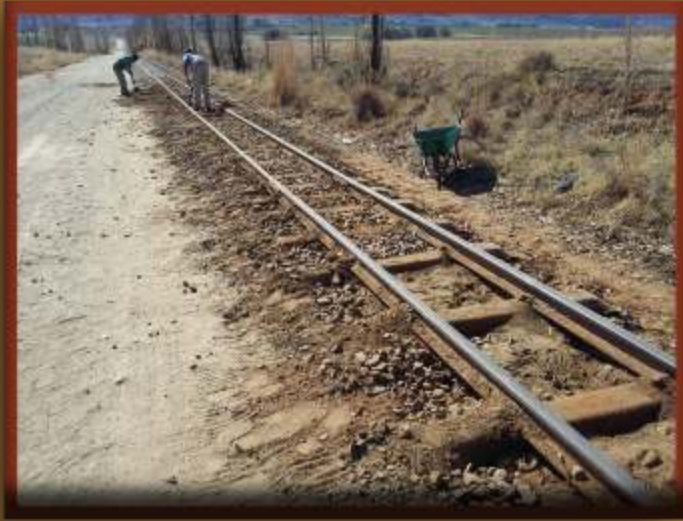
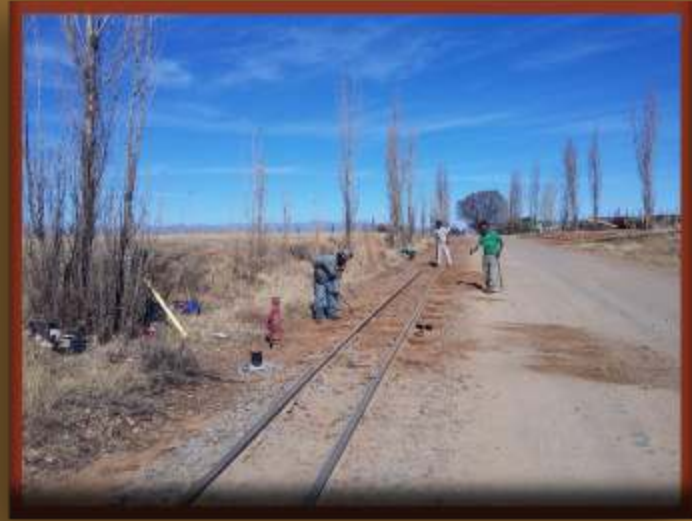
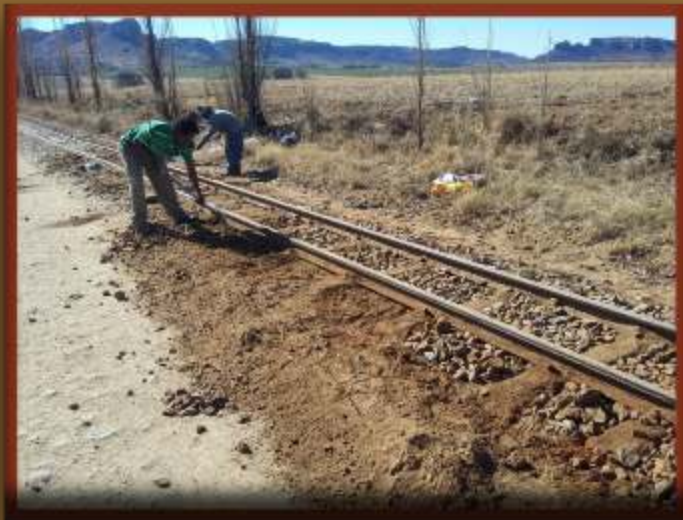
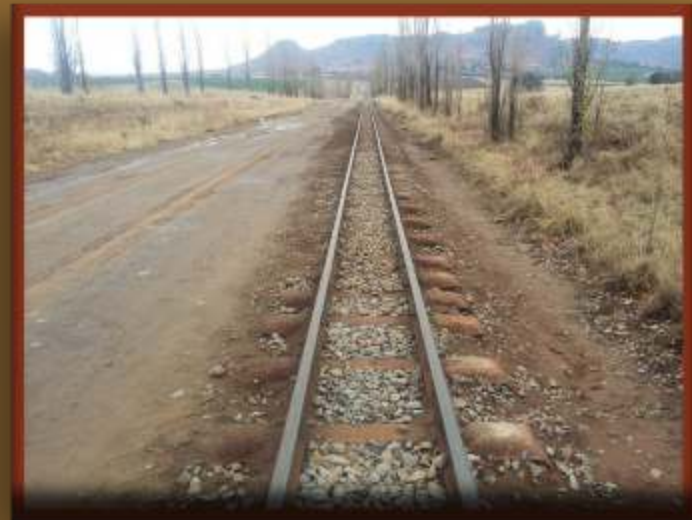
This section of line is in need of ballast and we will ballast this part of the line in next week. Enough ballast is essential As ballast is the foundation and suspension of the track and also ballast plays a important part of drainage on the track.

Excessive soil in the ballast promotes corrosion of the sleepers, fishplates, T bolts and track.

This section will take us some time but at the end it will be properly done.

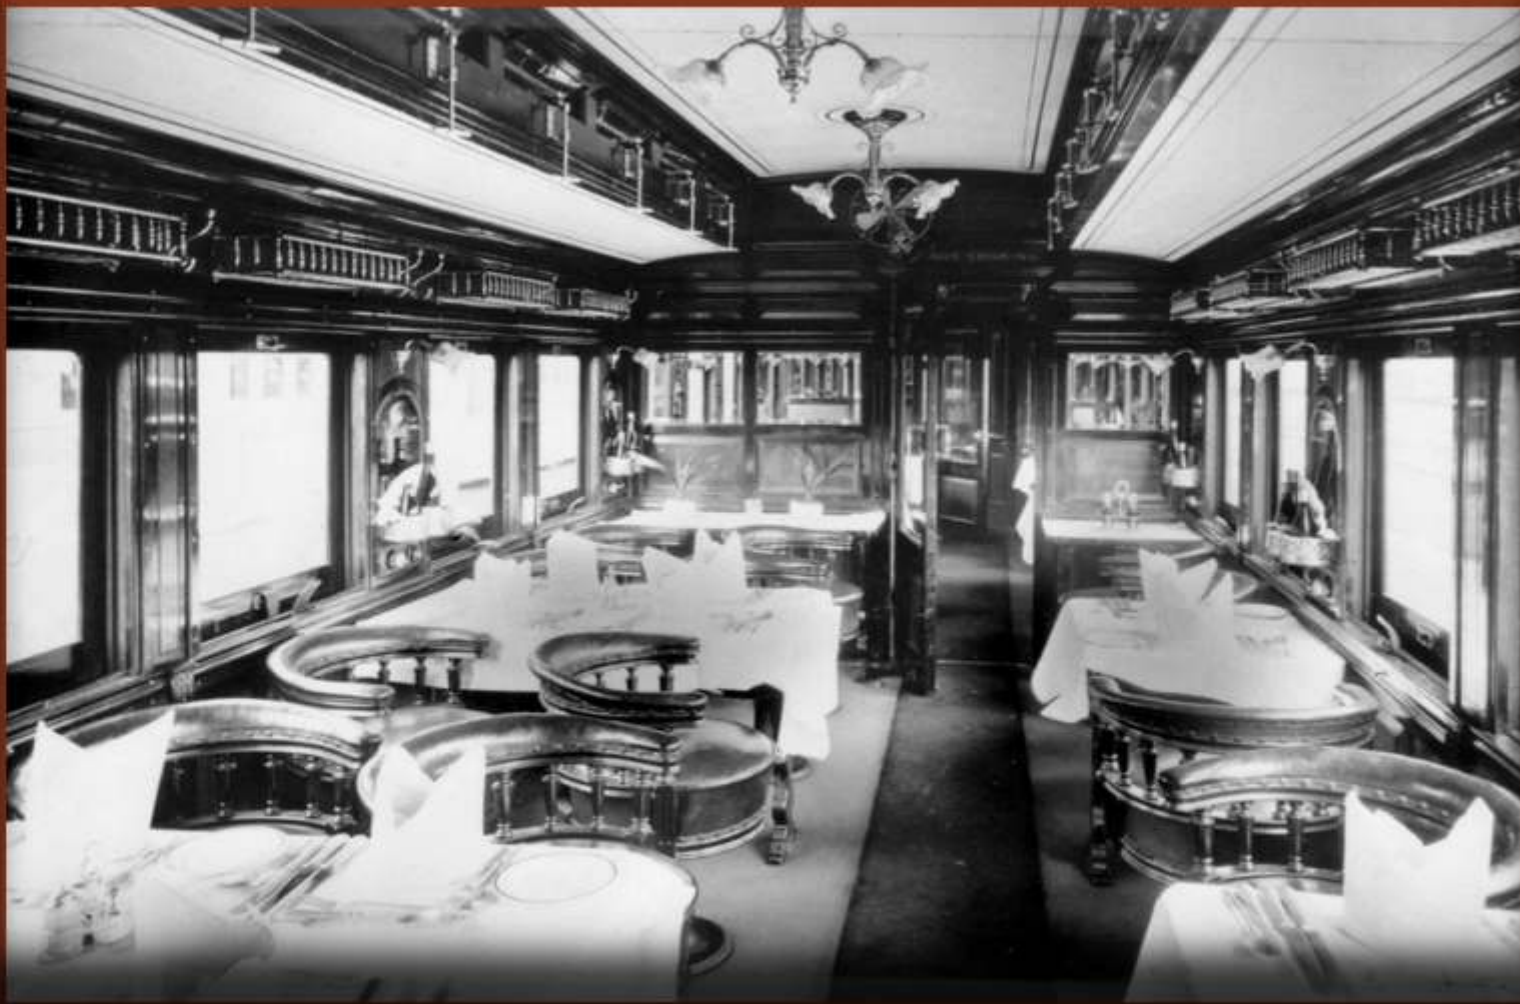
This is the interior of a dining saloon used by the Central South African Railways and taken over by the South African Railways in 1910.

This type was placed in service by the CSAR in 1907. The CSAR was the civil Administration that controlled railway services in the Transvaal and Orange Free State from 1902 - 1910.
