### Update on the NG10. 1<sup>st</sup> June 2017

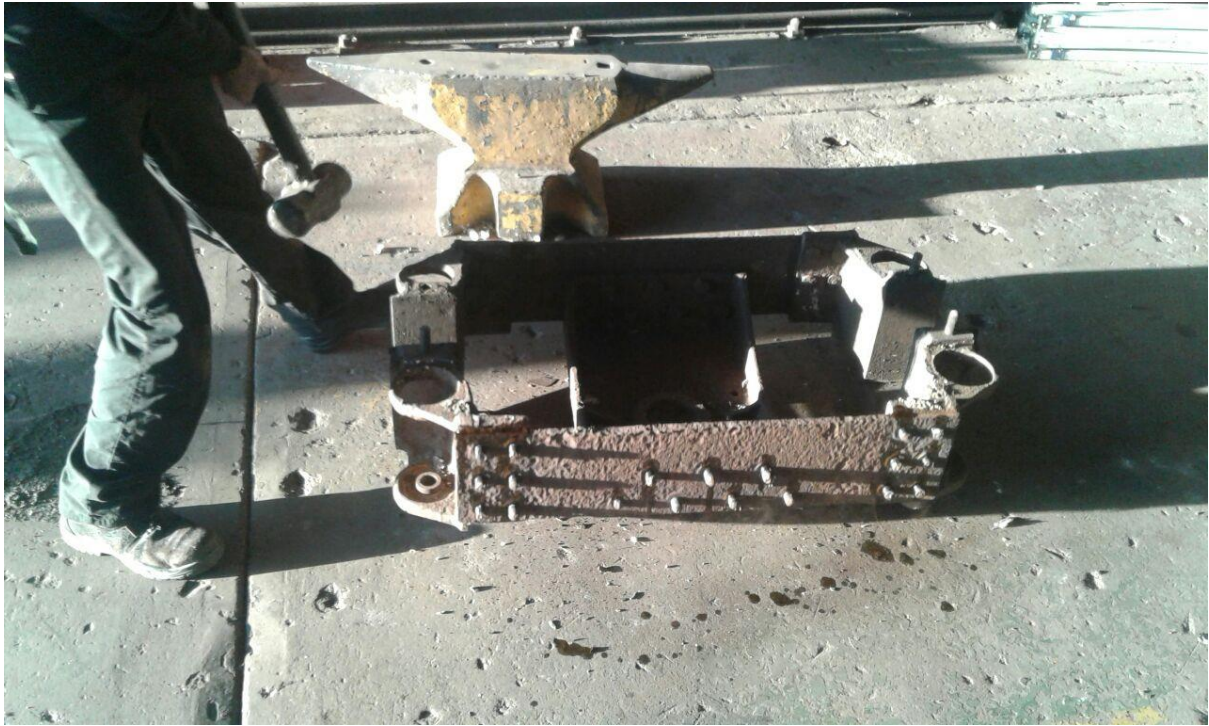
Our updates lately have not been the usual “glamorous” ones as Lukas Nel and the Bloemfontein team tackle the real hard work on the loco. The parts that most people do not see. This week the bissel bogie has been the subject of much scrutiny and will be scrapped in favour of a new build. Due to accident damage, but primarily corrosion, the existing bissel was disassembled and will be used as a pattern for the team to build a new one. Our pictures from Lukas show the existing bissel and after it had been taken apart.

The rusted bissel frame

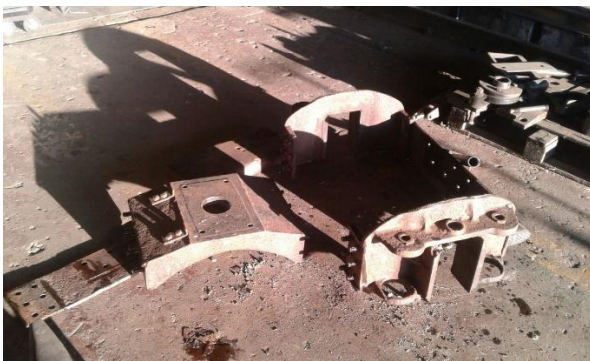
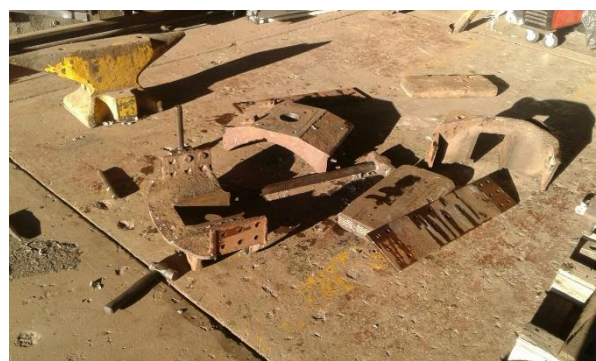
The disassembled frame
