## NG10 Boiler report from Keith Stevens

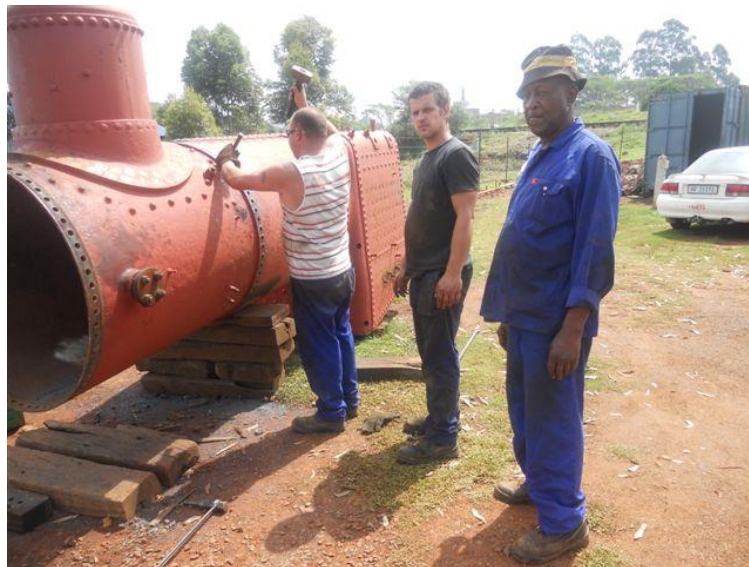
*Removing rivets*

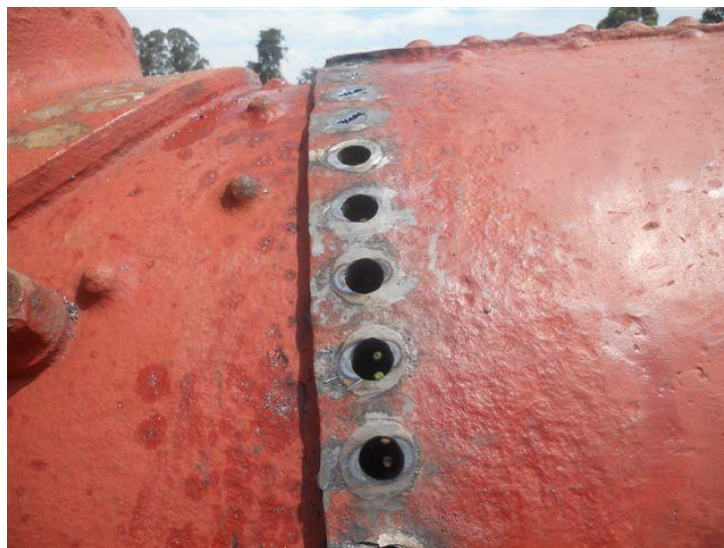
*Rivets removed*

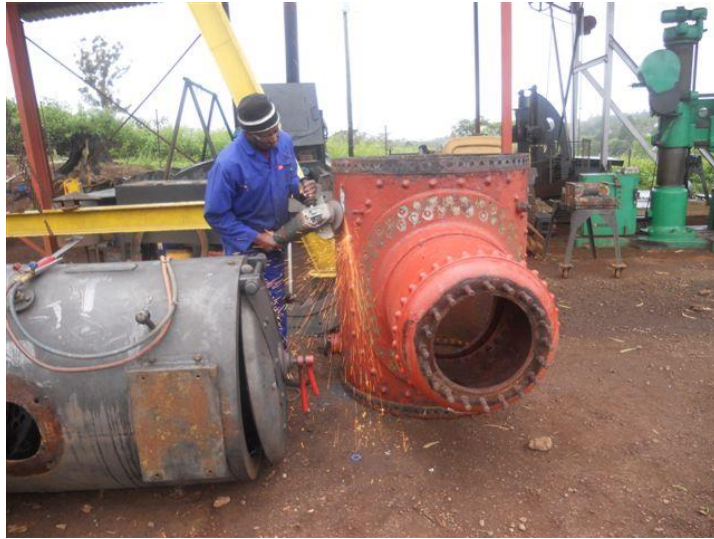
*Stripping the dome section*

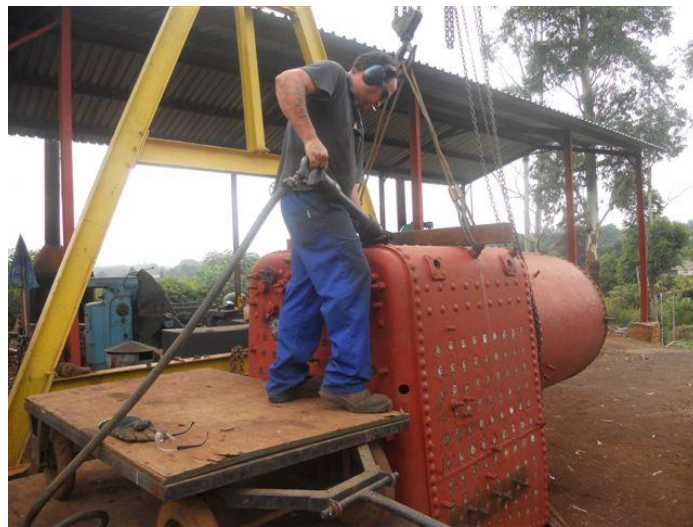
*Cutting the stay heads off*

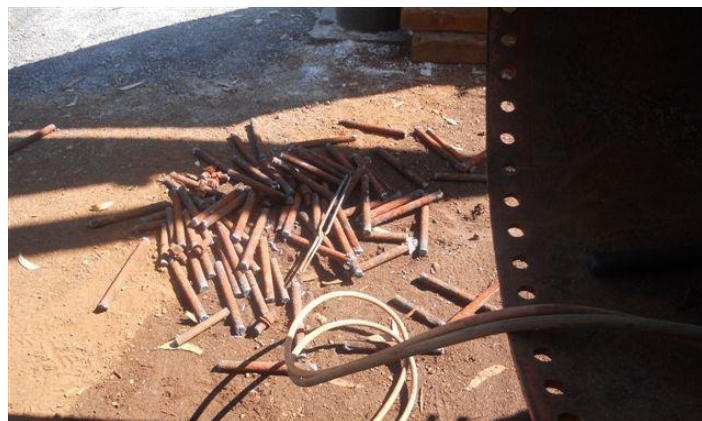
*The crown stays after being cut off*

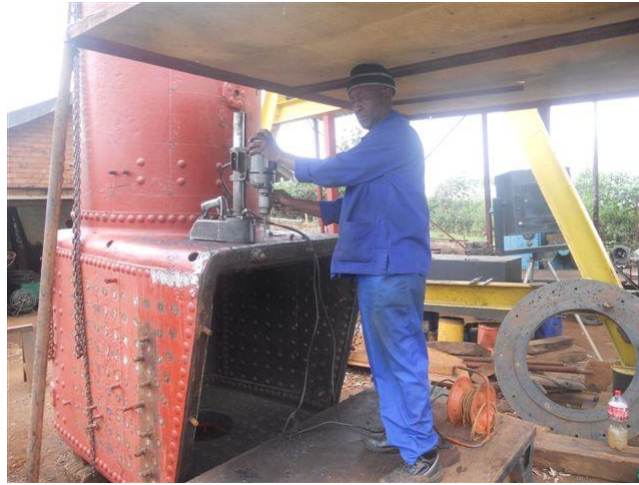
*The throat plate stays being drilled out*

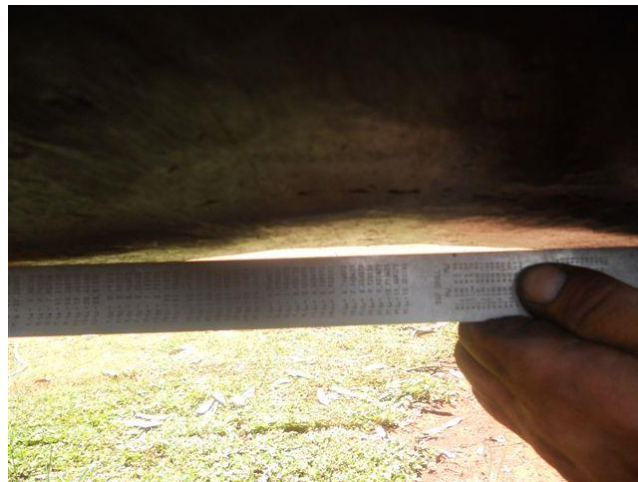
The boiler barrel also has a large bulge that must be attended to and our pictures from Keith show the work to repair the bulge.

*The extent of the bulge in the NG10 boiler barrel*

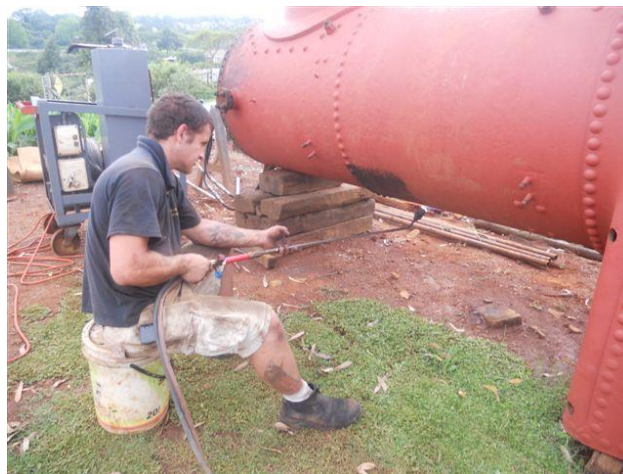
*Heating the area prior to the pressing out of the bulge*

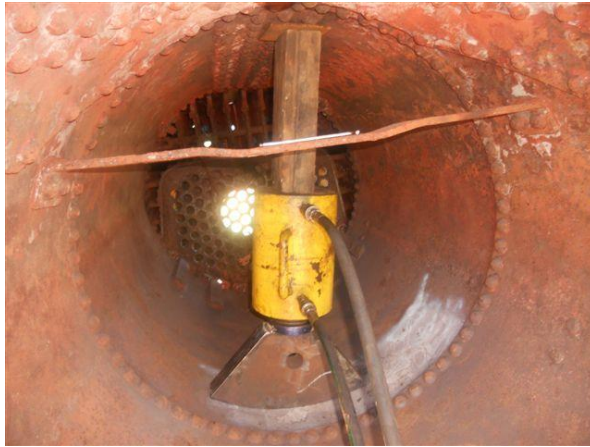
*Pressing out the bulge in the boiler barrel*
