## Report on NG10 number 61, May 2017 from Lukas Nel.

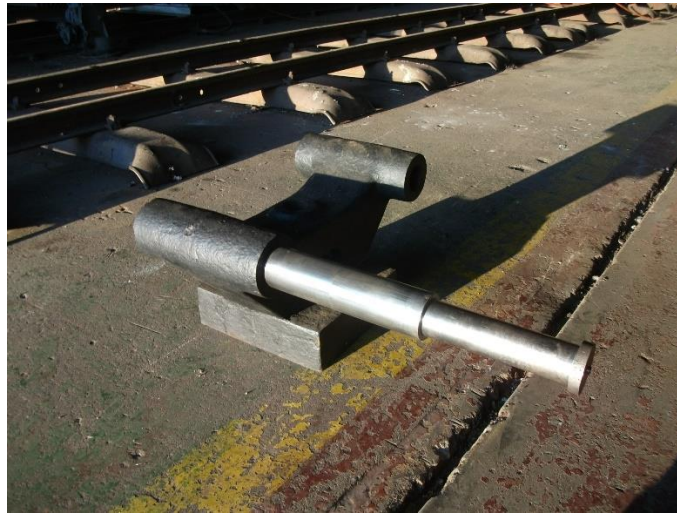
*The refurbished front bogie center.*

Tender tank body and the locomotive spring gear as well as the complete refurbishment of the front bogie center.

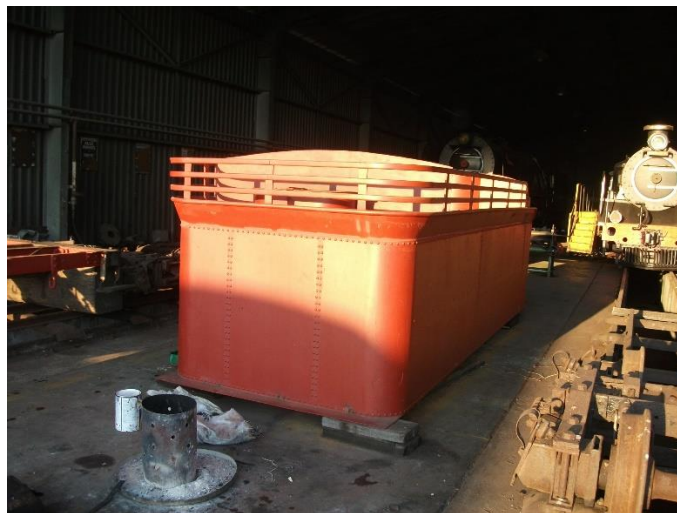
*The new tender tank.*

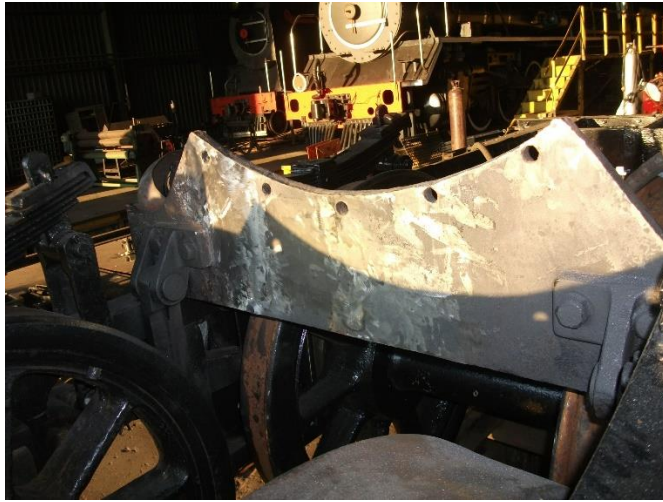
*The boiler belly plate.*

We have started to weld and replace most of the belly brackets and frame stretchers that were badly corroded.

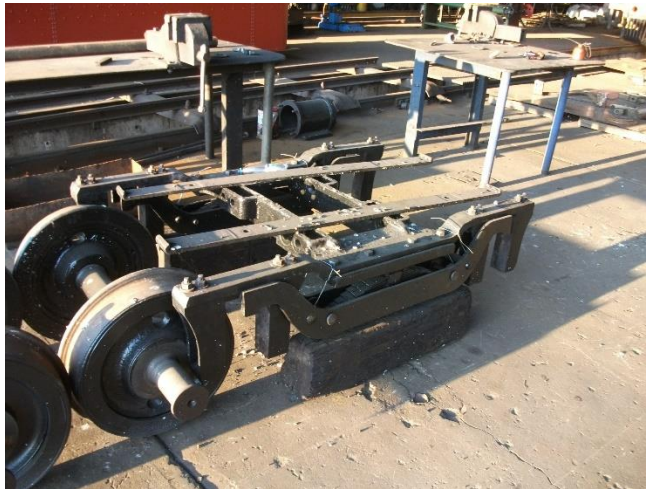
*The front bogie.*

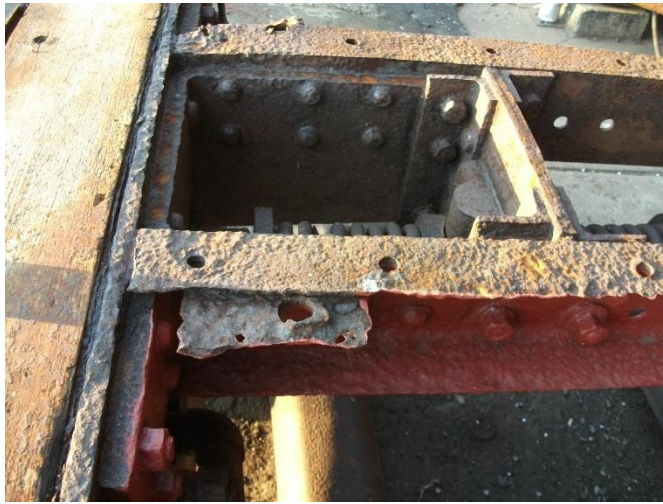
*The tender draw gear.*

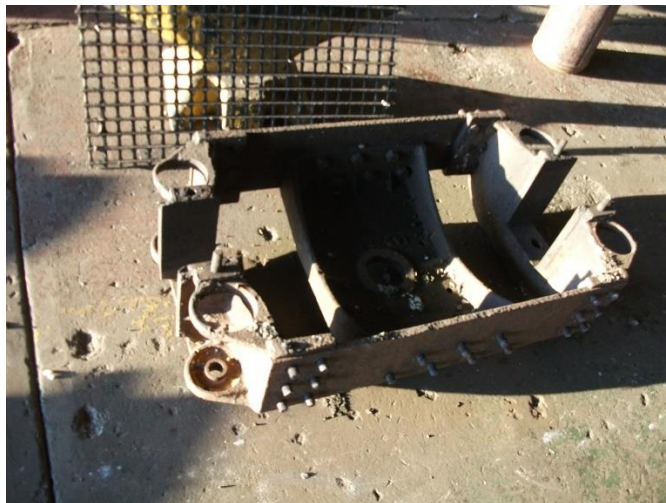
*The rear bissel frame.*

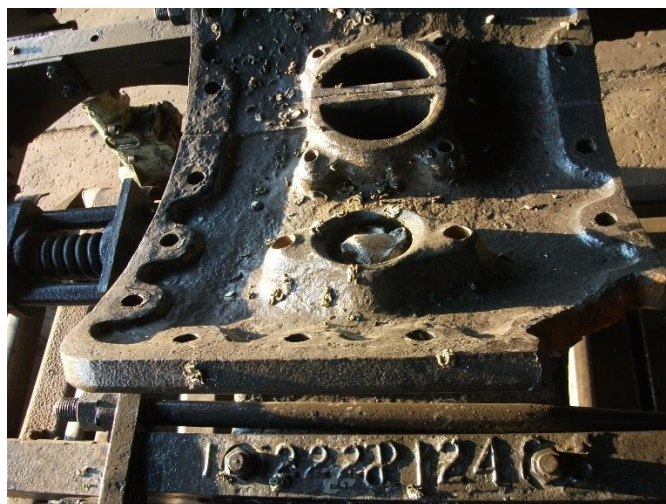
*The NG10 boiler saddle casting.*

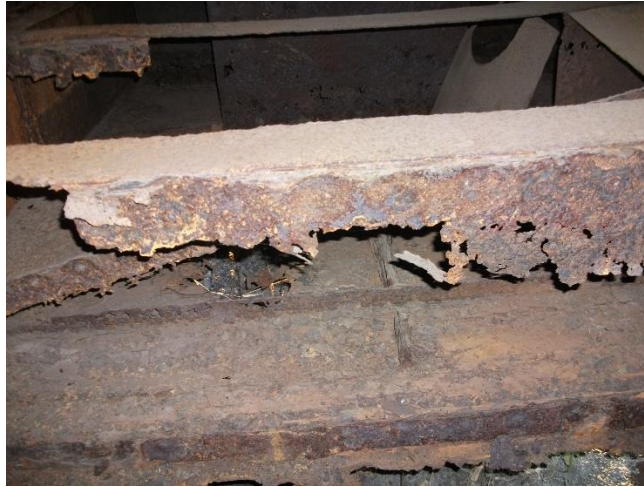
*The wasted interior of the old tender tank.*

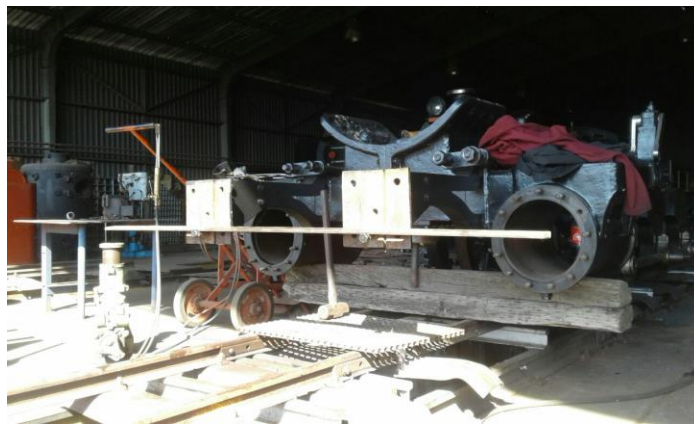
*Setting up the alignment of the buffer beam.*

The photos show the stripped spares of both the locomotive and tender plus work in progress on the buffer beam and frames.

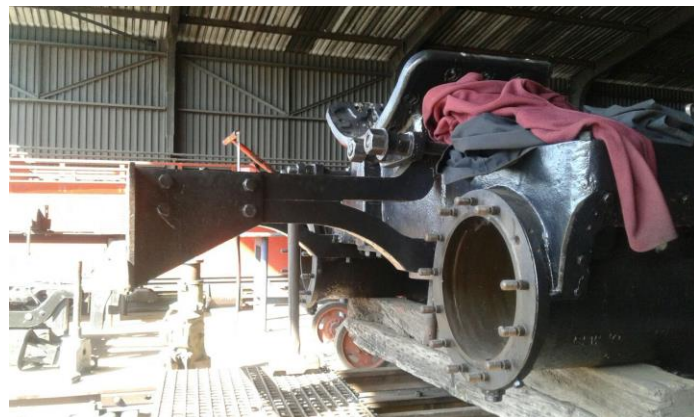
*Another view of the buffer beam.*

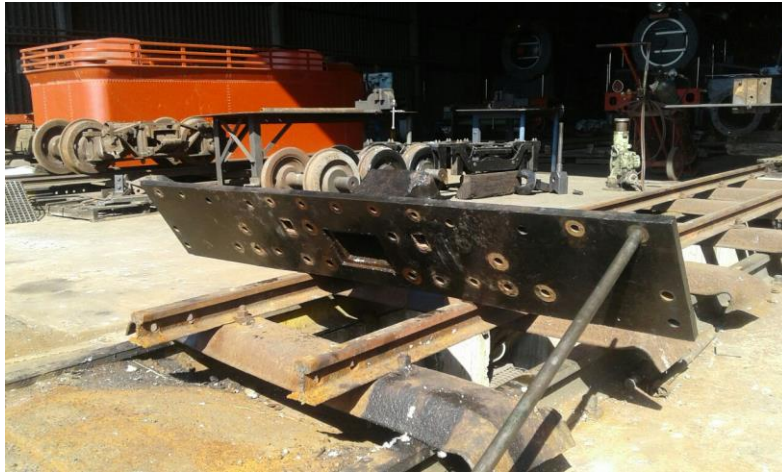
*The buffer beam after being re-aligned.*
