## Highlights of the week!

# NG Locomotive Boiler Maintenance

# Traction & Portable Boiler Maintenance

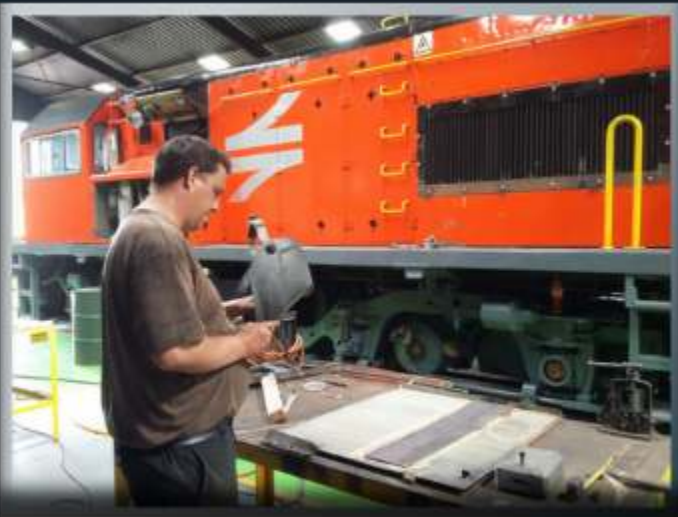
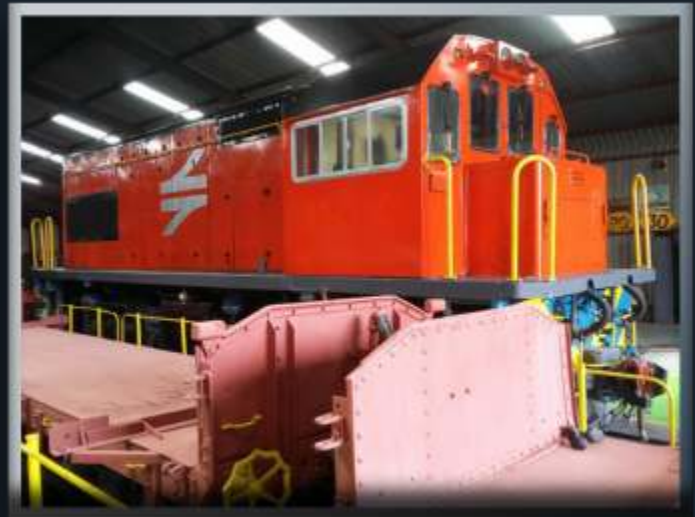
Below left: This rounded end on the compartment frame was completely rusted away and Wouter then fitted New steel to ensure a proper door hinge support on this side.

Since the last report Wouter went on with the cosmetic restoration of our Class 91 Diesel locomotive. The last was to make new doors for the compressor compartment.

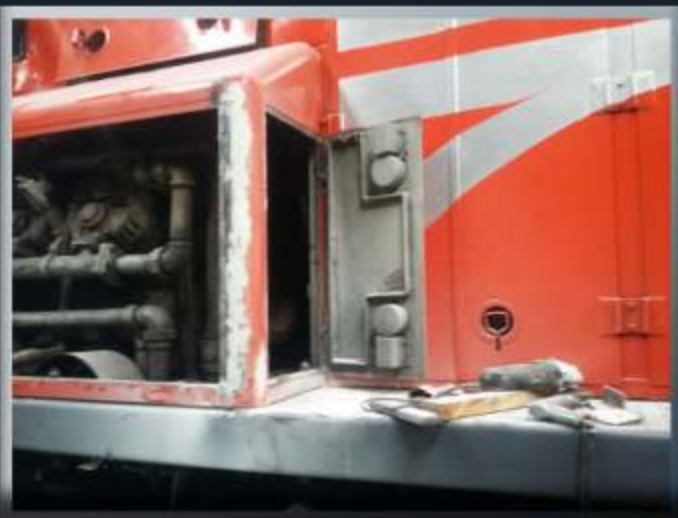
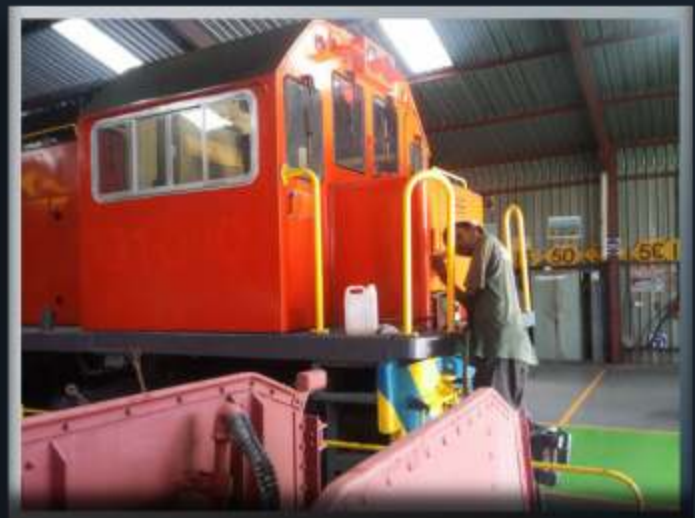
Brian and Johannes then touched up the paint and she now is ready for mechanical restoration that will commence Early 2017.

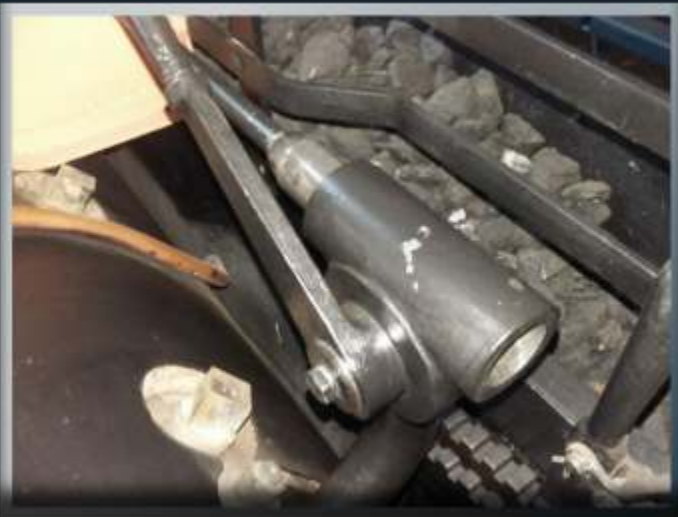
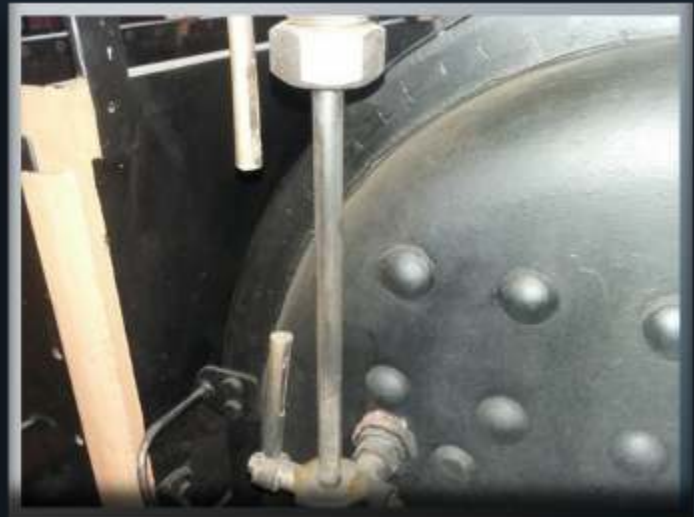
All the gauge glasses and rubbers were in pretty bad shape and were replaced. All the turret spindle packing nuts as well as gauge column test and cut off cork packing nuts were repacked with new Rope.

The maintenance on the Locomotive boilers are now completed and we have replaced all the gauge glasses, serviced the boiler mounts and packed all the regulator glands. This is quite a huge exercise and is very time consuming.

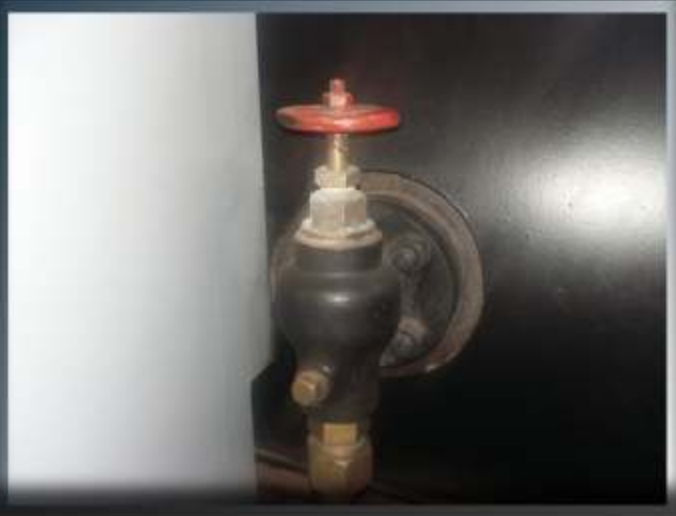
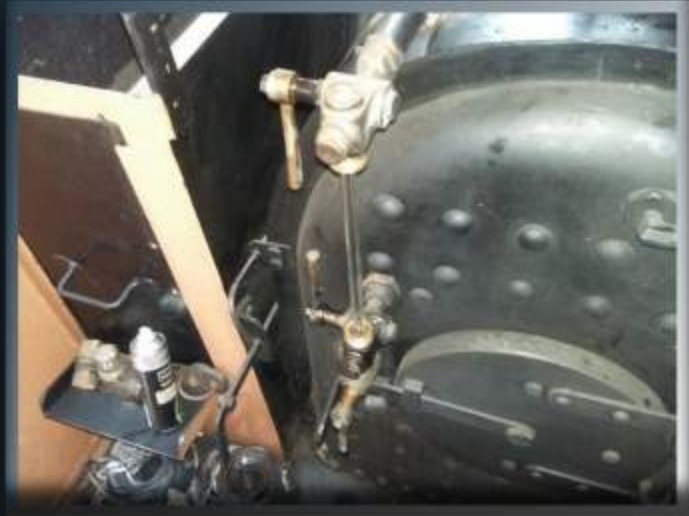
Below left: New gauge glasses being fitted.

Below right: Old rope being removed from regulator packing bushes. We also oil all the boiler studs to prevent corrosion.

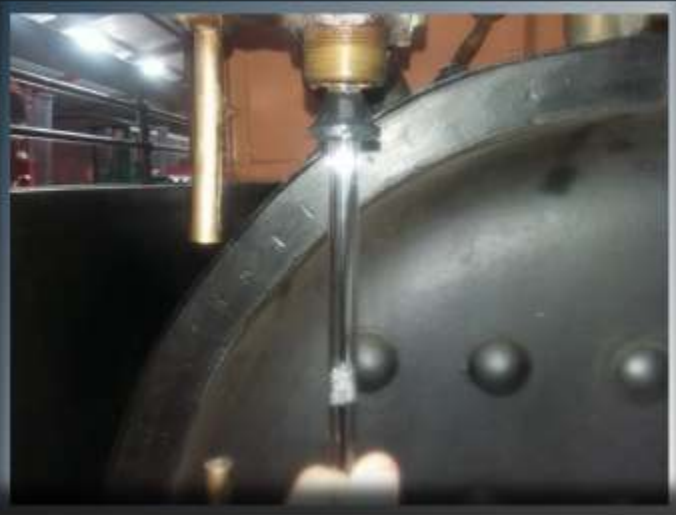
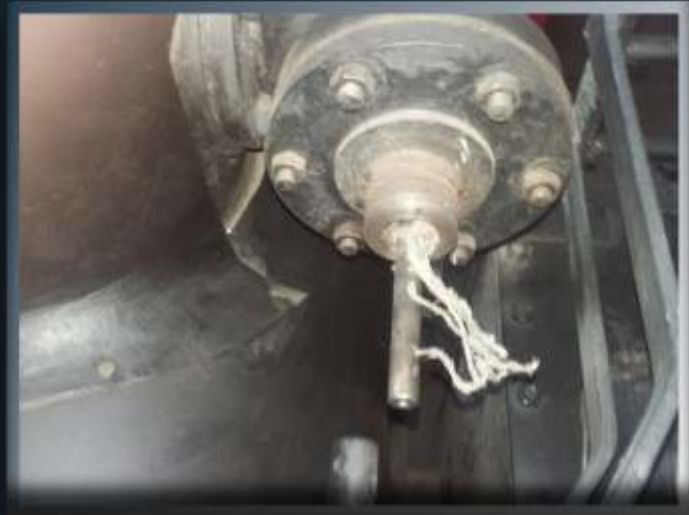
Below left: Another regulator gland being packed.

Below right: Clack box cut off cork packing nut. All the old rope was removed by a small sharp prigger.

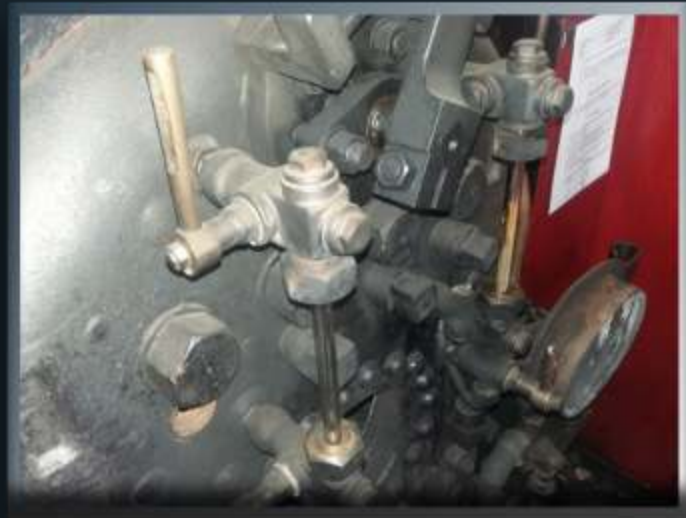
Below left: Old gauge glass being removed.

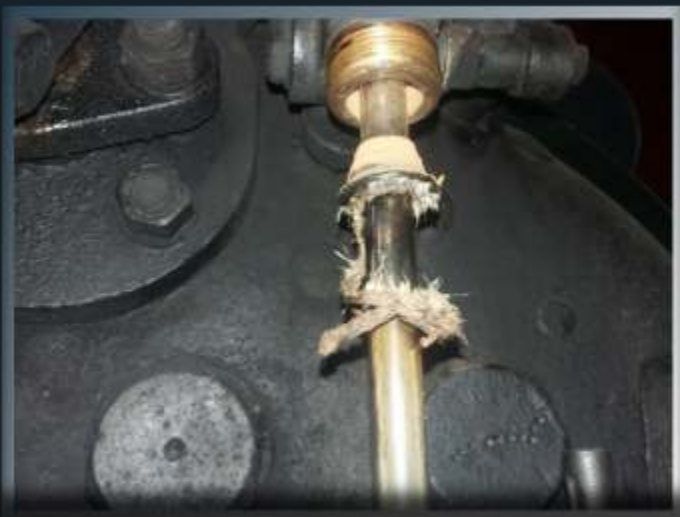
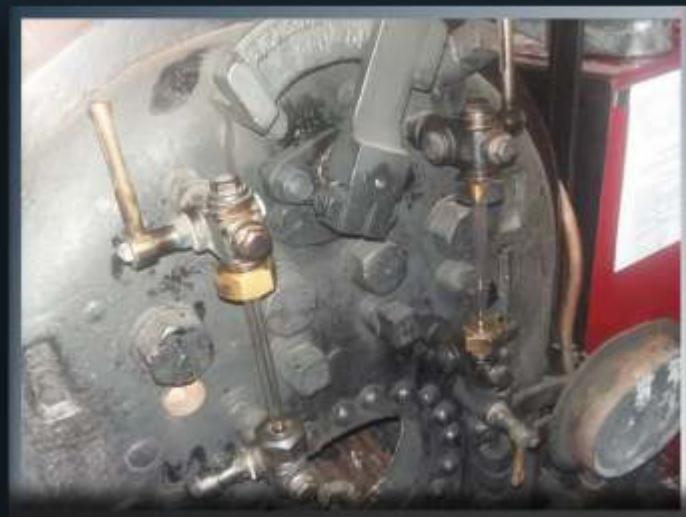
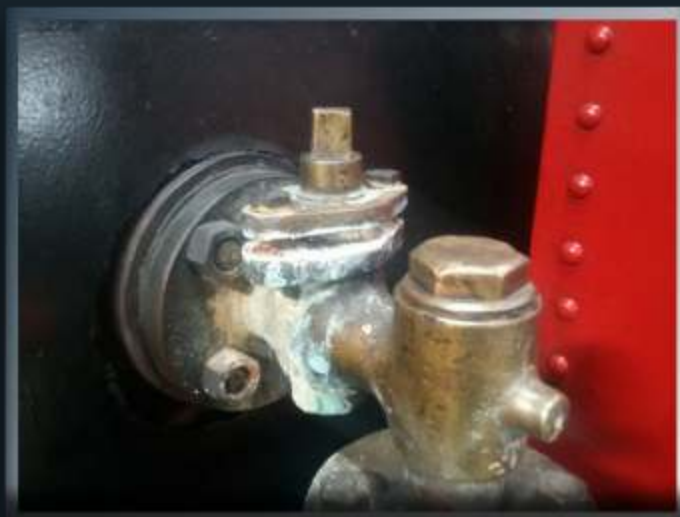
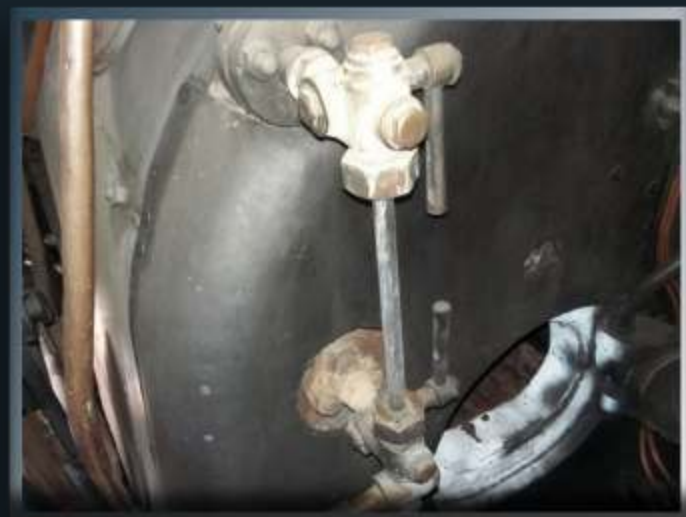
Below: The signs of leaking is evident in all the pictures, the white is all leaking joints and glands.

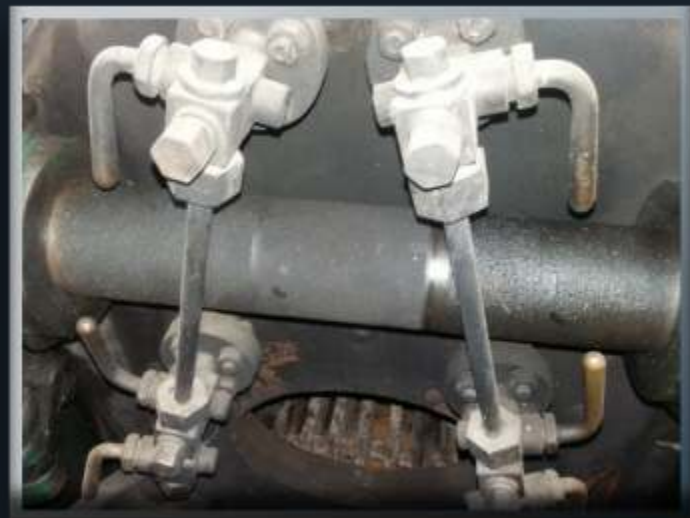
Below right: The gauge glasses on the Steam tractor. All these boilers were treated the same way as the locomotive Boilers and we are almost done with all these as well. Only need to finish the Sentinal and Fowler Steam crane to have All completed.

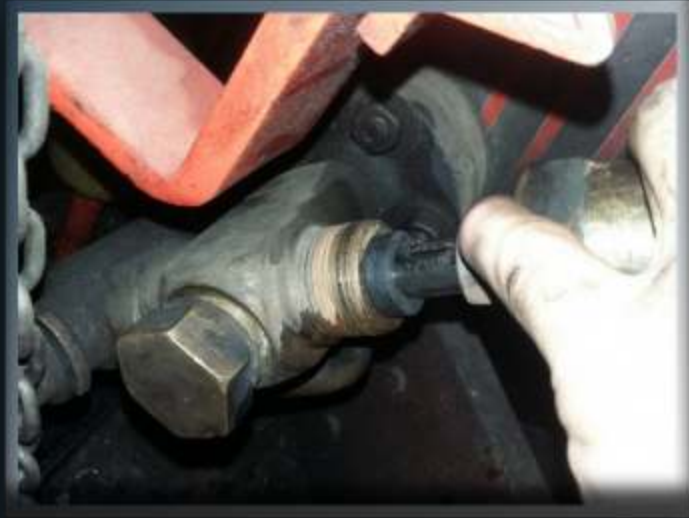
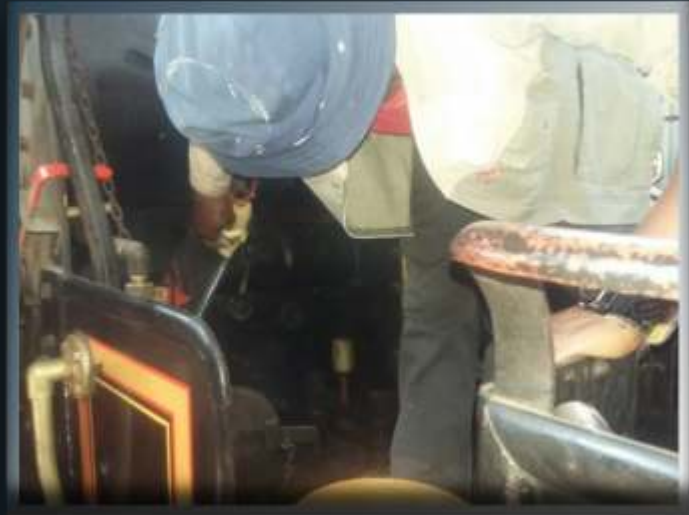
Below left: Brian checking and cleaning the steam and water ports of the gauge columns.  
Below right: New gauge glasses being fitted.

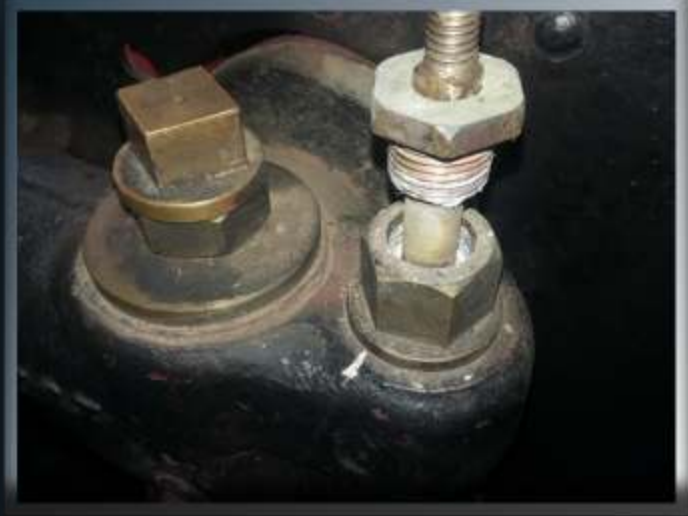
Below right: Pressure gauges being calibrated.

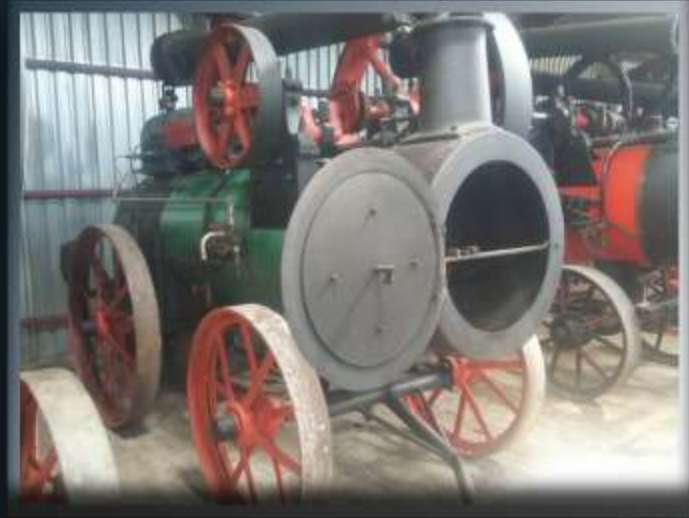
Below right: A portable boiler hand water feed pump being serviced.

The 4 portable boilers were next in line and received the very same treatment.  
After this all the brass work will be cleaned to perfection.

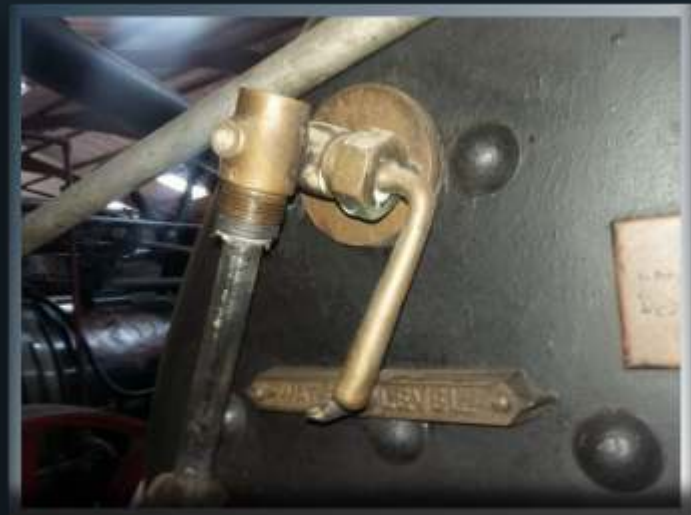
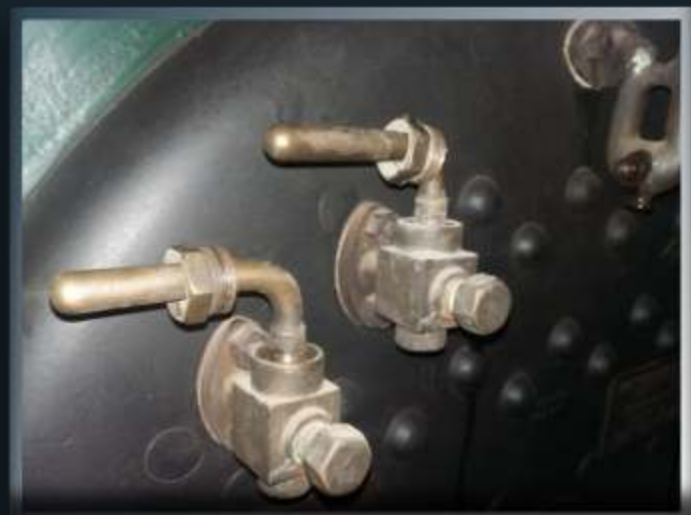
Below left: Regulator gland being packed.  
Below right: Test cork spindle packing nuts being packed with new ropes.

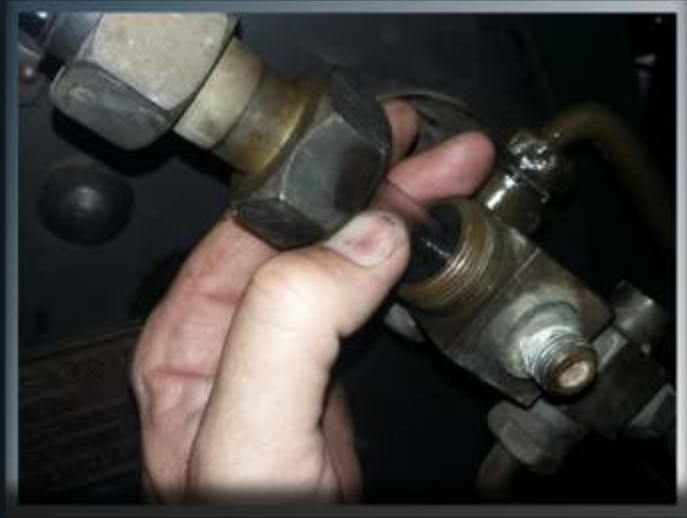
Below right: New gauge glasses being fitted and the task being made easy with the use of Soap water.

Below left: Another regulator gland being packed. All these packing nuts will need slight adjustment when They will be steamed for the first time.

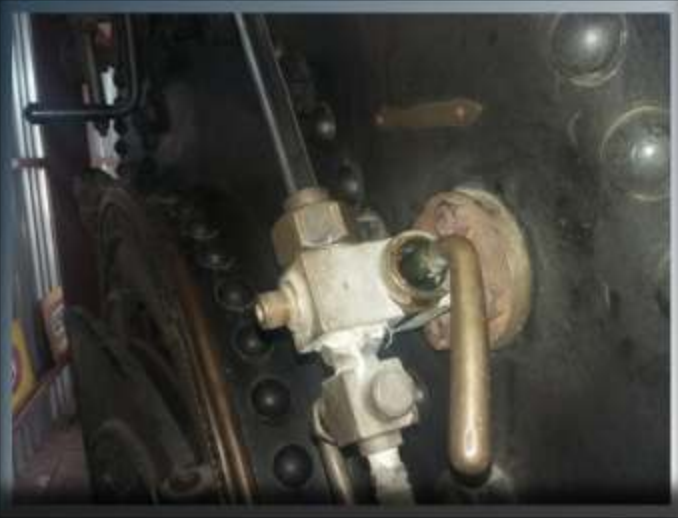
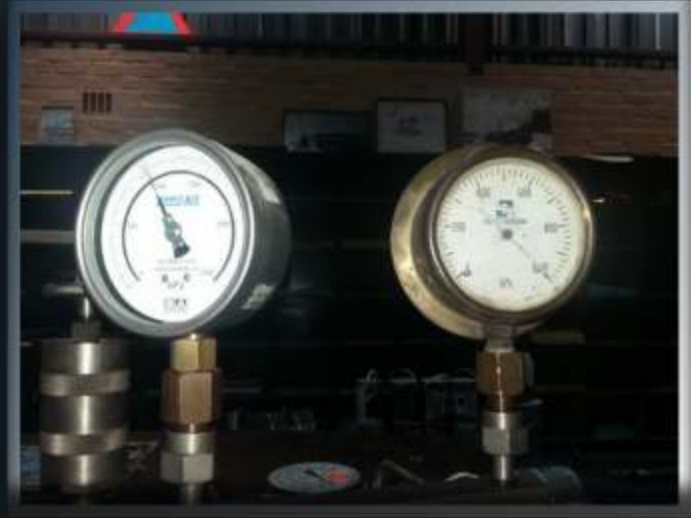
Below left: Gauge column cut off cork packing nuts being packed.  
Below right: A gauge that did not pass the calibration and testing and was replaced with Another gauge.

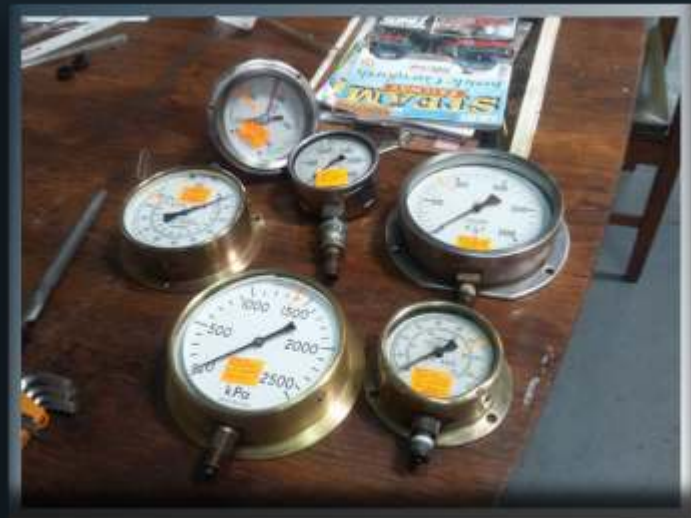
Below right: Calibrated gauges, now ready to be fitted back.

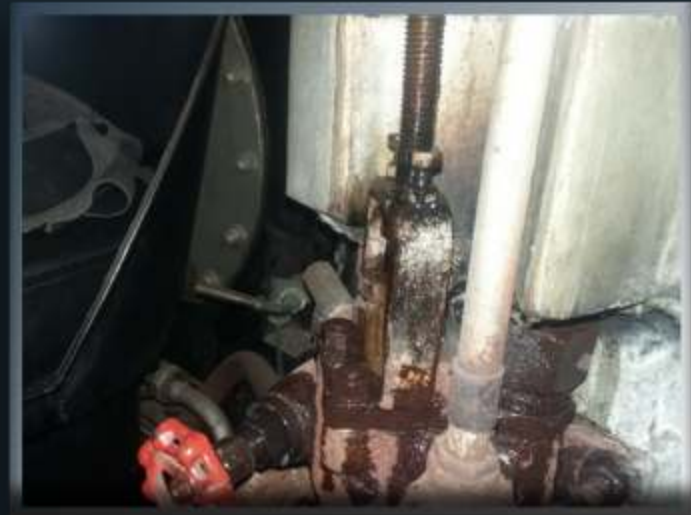
Below: The Sentinal steam lorry being attended to.

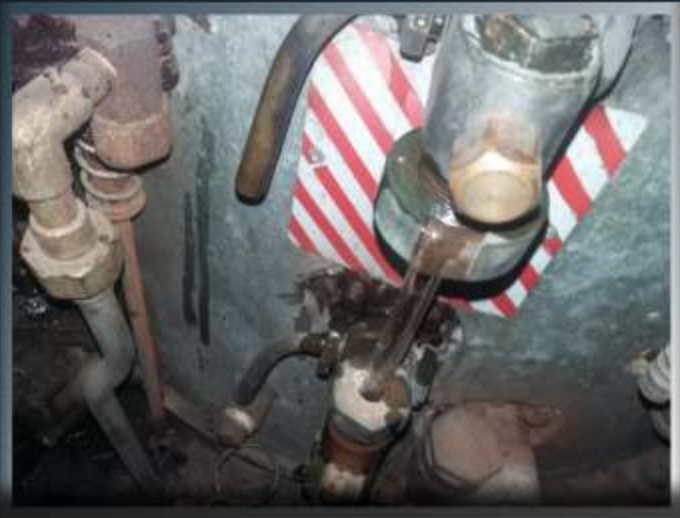
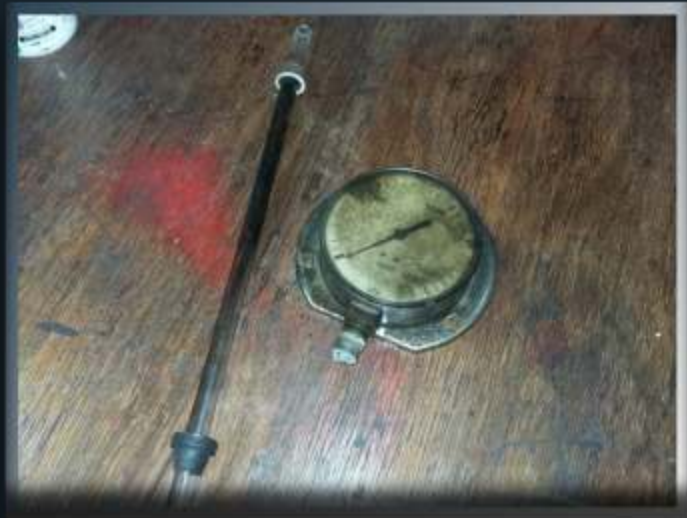
Below left: Replacing the gauge glasses on the Sentinal.  
Below right: The Fowler steam crane gauge glass and steam pressure gauge.

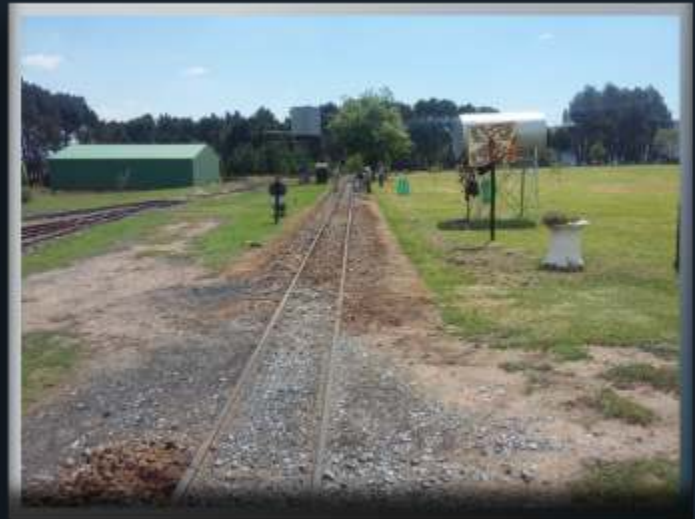
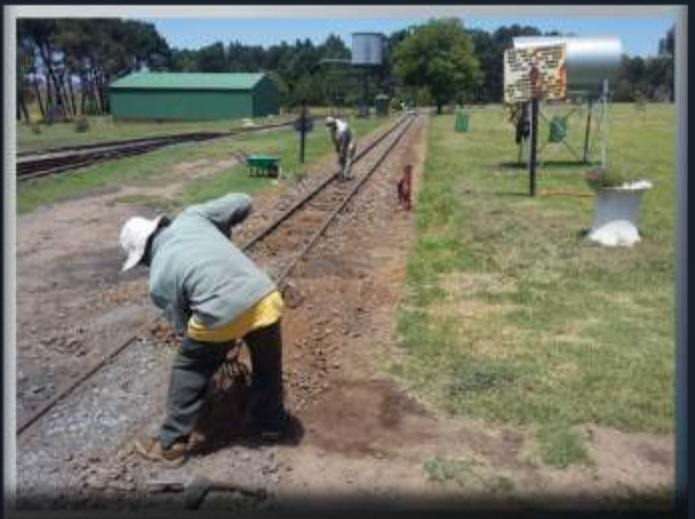
Our track maintenance crew have worked on the section towards Grootdraai and also attended to the line in Front of the Steam Shed. The slacks were removed and the ballast was boxed.
