## Highlights of the week!

# Fouriesburg Country Tours

# Class 16 CR Restoration

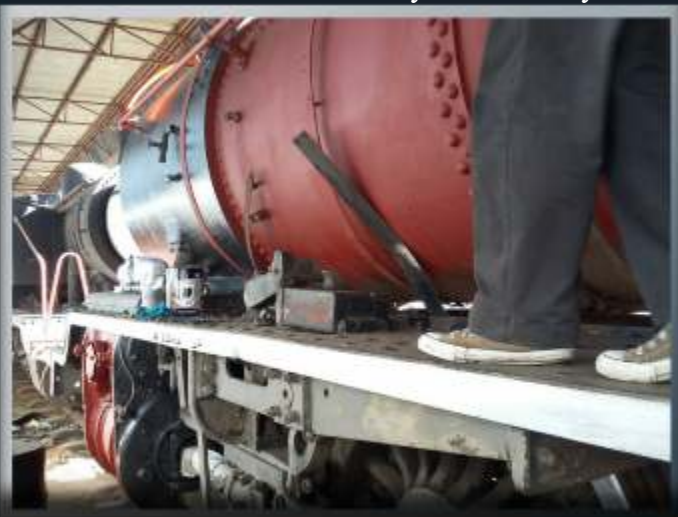
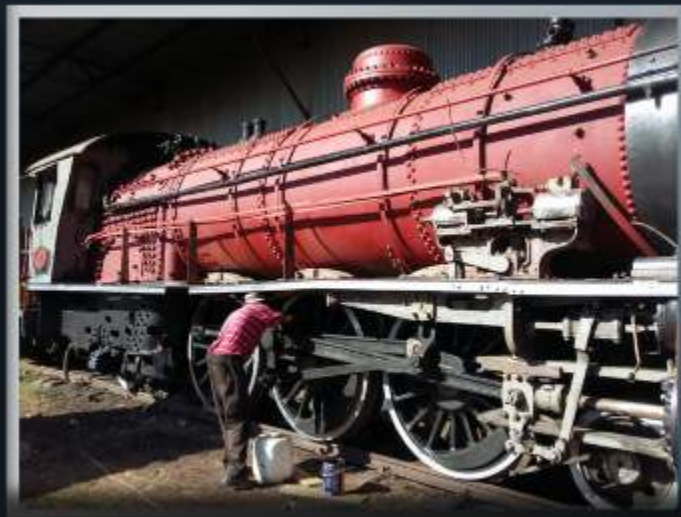
SAR Number 821

The restoration of our Class 16CR is almost complete. Last week Brian and Ernest painted the locomotive and They are currently varnishing the cab floor and window frames.

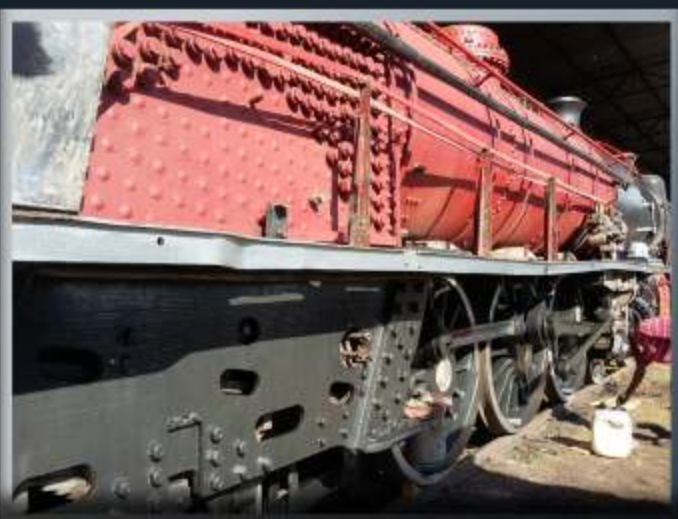
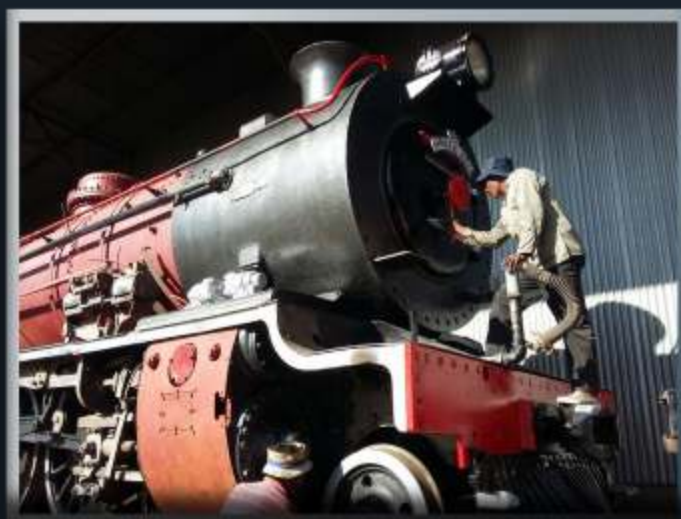
This week Wouter will fit the cylinder cladding. The cab fittings will be fitted after we have moved her In December this year.

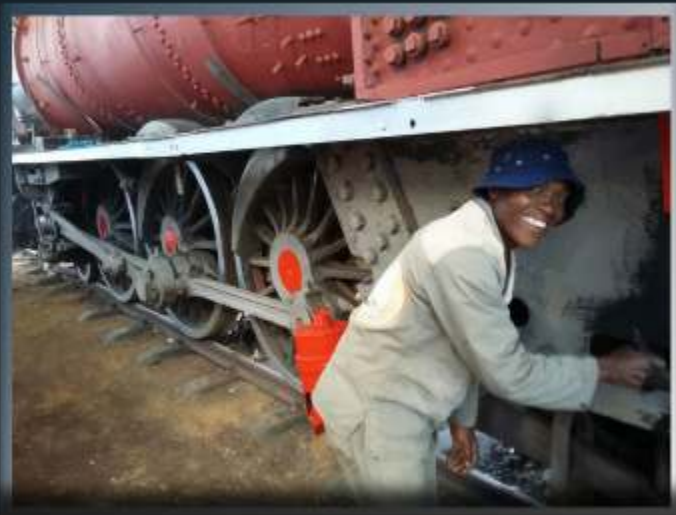
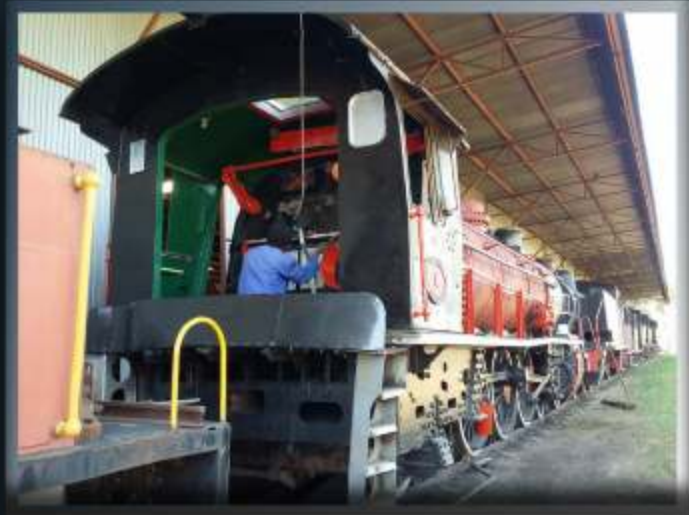
Below: The frame and wheels were painted in a dark graphite colour.

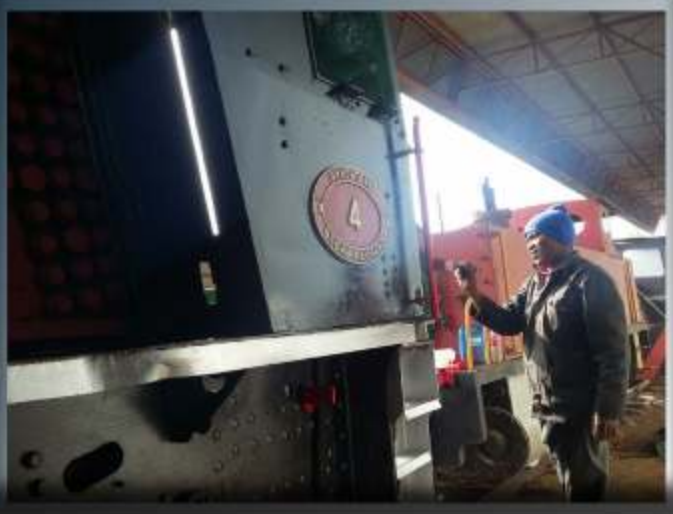
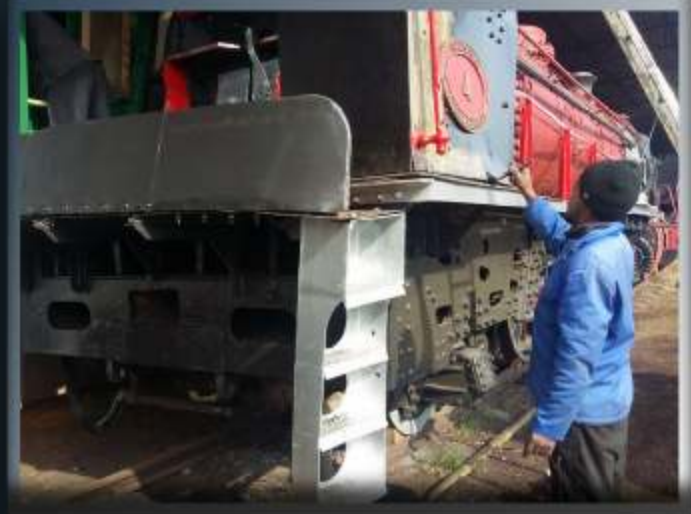
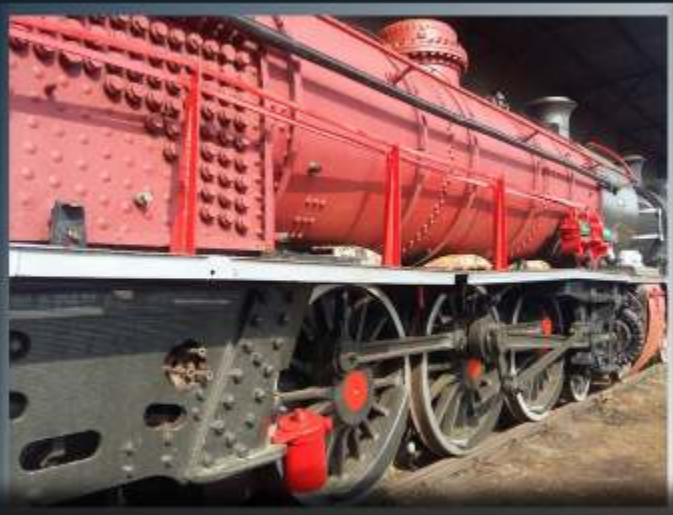
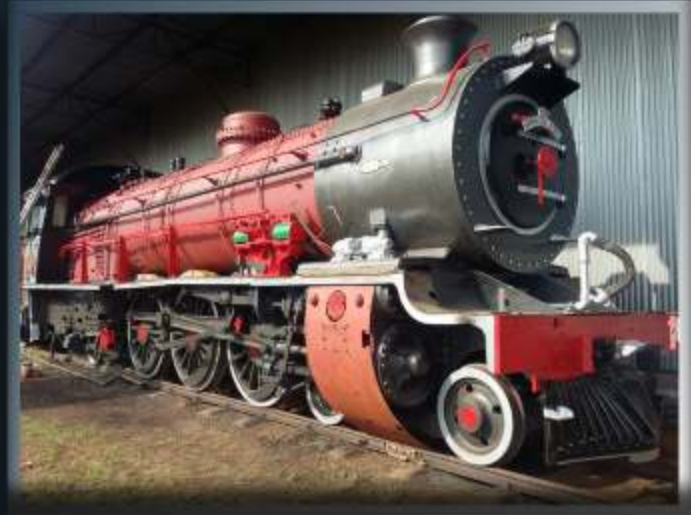
Below: Paint work almost completed and looking much better with her Sandstone number plates.

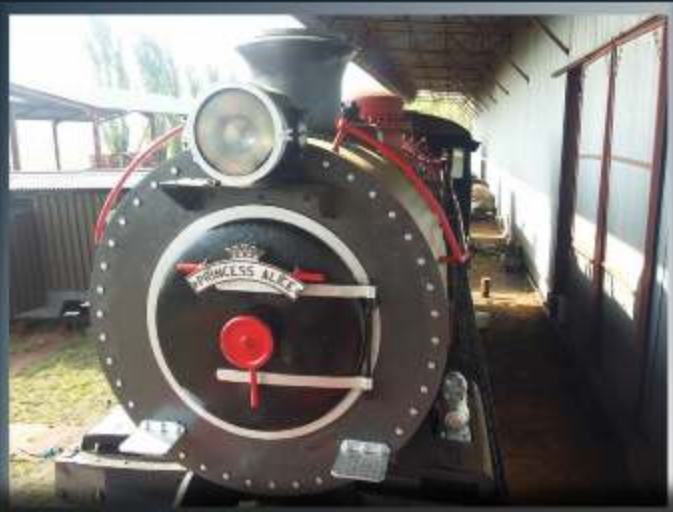
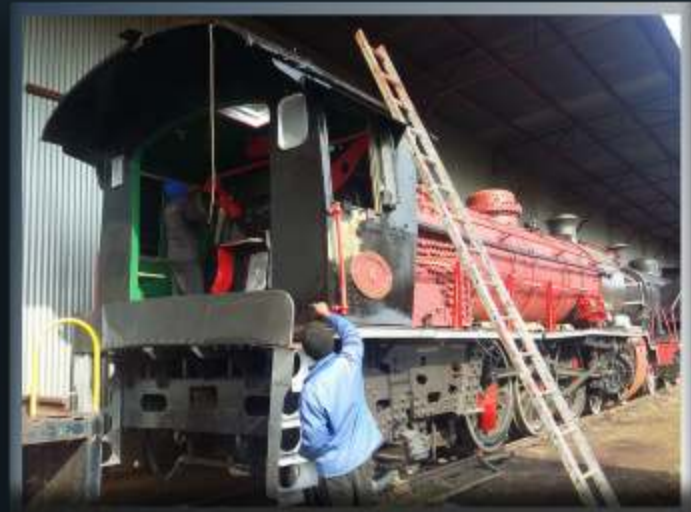
We will fit the boiler cladding plates as soon as our suppliers deliver it.

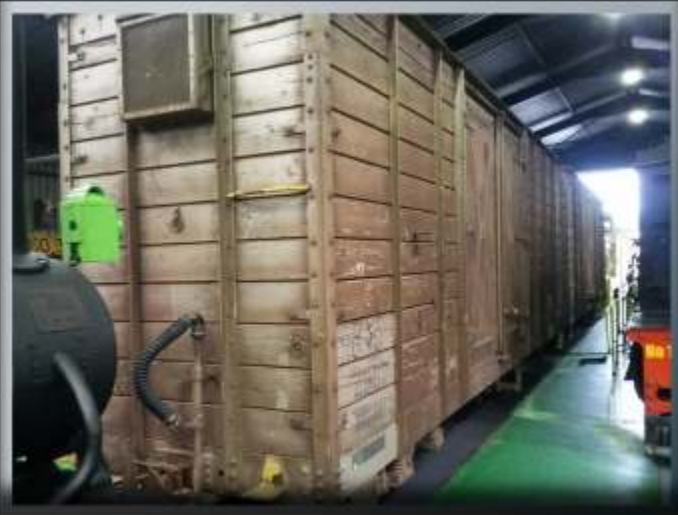
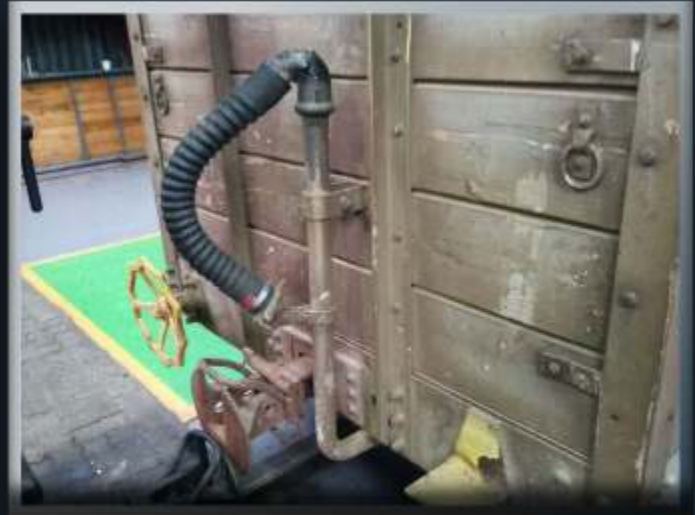
A large consist of Box wagons always looks great on a train and we have decided to fast track the restoration of another 2 x O wagons. We shunted them to the shed and both only need a fresh coat of paint now.

New vacuum hoses were fitted and brake and leak off test was satisfactory done.

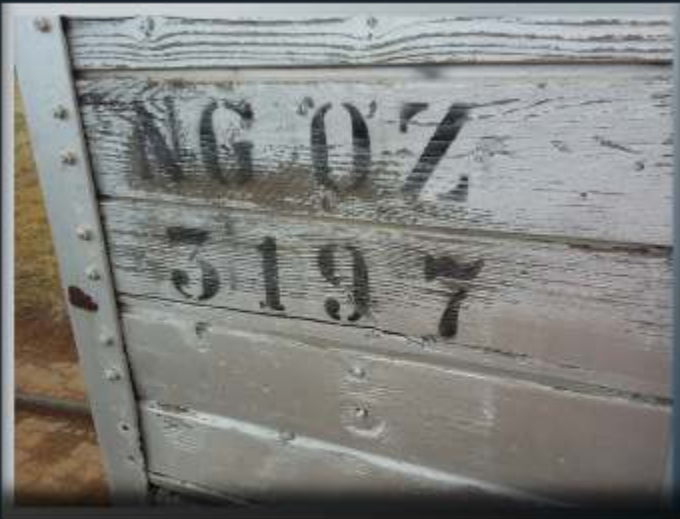
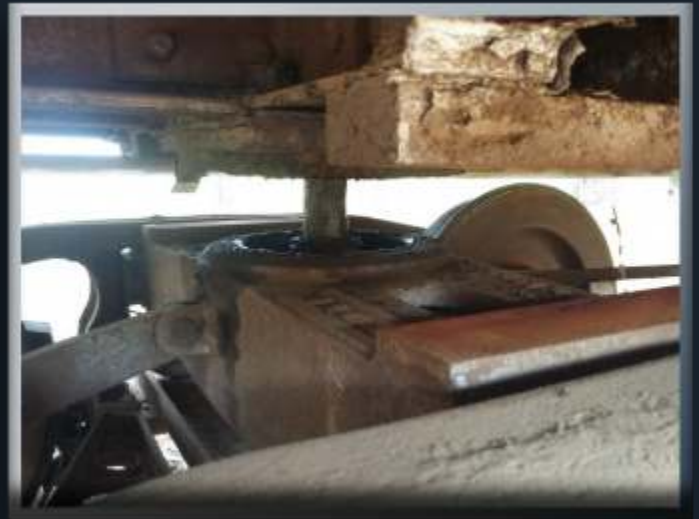
OZ 3197

While shunting consists we have noticed the 3197 had a problem on the bogeys. We have shunted the wagon to The shed and lifted it from the bogeys to grease the centers and side control friction plates.

It is very important to lift the wagons from the bogeys to grease the centers and side friction plates. The bogeys need To turn easily on the pivots to limit flange and track wear on the curves.

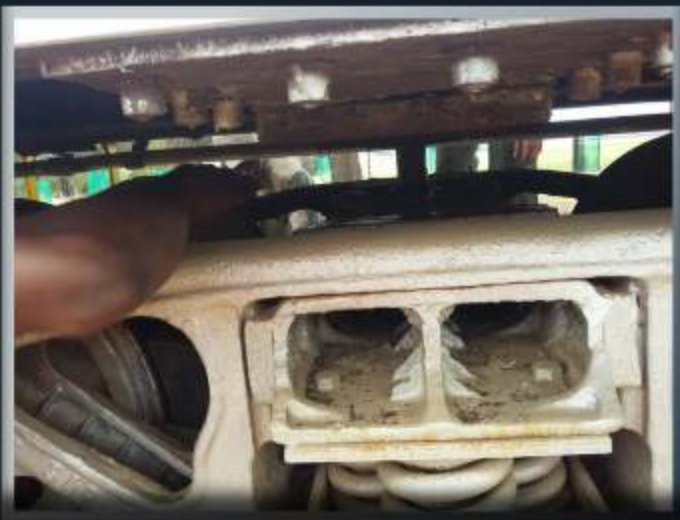
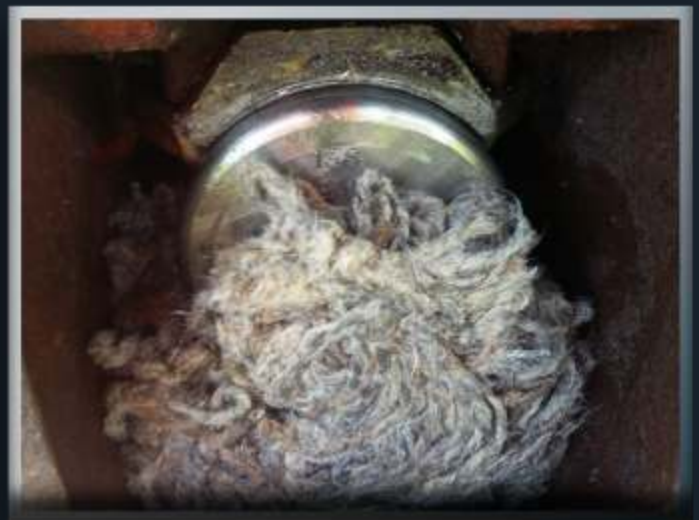
We also had to replace all 8 bearings on this wagon because it was damaged. The axle box wool loses its feeding Capabilities over time and results in dry axles which damages the white metal on the bearings.

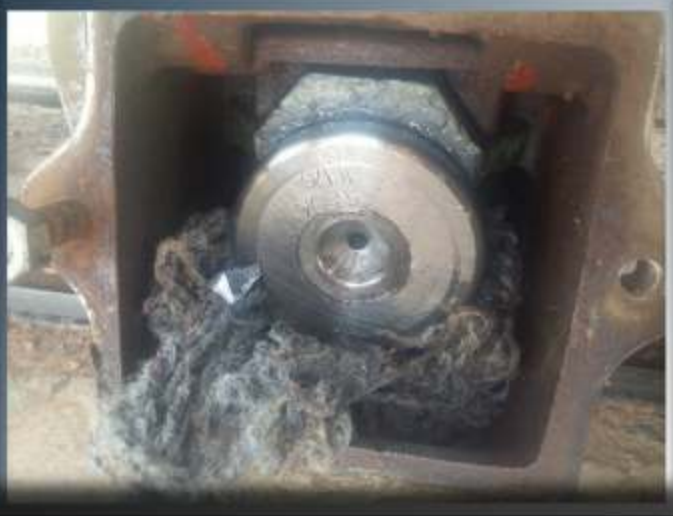
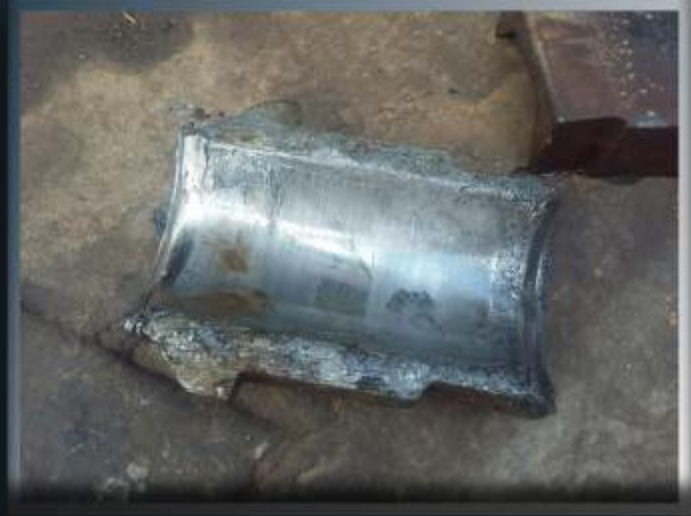
Below left: The picture shows the wool being end of life. Petrus packed the axle boxes with New soaked wool after the new bearings were fitted.  
Below right: Damaged bearings

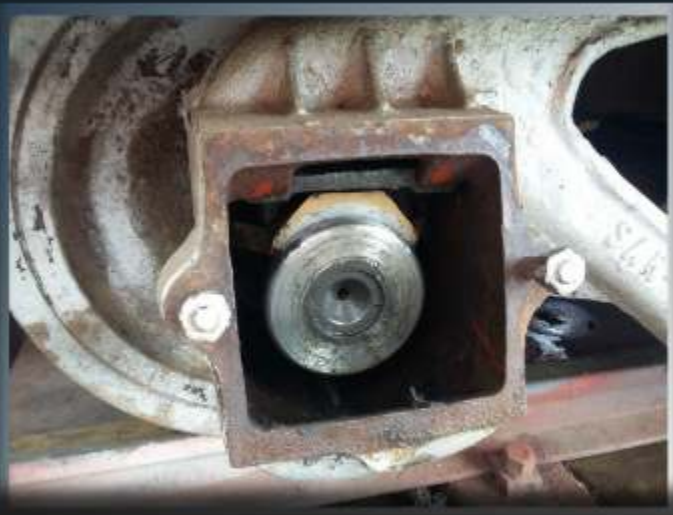
Below left: New bearings fitted.

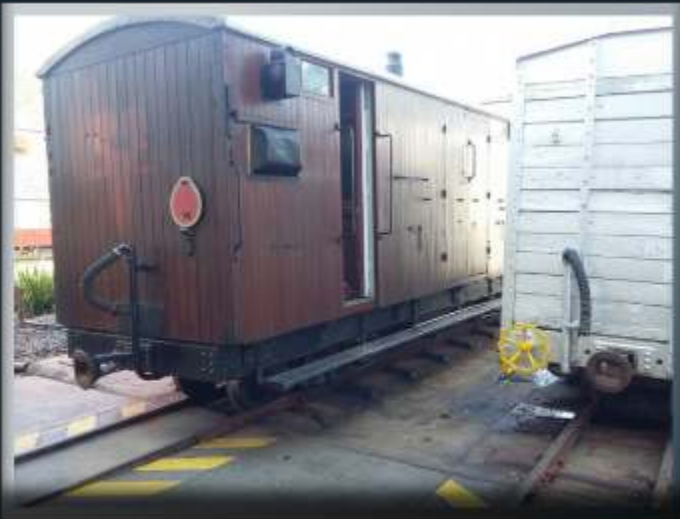
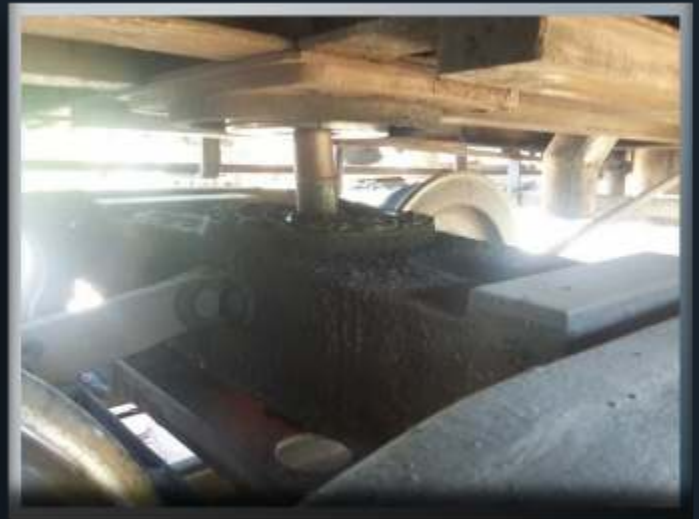
GV 2814

The wheels on this Guards Van was badly skidded and the Van also were running skew. We found collapsed springs On the bogeys and we are currently busy fitting two overhauled bogeys to our Guards Van

8 New bearings were fitted into the new bogeys and she will be good to go again soon.

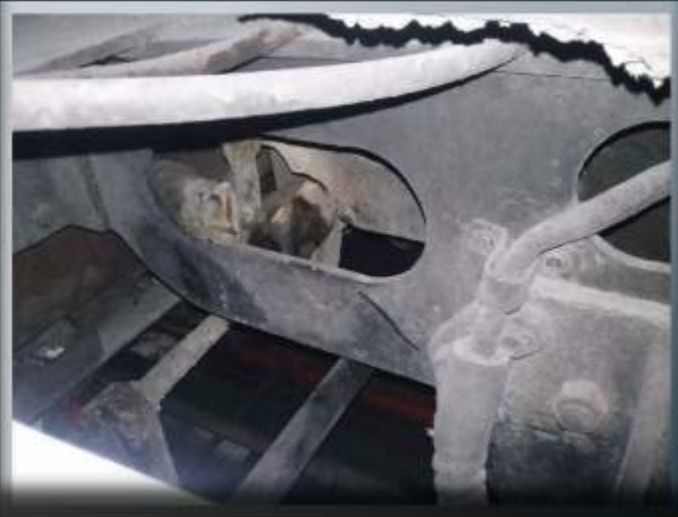
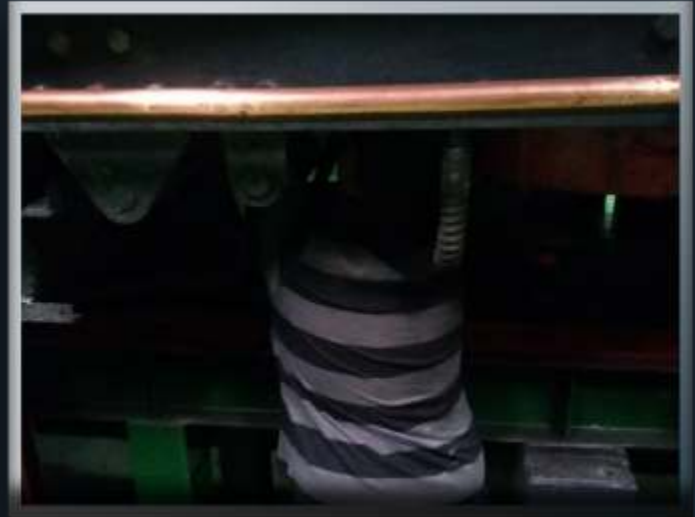
## Class NGG 16 Number 153

Our Class NGG 16 number 153 was shunted to the pit. The blow down cork spindle packing nut were leaking Badly and we had to pack it again with new rope.

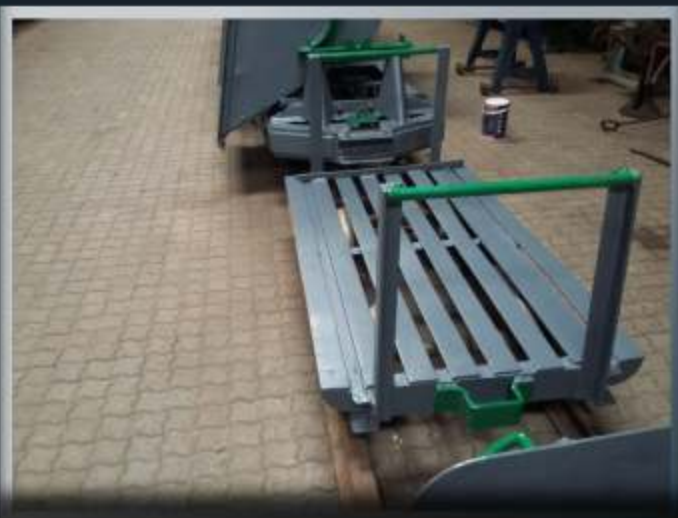
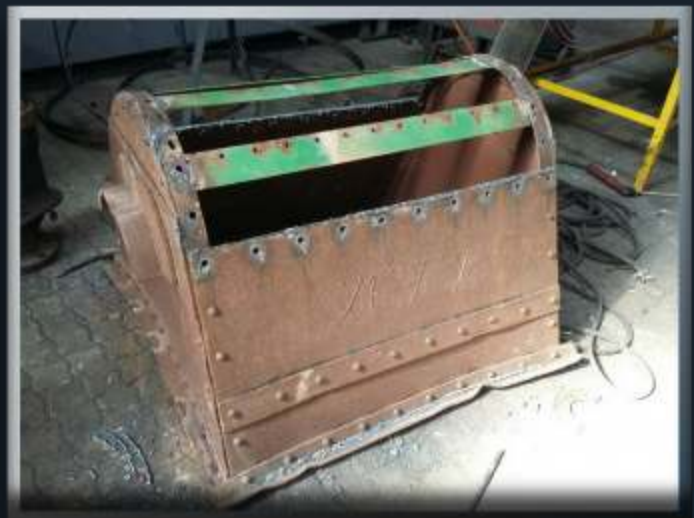
Below right: The Orania Coco Pan restoration.

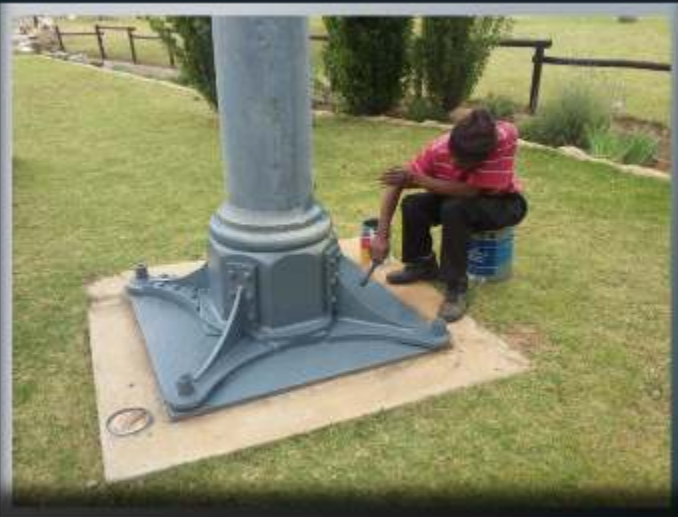
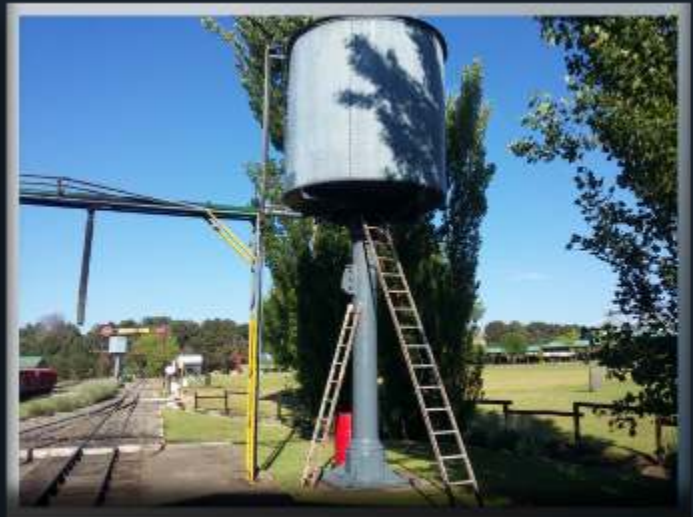
Johannes is currently busy painting all the water columns again. He first paint them as far as he can reach and then He will build scaffolding to reach the top part.

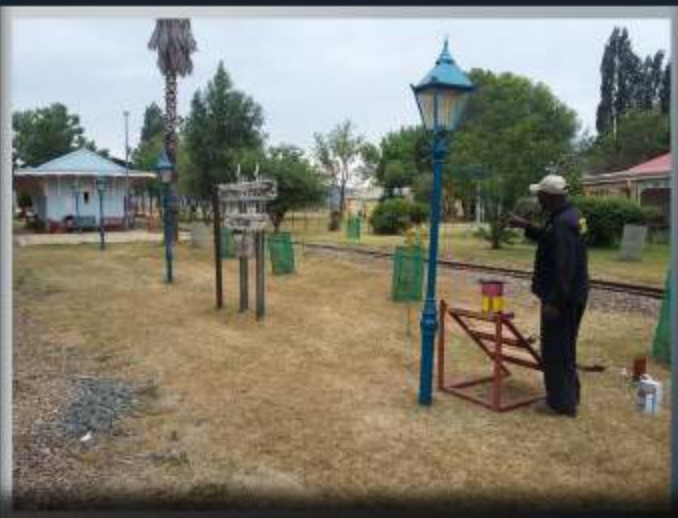
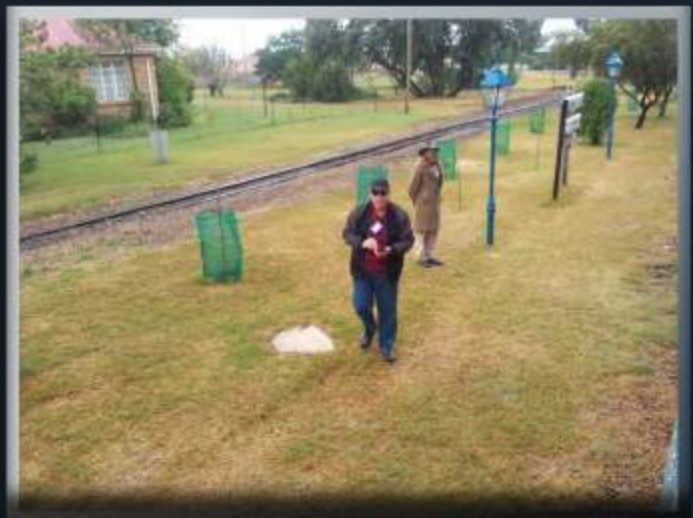
He have completely painted all 5 water column pillars and will now start with the tanks.  
Petrus painted the lamp stands in Hoekfontein Station that was in need of new paint.

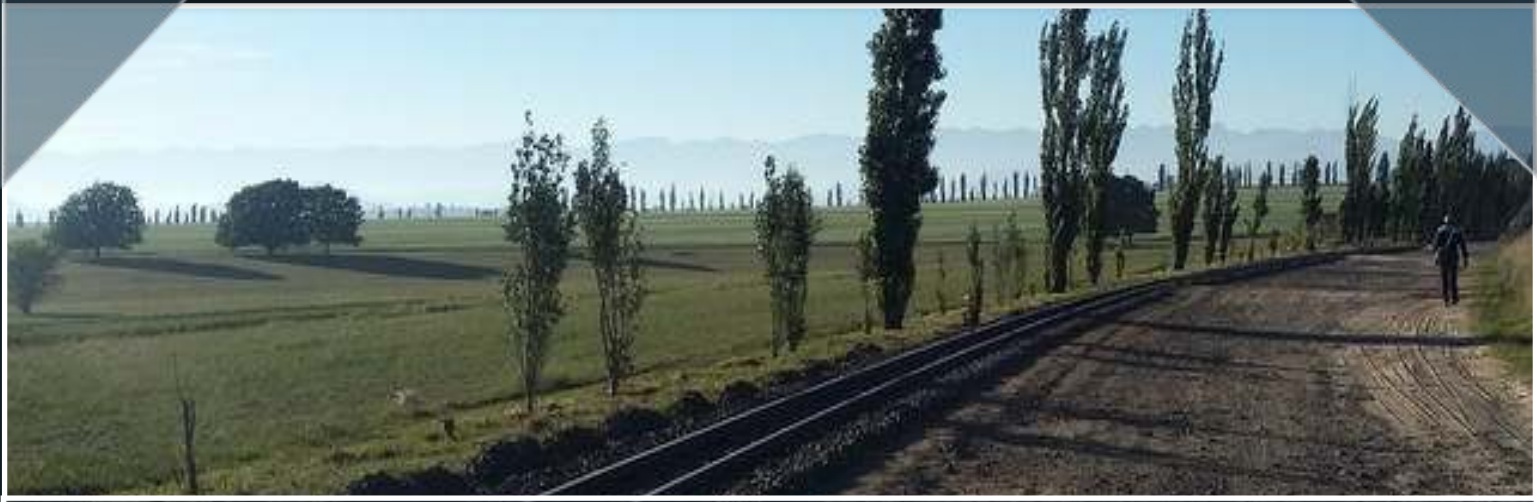
# Track Maintenance

Our team is now very close to Mooihoek points and they should be finish by the end of the week with the Lifting, screening of this section.

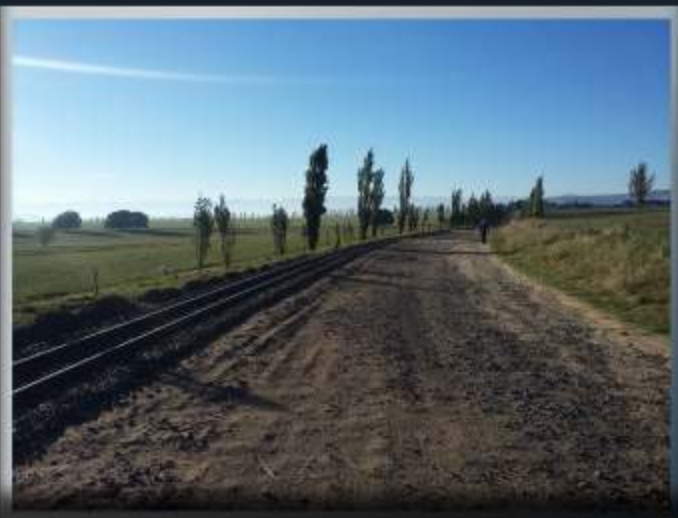
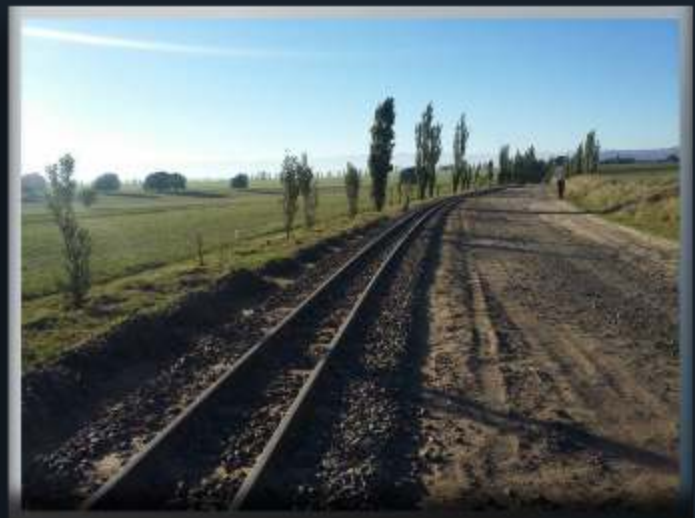
Once they are done here we will move on the the section Hoekfontein Station as well as Hoekfontein to Grootdraai Where there are rails that needs to be replaced and the line needs to be leveled on this section.

We also have shunted 2 Ay wagons to Mooihoek that were loaded with the last ballast of Mooihoek old siding. This Ballast will be used to fill in ballast shortages on the section Mooihoek to Hoekfontein.
