# Steam News From The Eastern Free State

## HIGHLIGHTS OF THE WEEK

- 1.) Class 10 CR Cosmetic Restoration.
- 2.) Class NGG 13 Number 49 Washout
- 3.) Ratanga Coach bearings and under frame
- 4.) DZ Wagon Restoration.

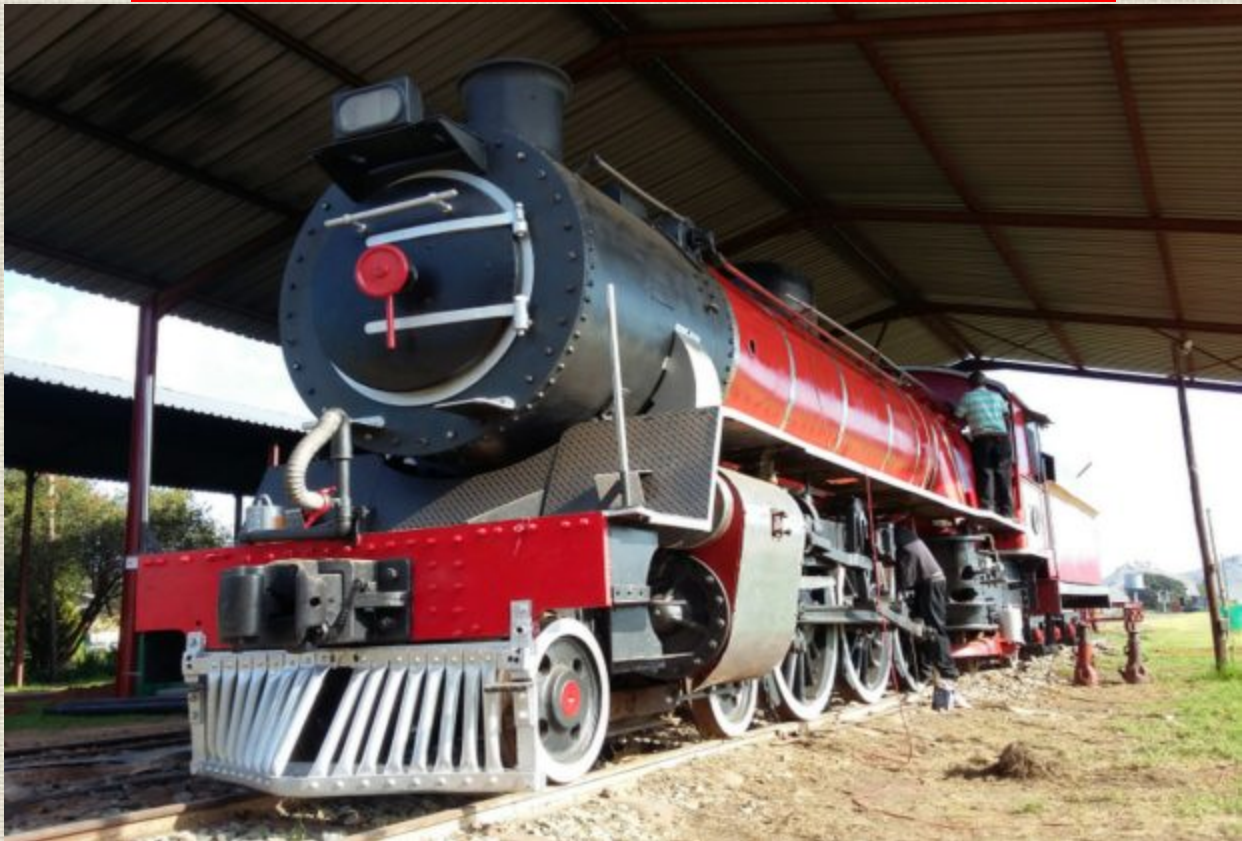
This week we spend most of our time on the restoration of our Class 10 CR Steam Locomotive. The boiler cladding was fitted back while the rest of our team prepared the locomotive to be painted.

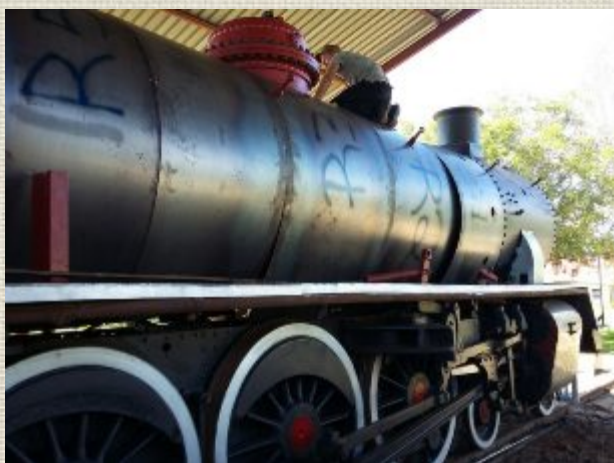
Below left: Brian did the most of the paint work on the Class 10 CR while Petrus, Johannes and Joseph Scraped of all the old paint.

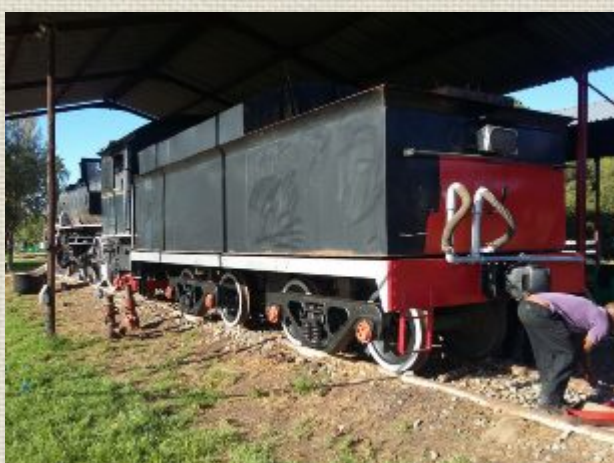
Finally the dome cover was fitted back and the heavy tarot was fitted back on. In next week we will Paint her a second coat and then will do the cosmetics inside the cab.

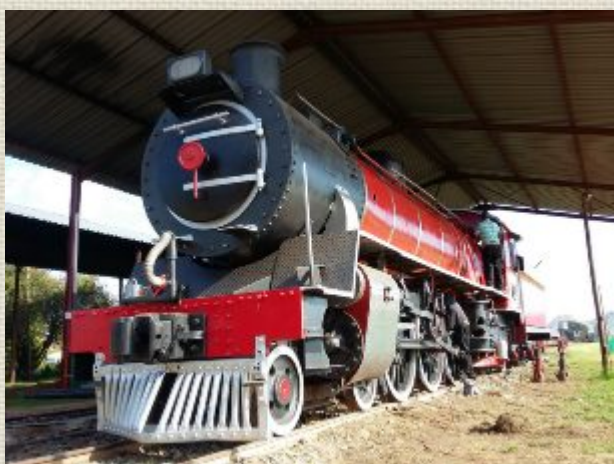
Below right: Adding some black paint to give the correct contrast.

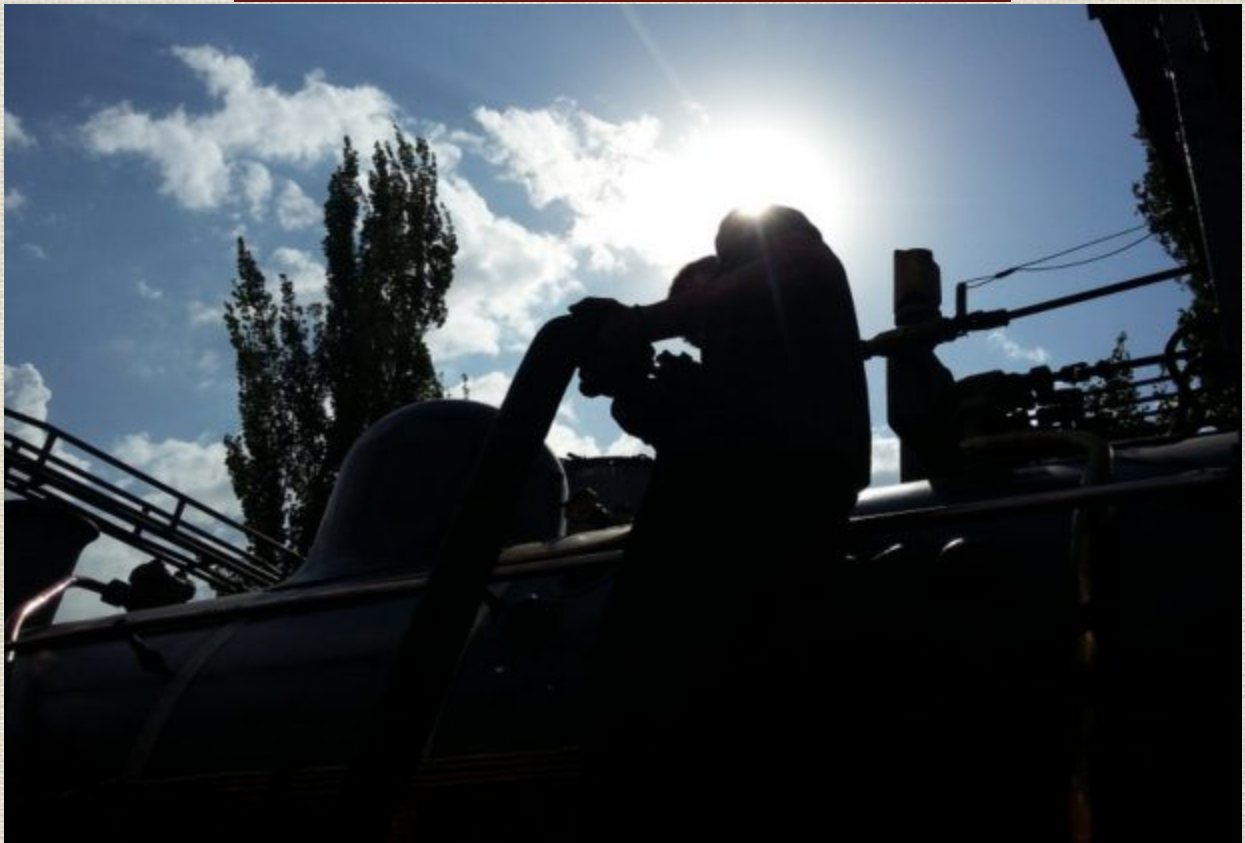
## 2.) NGG 13 NUMBER 49 WASHOUT

We shunted out our Class NGG 13 Number 49 for washout this week. The boiler was washed out and the tubes were Cleaned. We also removed the old gauge glasses and new ones will be fitted. Her lead plugs will now be re leaded.

A clean Boiler is a happy boiler. All the washouts are logged and each boiler will be washed out again after 6 Steaming days to keep them clean and healthy.

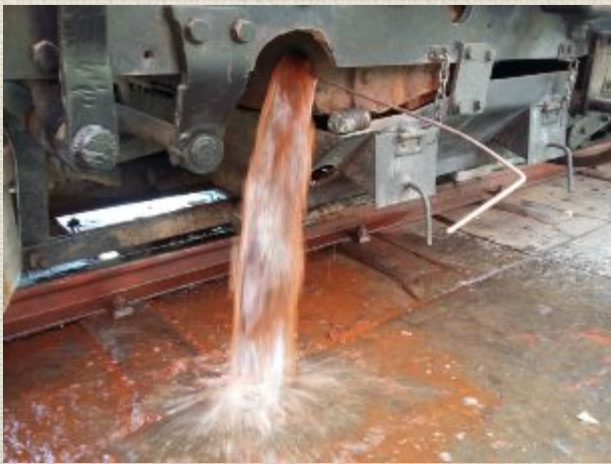
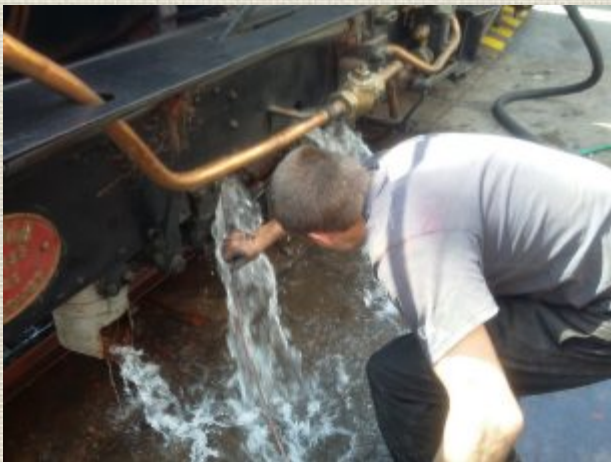
Most scale accumulates around the water space and in the barrel and it takes a lot of time to remove them  
But once it is properly done then she will be steaming well again.

Below left: The only way to help the stubborn scale out is by use of a copper scraping rod.

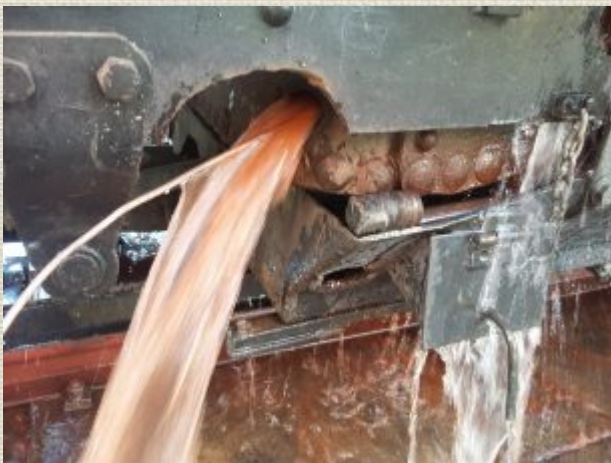
Below left: Washing the water space between the inner and outer fire box with a bend nozzle.

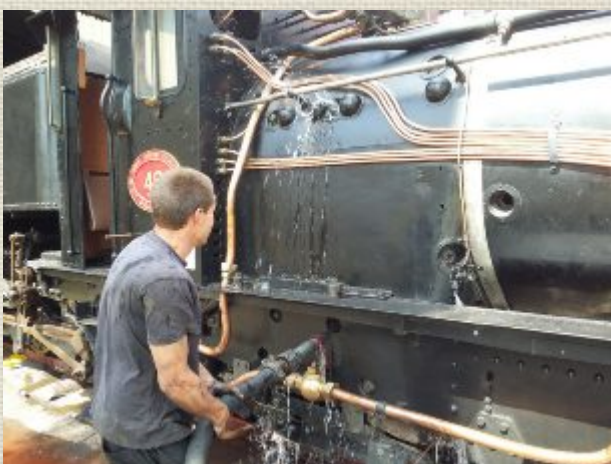
Below: Mud and scale being washed out.

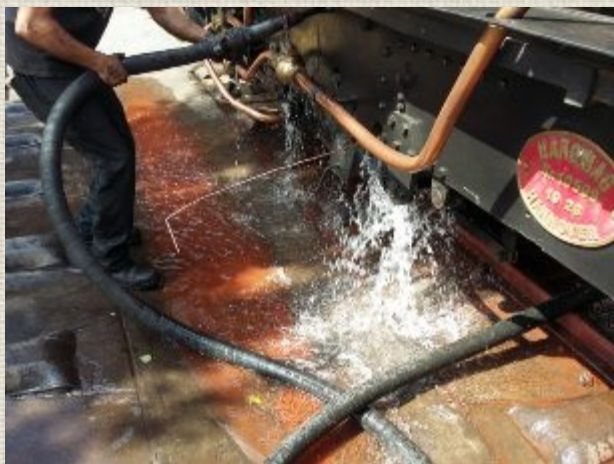
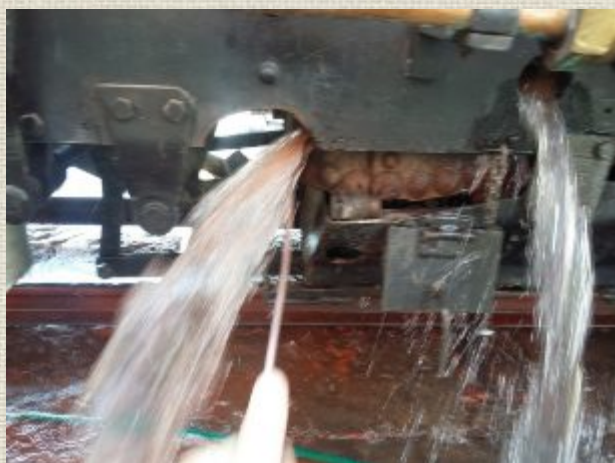
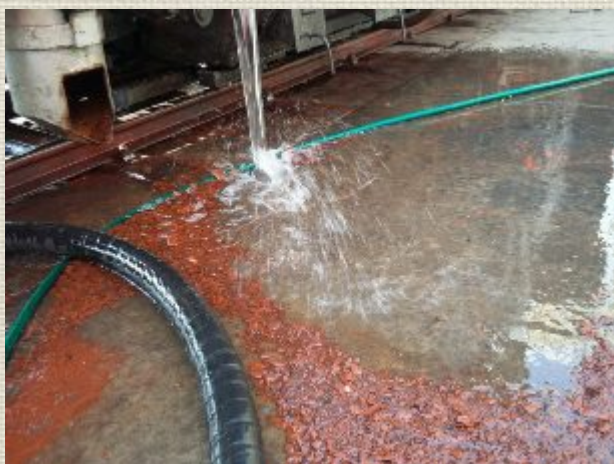
Finally we cleaned the tubes and ensured that no one is blocked with cinders.

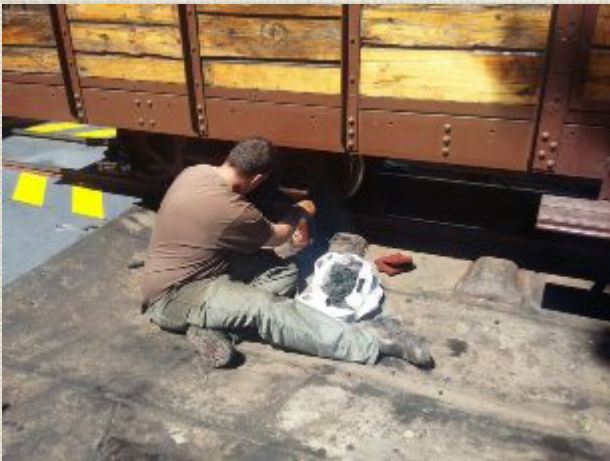
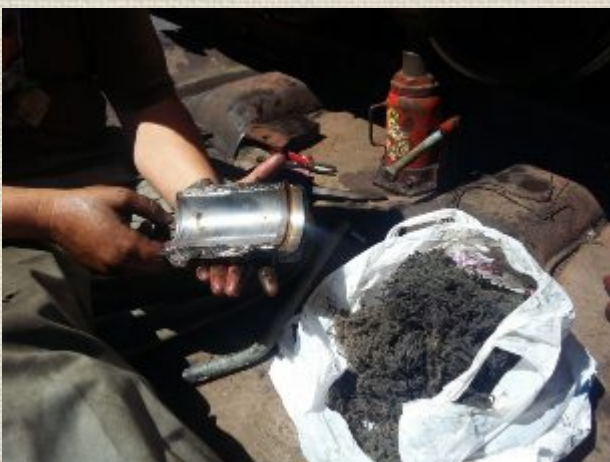
Our Ratanga wagon Number 3284 was shunted to the shed this week. The bearings on one of the bogeys were in a very bad condition and were replaced with brand new ones. The V hanger was removed And the brake axle was sanded, greased and put back again to ensure easy movement of the brake gears.

Below: New bearings fitted and the boxes were packed with new soaked axle box wool.

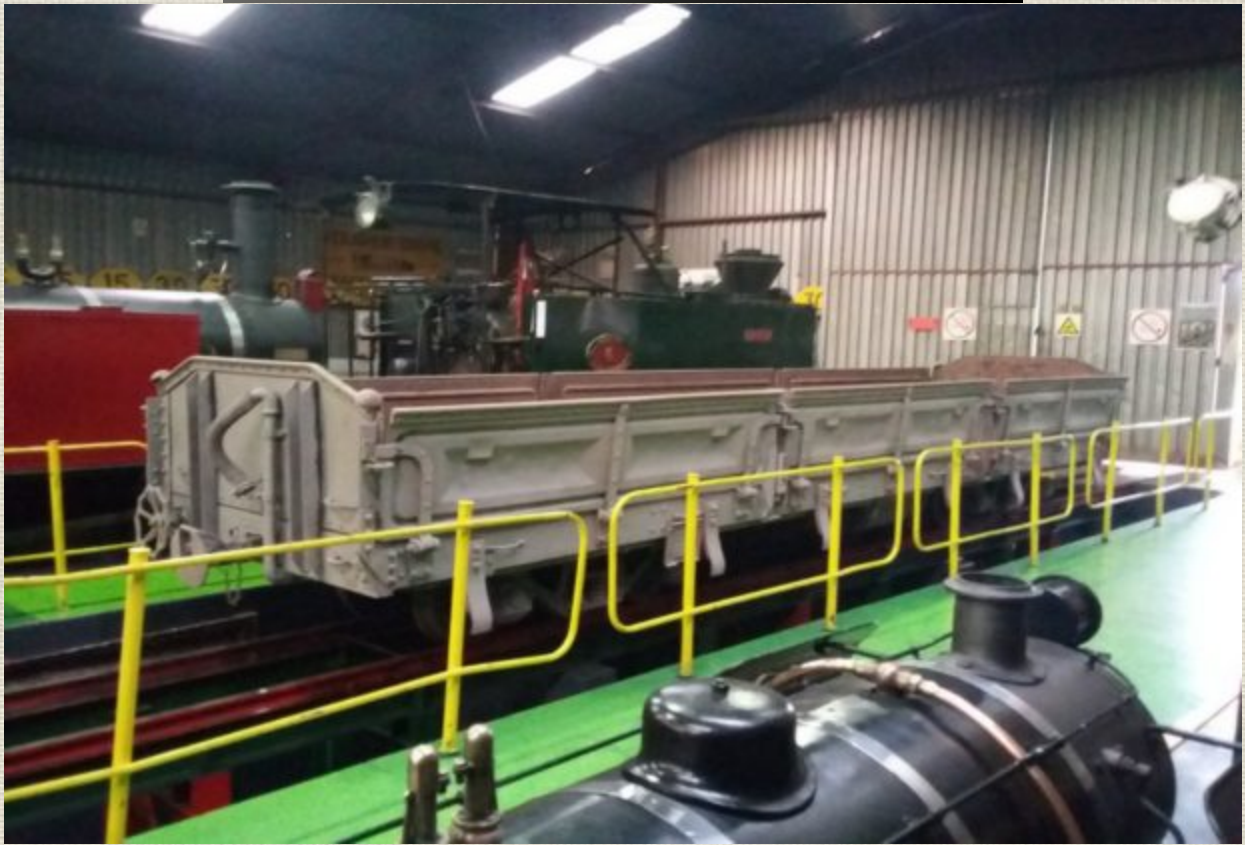
#### 4.) DZ WAGON 1975 RESTORATION

Our DZ wagon number 1975 was sandblasted this week. In next week we are going to sandblast another C wagon And will spray paint the DZ plus 2 x C wagons. These wagons then will come to the inspection pit for under frame Restoration and stenciling.

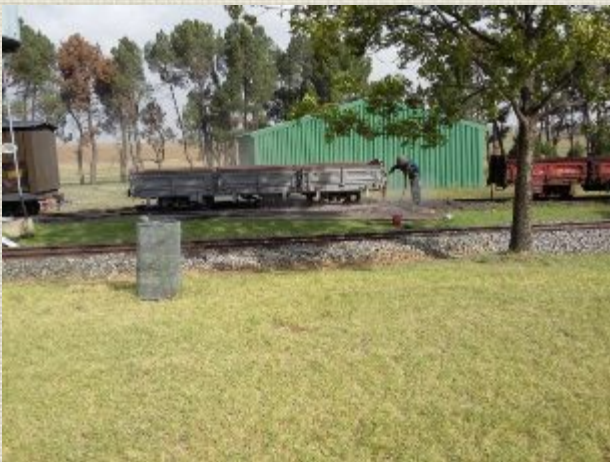
Below right: The second C wagon that will be sandblasted and painted in next week.

The DZ and 2 x C wagons will be painted in gray livery.
