# Steam News From The Eastern Free State

Sandstone Estates Steam Railway News 15 April 2016

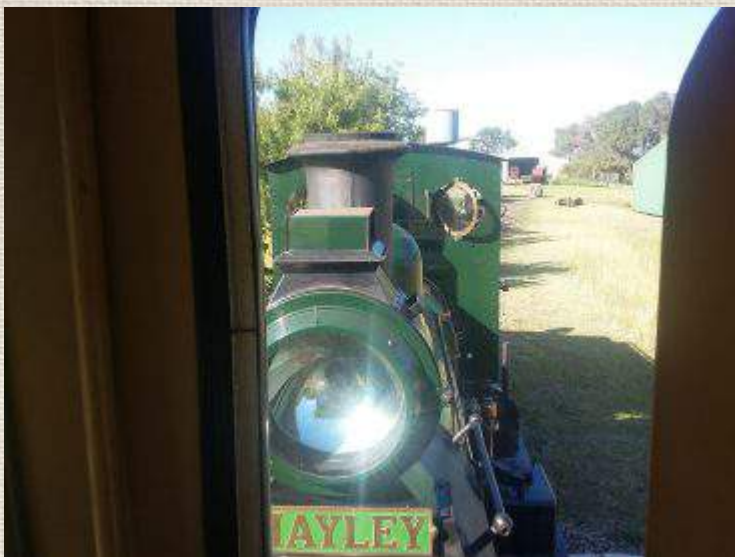
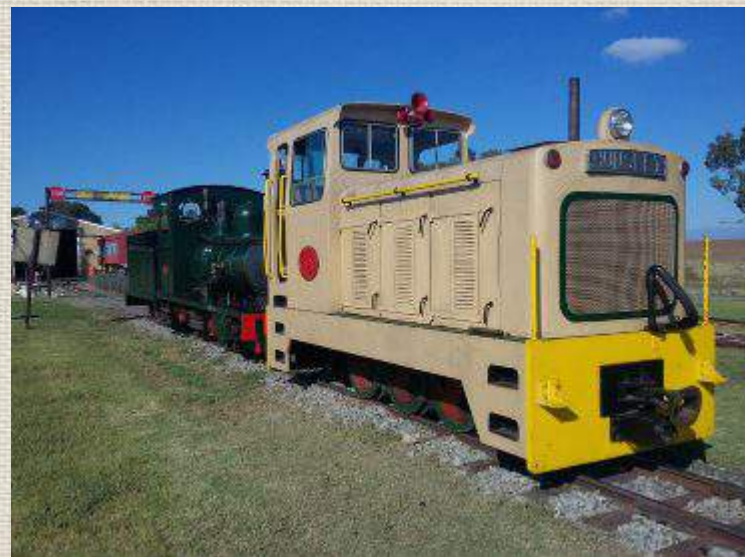
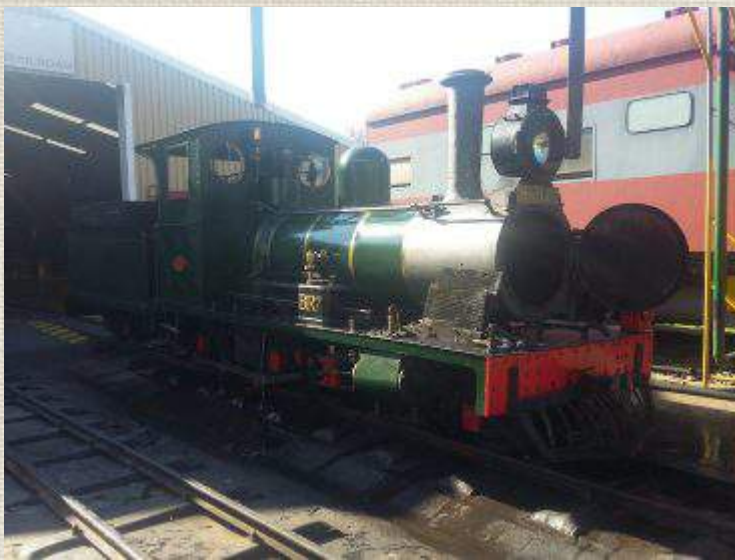
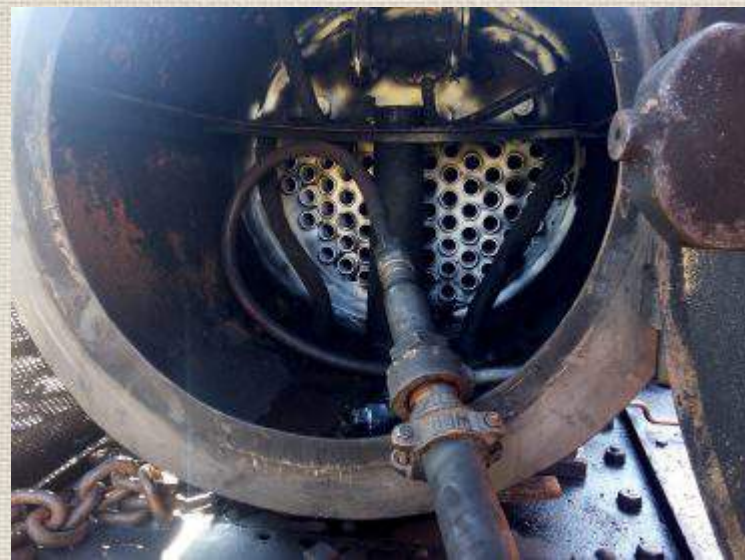
Below: The Lawley on her way to the Steam Shed!

The procedures are the same on small and larger boilers and it is a very important task.

The lawley's boiler was not so dirty but now we know that she is washed.

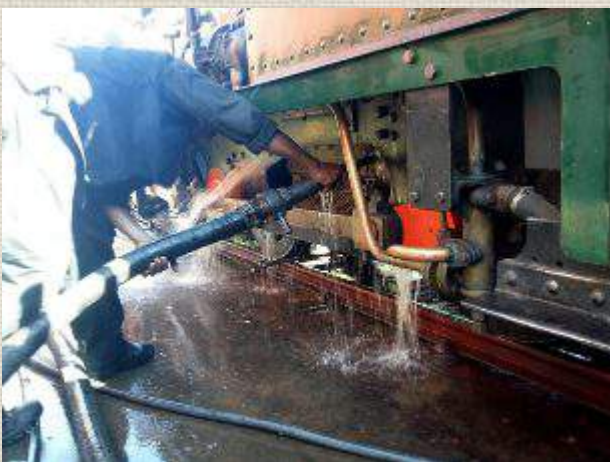
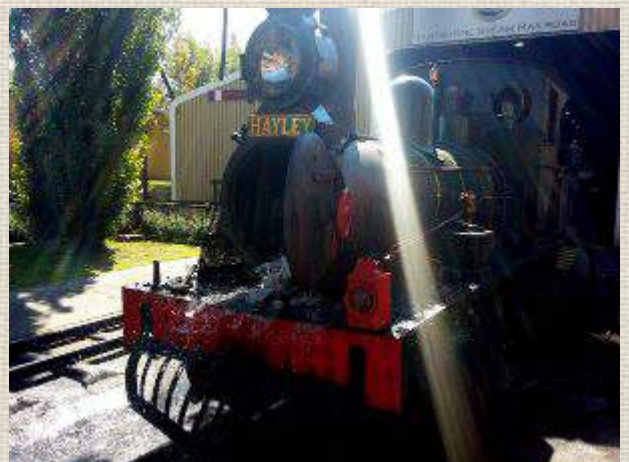
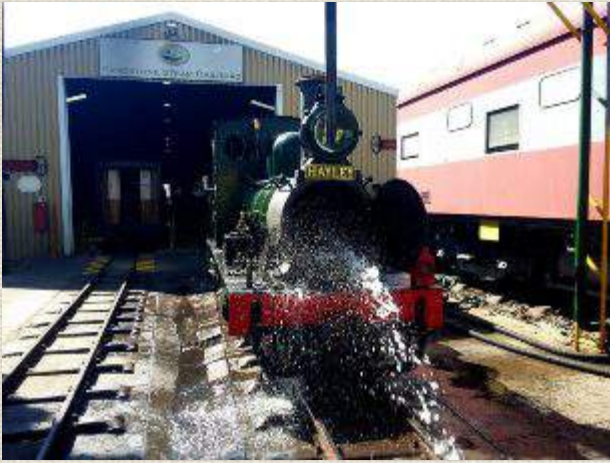
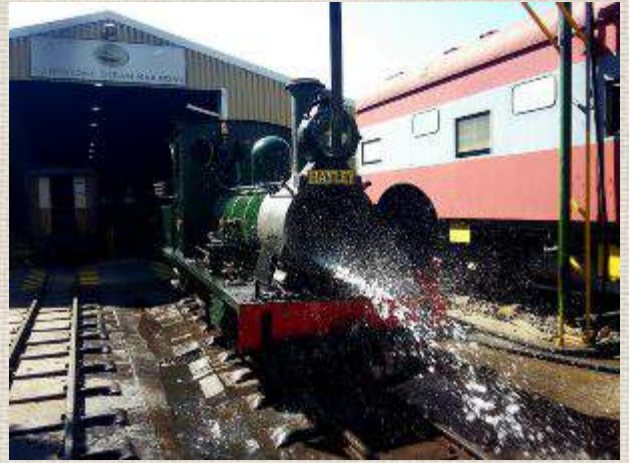
We then cleaned all the tubes after the boiler was washed out to ensure that she will be steaming freely again.

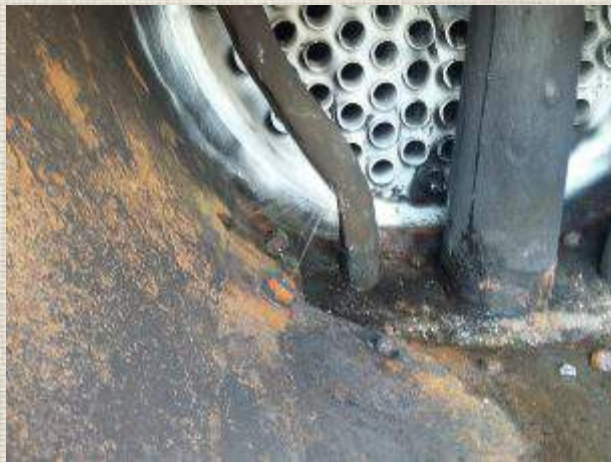
After the washout we did a hydraulic test to look for leaks and found the R-Hand branch steam pipe to be Totally rotten through.

Next week we will shunt her to the Inspection pit where the pipe will be removed and repaired. Once this is done We will steam test her on the next available train tour to make sure all is in order. A branch steam pipe leaking Like this will have a huge effect on her steaming capabilities.

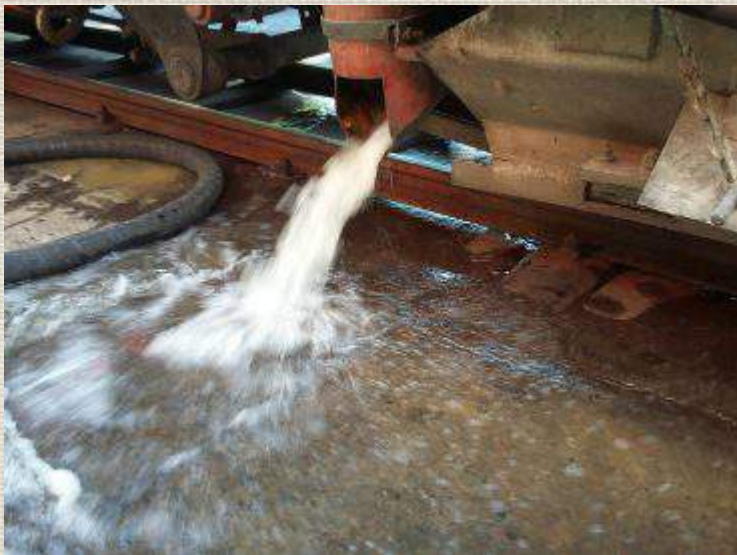
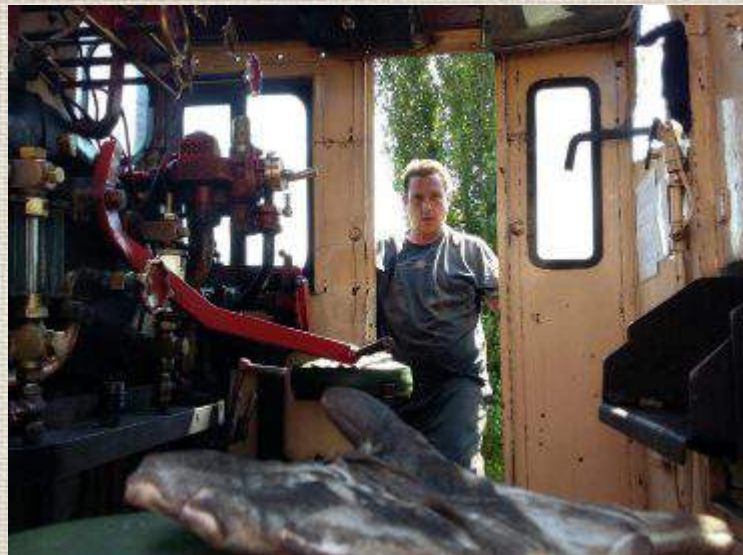
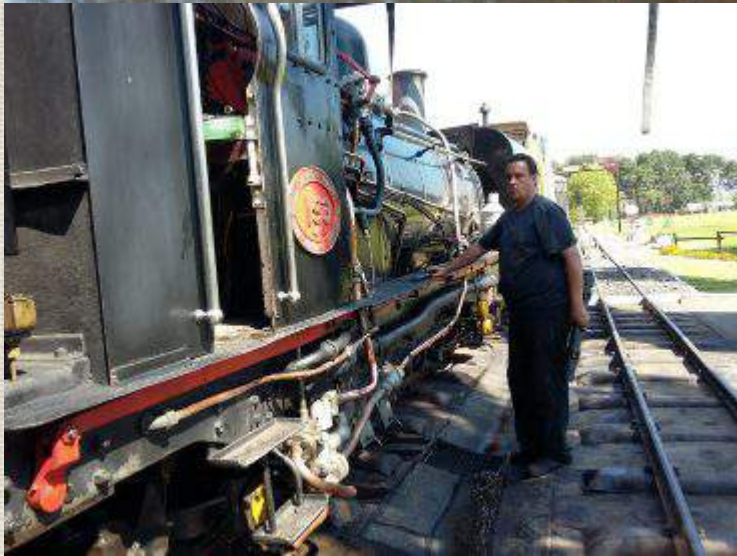
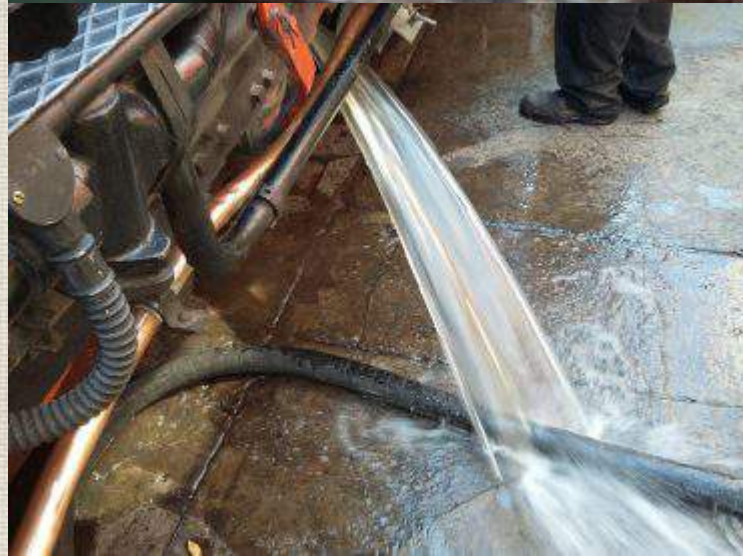
This week we washed out 153 again after she did 5 trips from last washout. We treated the water and wanted to test The effect of the chemicals on the hardened scale inside the boiler.

We keep record of how many times a locomotive is used after washout and normally we wash them after 6 Trips but we noticed that the water in the gauge glasses became very milky and knew that the chemicals were doing the job, softening hardened scale.

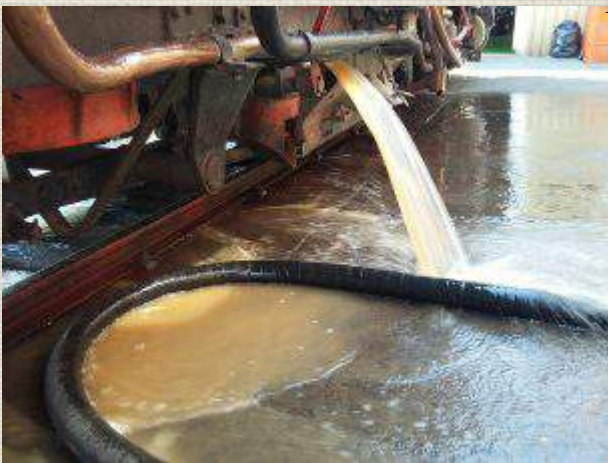
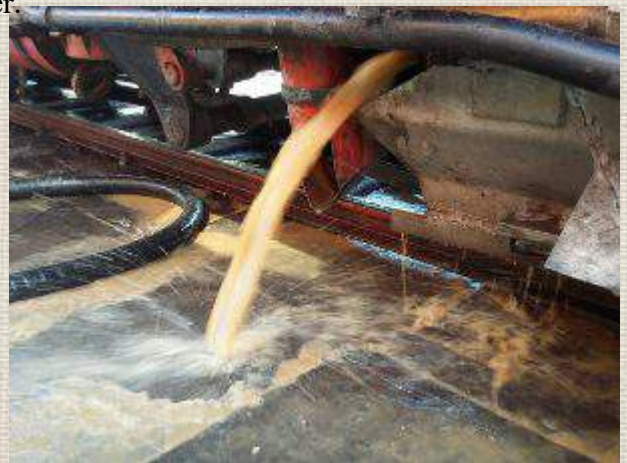
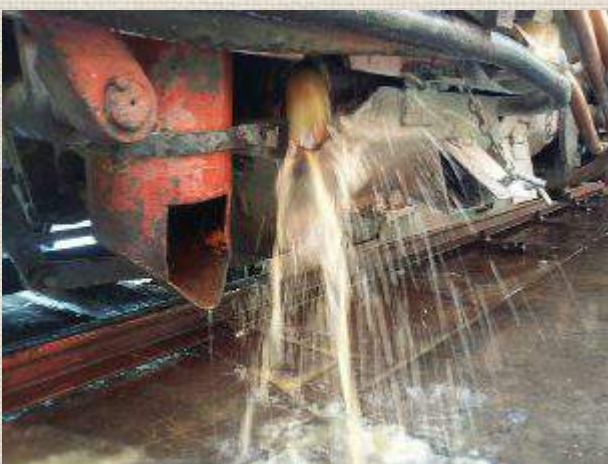
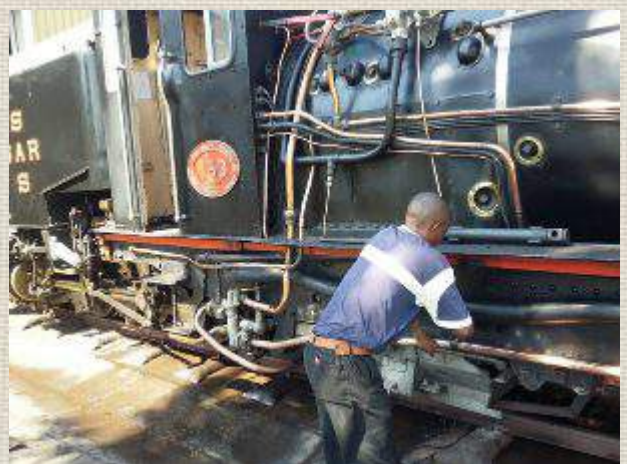
Below: Only a little bit of hardened scale came out, the rest was a milky brown sludge that was washed out Easily. The chemicals are now doing the hard work and washouts will become easier as we keep treating The feed water.

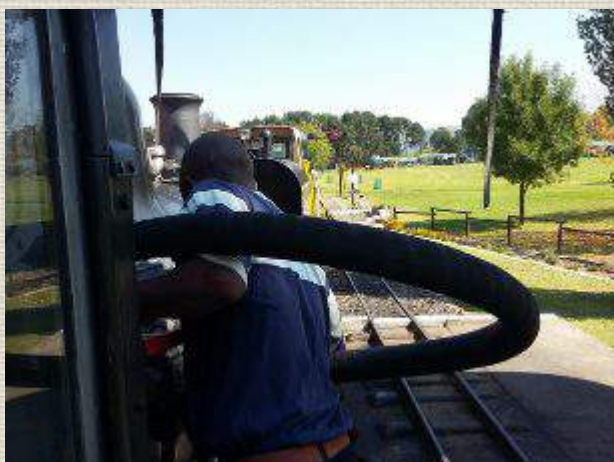
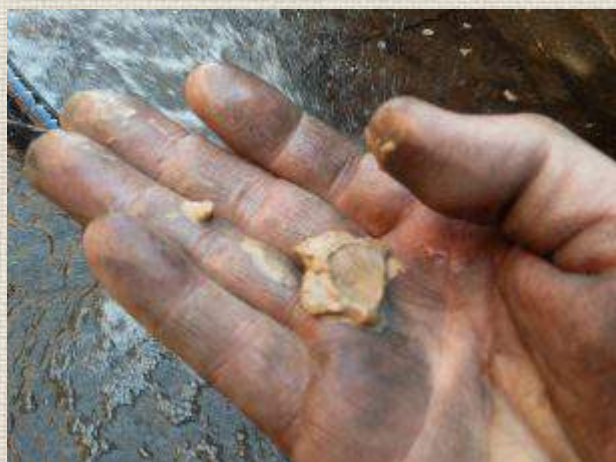
Below: The softened scale, evidence of a very good chemicals that we use. This scales is the same colour as the Sludge that we are washing out and it literally de solves in water.

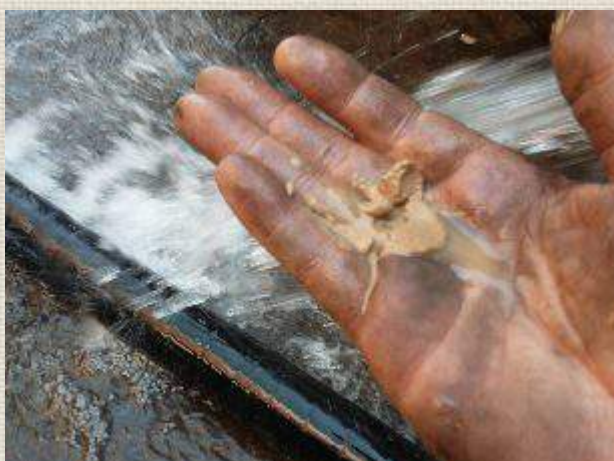
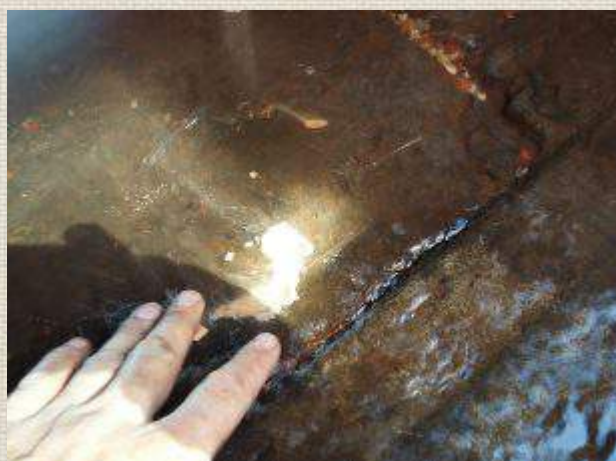
Below: When the scale gets in contact with water it dissolves, making washout easy and also it will soften all The remaining hard scale in time, thus keeping our boilers clean and healthy.

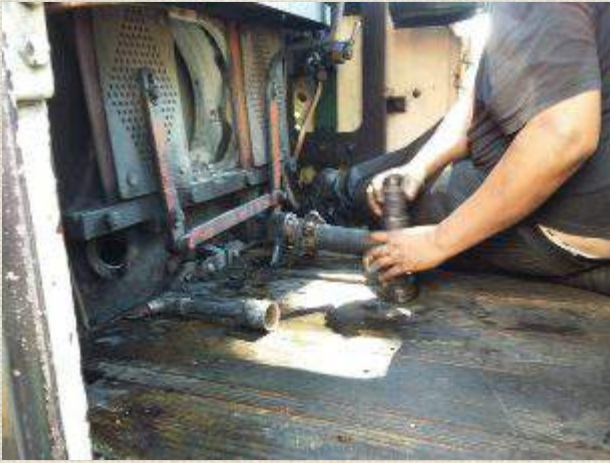
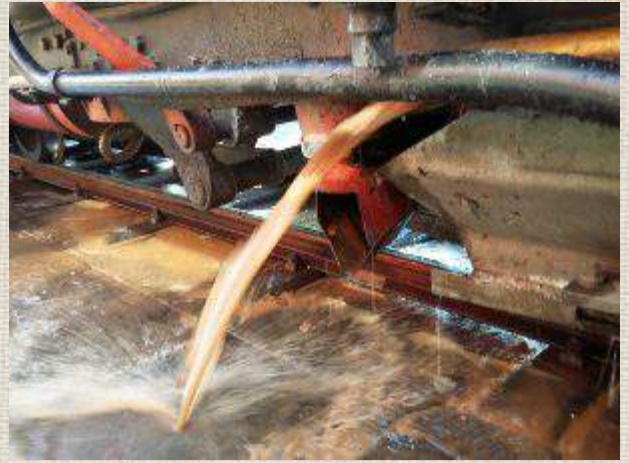
Finally we washed the water space between the inner and outer fire box and was surprised by the amount Of mud that came out, proofing that the chemicals are spot on and well worth it.

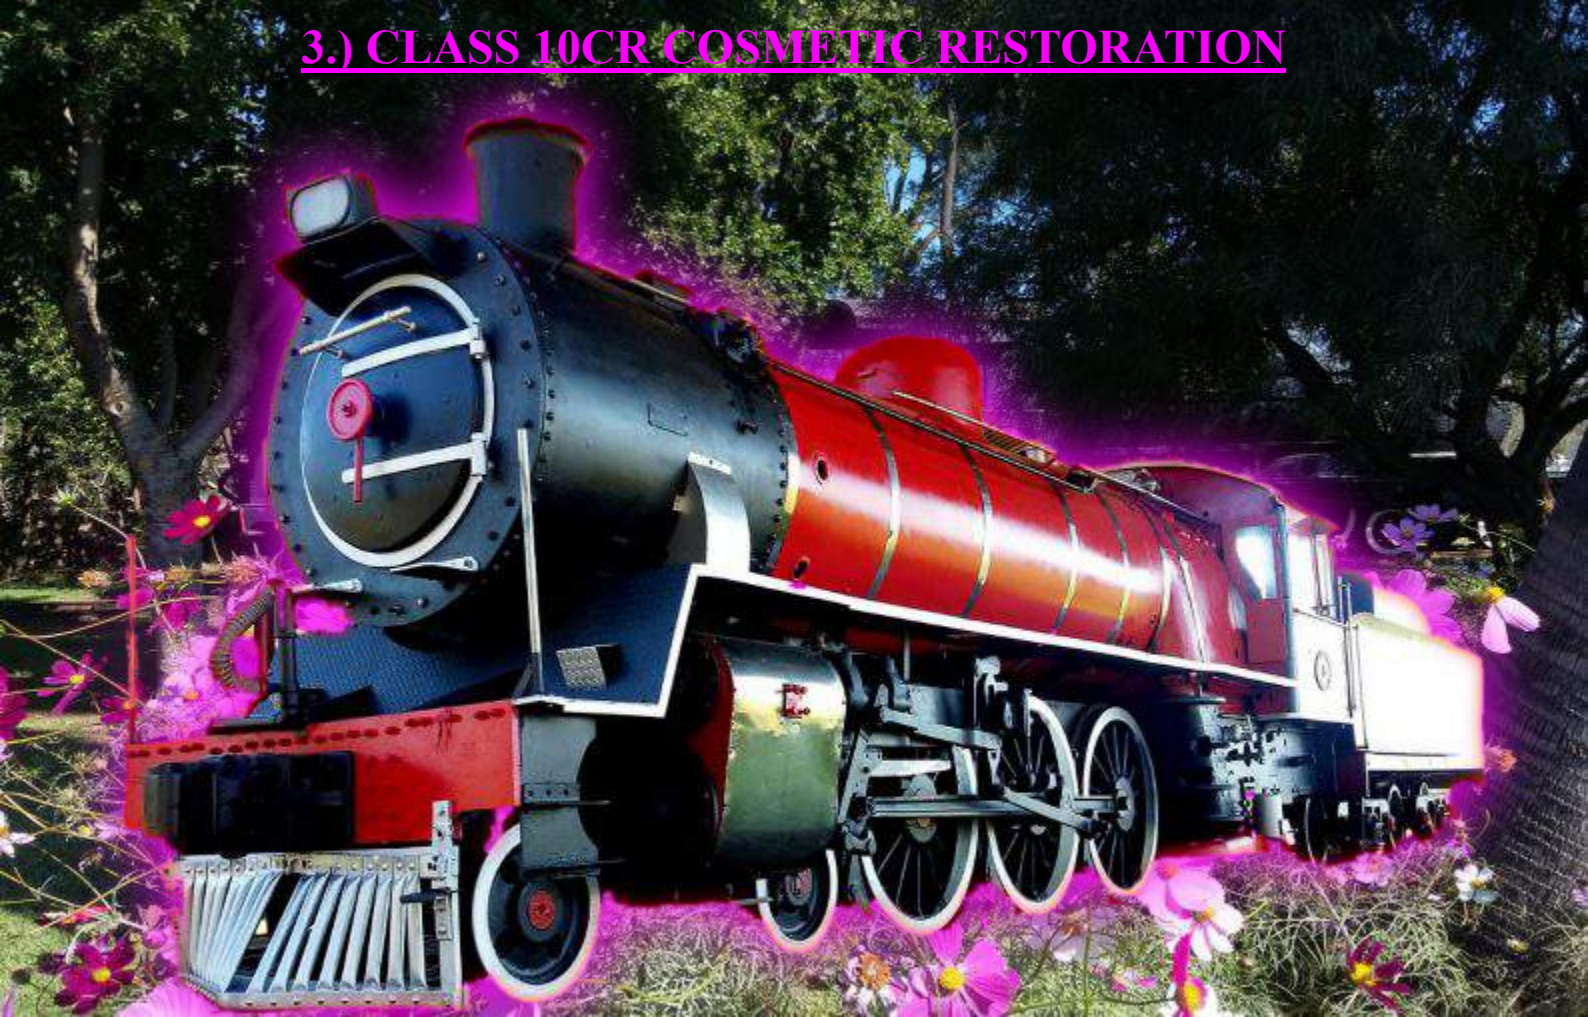
### 3.) CLASS 10CR COSMETIC RESTORATION

During the week Brian started with the cosmetic upgrade of the cab and he removed all the old paint, repaired the Broken planks of the roof and started with painting. This will take him another 2 days to complete.

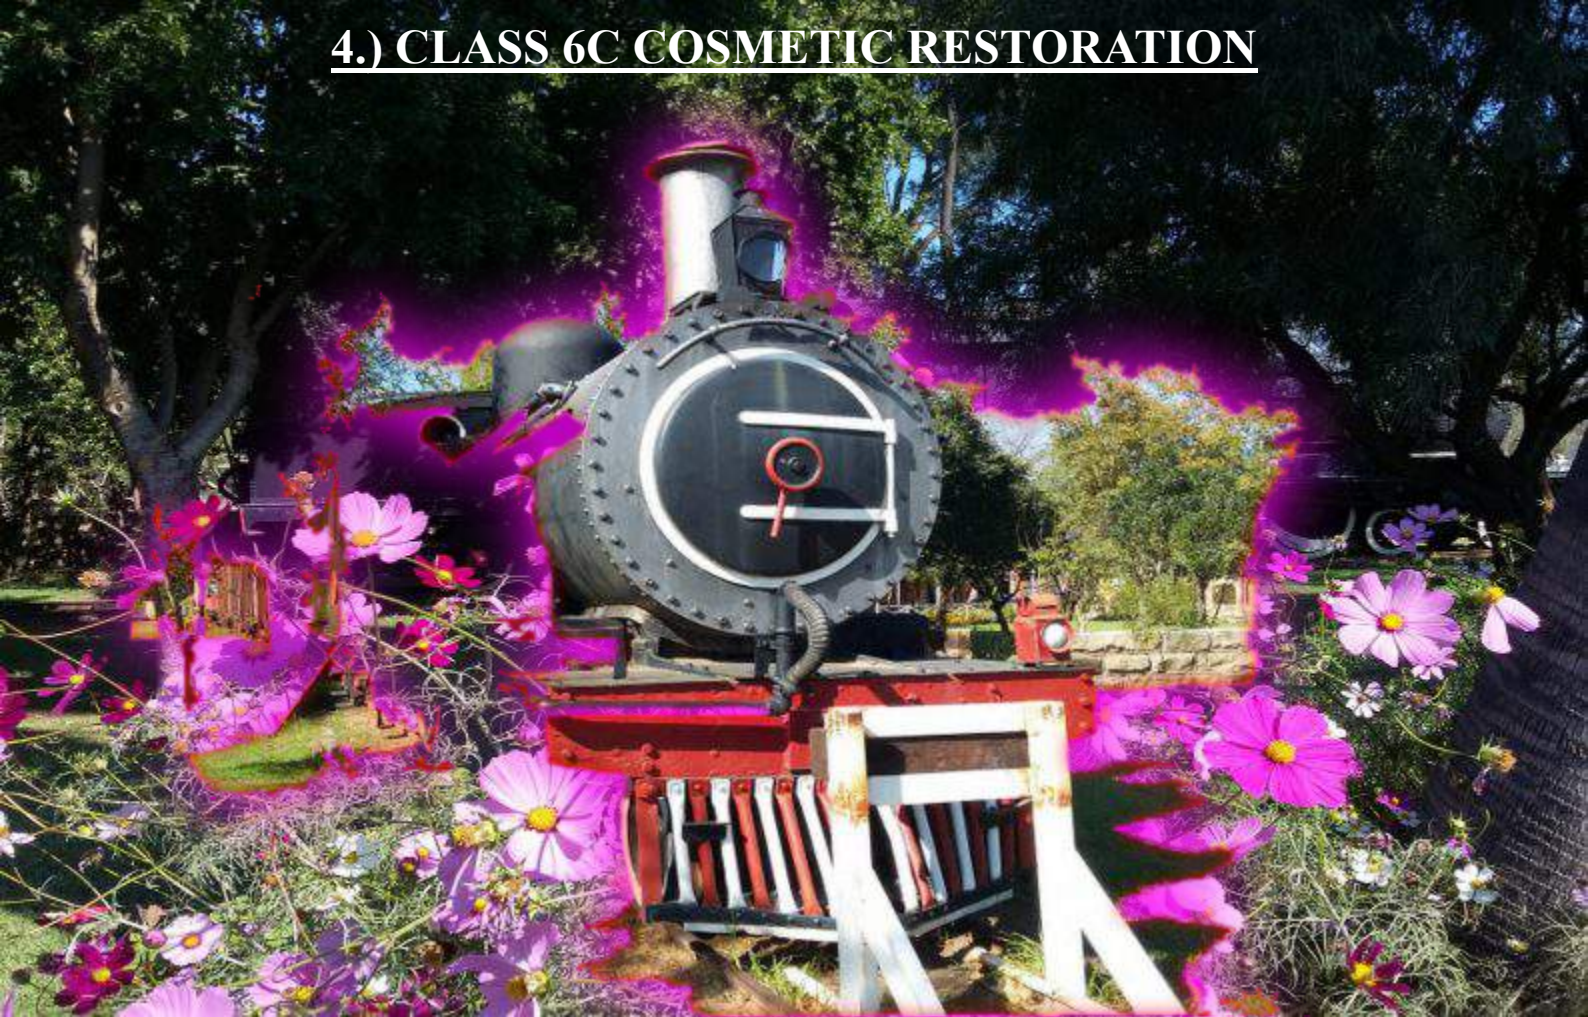
#### 4.) CLASS 6C COSMETIC RESTORATION

On Friday we started with the cosmetic upgrading of our very pretty and elegant locomotive, the Class 6C. First we Had the Ladies there to do a good cleanup inside the cab and tender and then we removed the rotten cylinder cladding.

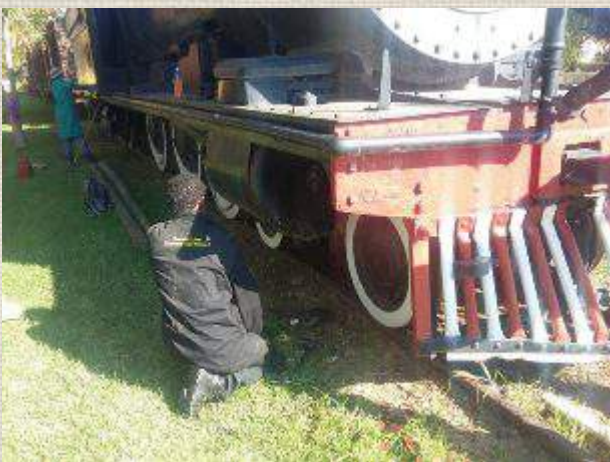
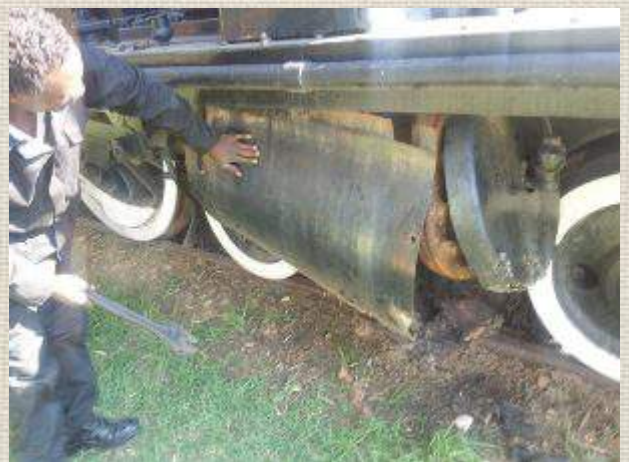
Below: Joseph removed the cylinder drain corks and the rotten cylinder claddings. All the brass parts will Be cleaned down at the shed.

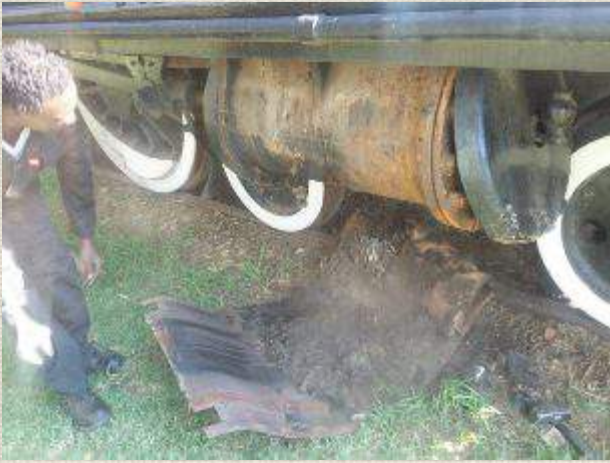
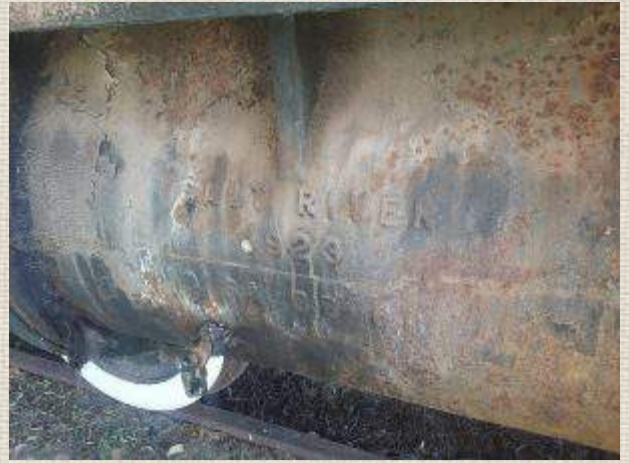
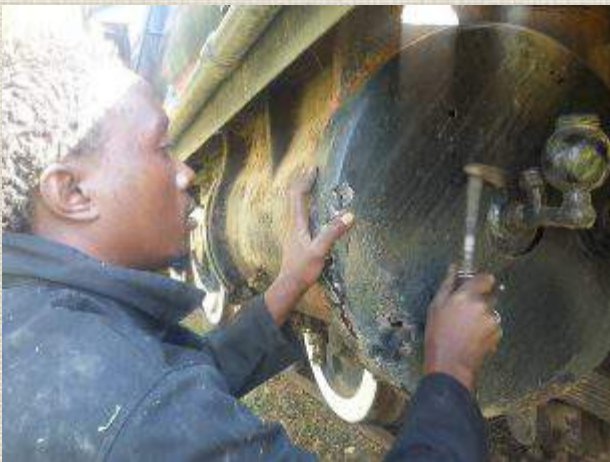
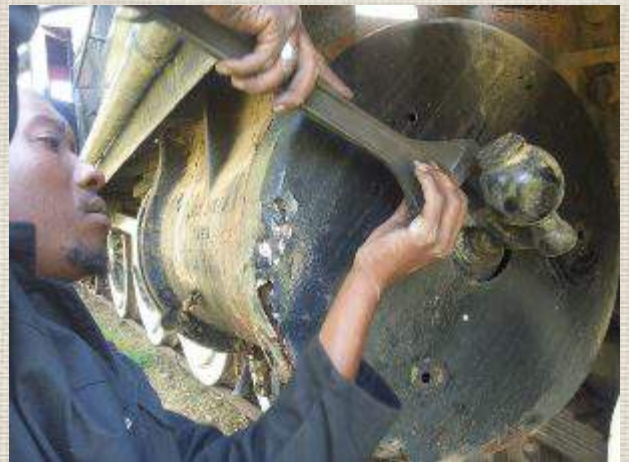
Salt River, 1923. Class 6A,6B and 6C patent cylinder castings.

She will need a new wooden roof, wooden window frames and cab doors will be made new again.

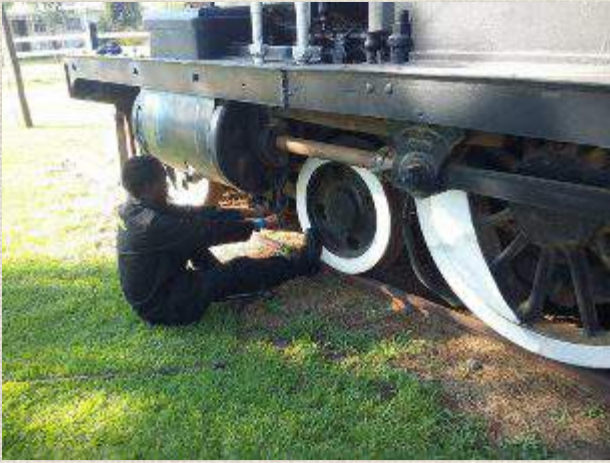
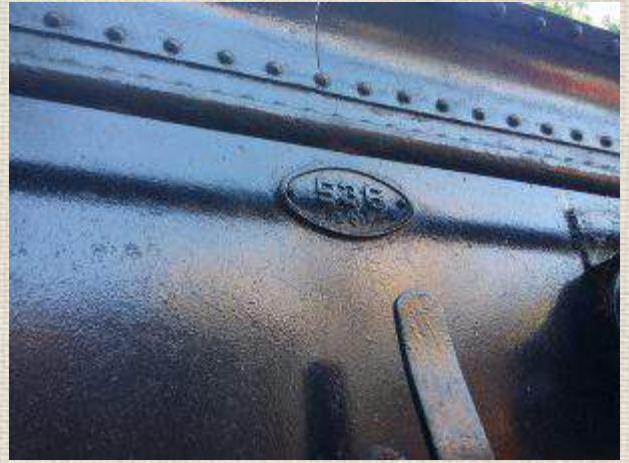
Below left: The old paraffin lamp.

Below right: The number plates were taken off and will be made like new again.

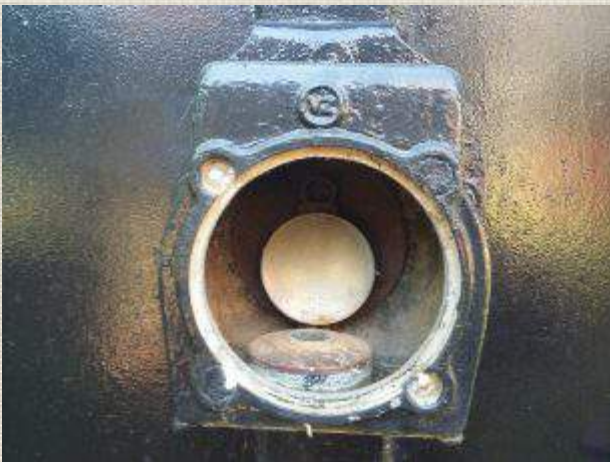
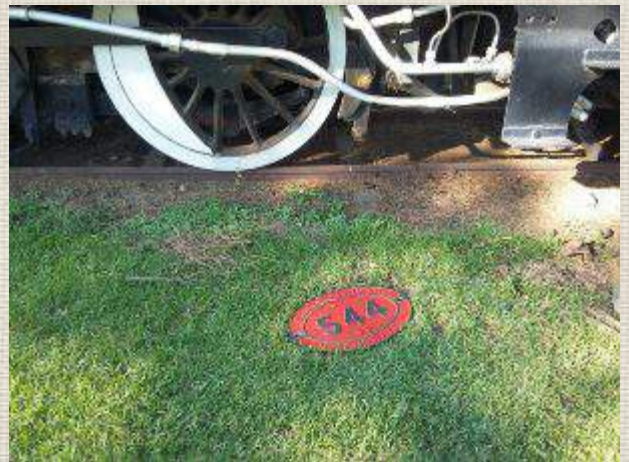
Next week Wouter will make new cylinder claddings and covers.

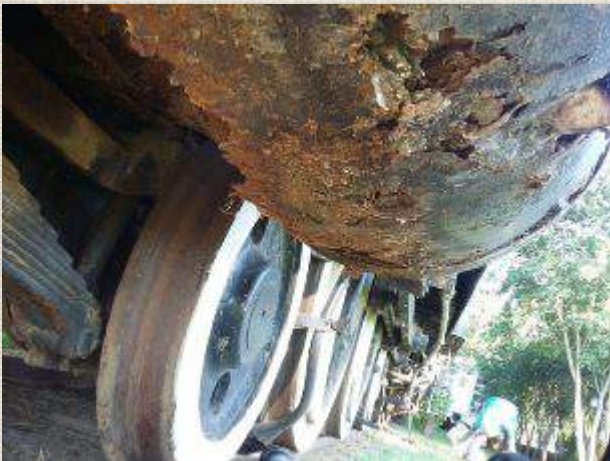
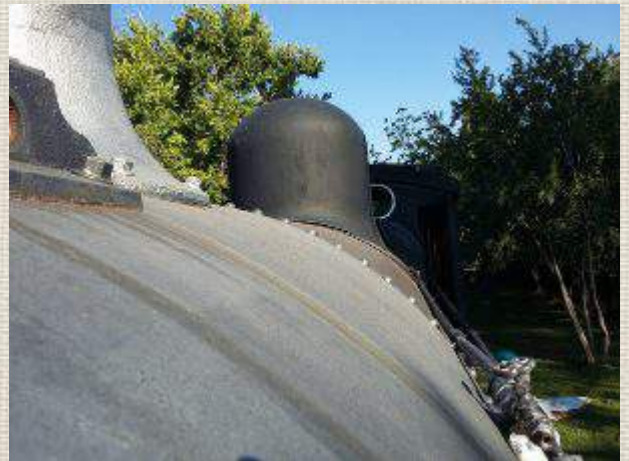
The locomotive now will be sanded down before we will start with painting her.

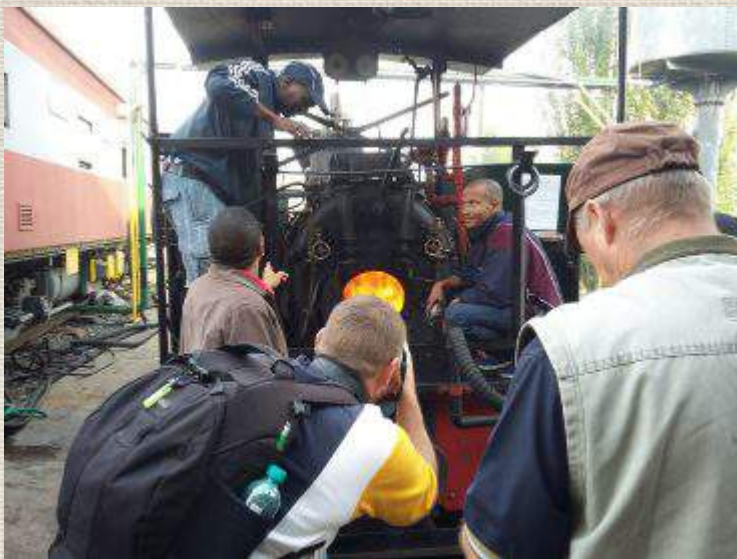
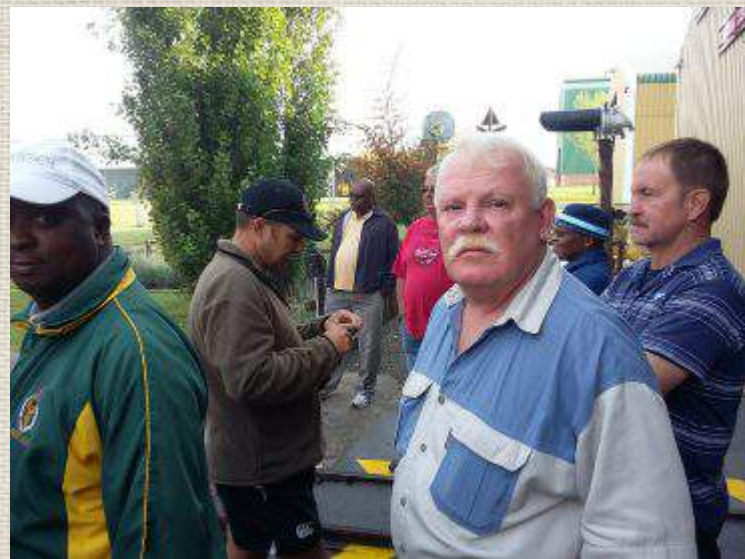
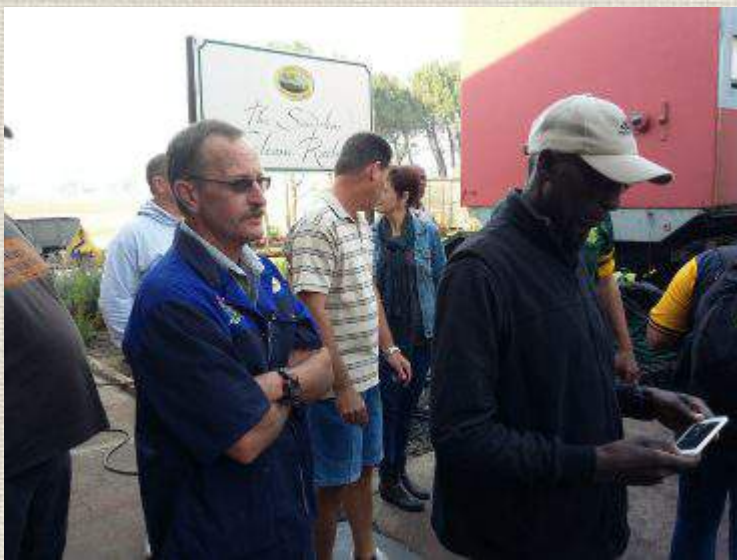
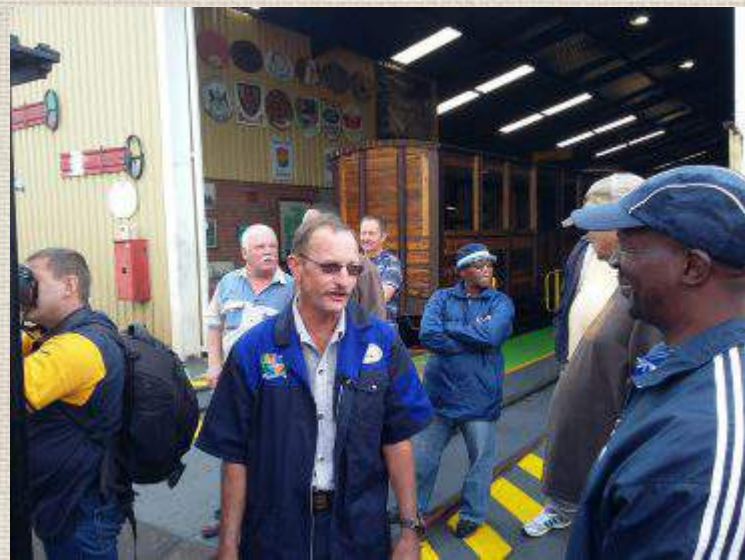
First they coaled the locomotive, then filled the side tanks with water and then prepared the fire. Every now and then they had to hurry down and build the fire layer for layer till she was in steam, breathing on her own.

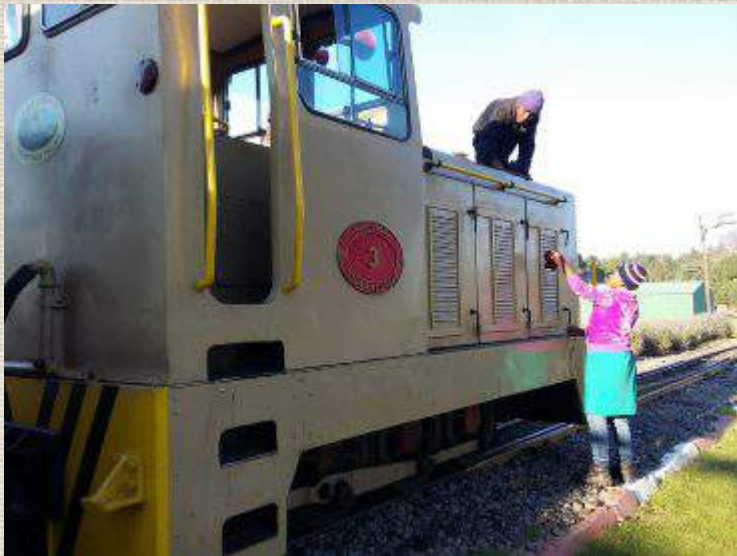
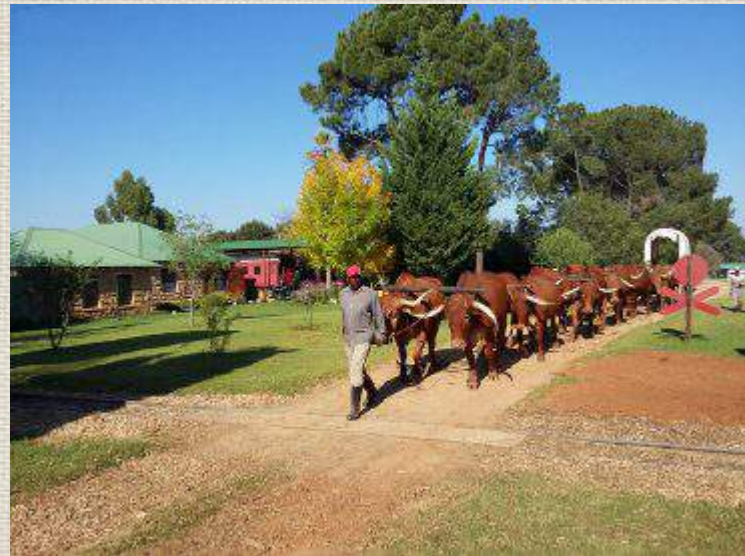
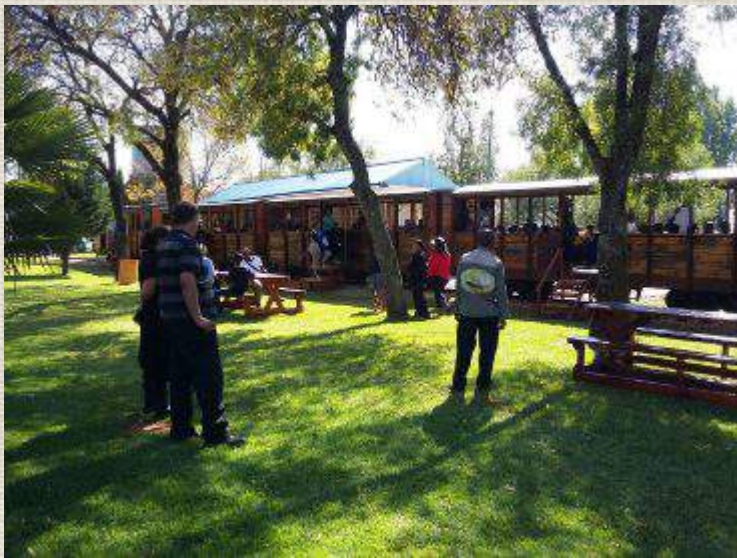
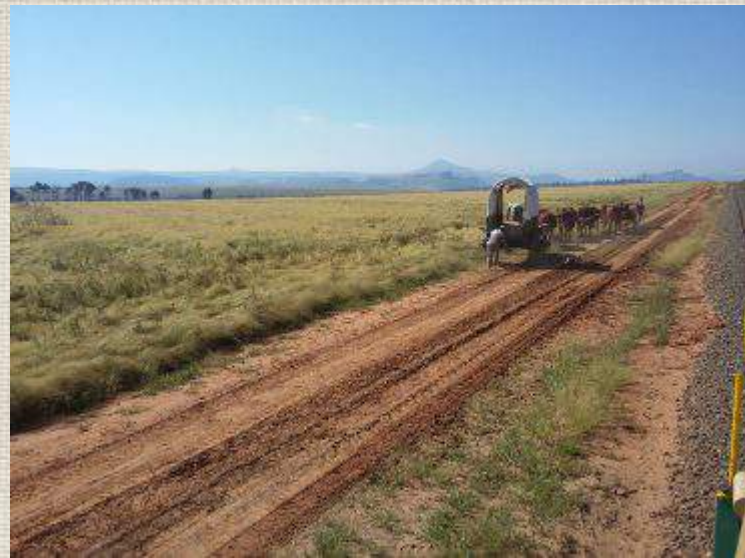
On Thursday we had a special passenger train for 300 children and we did 2 trips with the Hunslet Diesel Locomotive To Grootdraai and back.

Steam or Diesel, they must shine!

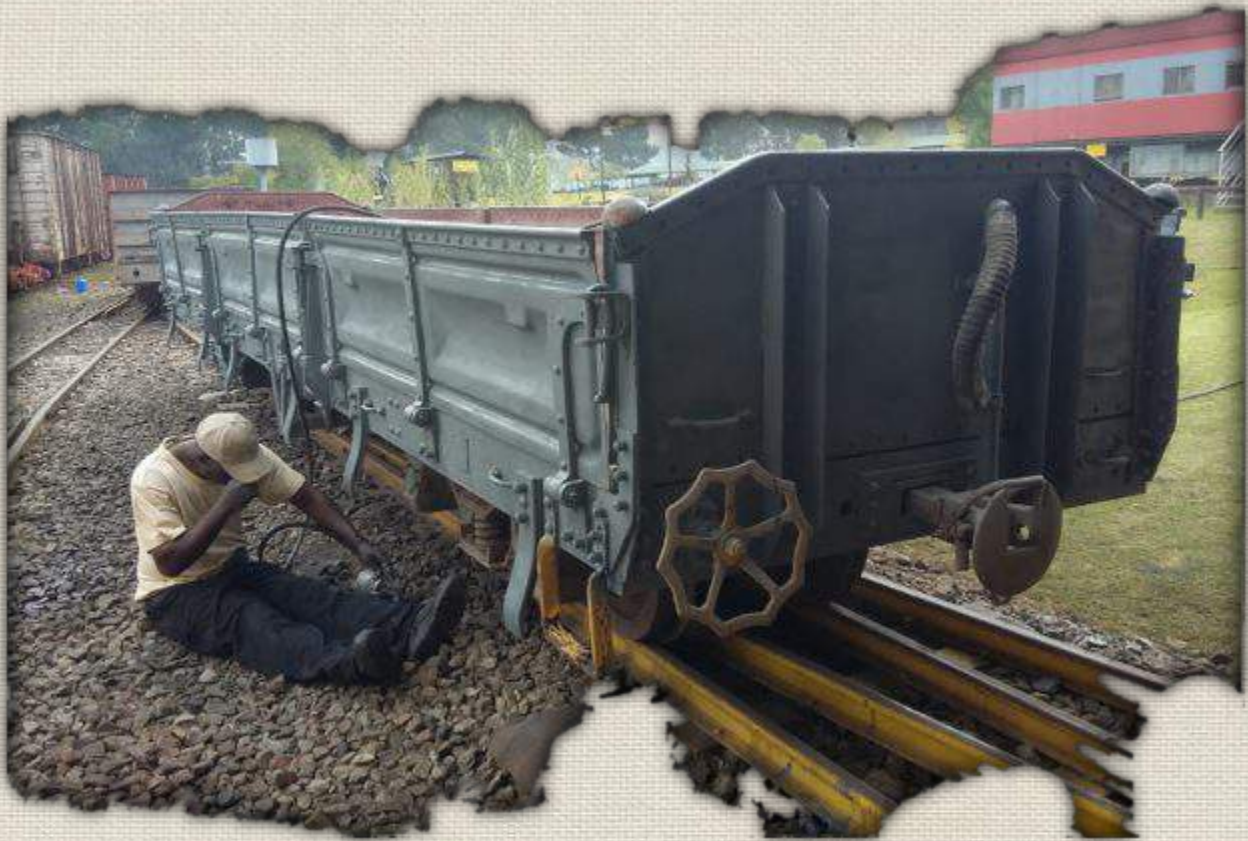
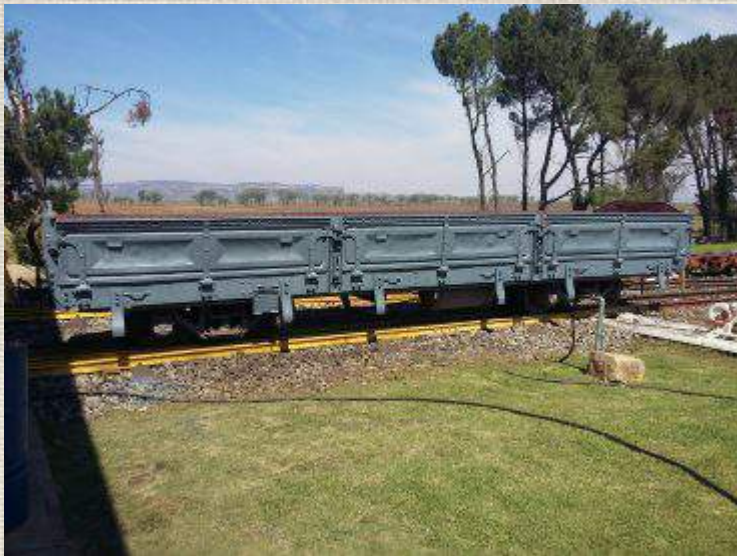
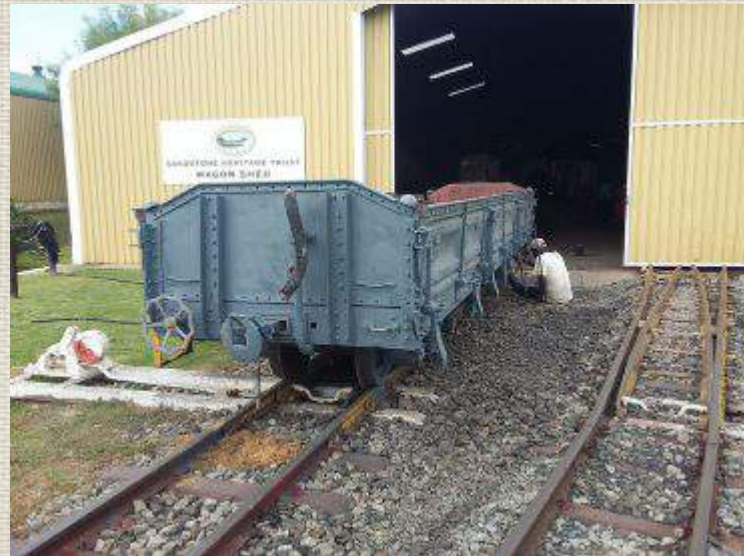
## 7.) DZ & C WAGON RESTORATION

This week we spray painted the DZ and C wagon that were sandblasted recently. These 2 wagons now will come to The inspection pit for under frame restoration and will be stenciled as well.

- 1.) Class 10 CR Cab restoration
- 2.) To complete Washout of NGG 16 number 153
- 3.) Class 6 C Cosmetic restoration.
- 4.) DZ and C wagon mechanical restoration.
- 5.) Otavi Wagon Restoration.
- 6.) Repair Lawley Branch Steam pipe.
- 7.) 3'6' Goods wagon restoration.
- 8.) Washout Barclay Locomotive
- 9.) New 1 km Light Railway line construction.
- 10.) Tamping Machine
- 11.) Washout Class NGG16 number 88

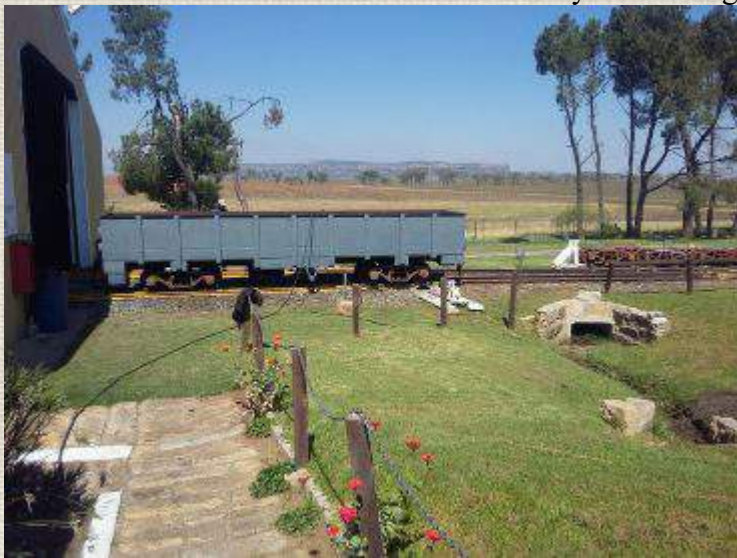
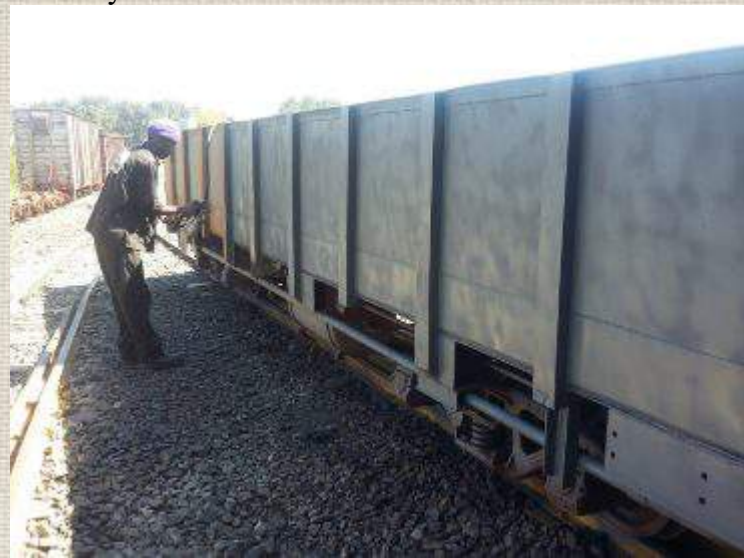
Below: The very first C wagon on the way to full restoration.
