# Steam News From The Eastern Free State

Sandstone Estates Steam Railway News 15 April 2016

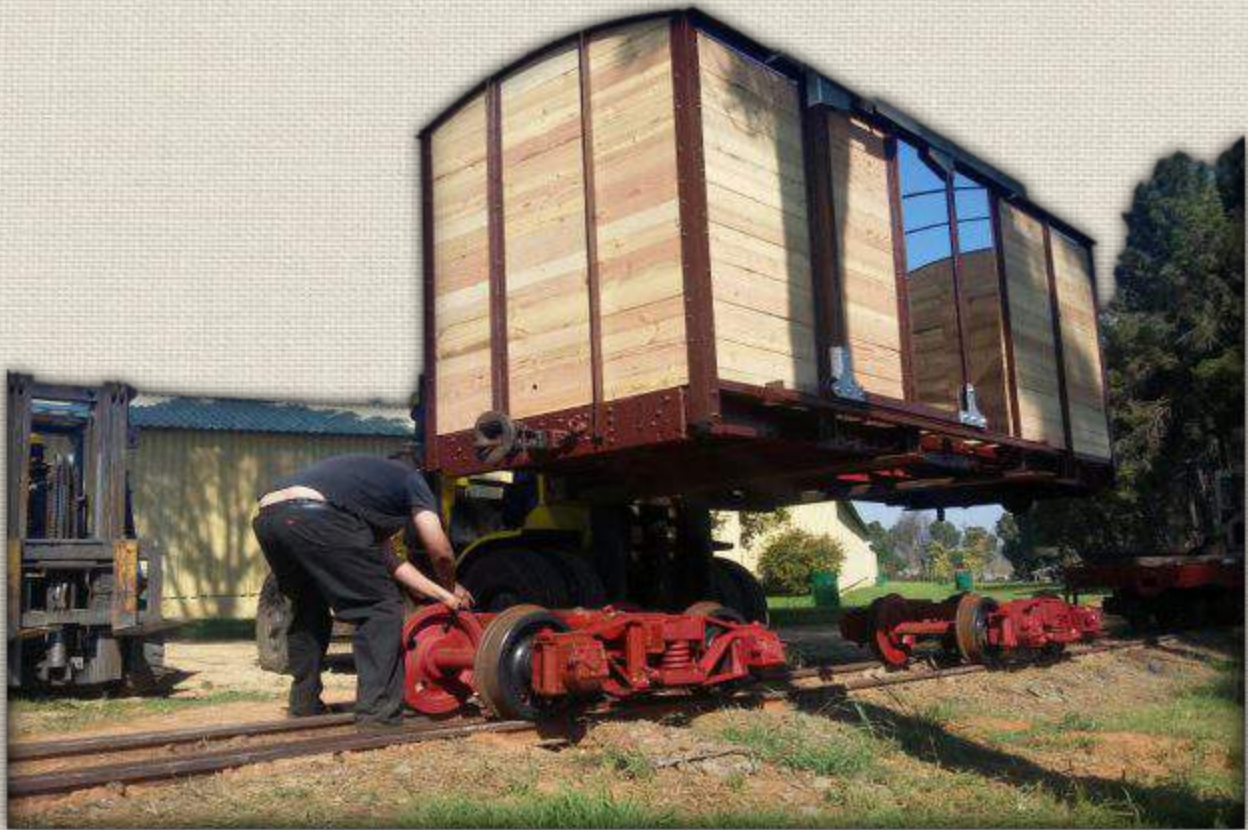
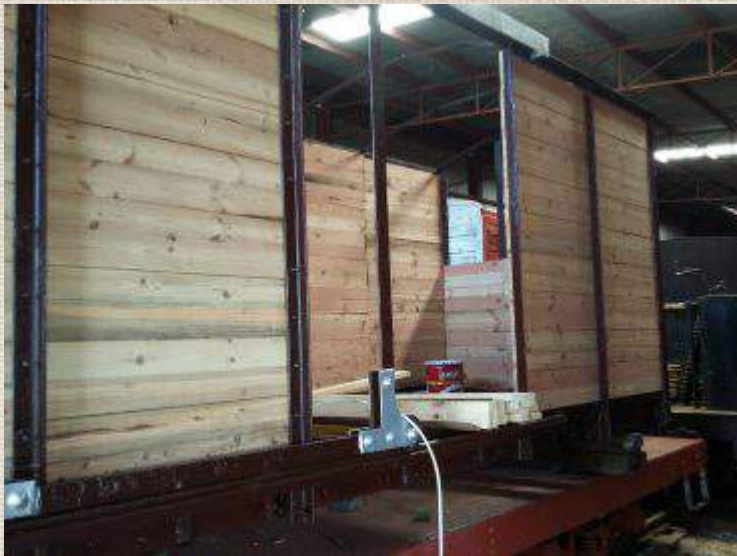
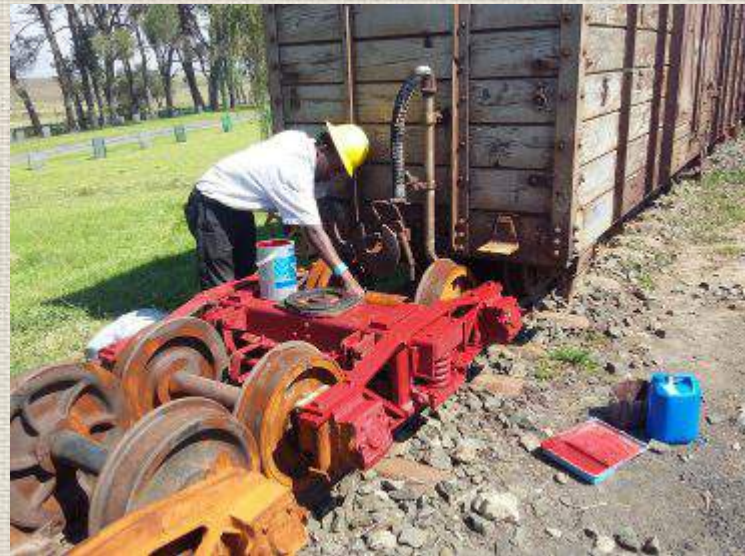
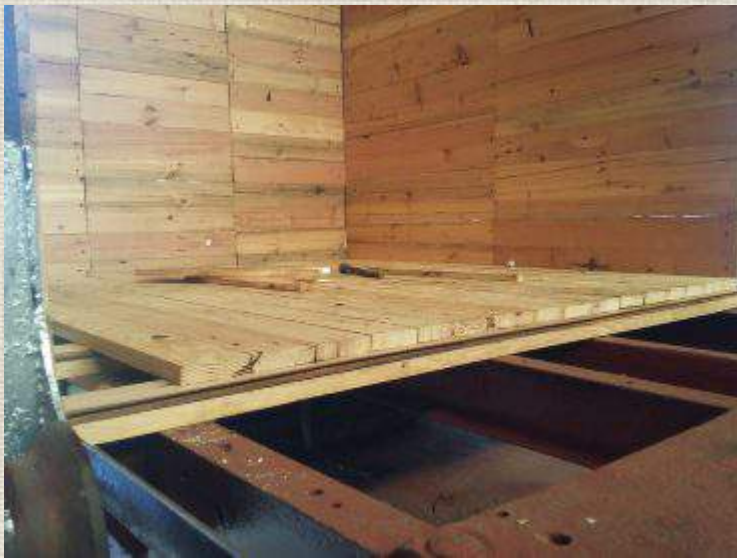
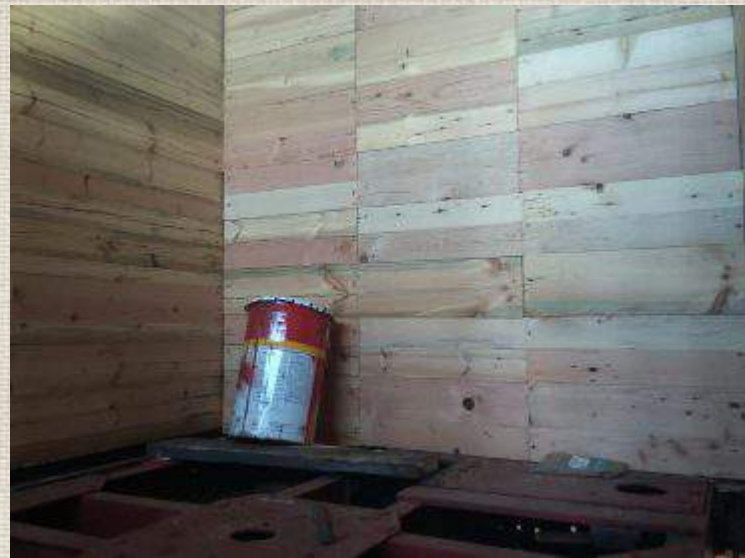
## 8.) OTAVI WAGON RESTORATION

The restoration of the Otavi wagon is slowly coming together and this week we lifted her onto temporary bogies That we restored for use under a DZ wagon. We want to have her mobile to move to the shed for further restoration.

In next week we will start with the restoration of the original bogeys and we will shunt this wagon to the Steam Workshop to fast track the restoration work still needed. A brake system will be fitted and new 2" vacuum brake pipe Will be fitted.

- 1.) Class 10 CR Cab restoration
- 2.) To complete Washout of NGG 16 number 153
- 3.) Class 6 C Cosmetic restoration.
- 4.) DZ and C wagon mechanical restoration.
- 5.) Otavi Wagon Restoration.
- 6.) Repair Lawley Branch Steam pipe.
- 7.) 3'6' Goods wagon restoration.
- 8.) Washout Barclay Locomotive
- 9.) New 1 km Light Railway line construction.
- 10.) Tamping Machine
- 11.) Washout Class NGG16 number 88

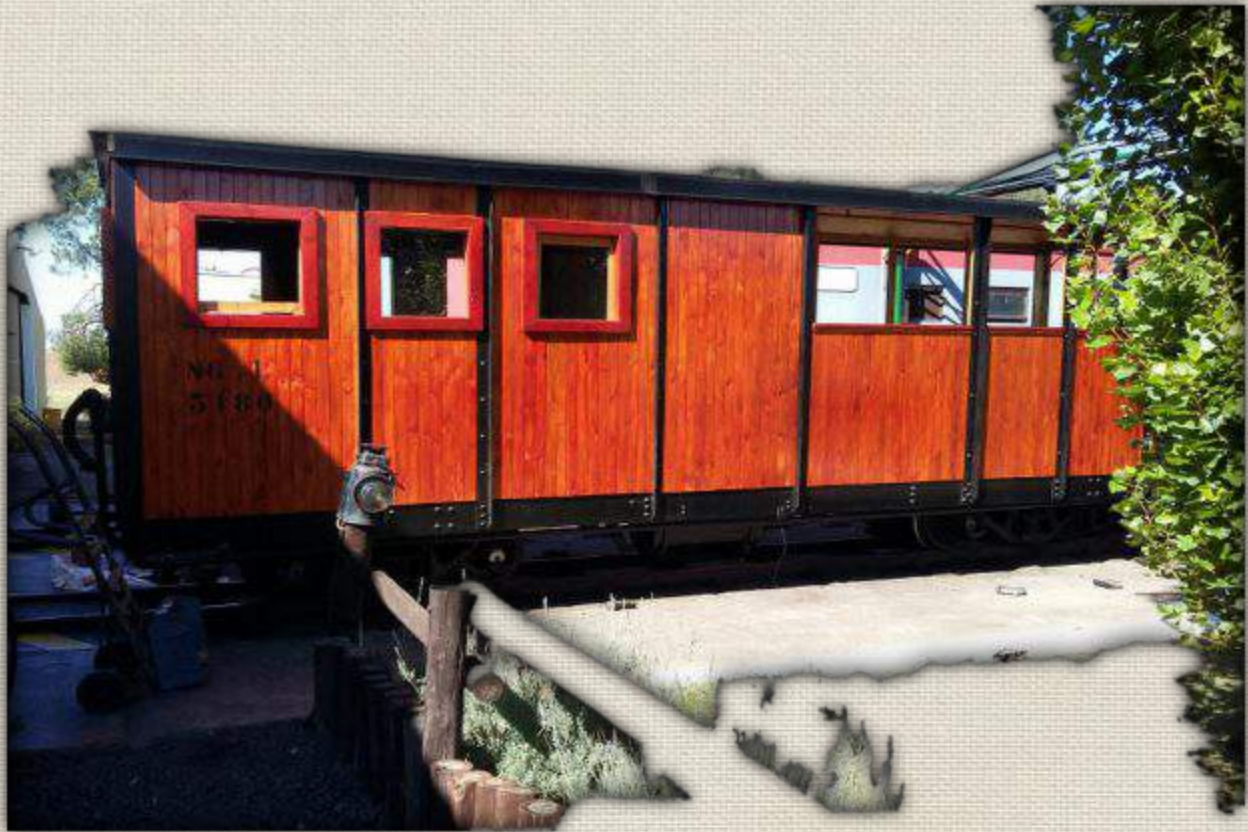
## 9.) VIP COACHES

This week we shunted our 2 VIP coaches to the Steam Workshop. All the bearings on these 2 wagons were damaged And were replaced by new bearings. The Axle boxes were also packed with new wool.

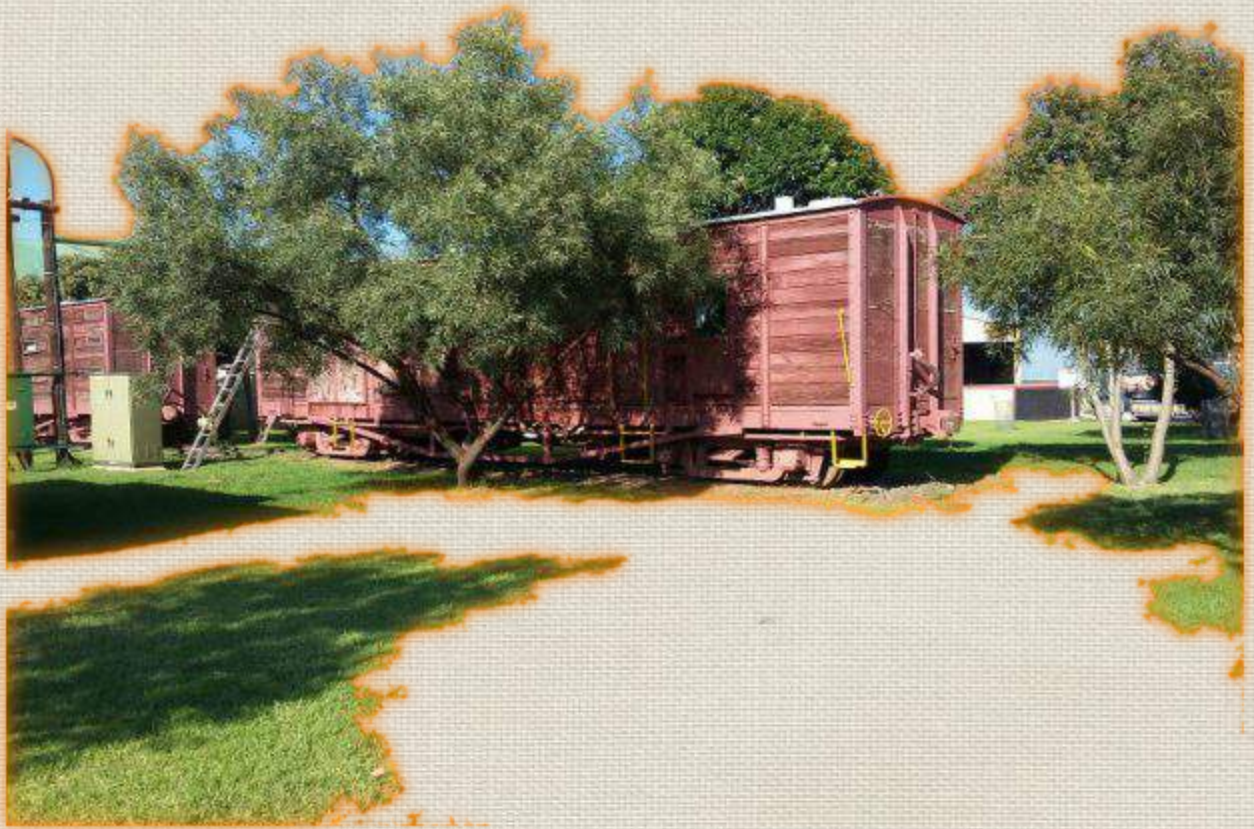
## 10.) 3'6" GOODS WAGONS COSMETIC UPGRADE

Johannes started with the cosmetic upgrade needed on the 3'6" goods wagons in Hoekfontein Station. All the rotten Planks are replaced and the first wagon is sanded down and will be completed by next Friday.

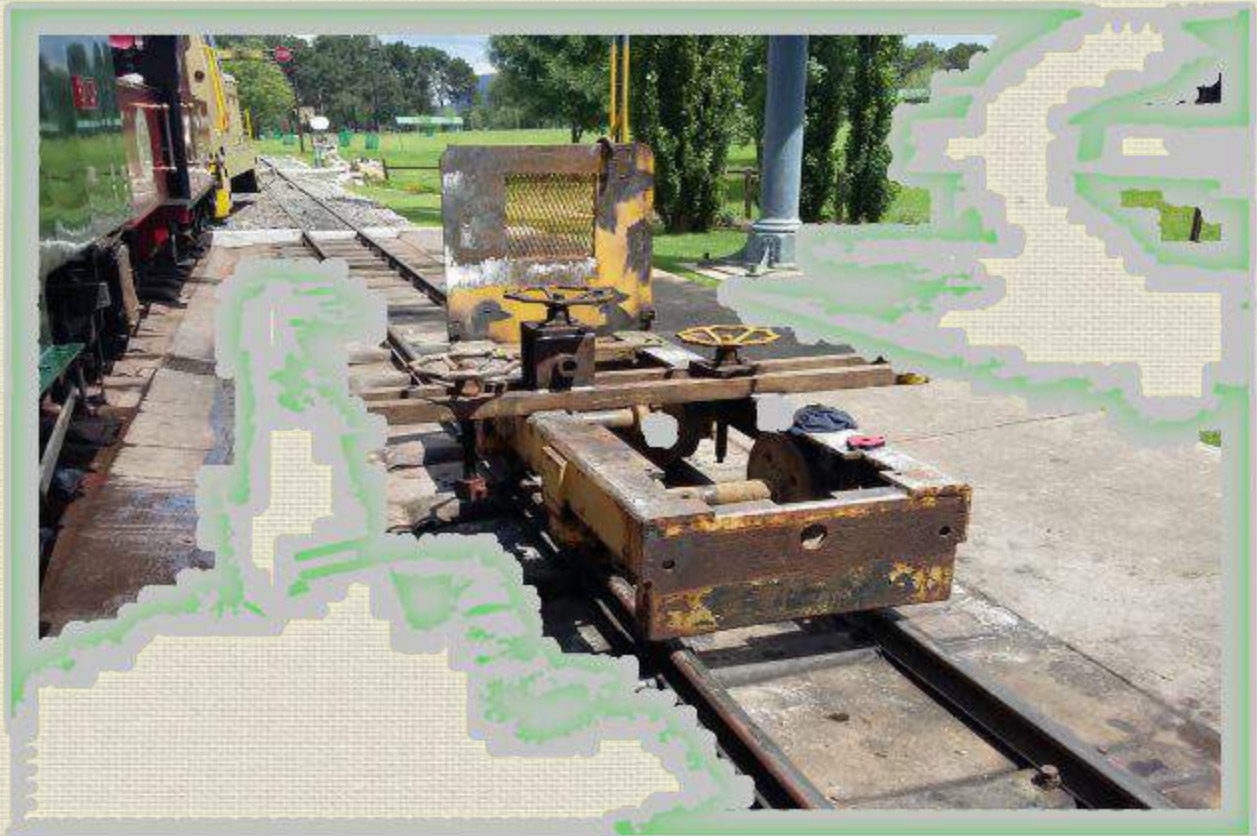
## 11.) TAMPING MACHINE CONSTRUCTION

The construction of our little Tamping machine is in progress again and Wouter went on where Thinus stopped some time ago. Thinus and Isak is back in Bloemfontein again working on the Class NGG11.

The 2 hand brakes in the middle will work the rail tongue grabs and the 2 handbrakes on the sides will lift the Tamping machine and track and will act as the main rail jacks.

Wouter is almost finished with the construction of the side end jacks and will make the tampers next.

The Tamping machine then will go to the Sandblast bay and will be spray painted with a yellow livery. This little machine will make tamping a easy task and will move 10 times faster than hand tamping can go.

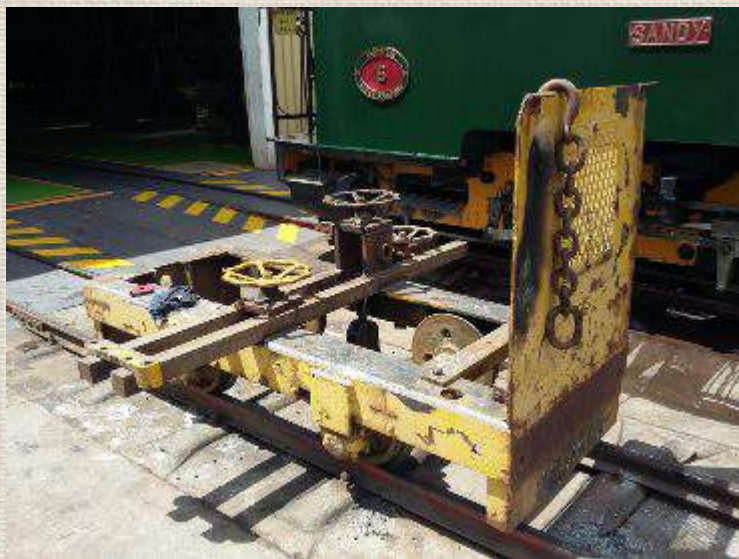
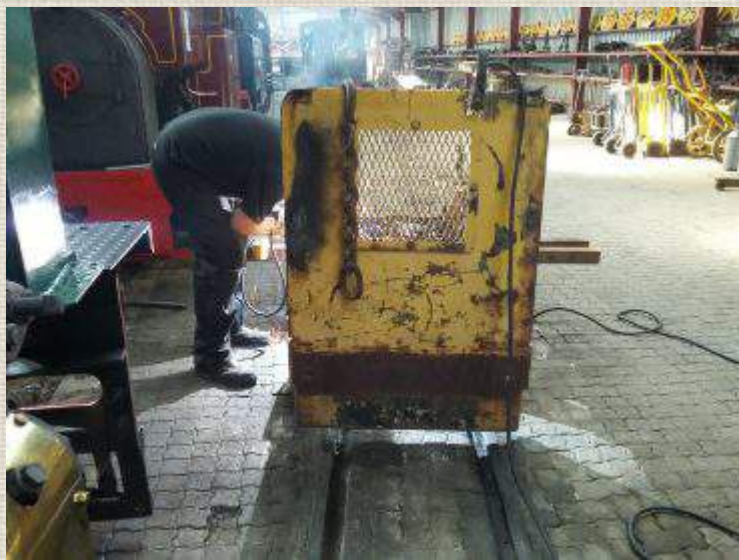
Below right: The 2 rail grabs.

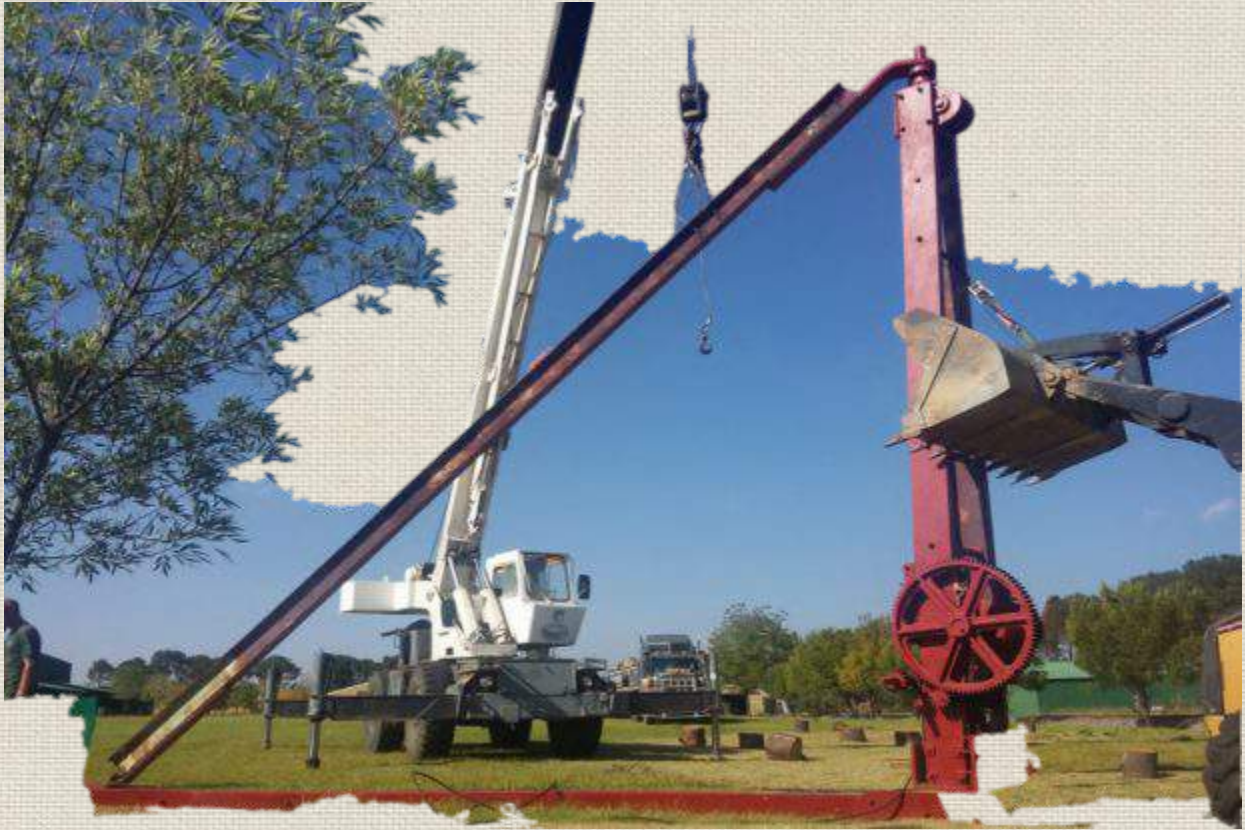
## 12.) OLD RAILWAY CRANE

This week Des, Henry and Menasse erected the very old Railway crane near the Coal Stage and what looked like A pile of steel became a very interesting construction indeed.
