# Steam News From The Eastern Free State

## HIGHLIGHTS OF THE WEEK

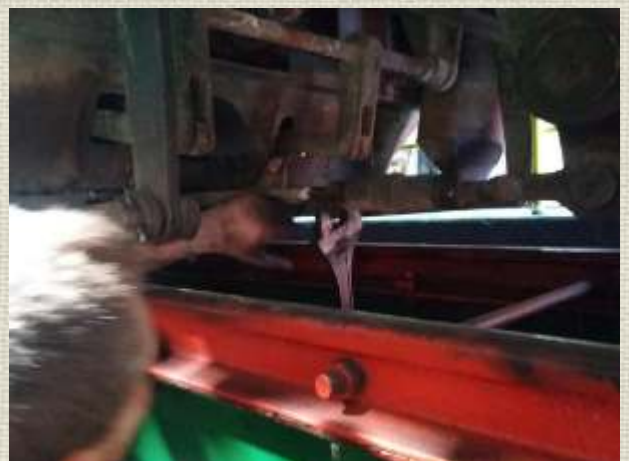
Below right: Isak repaired a leaking flange on the vacuum exhaust pipe of number 153.

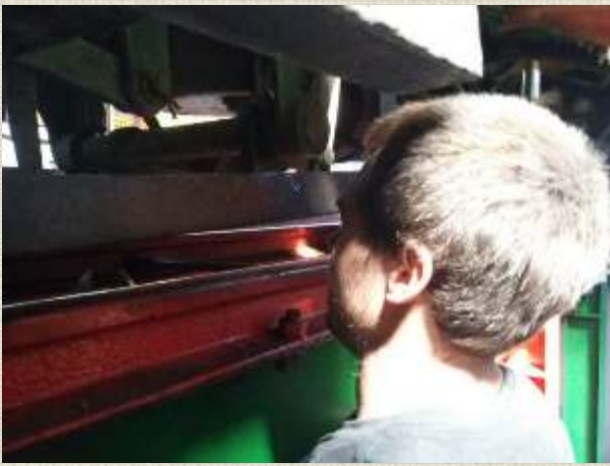
Below left: The leaking vacuum exhaust pipe.

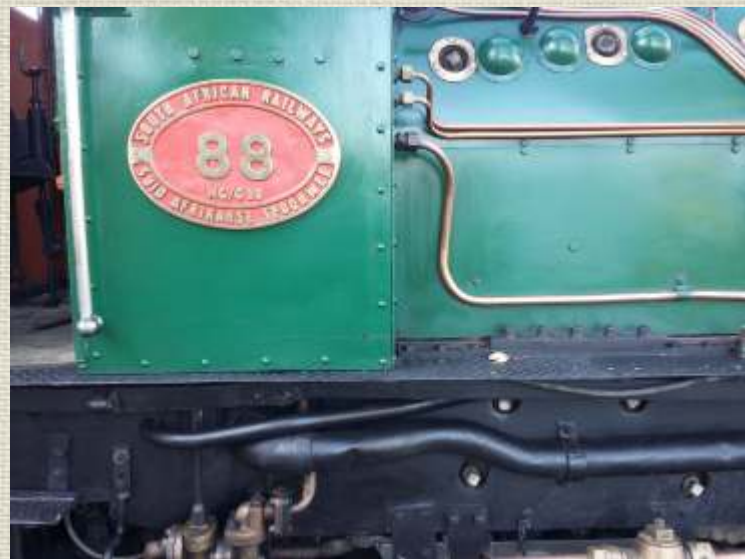
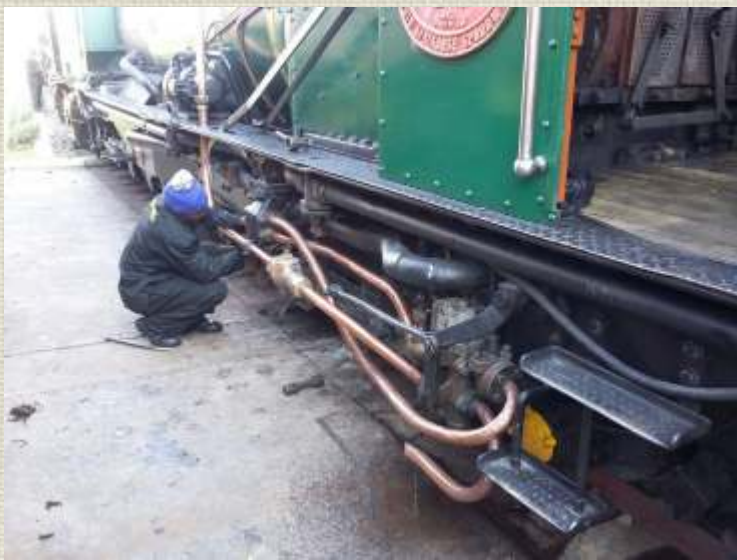
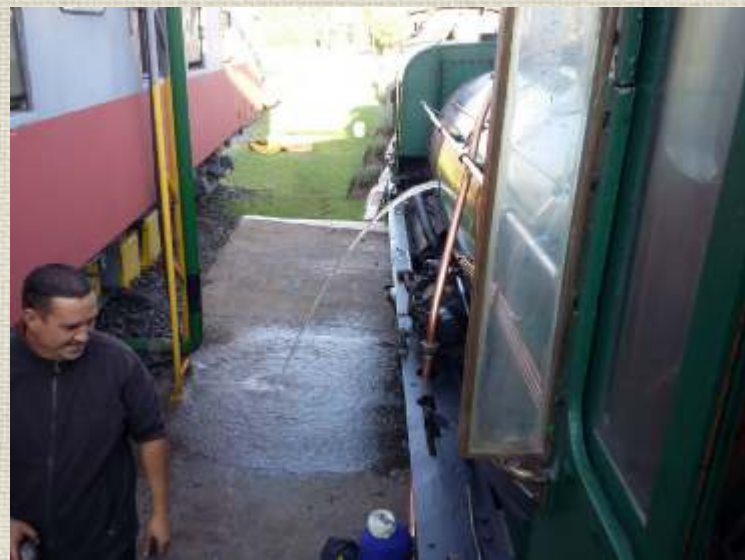
We have noticed that the water in the gauge columns were very milky because of the chemicals dissolving the Scale inside the boiler and we decided to wash out Class NGG 16 number 88.

Below: Removing the washout plugs.

Below: Dissolved scale was washed out of the boiler.

We removed the spark arrestor plates and covered the blast pipe cap before we washed out the smoke box  
And tubes.

Below: All the washout hole and washout plugs threads were inspected and the washout plugs were wire brushed  
And the threads coated with black lead grease before we secured them again.

We then filled both 153 and 88's boilers with water and added our water treatment again. In time the boilers  
Will be free from hardened scale, just takes a lot of patience.
