NEWS LETTER AUGUST 2017

# SANDSTONE

## STEAM RAILWAY

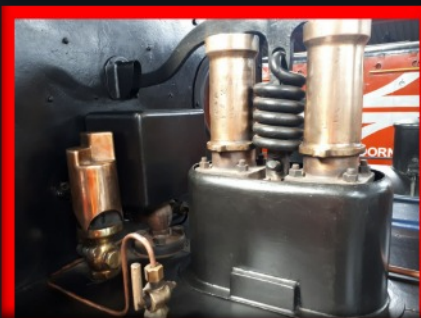
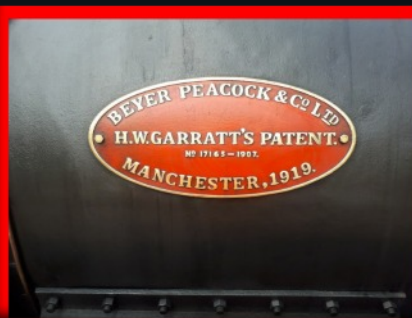
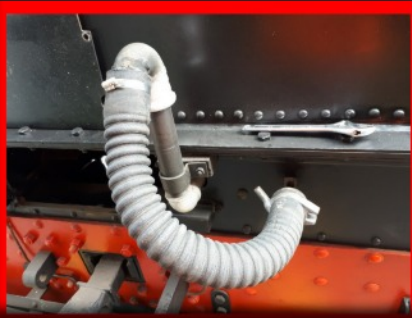
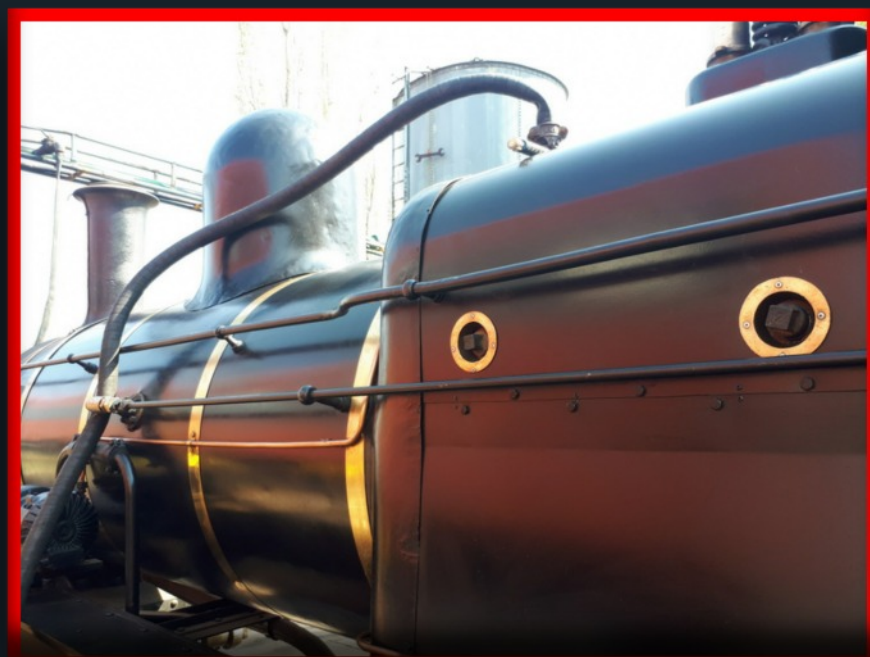
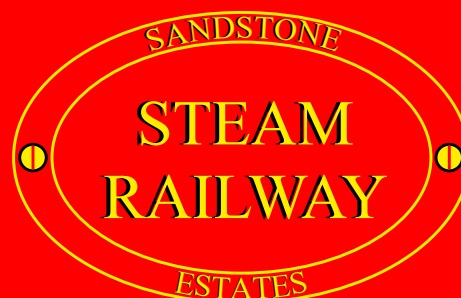
Our class NGG 11 was chosen to work a special passenger train in August and we steamed her up prior to the event to insure that she is in good running condition. She has been standing for quite a while and did not need much attention at all.

We fitted 2 new vacuum hoses and vacuum couplers and changed the gauge glass rubbers that became hard over the years.

The turret spindle packing nuts and the regulator gland was packed as a normal procedure after a restoration.

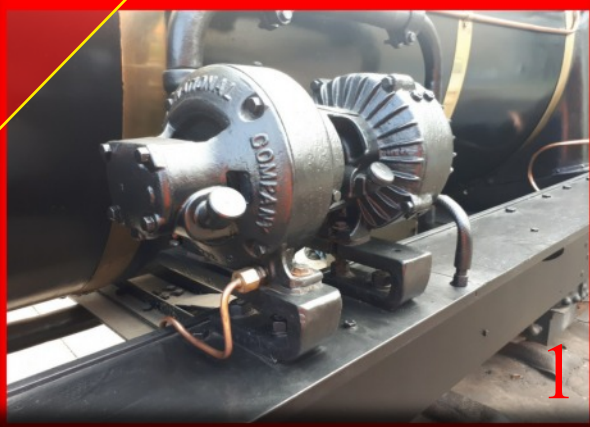
Image on the left shows the very old dynamo and still in very good working condition.

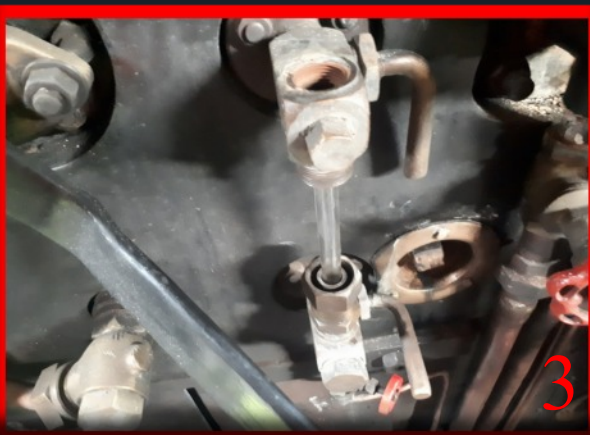
Image 4: The cab cleaned, the wood ready for the lighting up of the locomotive for the special passenger train.

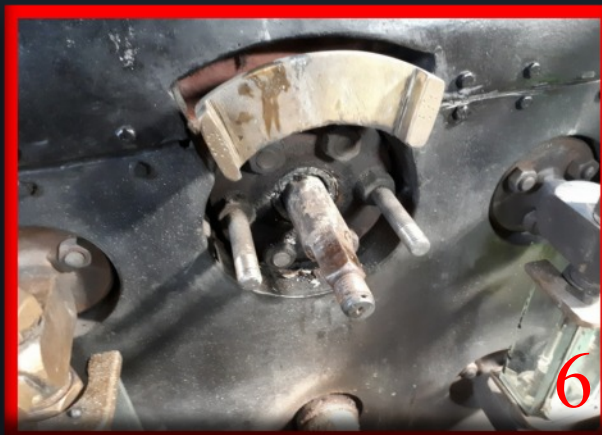
Image 5: The turret spindle packing nuts being packed.

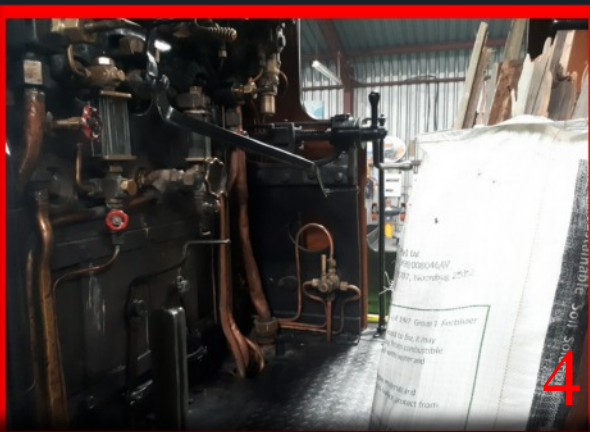
Image 6: The regulator gland being packed.

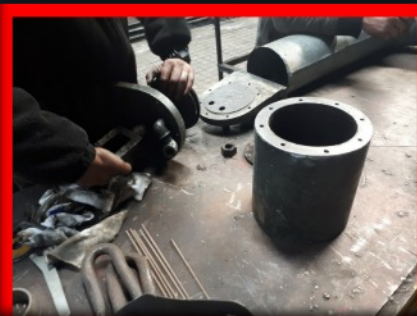
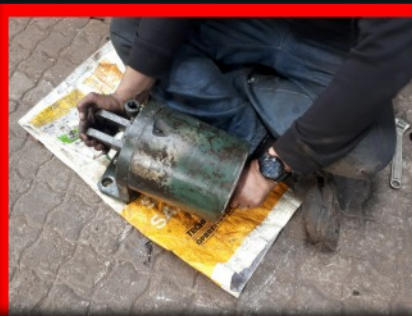
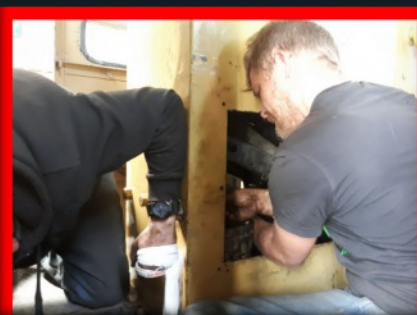
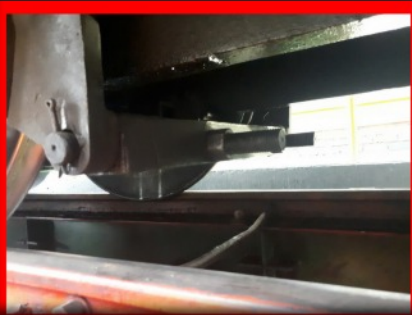
The Hunslet suffered from a defect in one of her airbrake cylinders and Wouter and Thinus removed the heavy cylinder, cleaned it and then rectified the problem.

The cylinder was fitted back and the brakes were adjusted and tested.

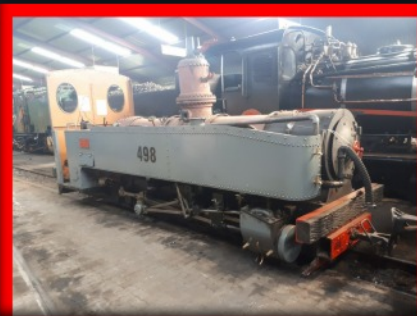
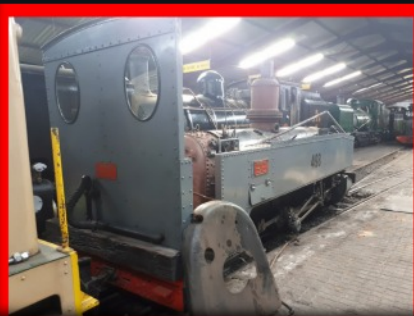
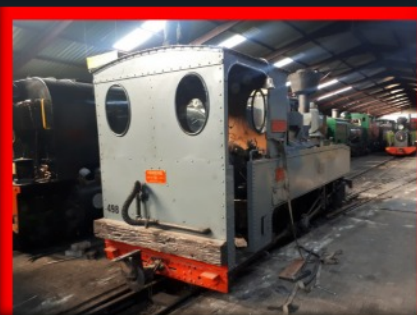
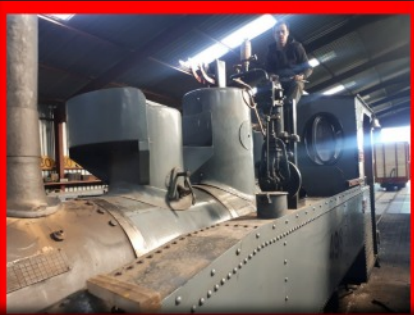
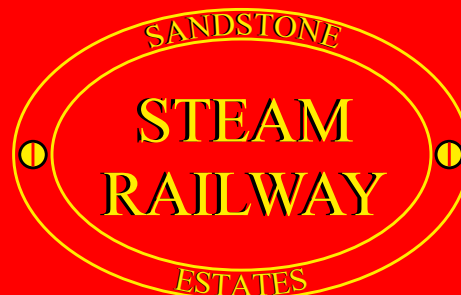
In the last report we refitted back the Feldbahn boiler. Wouter the continued with the assembly of all the parts on this locomotive.

The cab and left side tank were fitted back and Wouter is almost finished with this task.

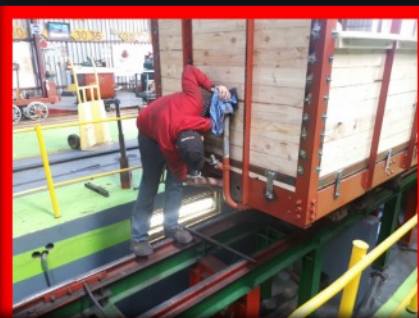
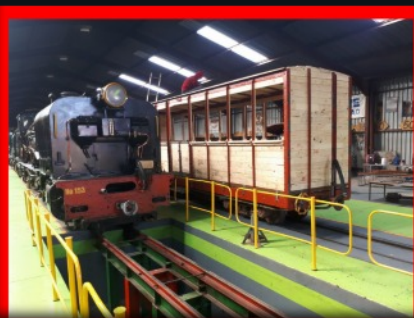
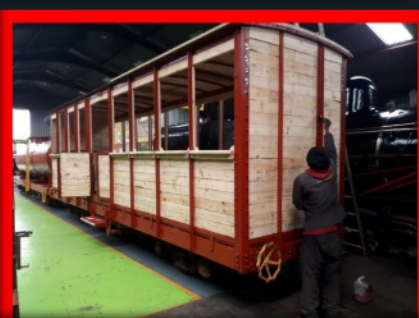
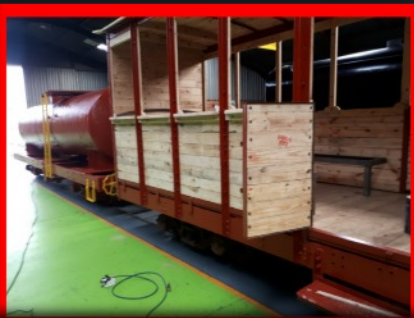
The second and last Ratanga we have was only a skeleton when we started with the restoration and it was needed to rebuild the entire wooden roof.

Wouter then fitted the steel roof plates over the wooden roof and sealed it.

The Ratanga also received a final touch up of paint, 2 new vacuum hoses and vacuum couplers were fitted and the brakes were adjusted.

Wouter also fitted 2 bell type couplers to this coach.

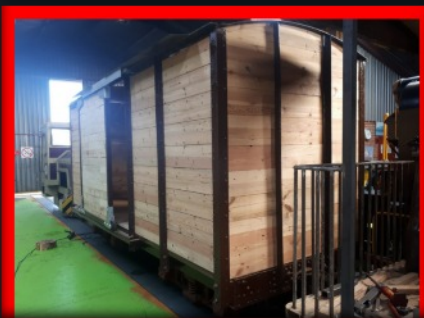
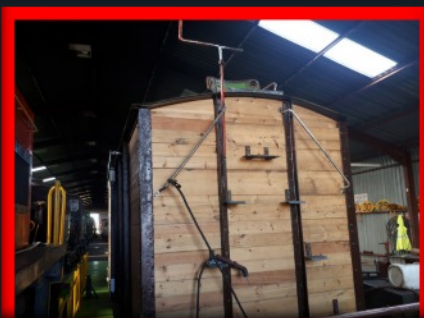
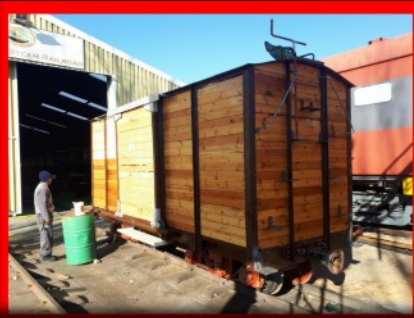
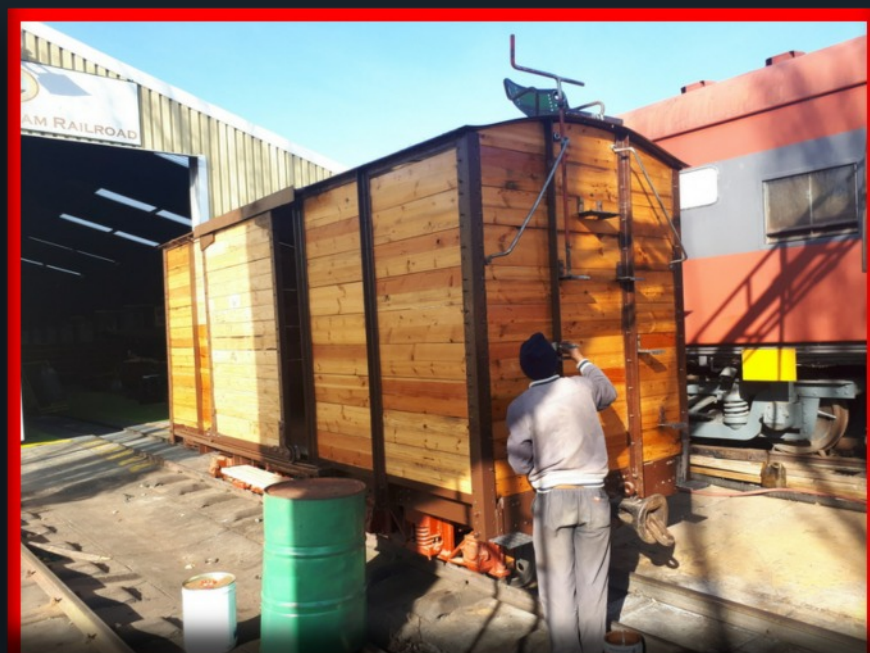
The restoration of the Otavi coach is now complete and the wagon was shunted to the 150M shed.

Wouter did all the steel work required on this wagon while Bryn did the paint work.

The inside and outside of this wagon then received a coat of Wooddoc varnish.

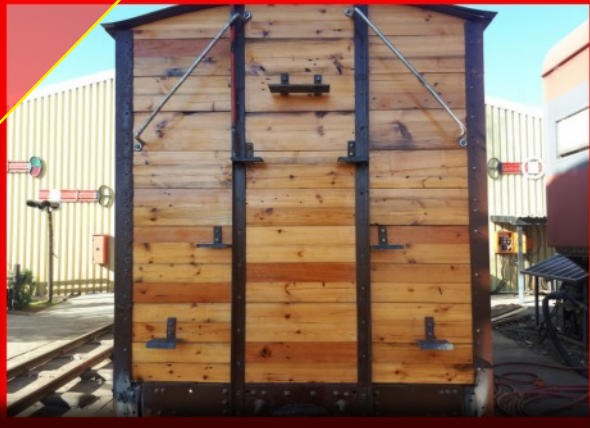
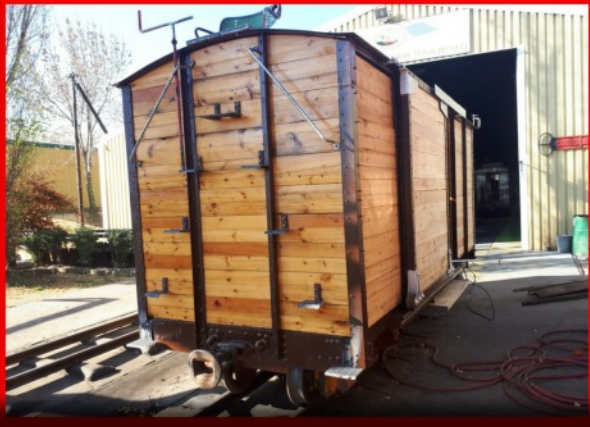
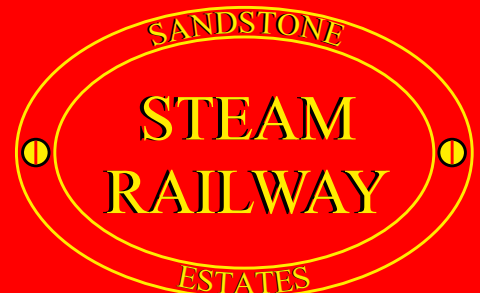
Images of the restoration of the Otavi wagon.

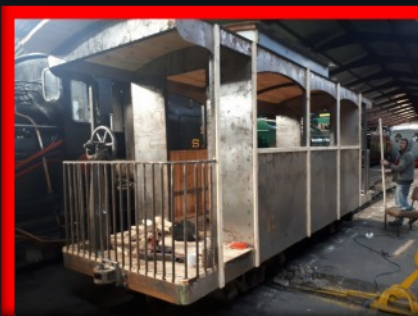
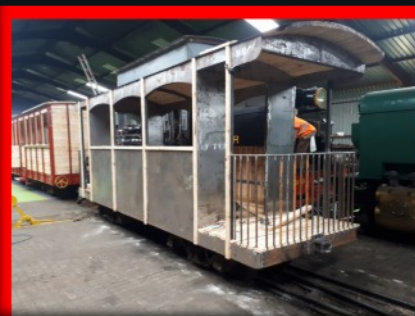
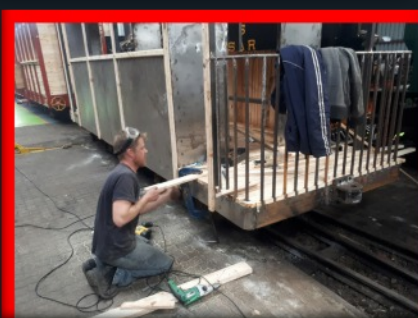
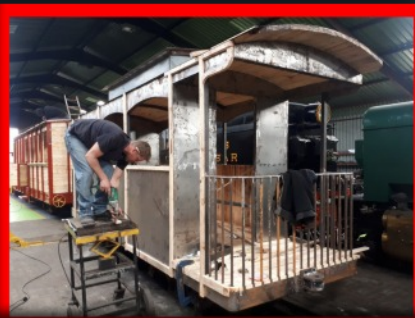
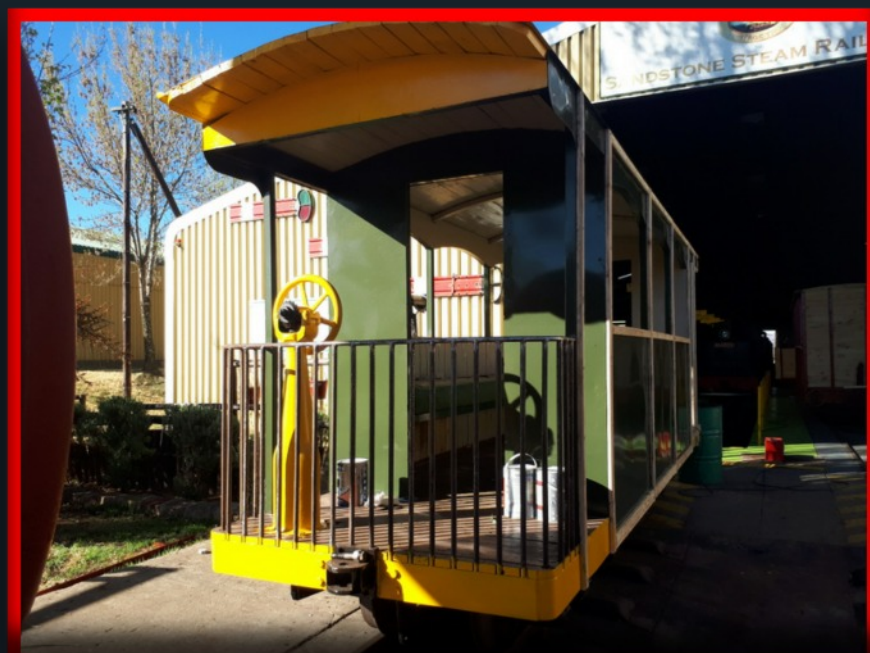
The restoration of the Carlswald coach is well on the way and should be finished soon.

Bryn painted the coach while Thinus did all the construction work needed as well as the woodwork.

This coach was also fitted with original SAR seating, very comfortable indeed.

These wooden frames soften the image of this coach. The wood will be sanded and then we will varnish it.

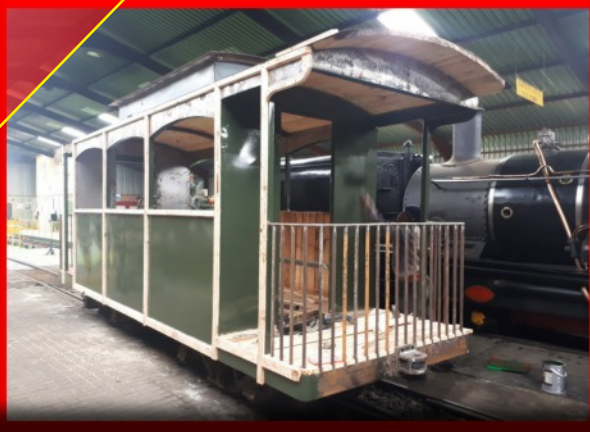
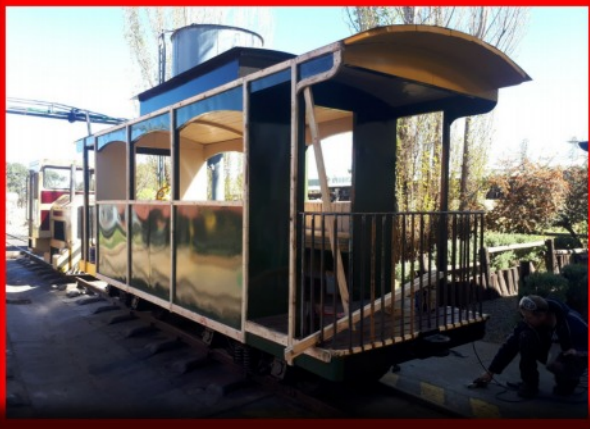
Images of the exterior and interior of the Carlswald coach with the original SAR passenger coach seating.

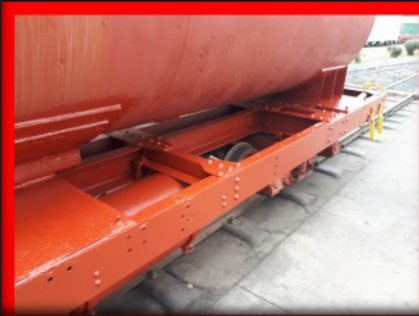
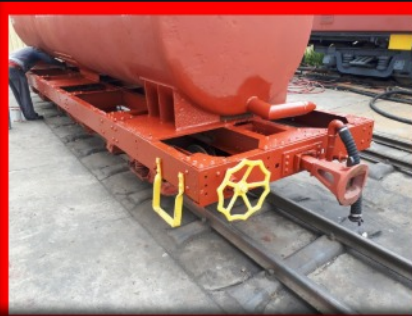
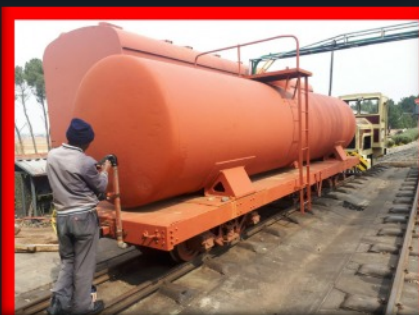
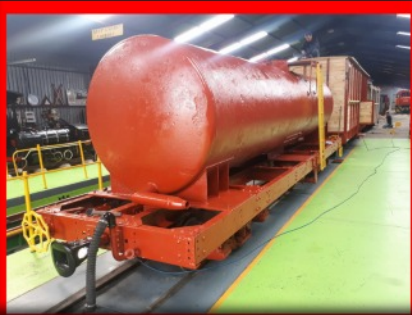
The cosmetic upgrading of all our XC tanker wagons has commenced and Bryn finished the first two XC wagons and is currently busy with the painting of the third XC wagon.

The sun has really faded the paint during the years and the paint does not last very long before it become dull.

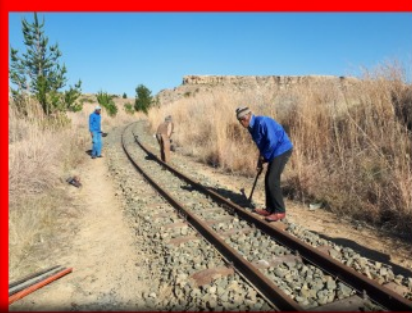
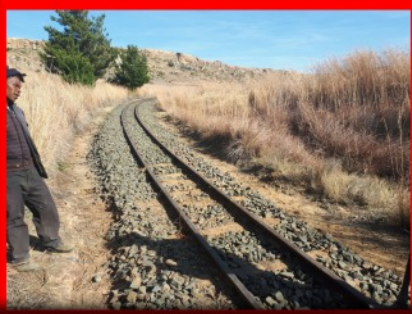
Images Left: Our Team at the section above Pandora Junction curve.

During the last month our Track gang has covered three sections on the main line, they finished the track maintenance on the Pandora Junction curve and then worked their way up to the second curve above the Pandora Junction curve.

The slacks were removed and the cant on curves were adjusted.

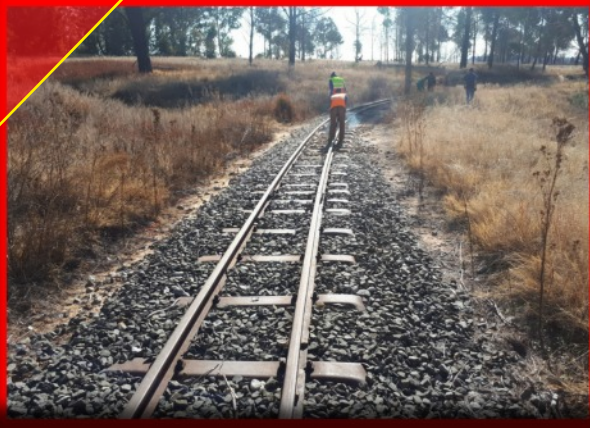
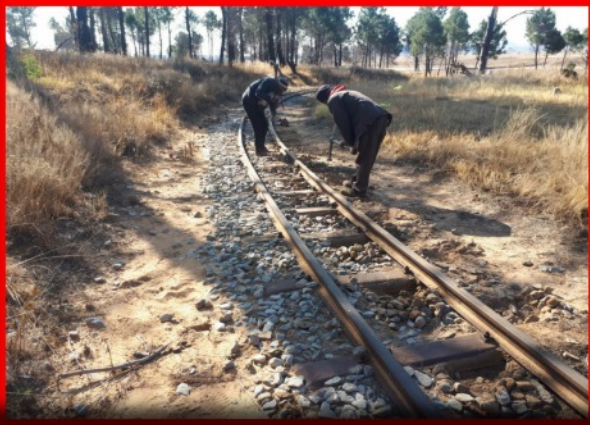
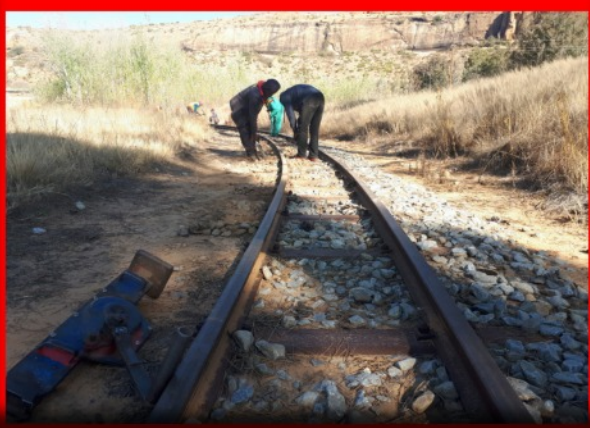
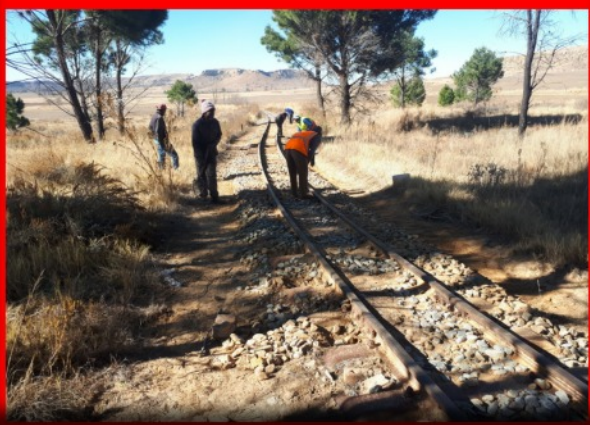
Images of the Track maintenance near the S curve and around the sharp curve.

Slacks removed, ballast screened and curve cant were adjusted.

Our Track team then went on to the S curve near the Farm School, they started about 100 meters before the S curve, removed the slacks, screened the ballast and adjusted the cant around the curves. They then worked their way up all the way to the Farm School crossing.

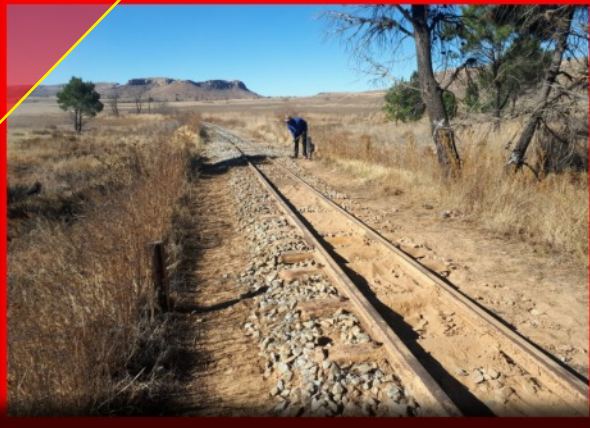
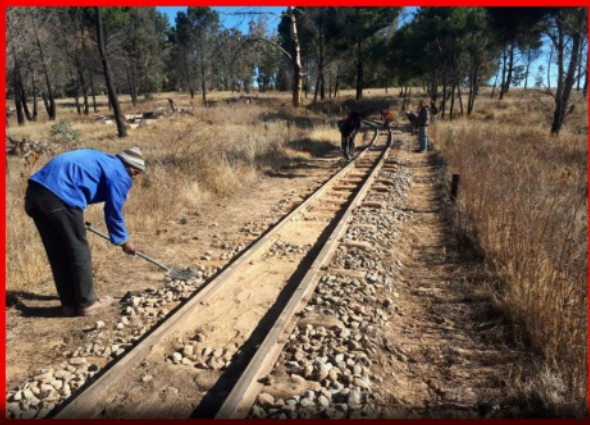
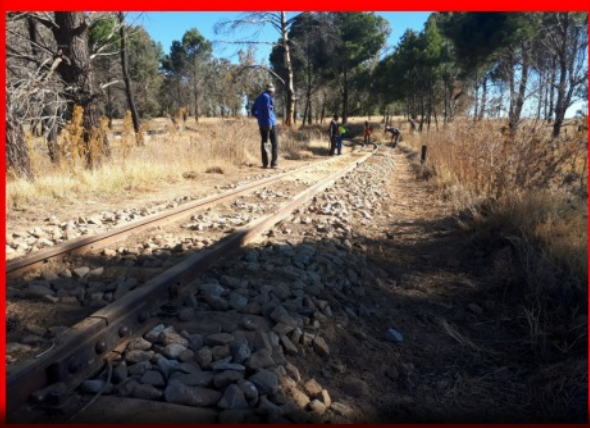
Excess ballast was moved from the track bed nearby and was used to fill the areas in need of more ballast.

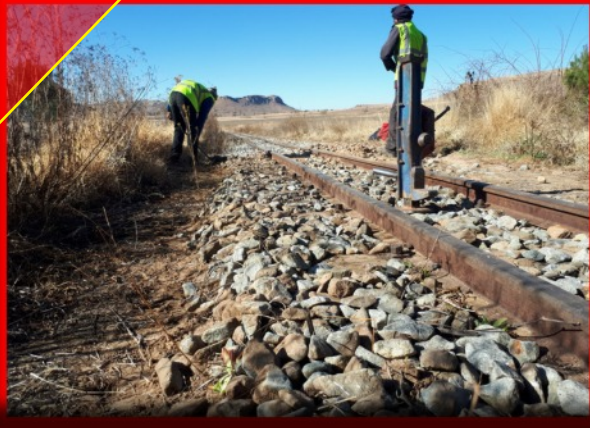
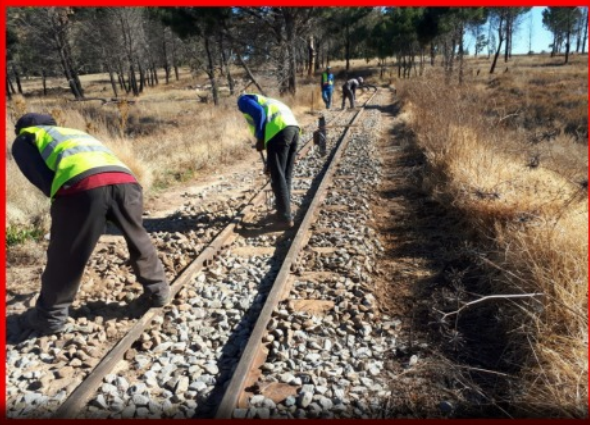
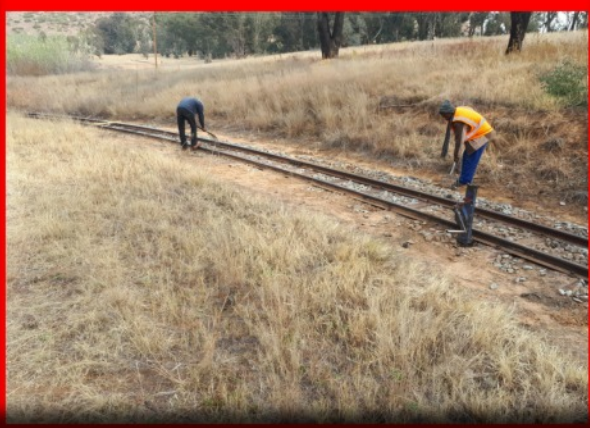
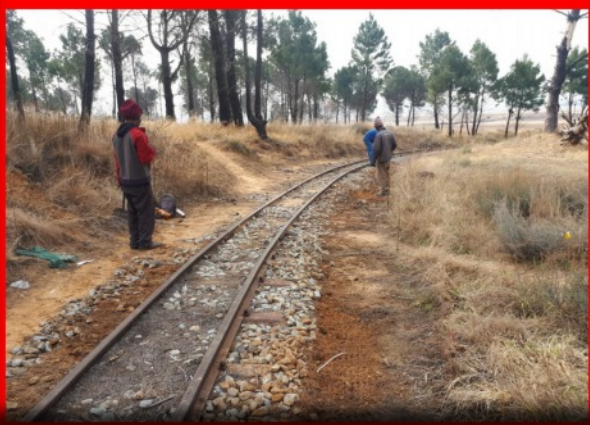
Our Track Team finished this section and went up all the way to the Farm School crossing, let us call this section the Ant section. There are a huge amount of red ants on this section of the line and it also contributes to traction lost.

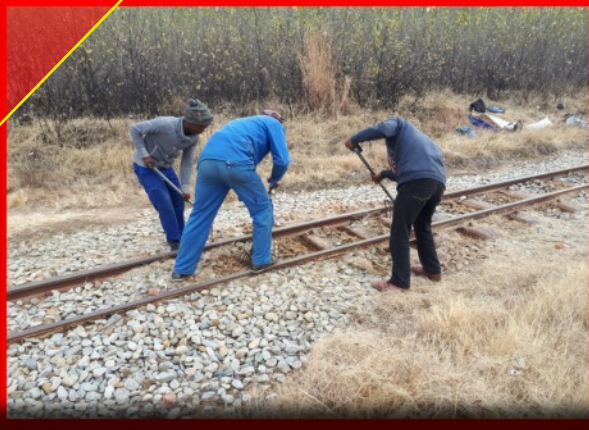
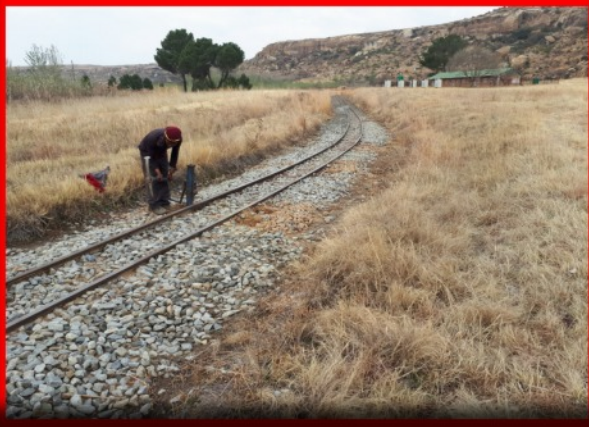
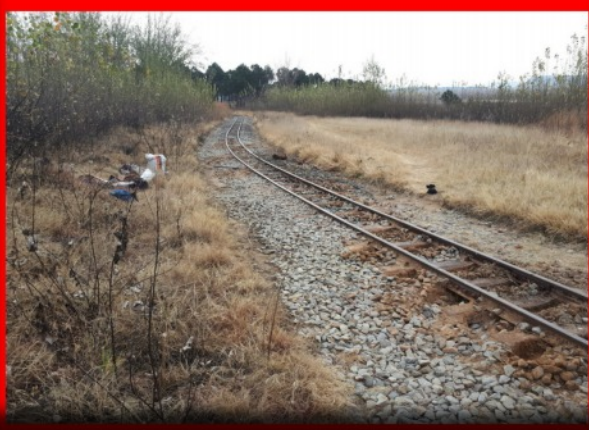
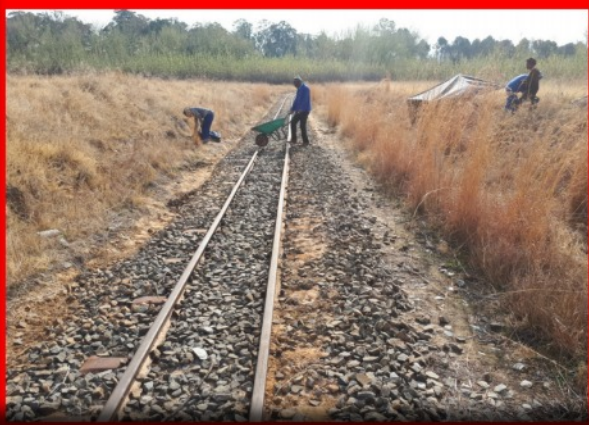
The images on this page are on the last stretch towards the Farm School crossing. This section was the worst of all regarding slacks and adverse cant on the curves.

Our Track team also needed to clean the level crossings.

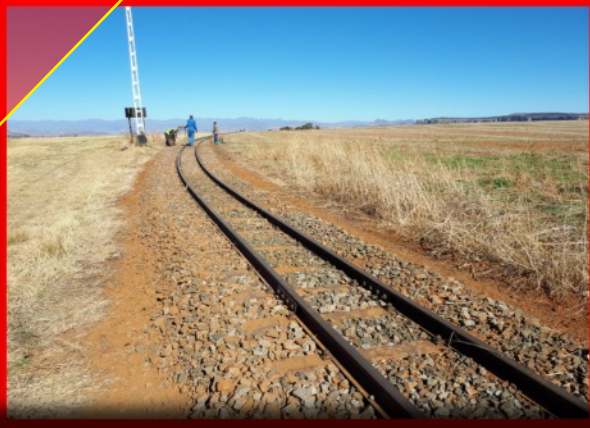
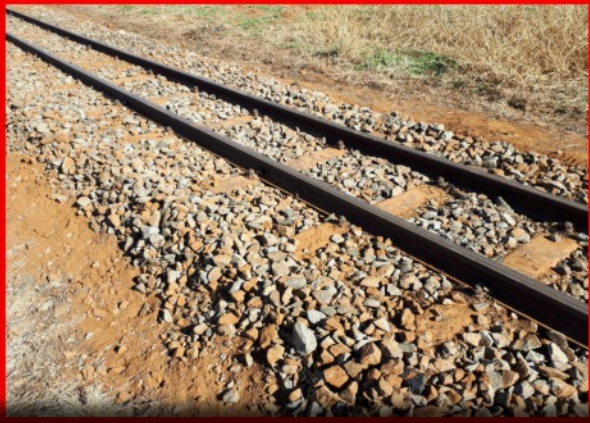
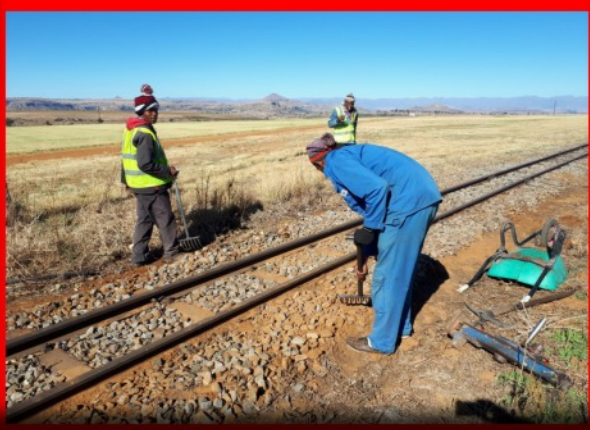
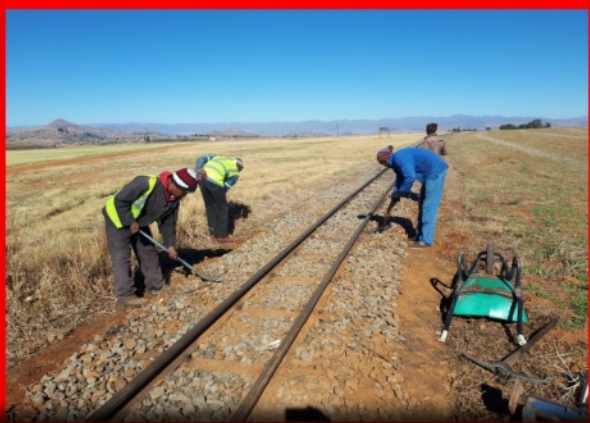
The images on this page are on the section towards Grootdraai. Our Track team will proceed all the way to the Grootdraai crossing and then will return to this curve and work their way down to the Hoekfontein Station.

There are quite a few severe slacks on this section of line but in time it will be fixed again.

Once this section is done we will return to Vailima to proceed on the section beyond Vailima towards the S curve. The plan is to remove the most severe slacks first and then we will tackle the less severe ones.
