## Highlights of the week!

### Cosmetic Restoration

# Class 91-010

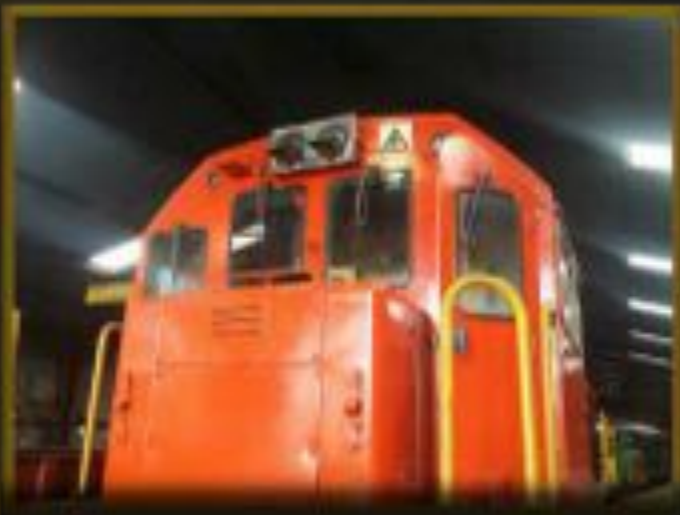
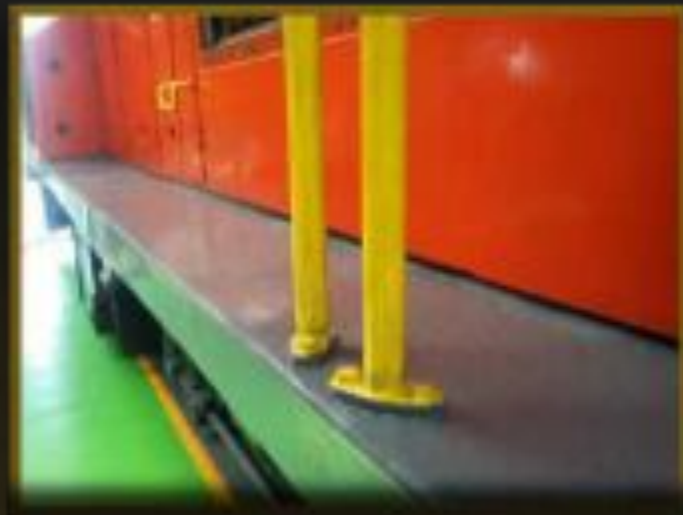
The cosmetic restoration of the Sandstone Estates Class 91 Diesel locomotive is still in progress and this past week Wouter went on with the body work needed to complete this restoration.

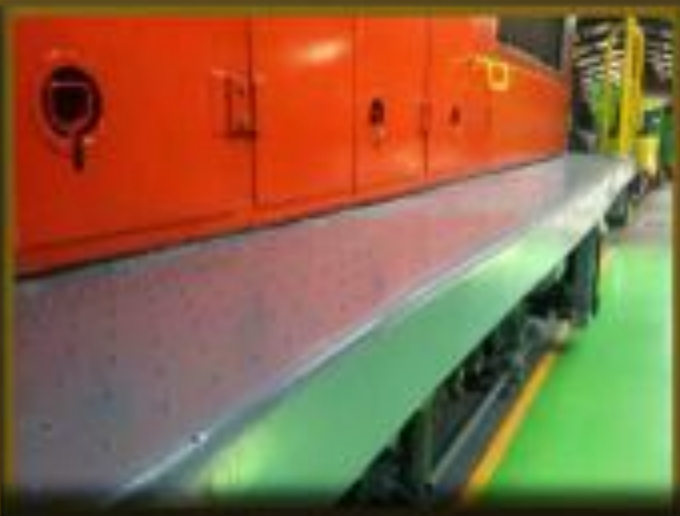
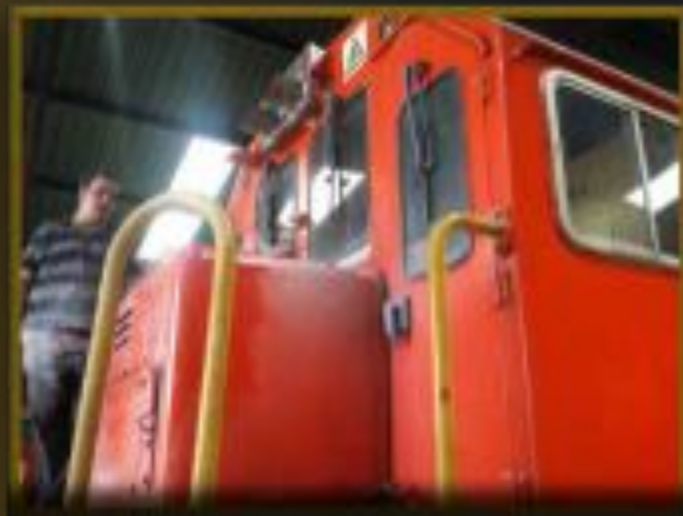
The headlights were repaired and fitted back and Wouter then repaired the rusted holes in the nose compartment Of the locomotive while Brian attended to the final touches of paint that were needed.

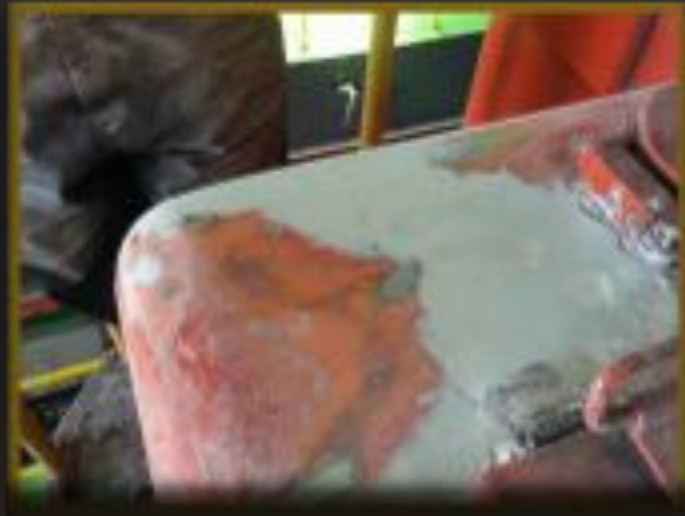
Below left: Fixing the nose compartment.

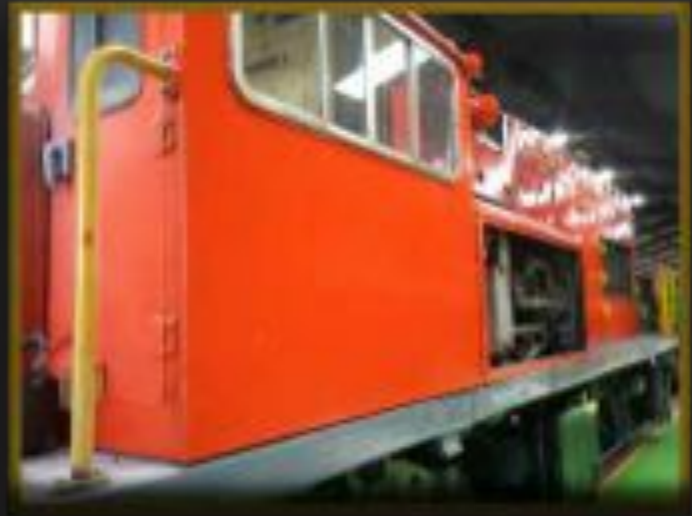
Below right: Wouter busy fixing the rear perforated panel from the Cooling Compartment.

Wouter is currently fixing the vacuum exhaustor and compressor room doors and he fitted back The panel at the Cooler compartment.

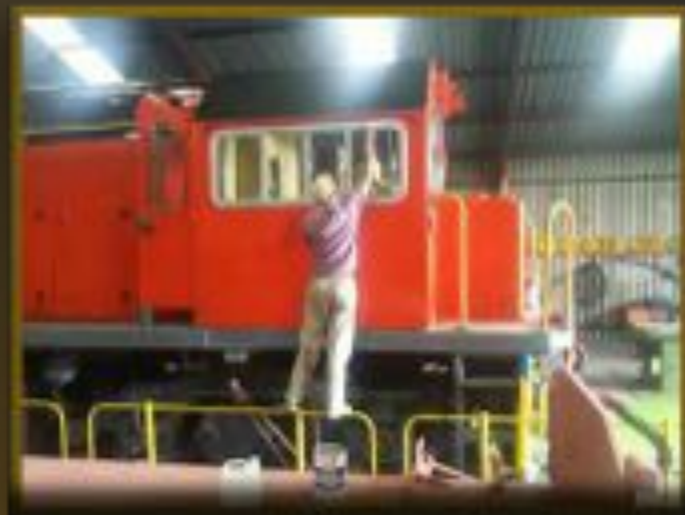
Below left: Brian cleaning the aluminum window frames

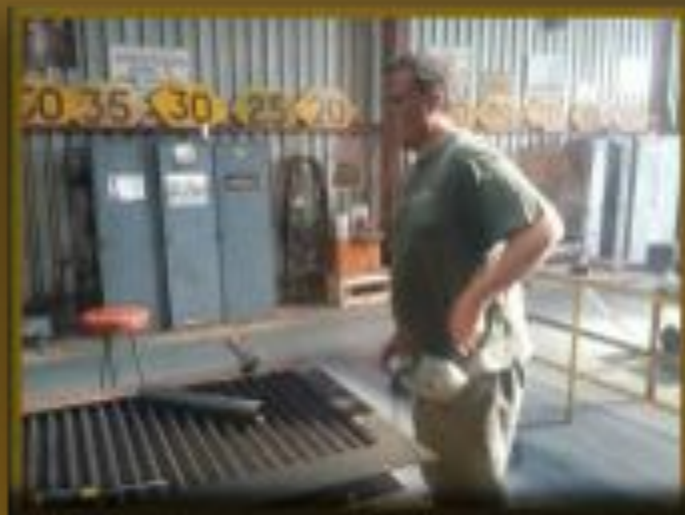
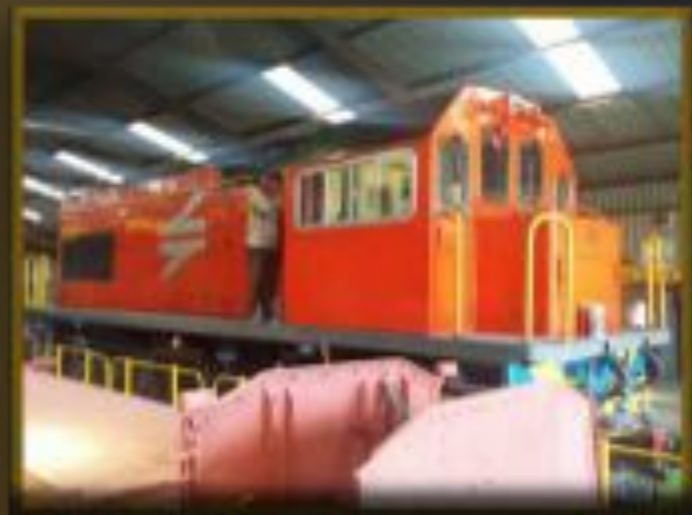
Brian painted back the Transnet logo and we await the delivery of the Spoornet lettering and the new numbers that Will be fitted. The Locomotive however will receive a final coat of paint at certain areas where Wouter worked.

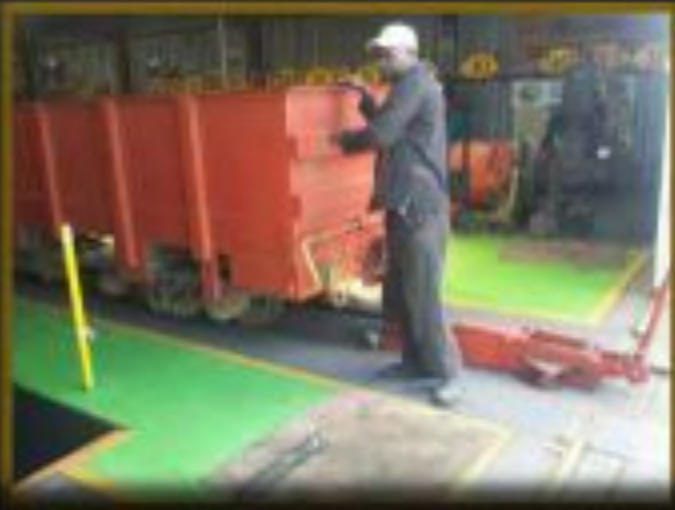
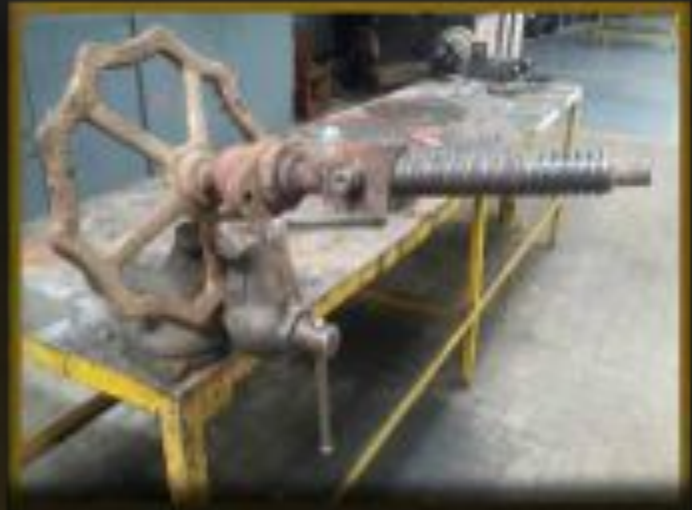
This week we have finished the under frame restorations of the 3 x C wagons and lifted them from the bogeys To grease the centers and side friction wear plates. Handbrakes were removed, cleaned and greased before Petrus Fitted them back.

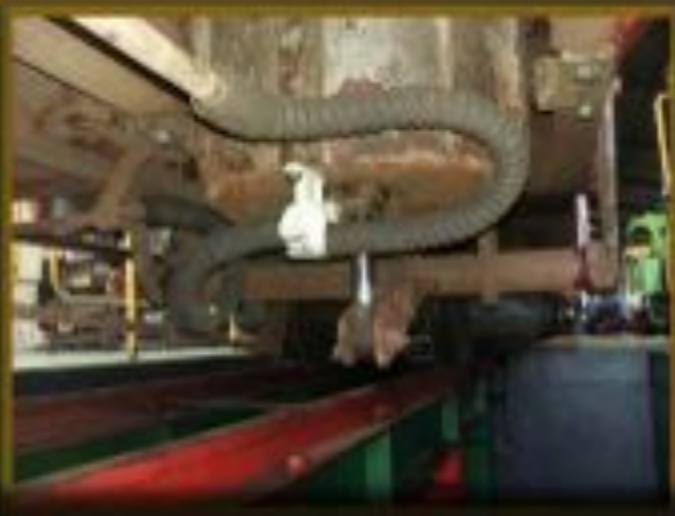
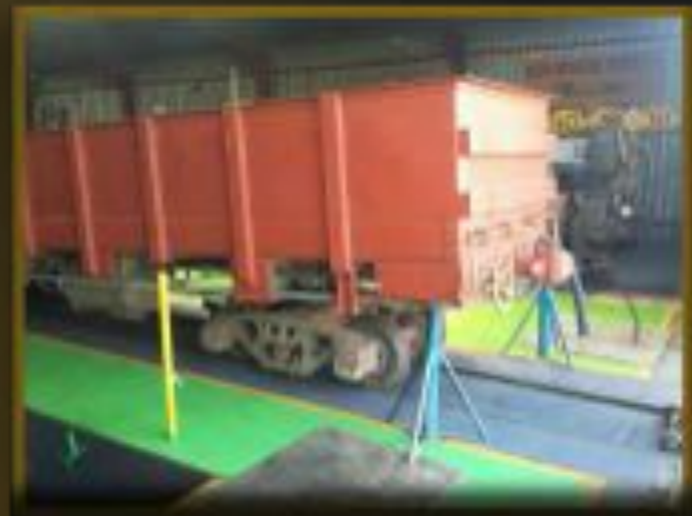
We also had to replace one C wagon bogey with a good secondhand one. The wagons then were shunted to the Pit for final brake testing.

New release valves and piston rods, new neck rings were fitted with chamber pipes.

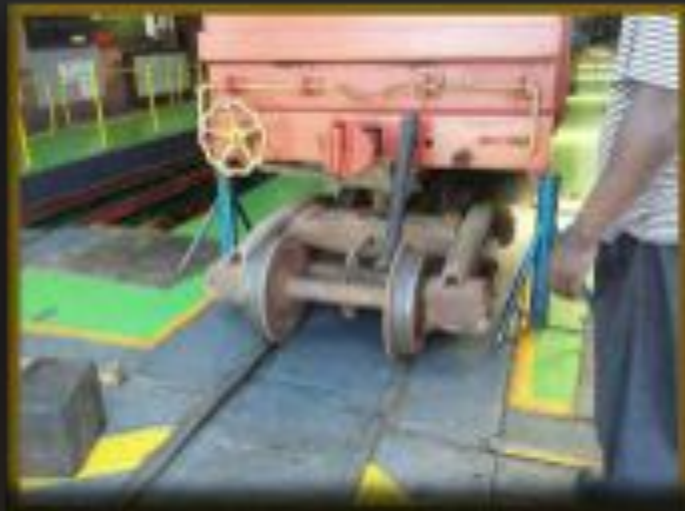
Below left: Removing the defective bogey of a C wagon.  
Below right; The normal condition of all the goods wagons shows dry centers and side Friction wearer plates.

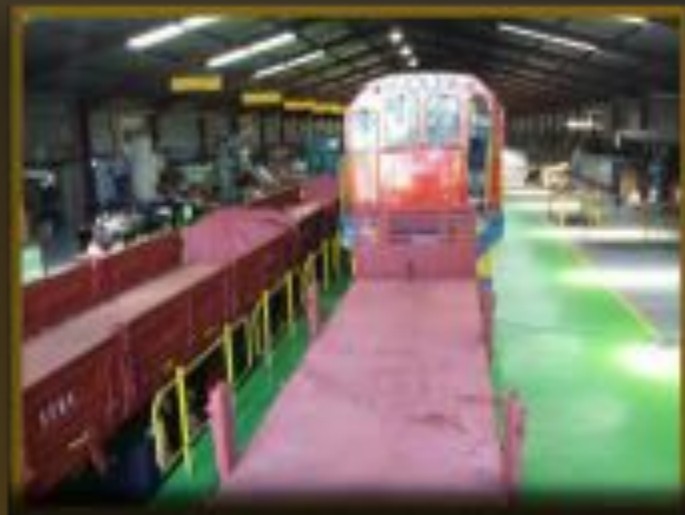
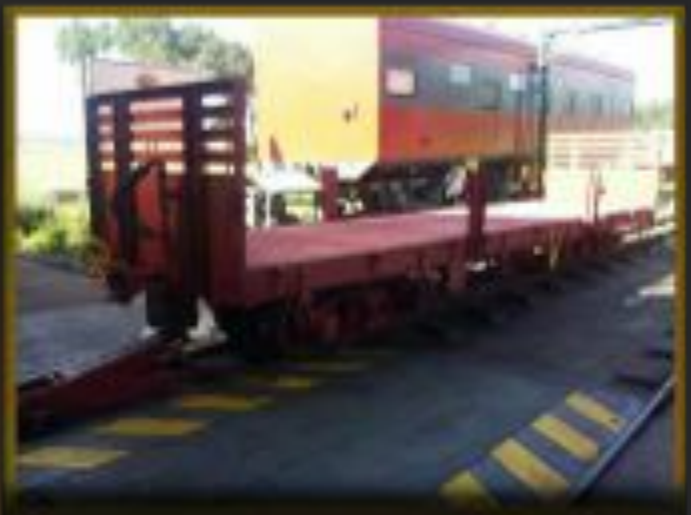
The last B wagons were shunted to Hoekfontein Station and 6 DZ wagons were shunted down for maintenance. This includes the lifting from the bogeys, greasing of centers and side friction wearer plates. The wagons then will Be shunted to the inspection pit for brake adjustment, leak off test and brake efficiency testing. Vacuum hoses Are also replaced if needed.

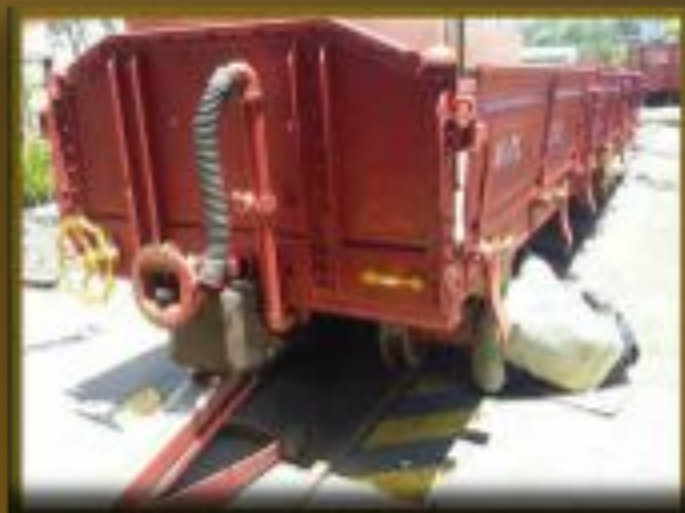
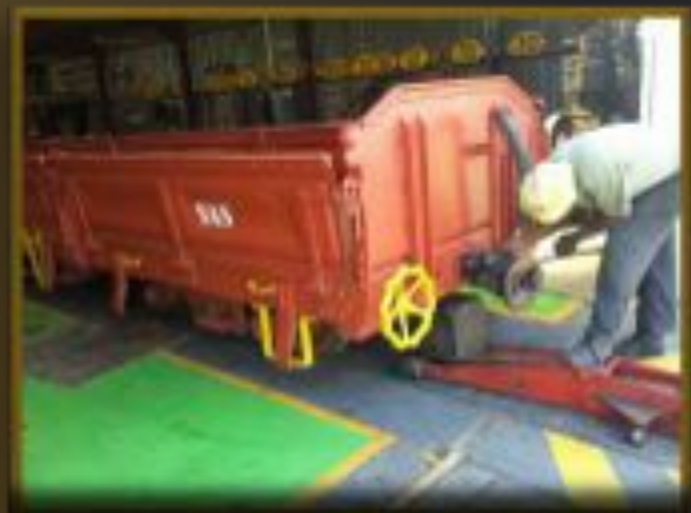
In the last week Petrus lifted 4 x DZ wagons from the bogeys. Only old DZ's will Be serviced this way as the newly restored ones were done at that time when we restored them.

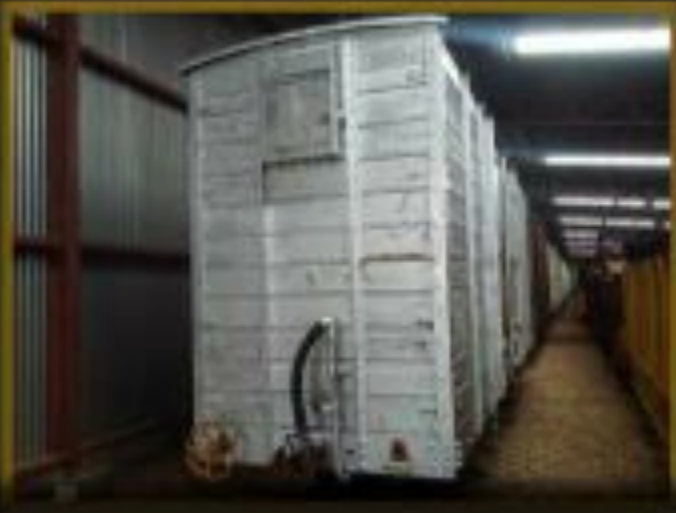
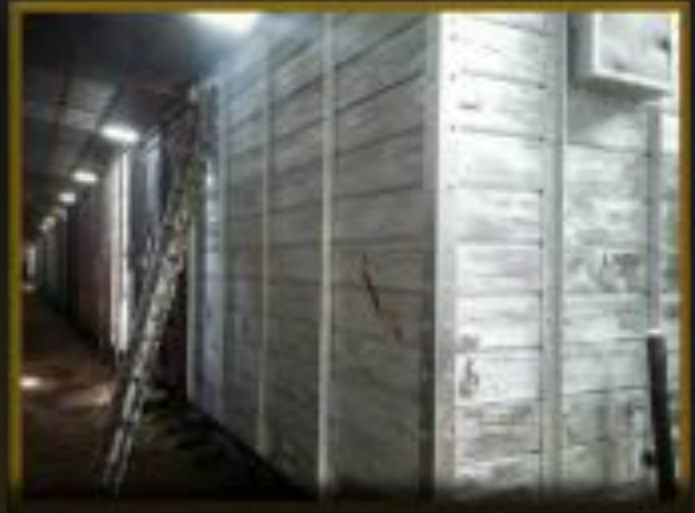
Johannes finished the painting of 2 newly restored O wagons that are standing in the Wagon Shed. He then started Painting the last 2 O wagons that we recently restored which are standing in the 150M Wagon Shed.

Above: The 2 x O wagons in the 150M shed being painted.

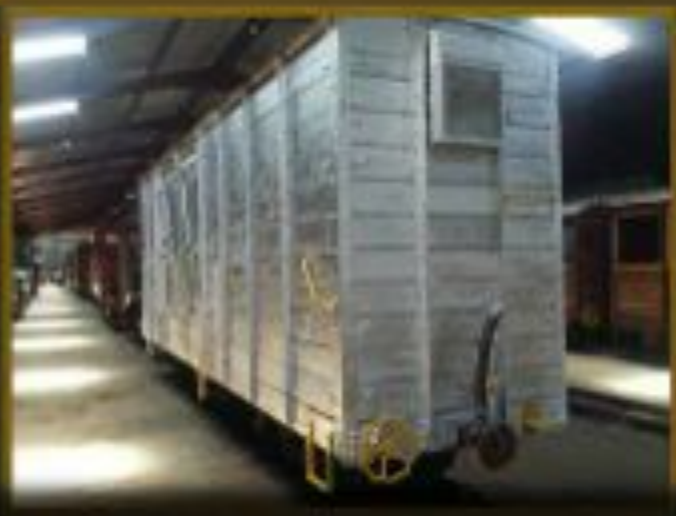
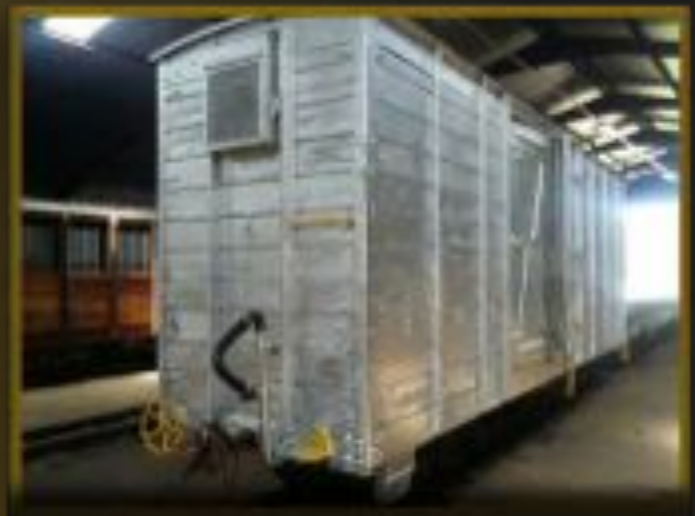
Below: The 2 x O wagons which are now completed and standing in the Wagon shed near the Steam Shed.

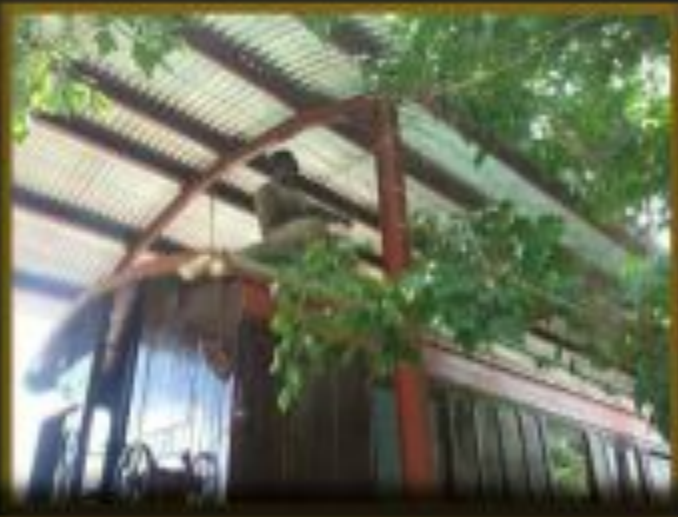
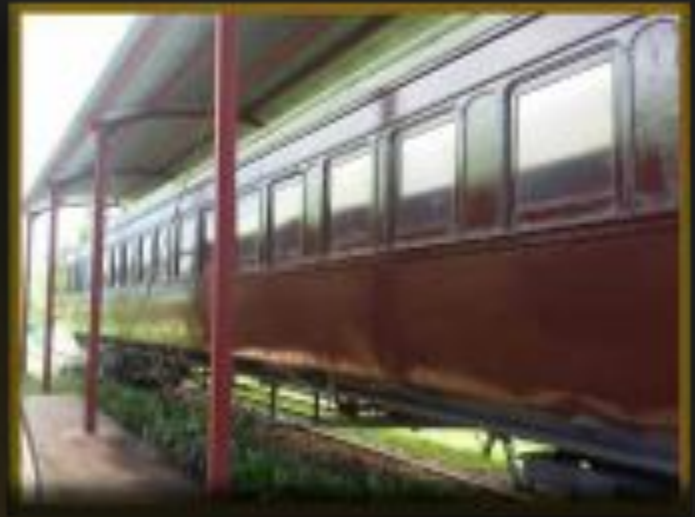
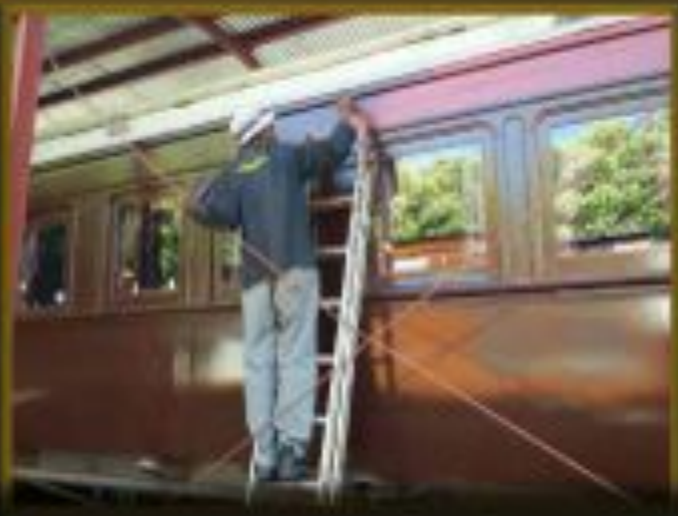
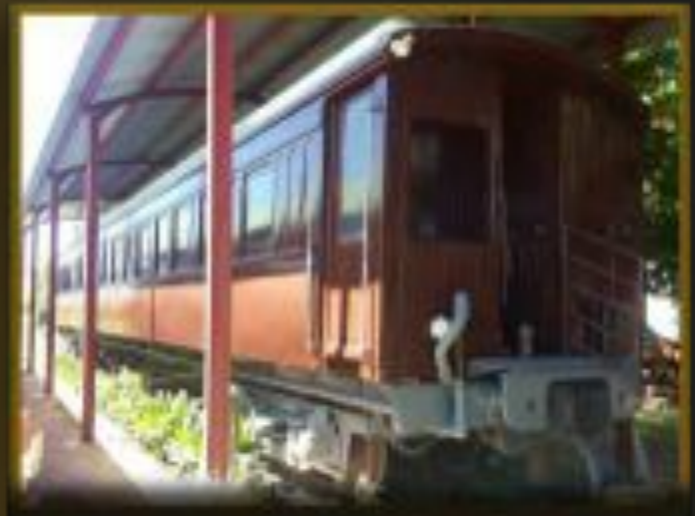
Brian and Johannes finished the painting of the 3'6" Dining saloon at the Waenhuis. The Saloon was painted in PWD Brown and the roof was painted silver again.

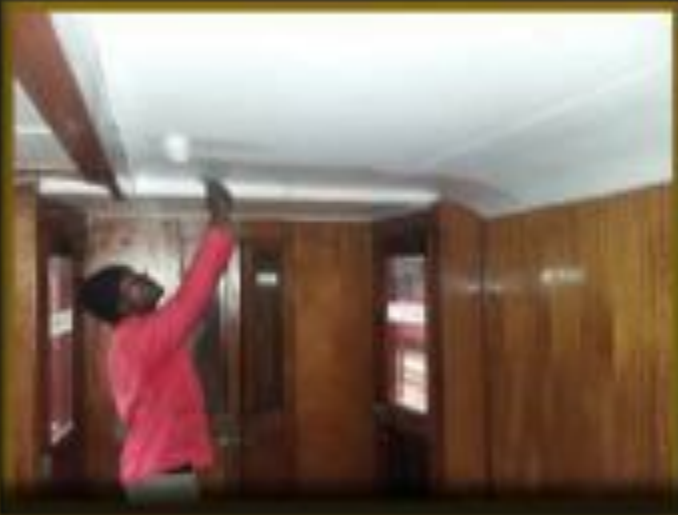
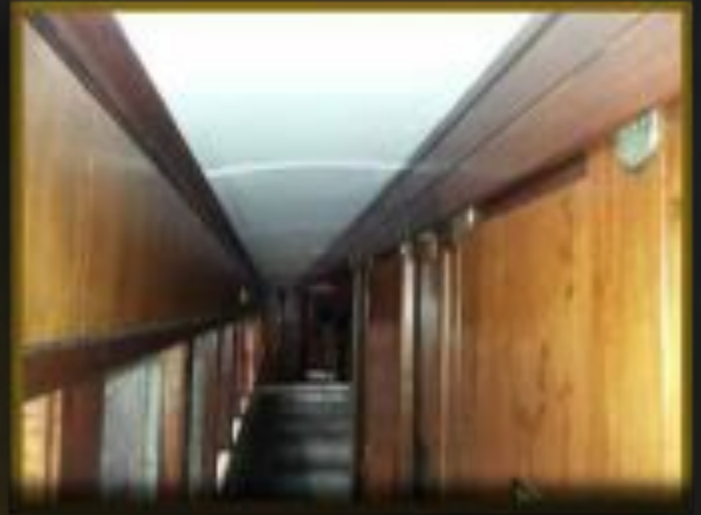
This past week Ernest our Carpenter attended to the cosmetic restoration of the 3'6" Sleeper coaches. He painted the ceilings white and is currently varnishing the interior of the sleeper coaches.

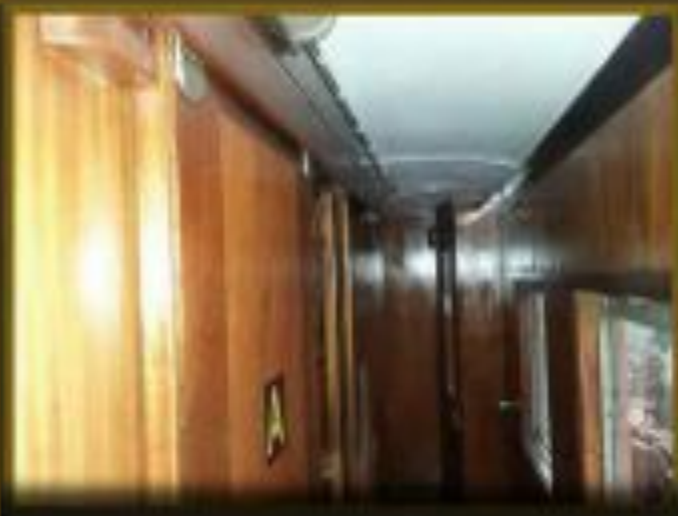
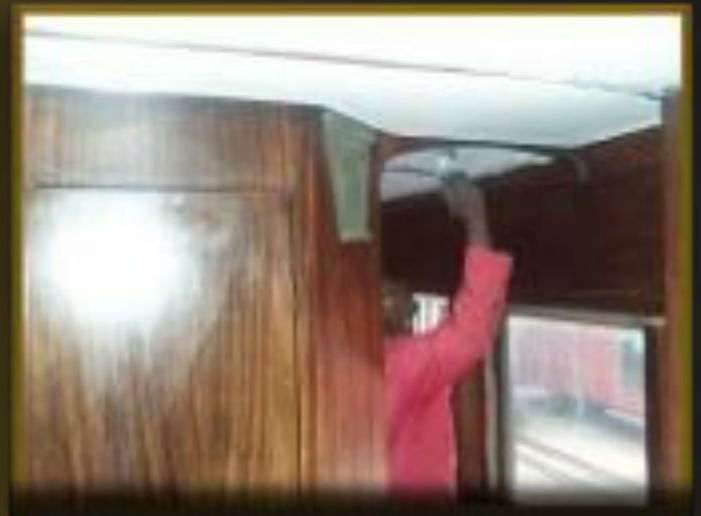
Ernest completed the painting of 3 sleeper coaches inside.
