## Locomotive Maintenance

We are currently doing extensive maintenance on all our Locomotives and we only have 5 locomotives left and will Continue the same maintenance on our Traction and Stationary engines.

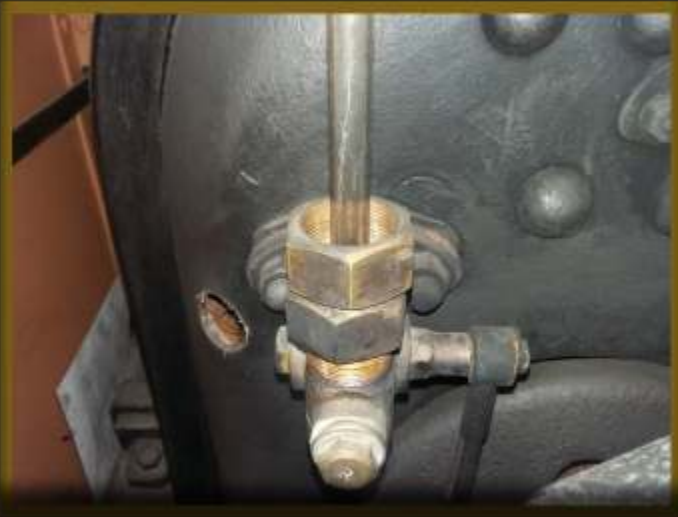
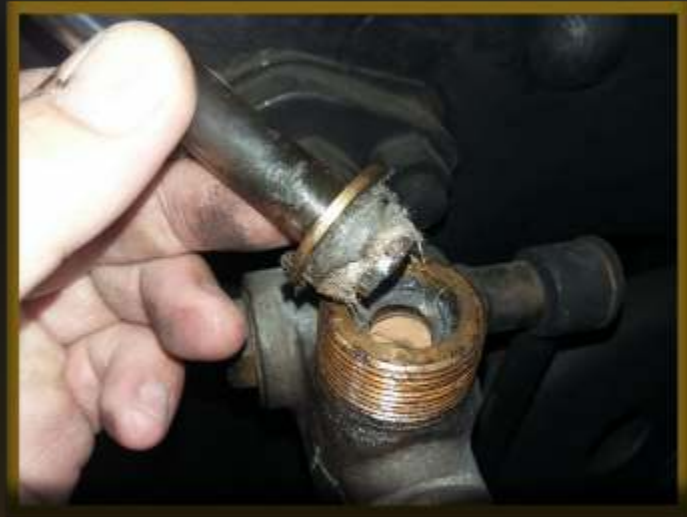
Gauge glasses are renewed on all the boilers, all turret spindle packing nuts are packed, all regulator glands were Packed as well. Handbrakes and reverser's are serviced and tested. Clack boxes are serviced.

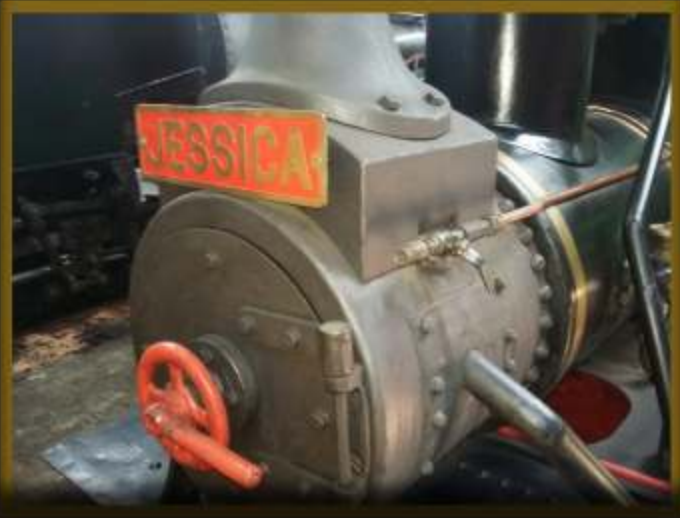
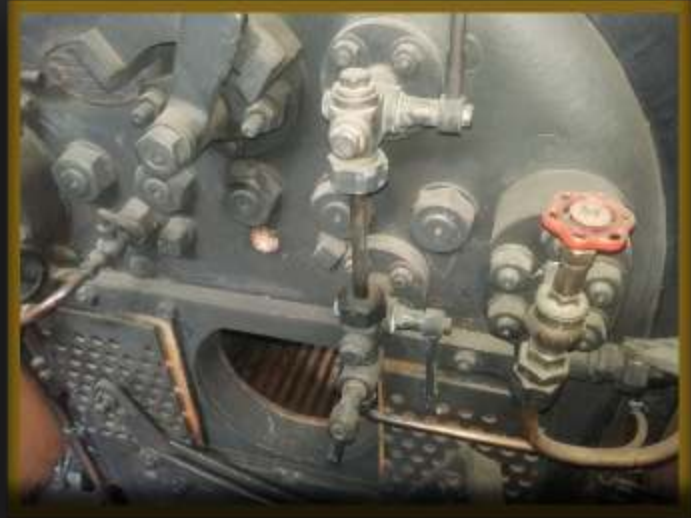
All injector steam spindle packing nuts are packed as well. All gauge glass cutoff valves are serviced and tested.

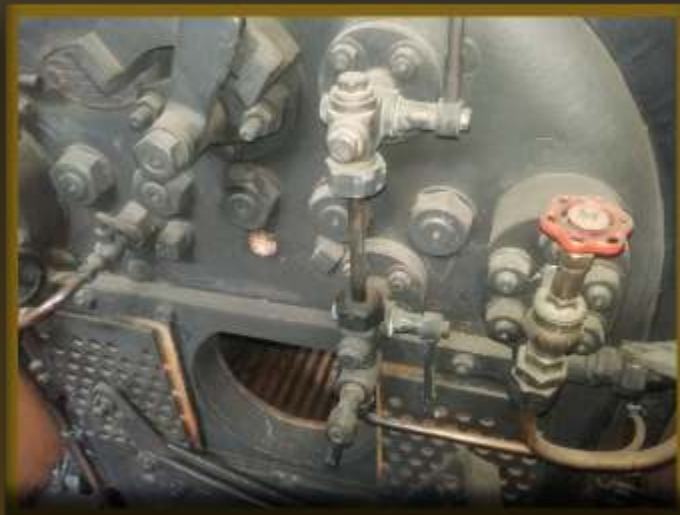
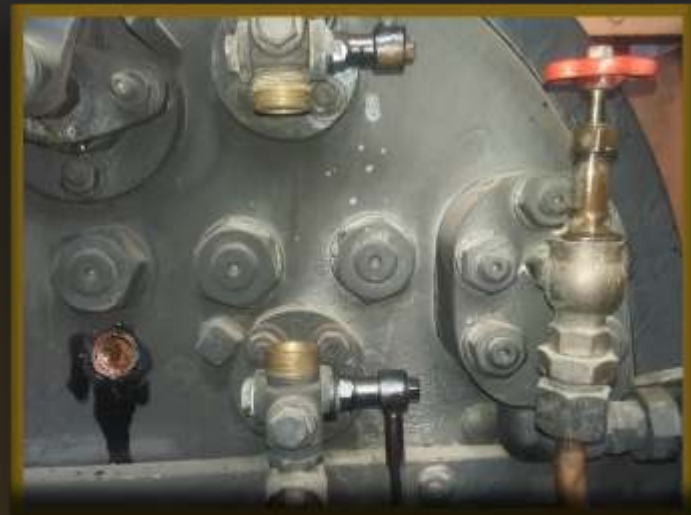
We use a little bit of water and soap when fitting new gauge glasses, we spray it on the glass tube and rubbers and this makes it much easier  
To fit.

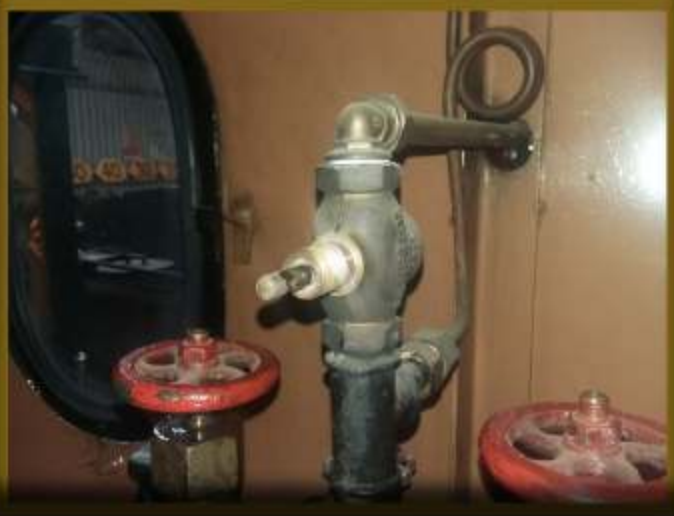
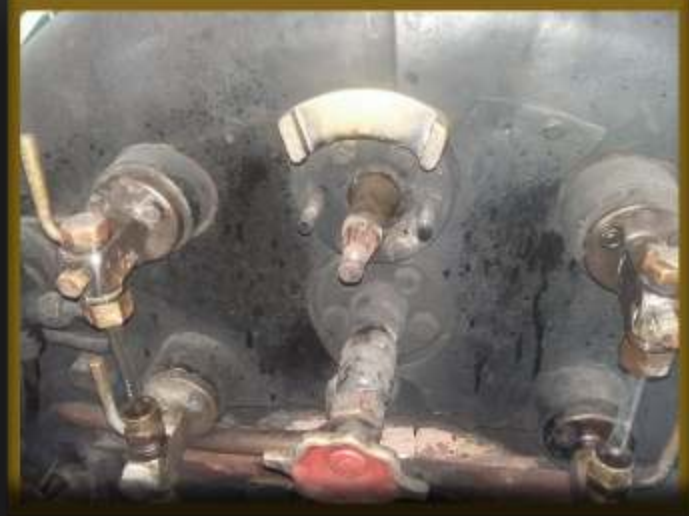
We packed all the valves, even the little whistle valves.  
The most time consuming task is to remove all the old packing ropes that were in most cases  
So dry and hard that it came out like powder instead of rope.

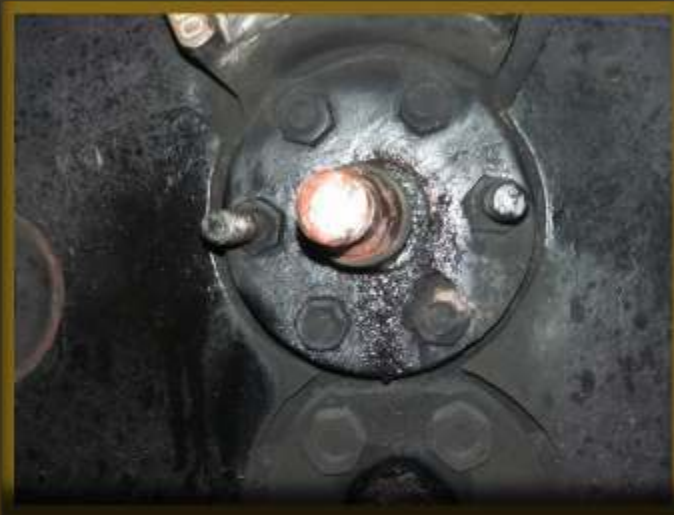
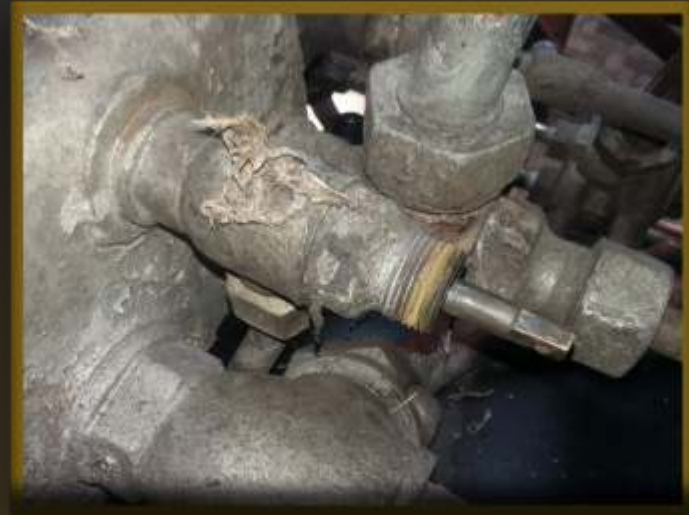
Below: Regulator gland of 153 being packed as well as all the turret spindle packing nuts.

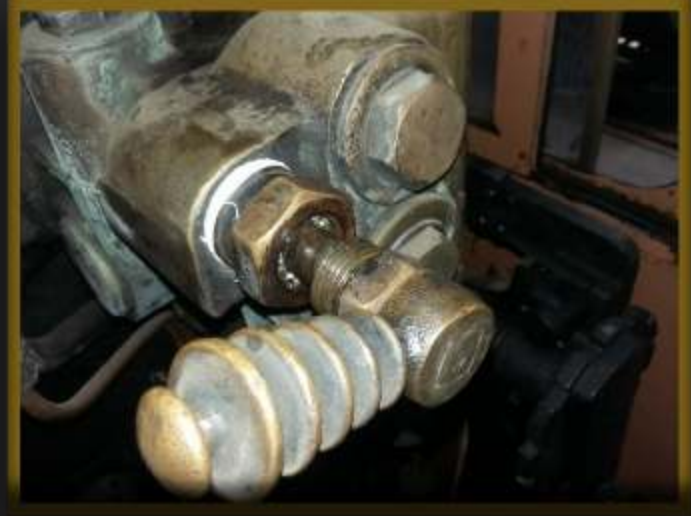
Below right: Small ejector spindle packing nut being packed.

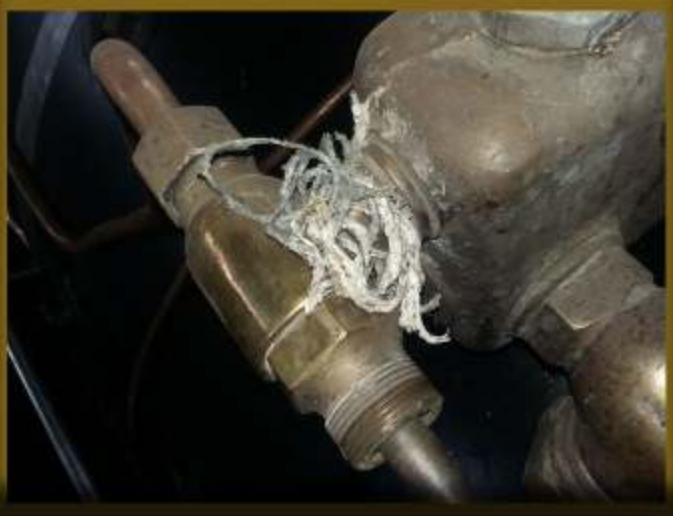
Below left: Old packing ropes removed.  
Below right: 113 Regulator gland showing signs of serious leaking. We however did pack  
All regulator glands even if not showing signs of leaking.

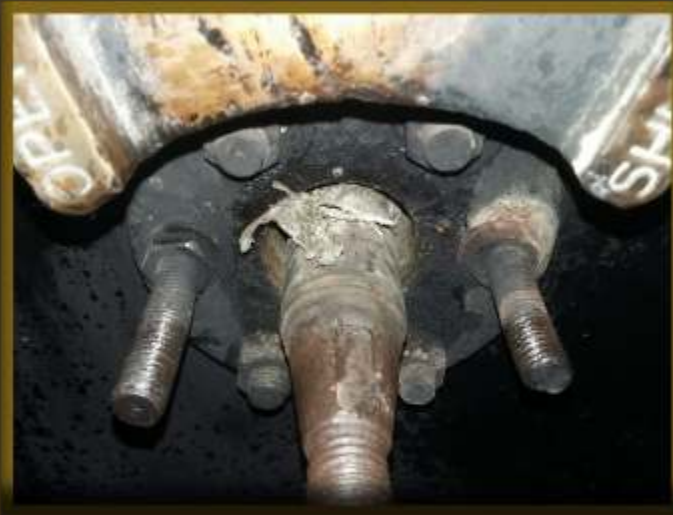
Below left: Old rope being removed.  
Below right: Reversers lubricated.

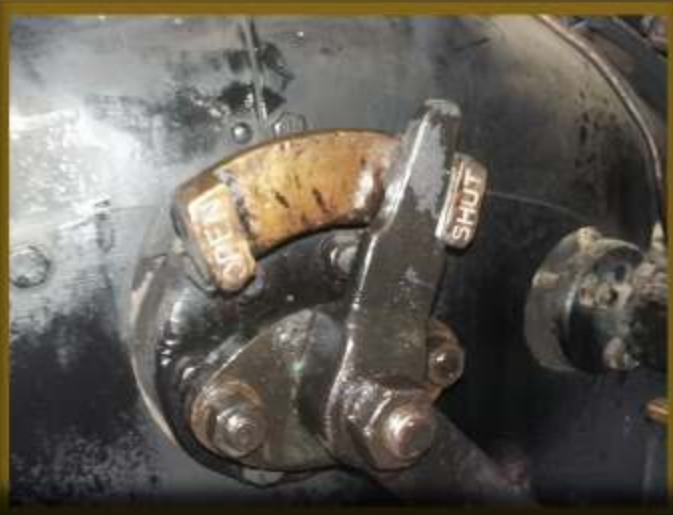
Below left: 113 regulator gland after packing.  
Below right: 113 turret spindle packing nuts being packed.

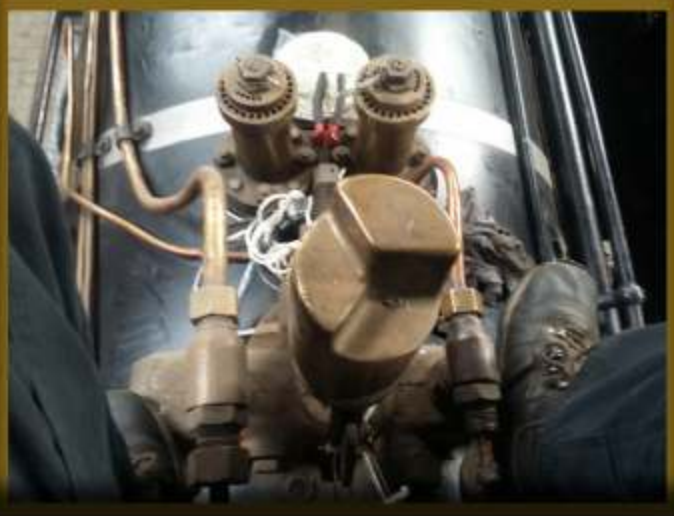
Below left: The NG 15 turret spindle packing nuts being packed.  
Below right: all spindle hand wheels removed to access packing nuts on 113.

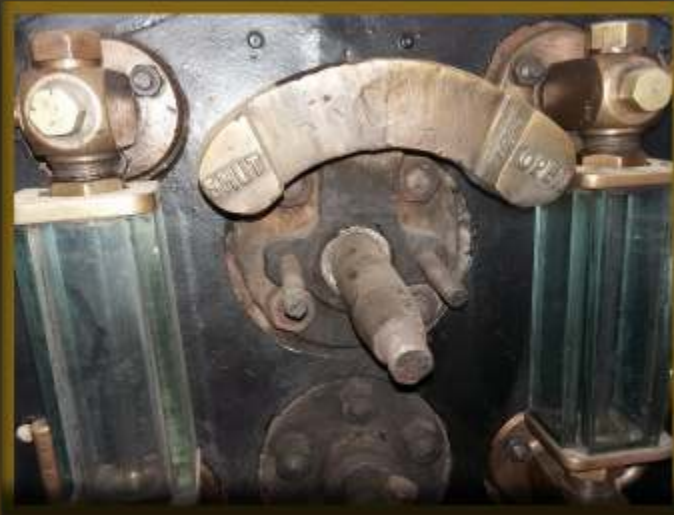
Below left: The NG 15 regulator gland being packed.  
Below right: Little Bess injector steam spindle packing nuts being packed.

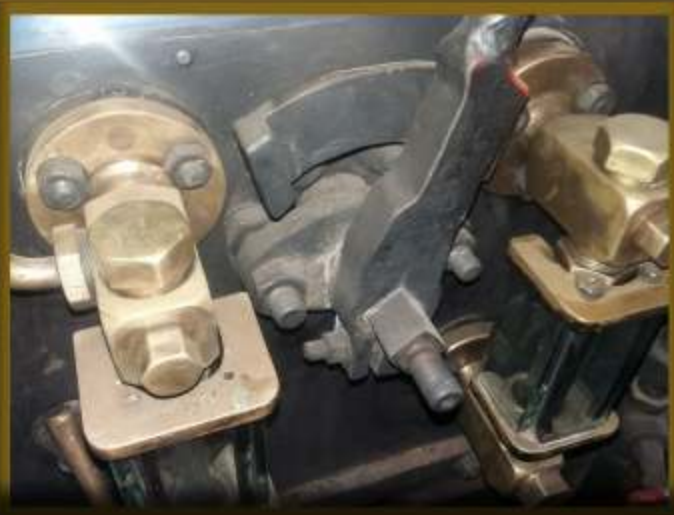
Below left: The NG 5 regulator gland showing signs of leaking.  
Below right: The NG 4 blower valve spindle packing nut being packed.

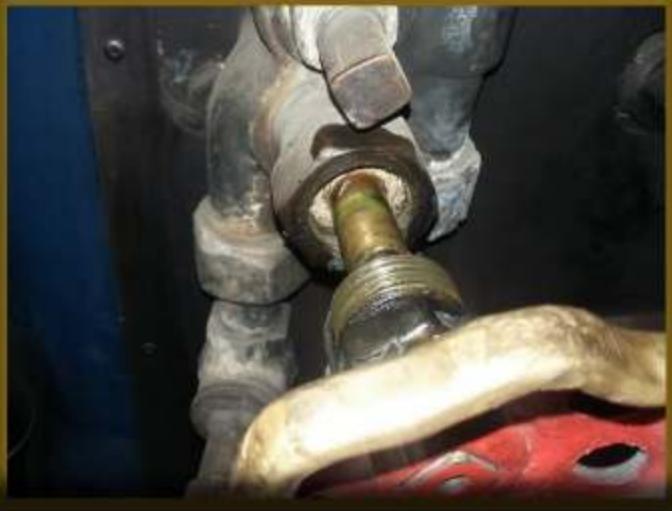
Below left: NG 4 Left injector steam spindle packing nut being packed.  
Below right: Class NG 4 regulator gland being packed.

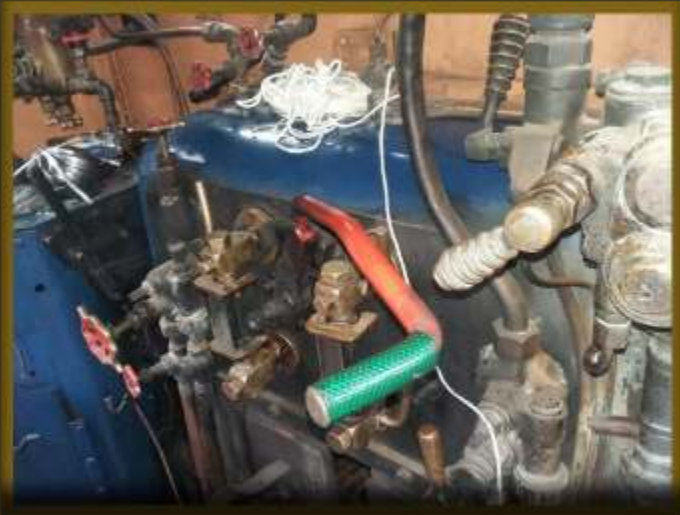
Below right: O&K 4102 injector steam spindle packing nuts packed.

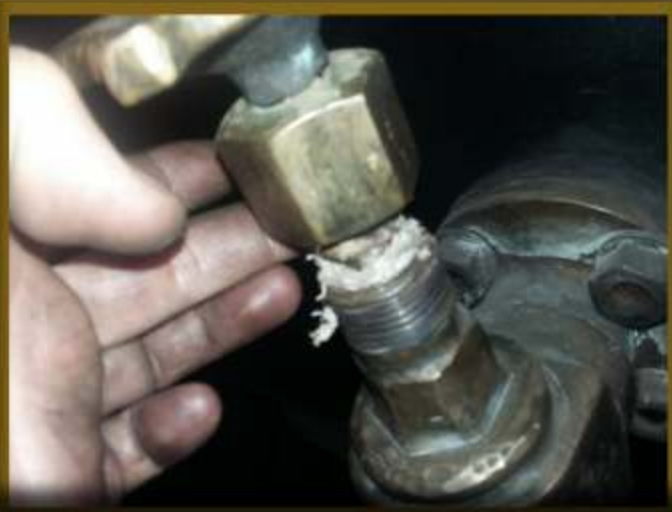
Below right: The Barclay gauge glasses replaced. Deep below is seen rubber and silicone blocking the port.  
All this was cleaned and new gauge glasses were fitted.

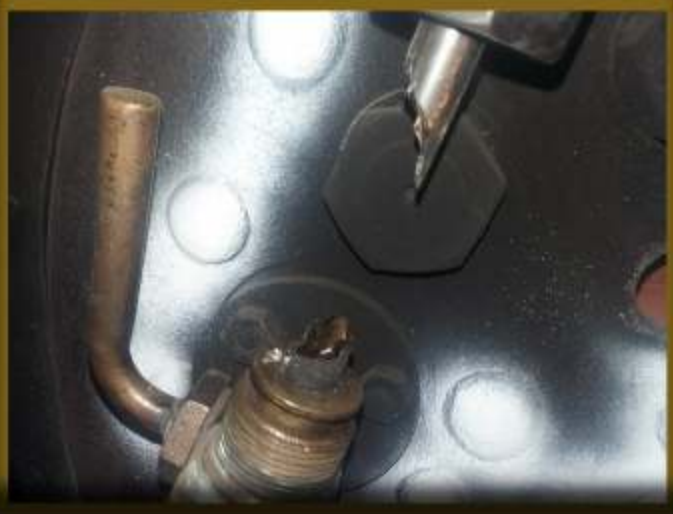
Below left: The old gauge glasses are broken to remove them.

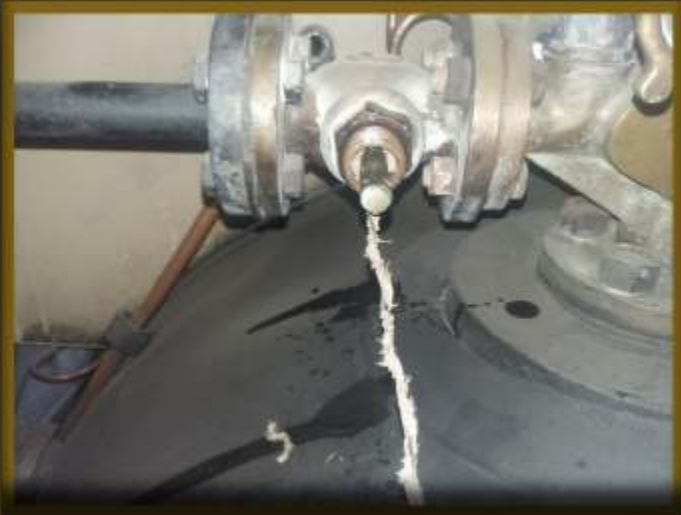
Below left: The Barclay's injector spindle packing nuts being packed. Seen here is the removal of Old packing rope. Some is easy like this one that winds out but most of them are not easy and needs To be scraped out with a sharp needle tool.

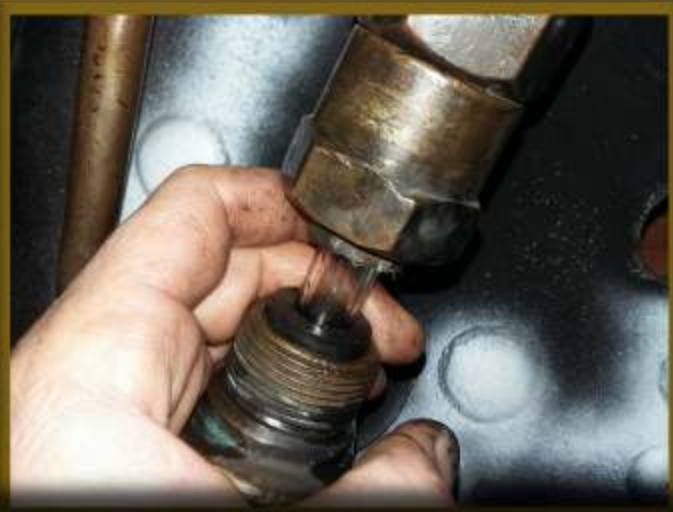
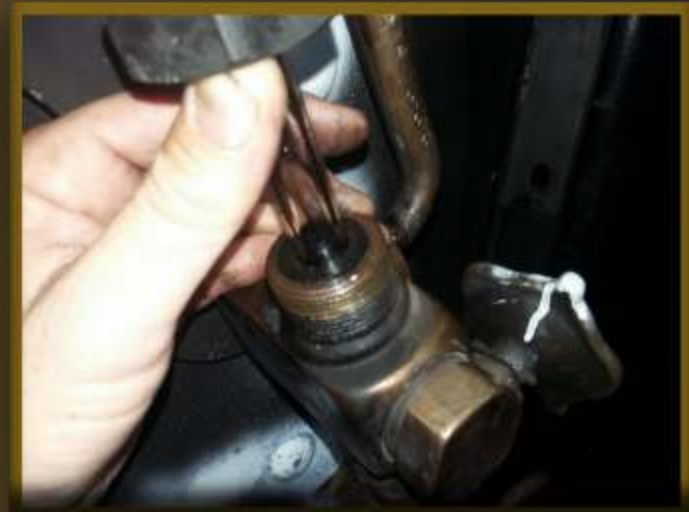
Below: New gauge glasses fitted to the Barclay.
