## Highlights of the Month!

# Track Maintenance

# NG 15 Repair

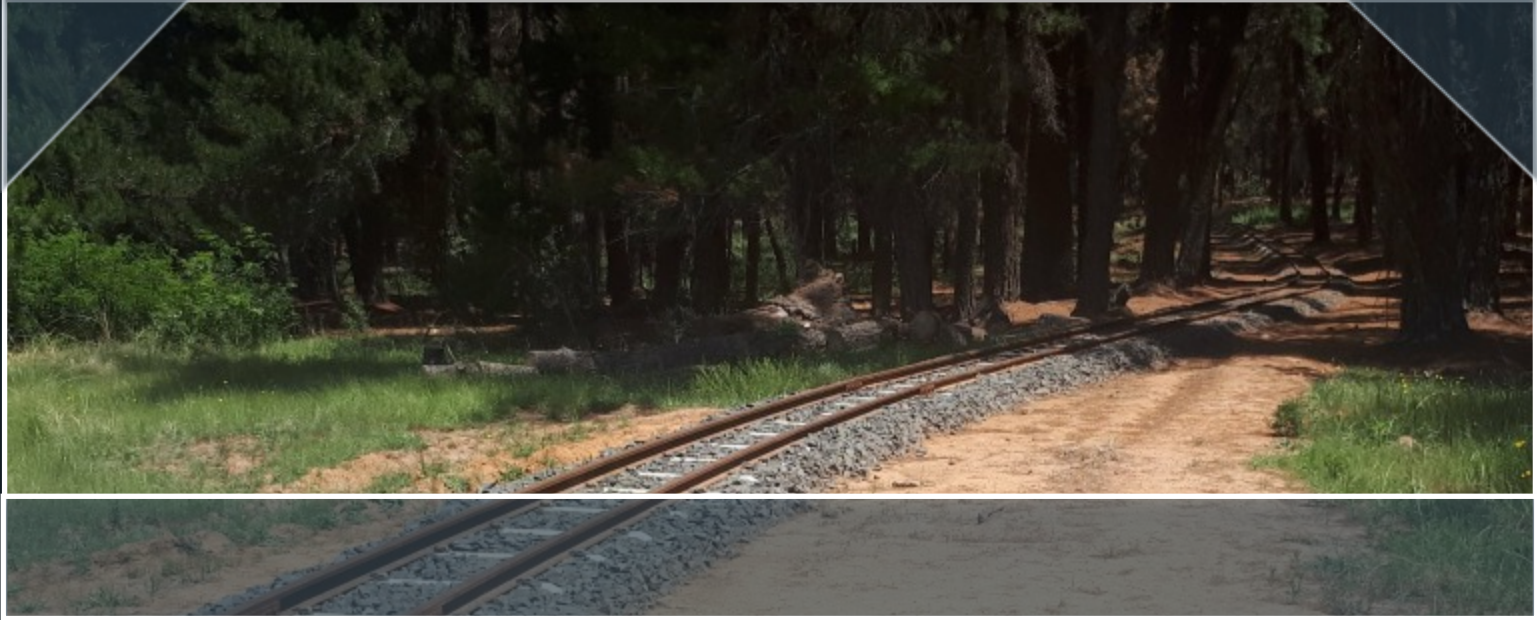
The last couple of weeks our Track gang worked on the gradients of the Pandora embankment. They screened the ballast and lifted the track, making it level again. We then moved over the Mountain to the Vailima Siding.

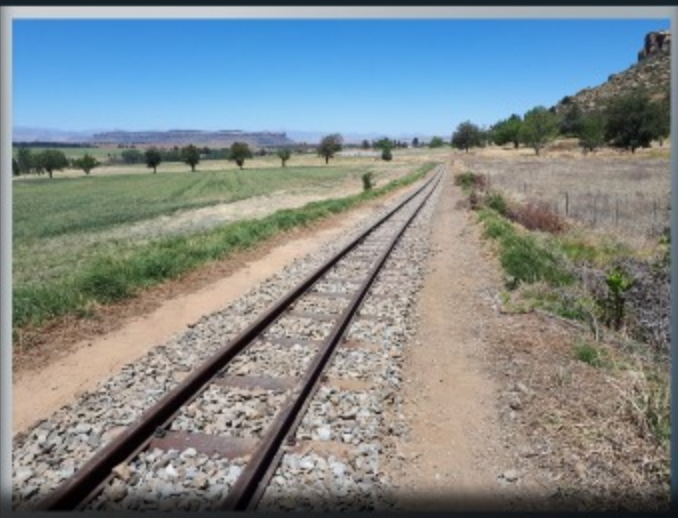
Below right: Starting at the Vailima crossing working their way up to the new culvert.

On this section of line we had to do the curve alignment and also screened the ballast. The slacks were removed and our Team is currently working down from the Vailima crossing into Vailima siding.

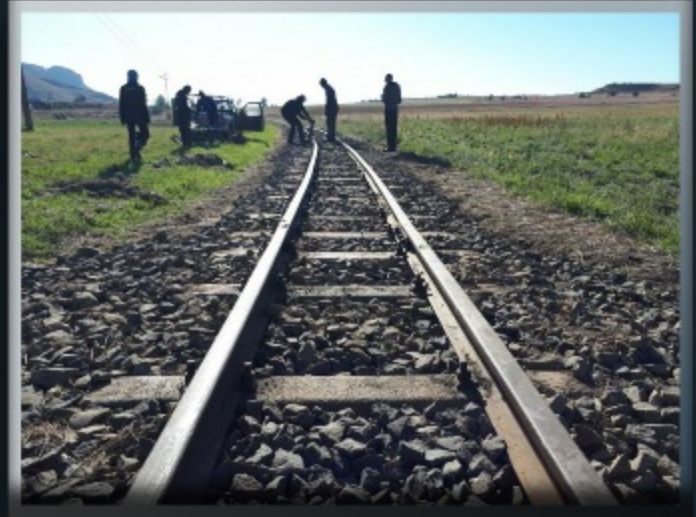
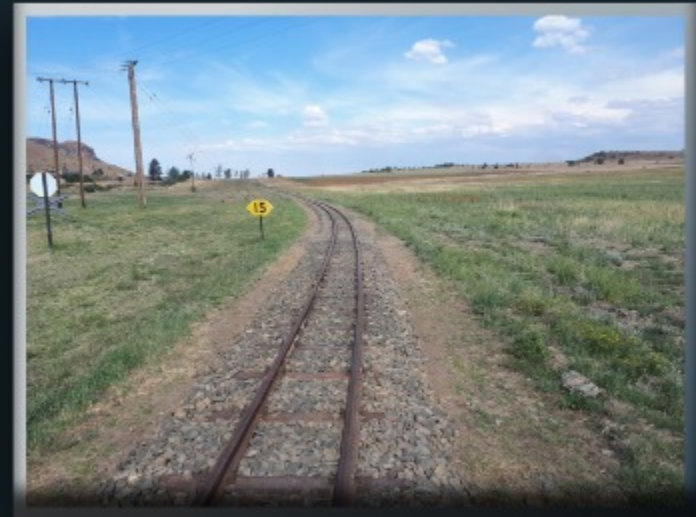
Below: Images of the track work between the Vailima siding up towards Pandora Junction points.

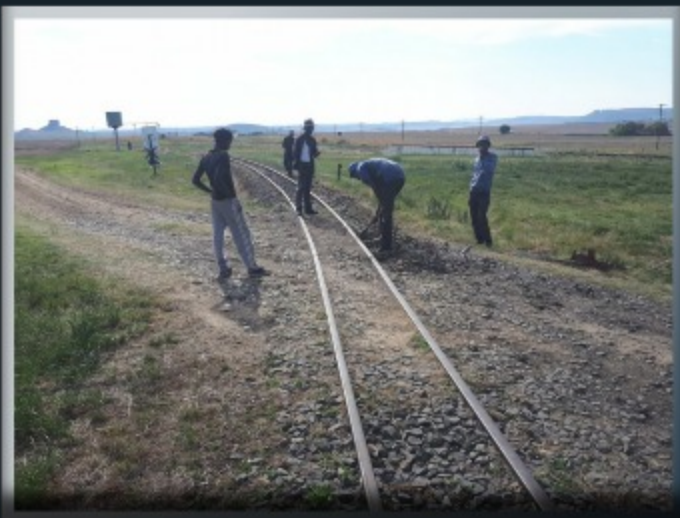
Below: Lifting out the Vailima crossing and working down towards Vailima siding.

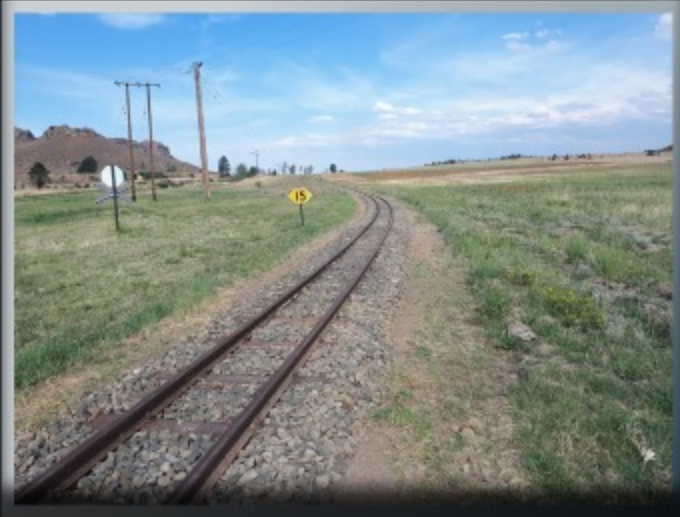
Below: More images of the section Vailima Crossing to the new culvert near Pandora Junction points.

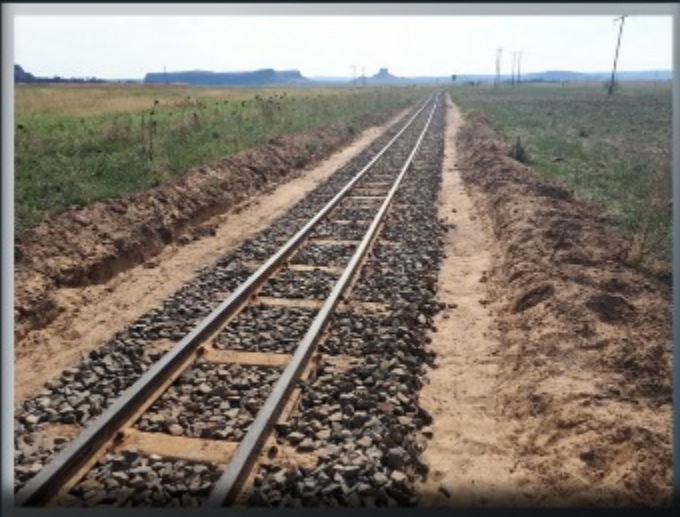
Below left: The section that was covered with soil, perfectly screened.  
Below right: At 36 degrees Celsius we attended to kick outs on Seb's line.

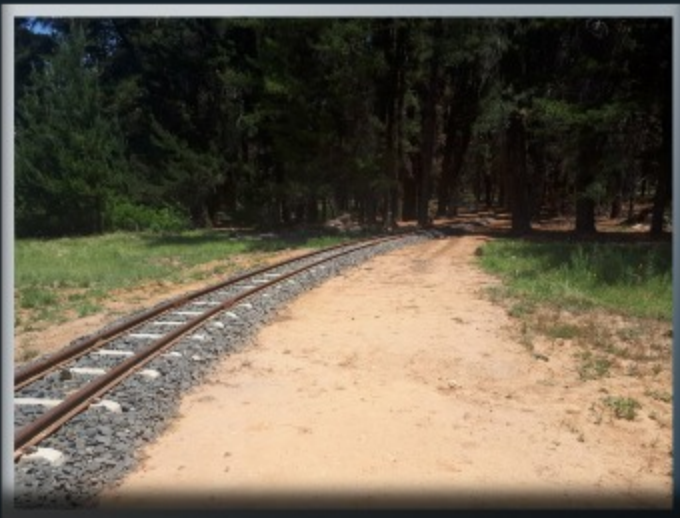
It was the perfect temperature to finalize the track alignment by the use of the Jim crow.

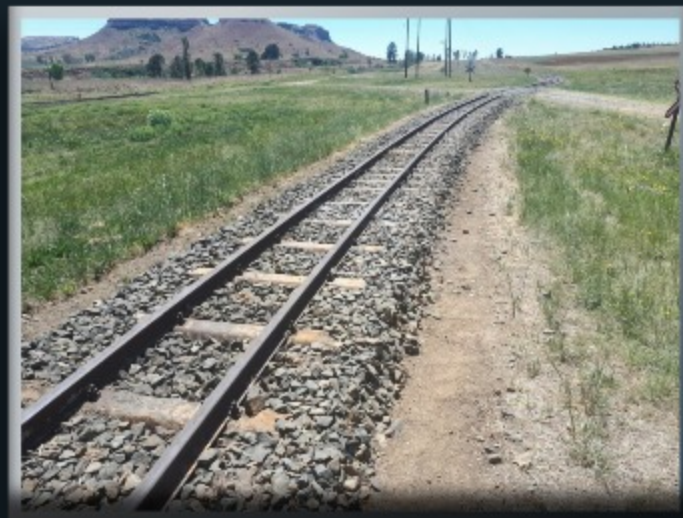
Below: Vailima Crossing to Vailima points section is now done.

Our Team will finish Vailima Siding and then we will move down the line towards the Farm School. This is the section of line that is desperately in need of levelling and curve adjustments.

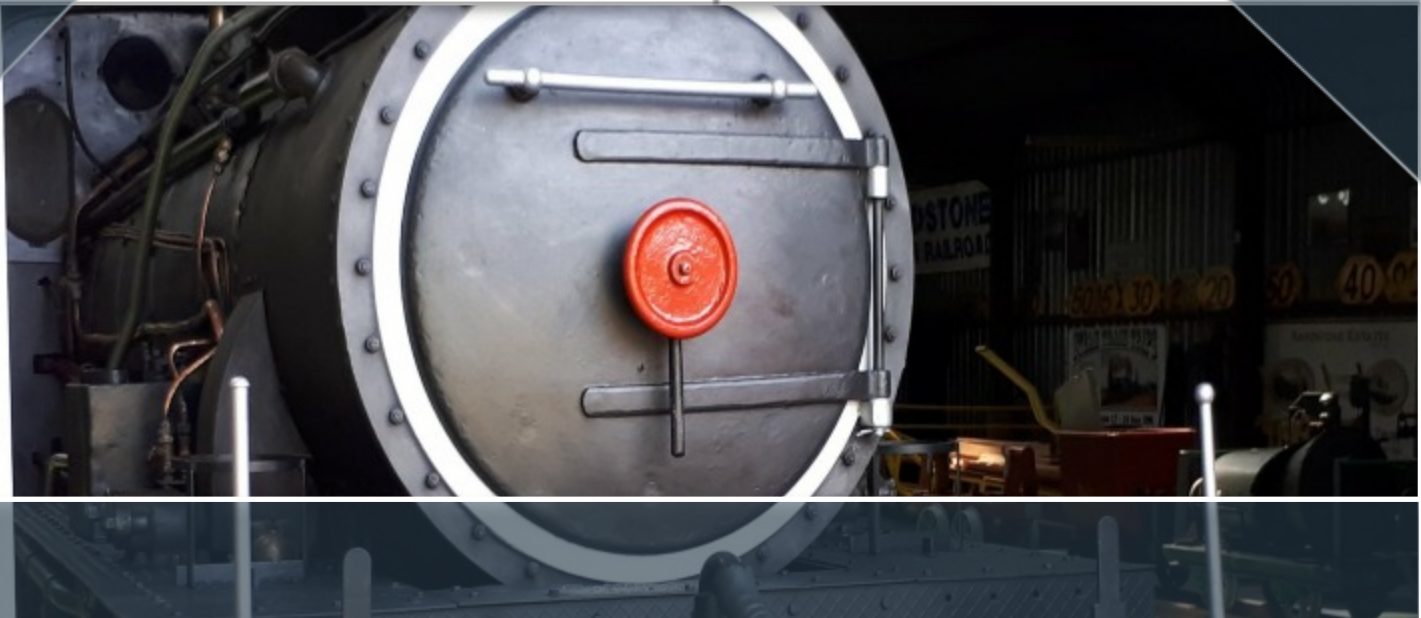
During the last few weeks we have completed the work needed on Sandstone Estates class NGG 15 number 17. The springs were adjusted and new fire bars were fitted. The tender and locomotive axle boxes were packed with new soaked wool and the tender brakes were adjusted.

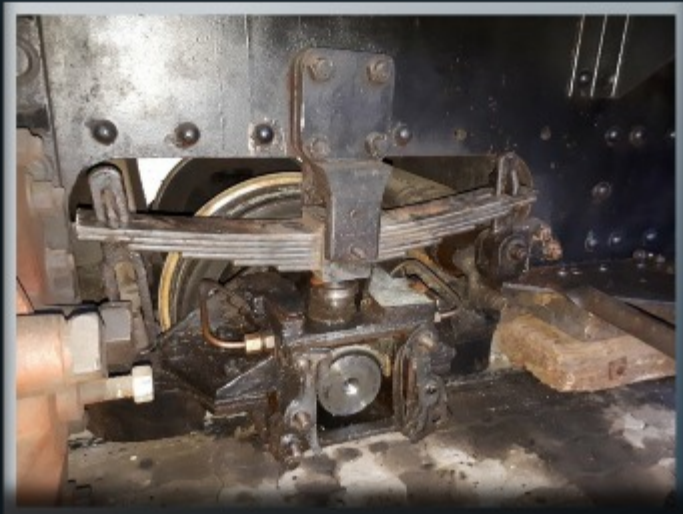
Above left: A spring was fitted on the front pony wheel.

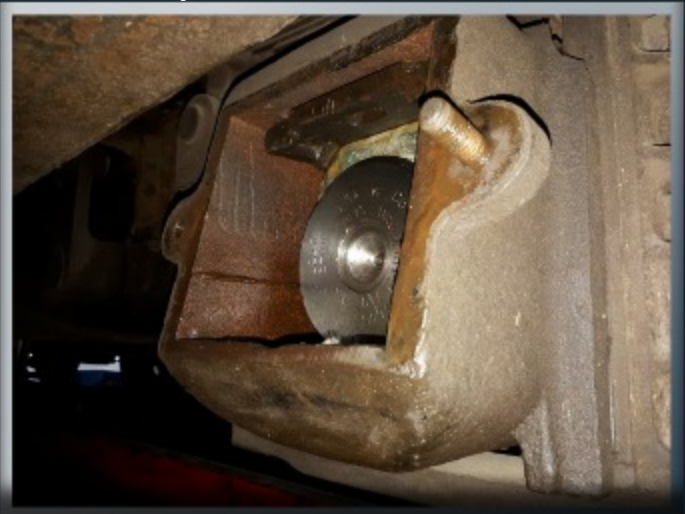
Above right: The tender axle boxes inspected.

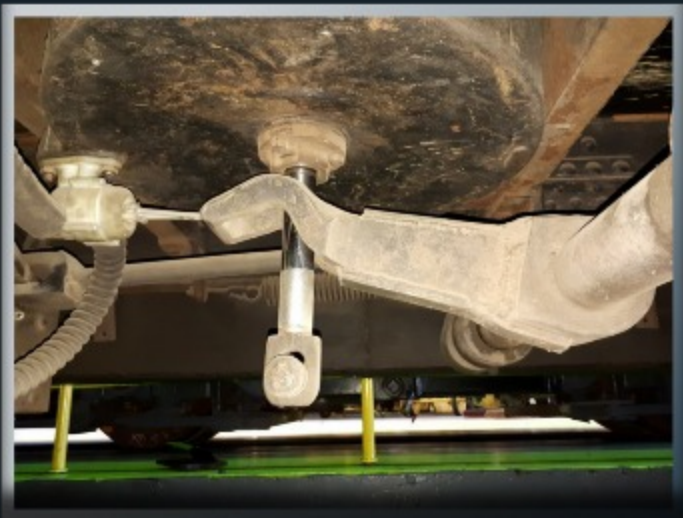
Above left: Showing the tender brakes were in desperate need for adjustment.

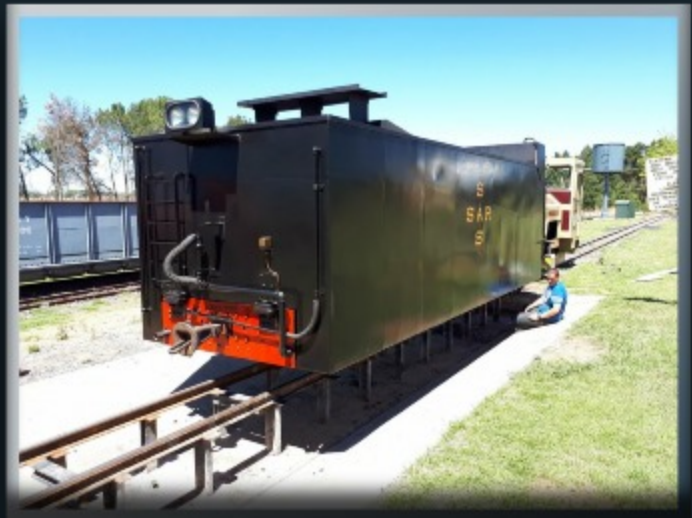
Above right: The NG 15 tender outside the shed on the ash pit. Wouter packed all the axle boxes with new wool.

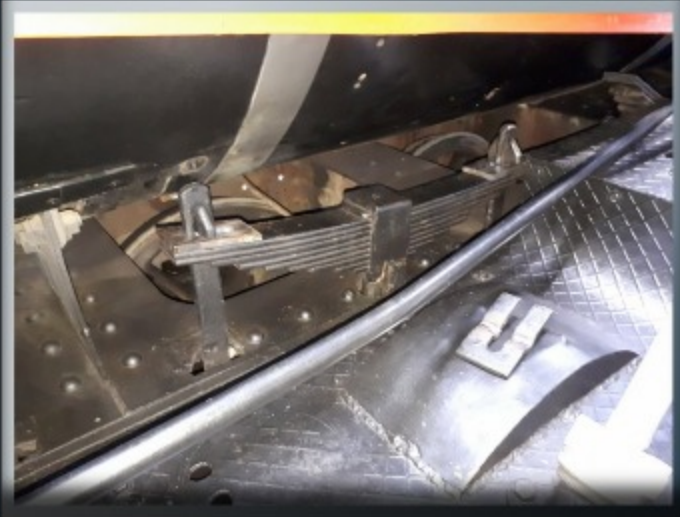
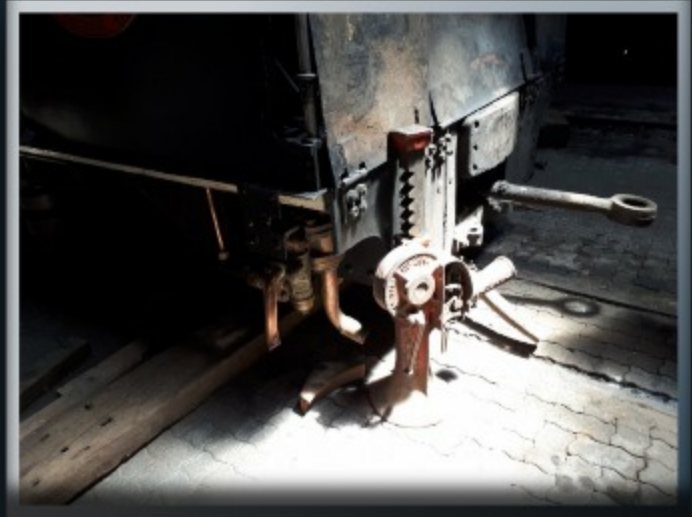
Below: Images of the NG 15 being lifted to enable us to do the necessary work on the spring system.

With the weight lifted off the wheels it is an easy task but to lift her up was quite a job, she is a very heavy lady.

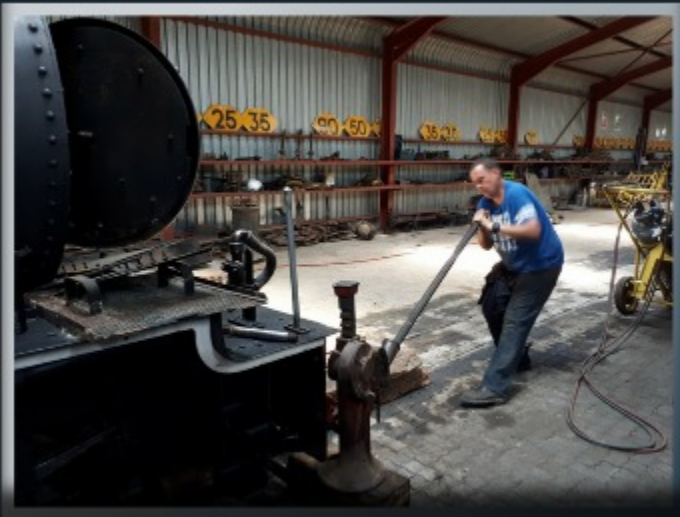
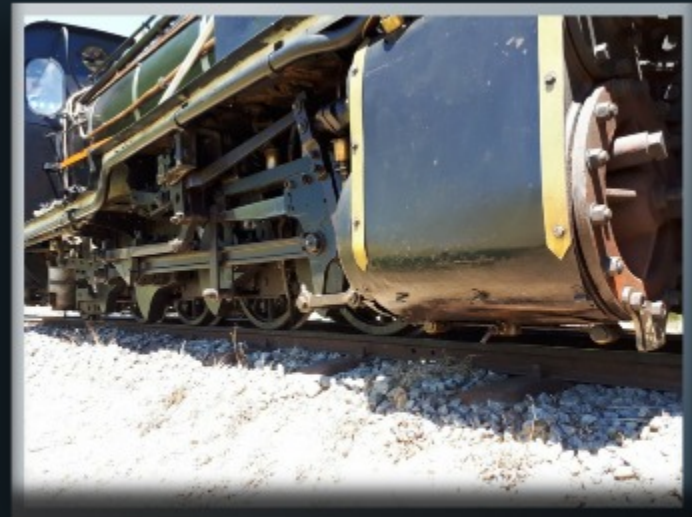
Below right: The main frame is now way above the pony frame and this eliminated the possibility of the main frame preventing the pony frame from moving which could easily lead to a derailment on curves.

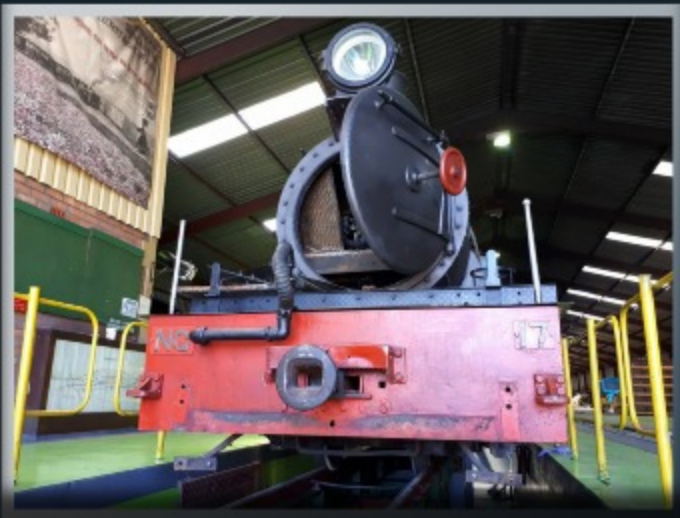
Above left: The NG 15 standing high and level again. She was always running with her nose was pointing down.

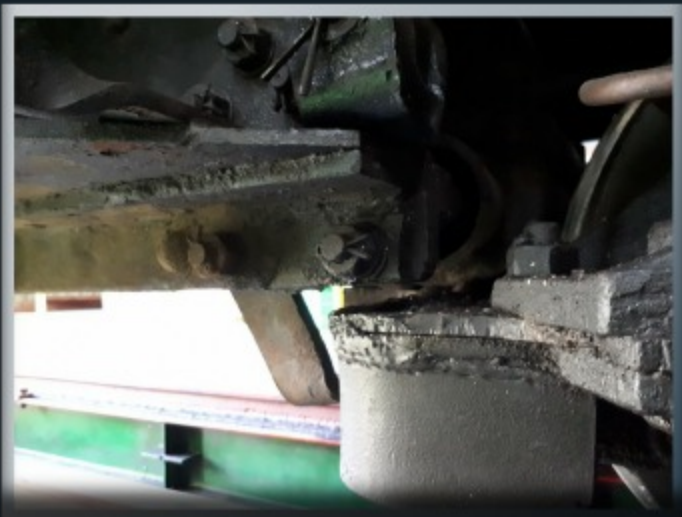
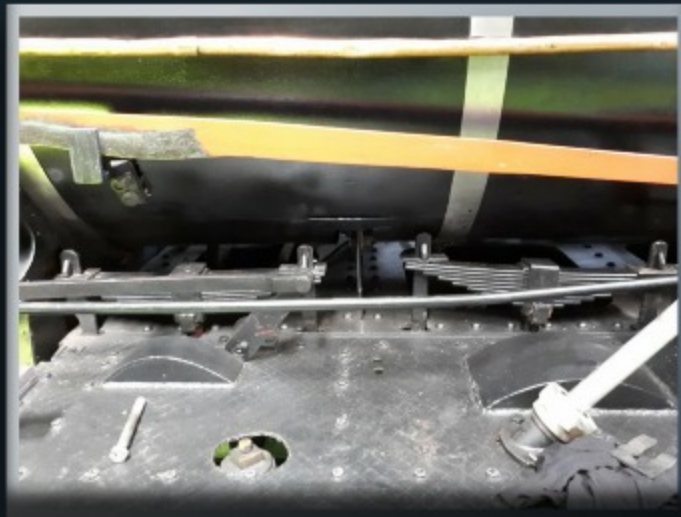
Below right: The driving wheel springs are also standing more level now.

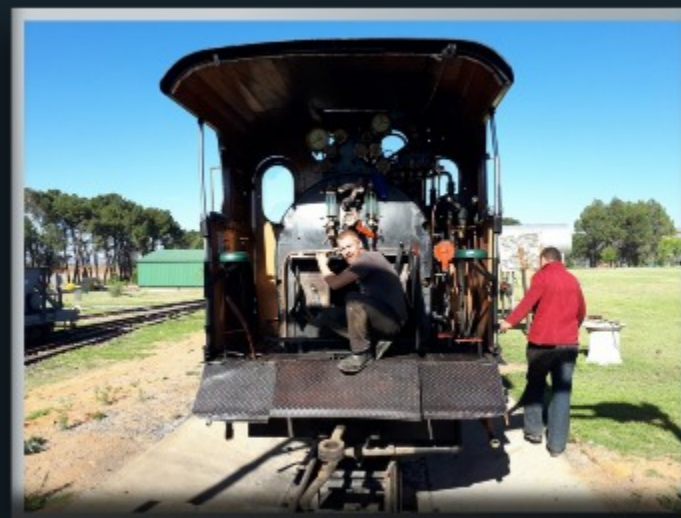
The NG 15 has a difficult to reach ash pan and if the proper cleaning of the ash pan is neglected then the fire bars burn. Thus removed two burnt and broken fire bars and he had to make new ones and refitted it.

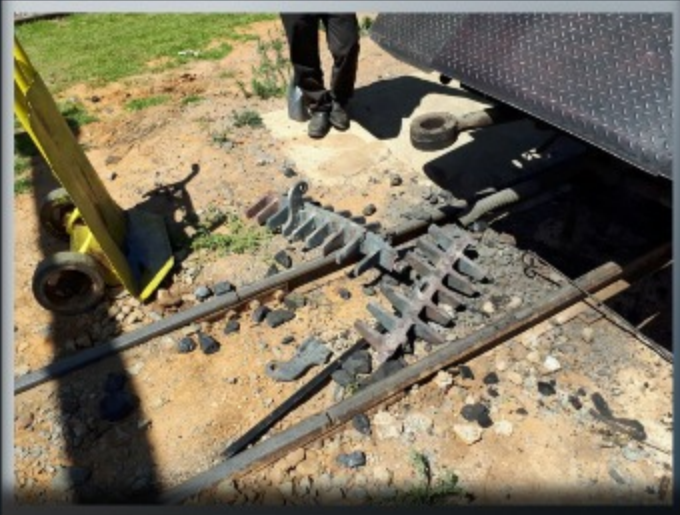
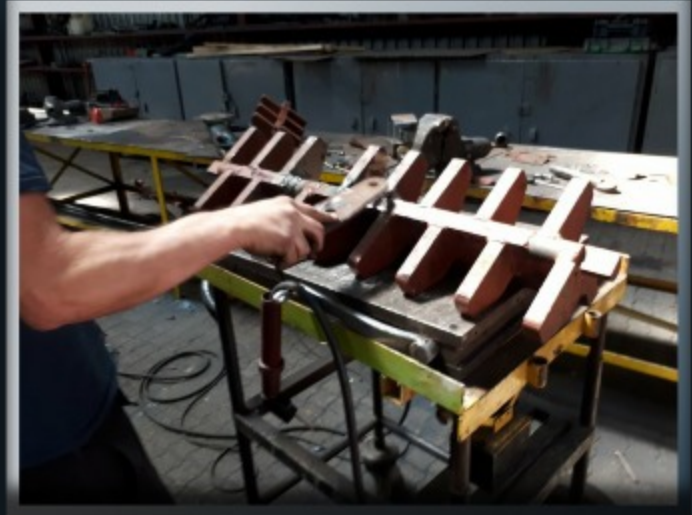
Below left: Burnt fire bars

Below right: Making new ones and extending them to fit the fire box.

It took Thinus three days to modify 2 ex Class 16CR fire bars to fit the NG 15 fire box.

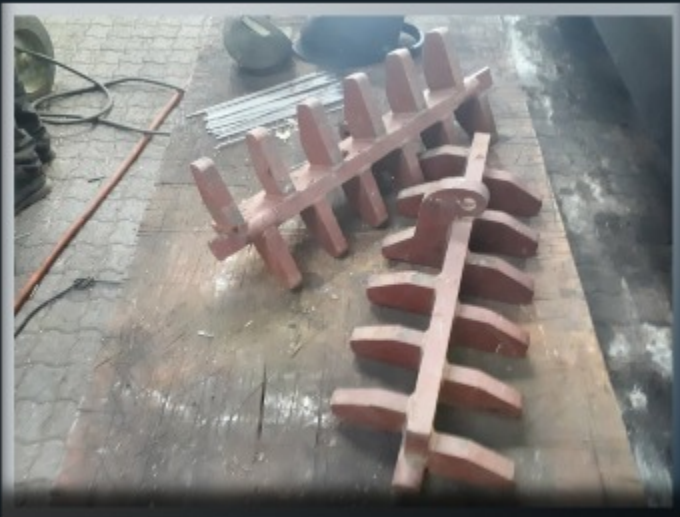
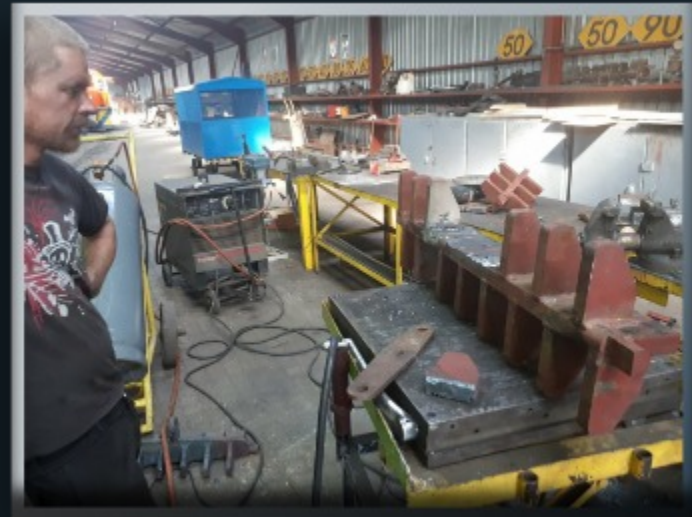
Below left: Wouter inside the NG 15 frame securing the spring saddle pin brackets.

Below right: Packing the locomotive axle boxes.

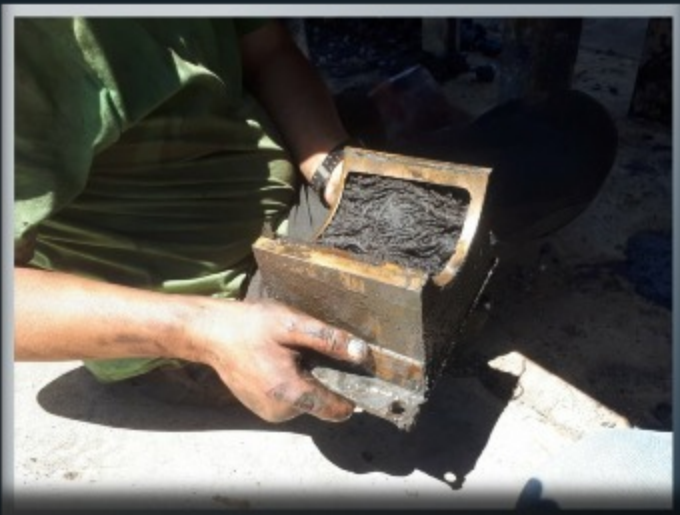
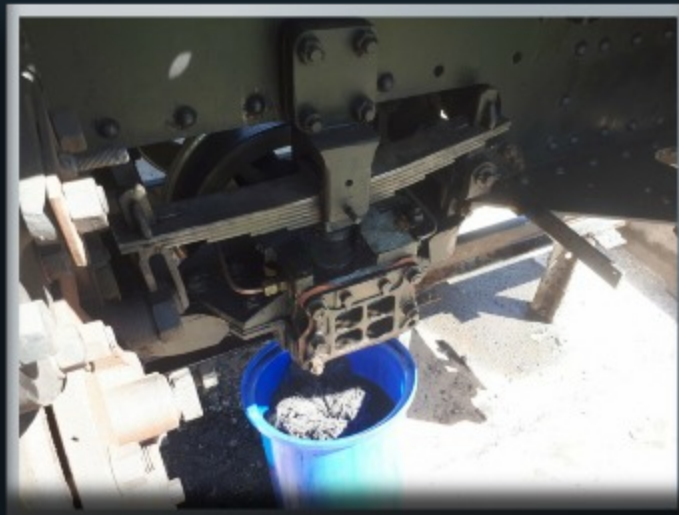
Below: The axle boxes being packed with soaked wool and oil.

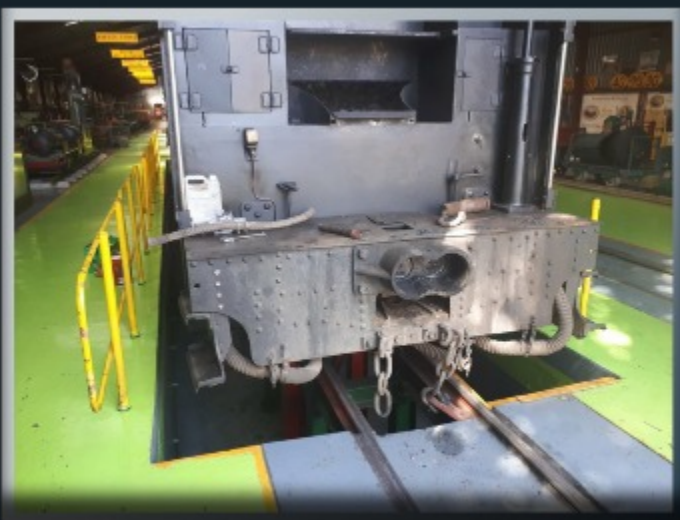
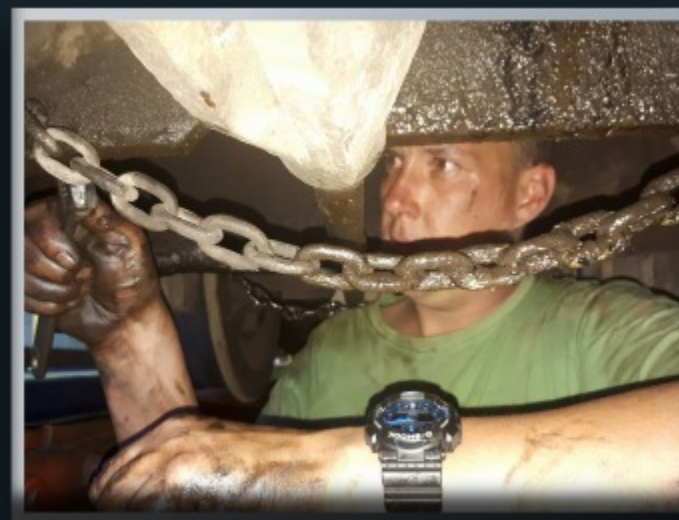
The tender then was shunted to the inspection pit, the brakes were adjusted and the brake gear safety chains were refitted.

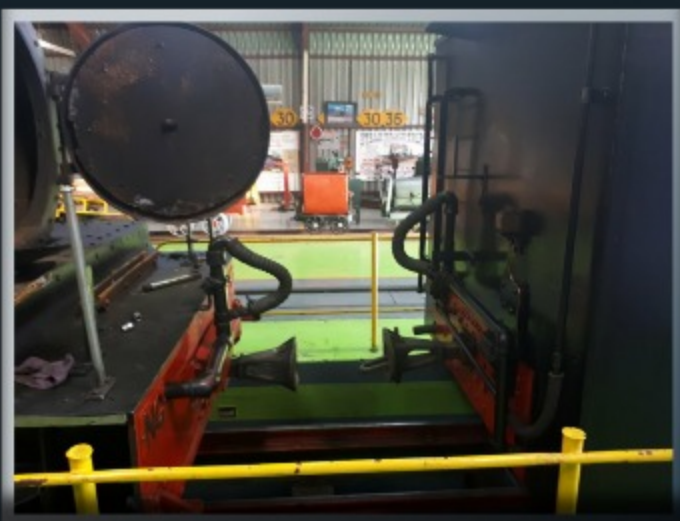
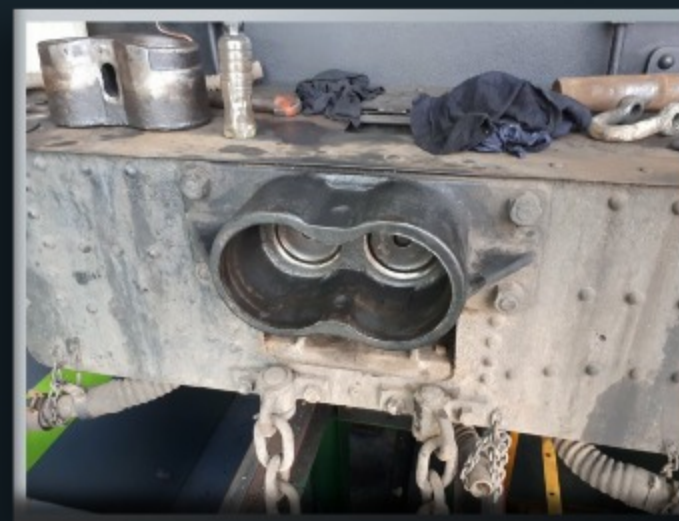
The tender then was prepared to be reconnected back to the locomotive.

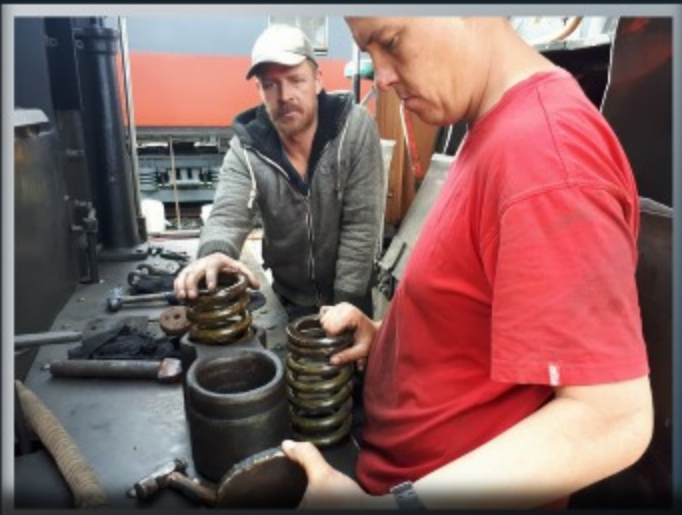
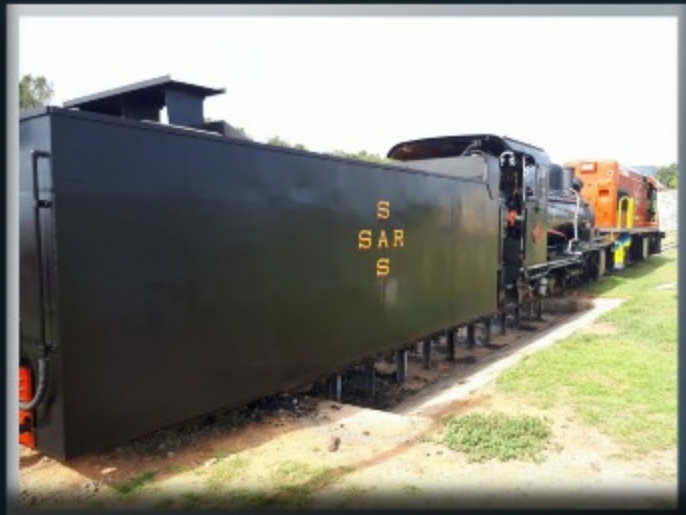
We made use of the Class 91 Diesel locomotive to press the tender back onto the locomotive. The tension springs are very strong and the tender had to be chocked to fit back the intermediate draw bar pin.

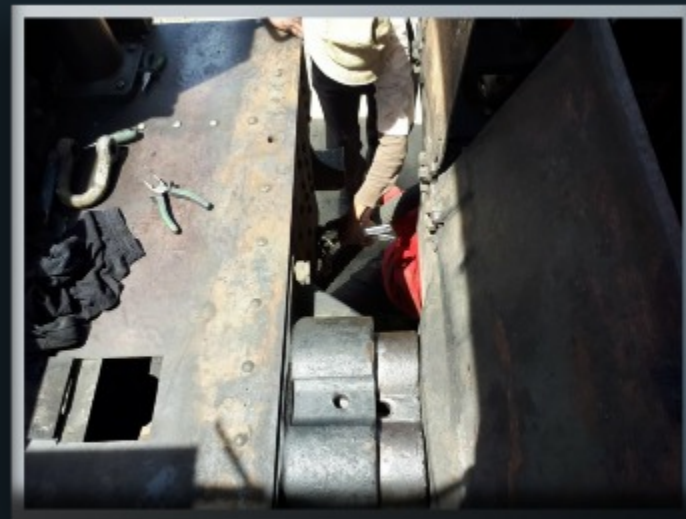
Wouter and Brian then fitted back all the pipes and connected the safety chains again. Some rubber hoses had to be replaced.

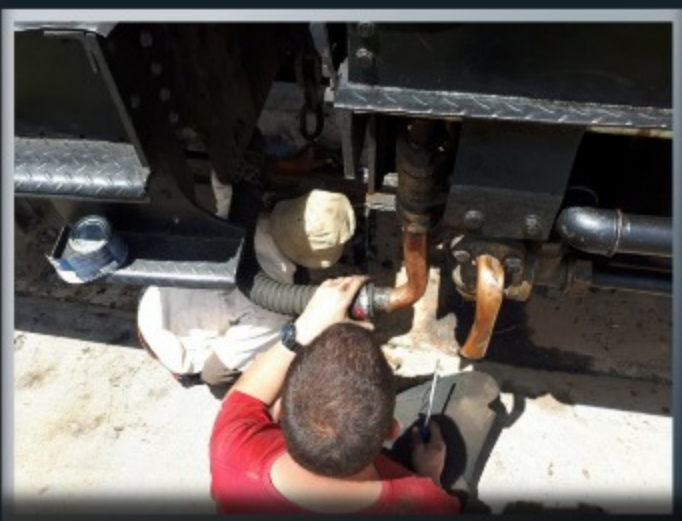
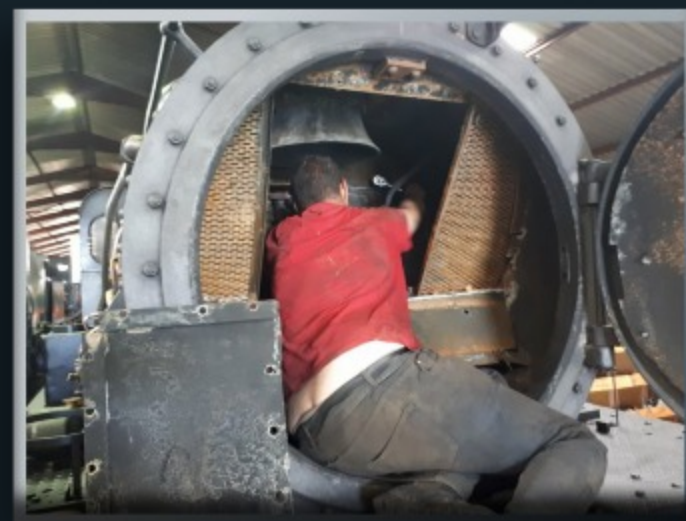
The spark arrestors were refitted back and Wouter filled the boiler to enable us to put the work done to test.

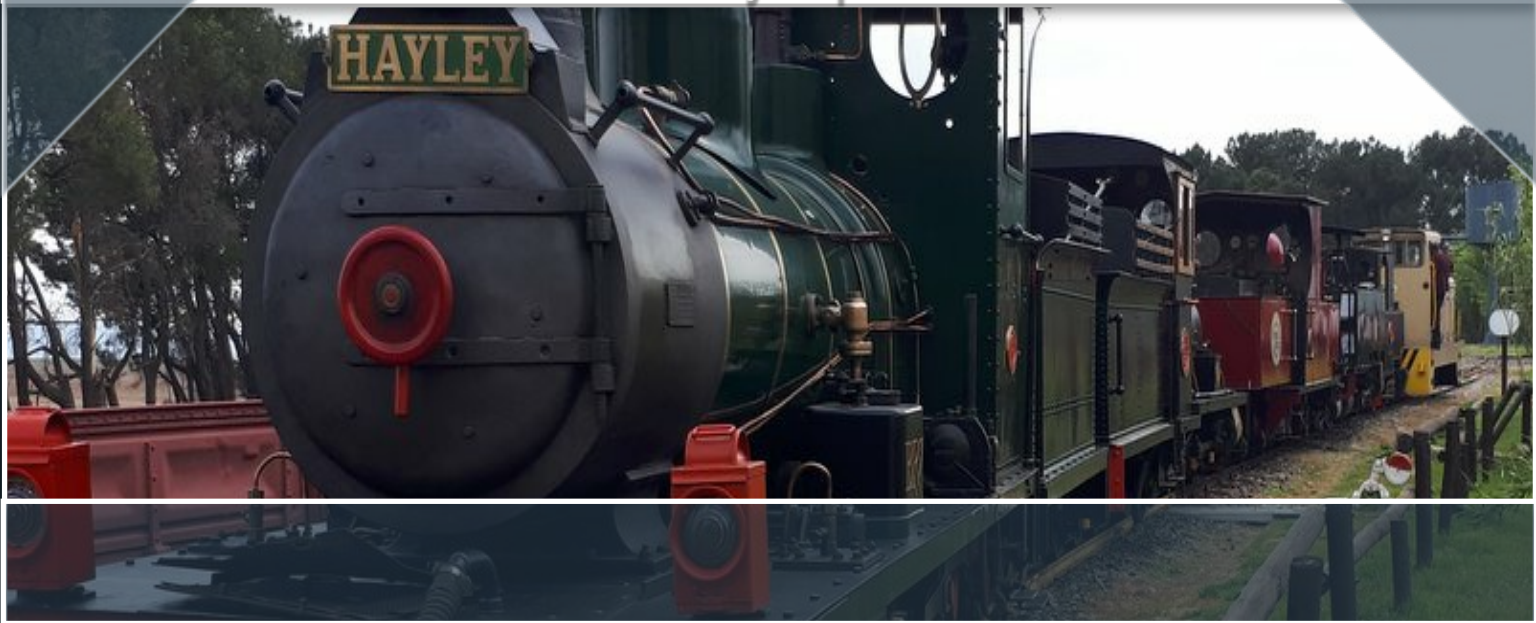
A while ago Thinus made a new branch steam pipe for the Lawley and we did a water test to ensure there are no leaks. The Cowcatchers on the Lawleys are bit to long and this results in the cowcatchers pushing against each other during shunting or double heading and we decided to make the cowcatchers a bit shorter to eliminate this problem.

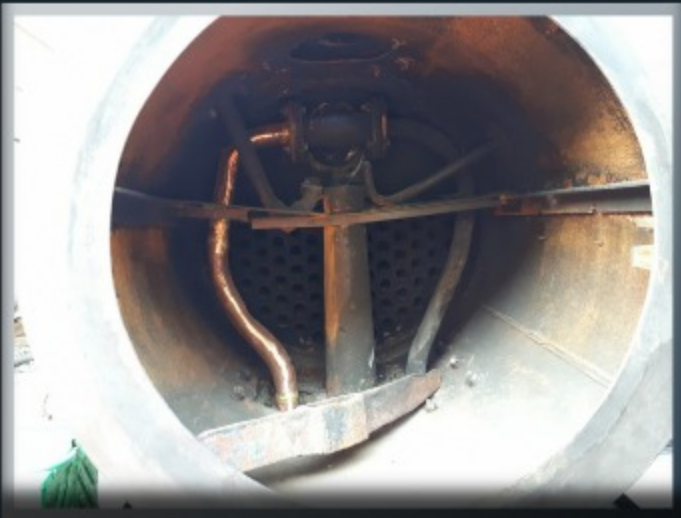
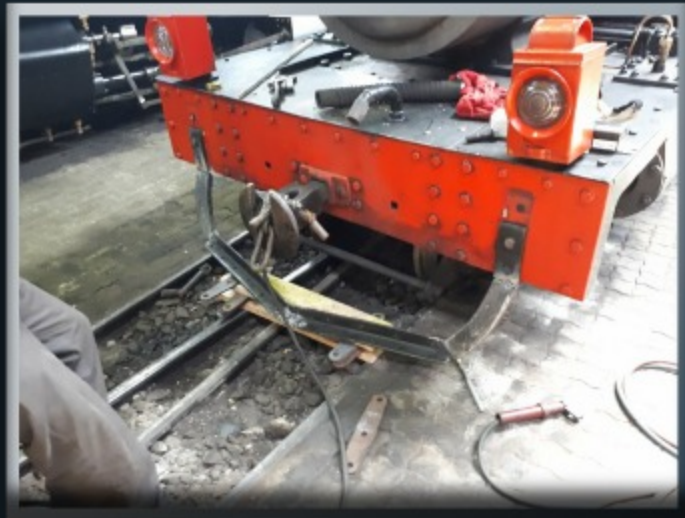
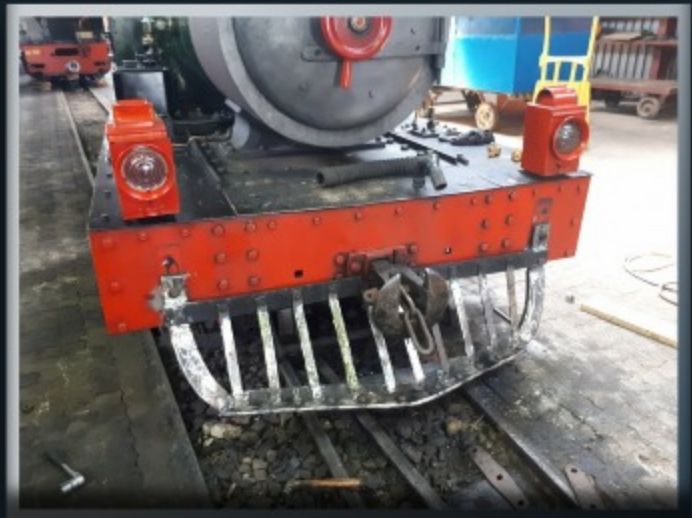
Above right: The shorter cowcatcher.

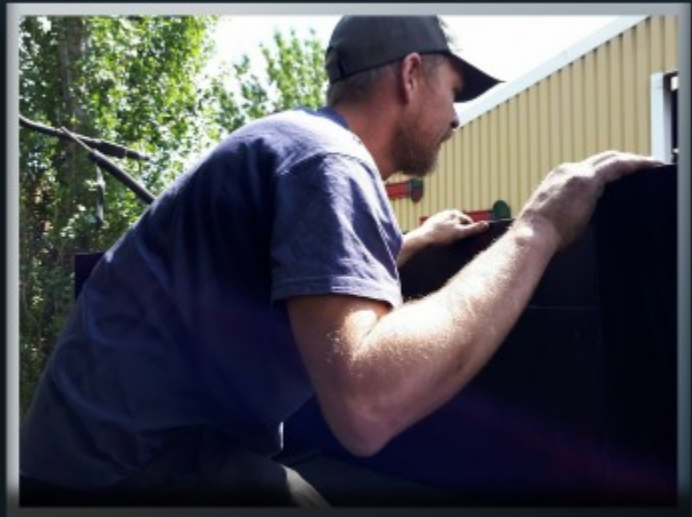
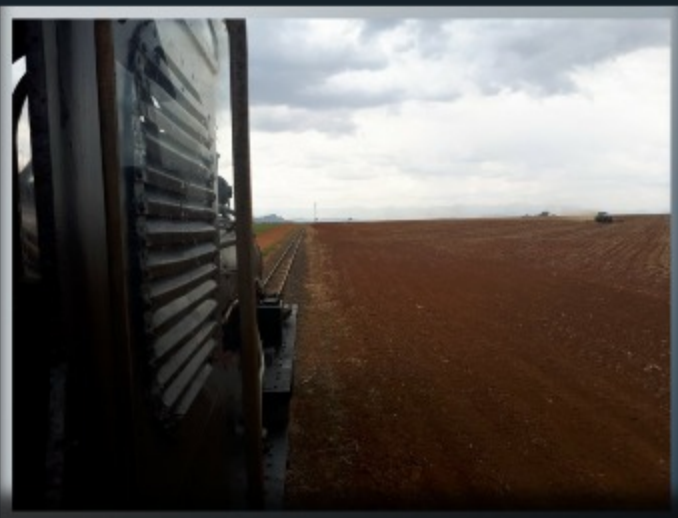
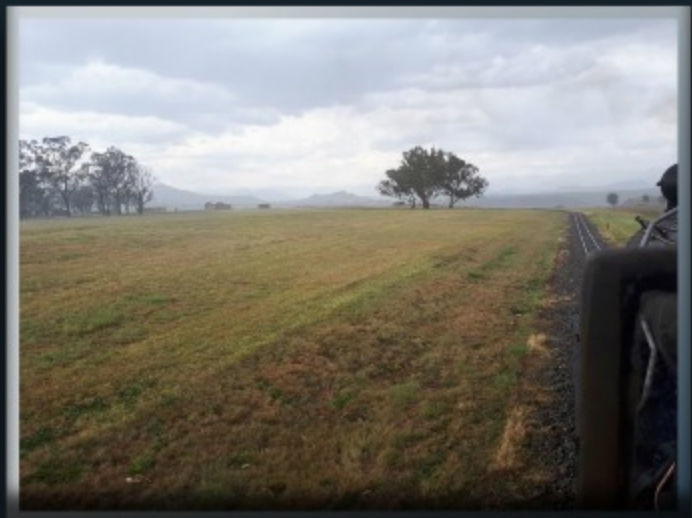
We then steamed up our class NG 15 to test her on the gradients out of Grootdraai and Vailima with a load of 8 passenger coaches to evaluate the grip of the driver wheels on the tracks.

A storm was approaching and by the time we reached Grootdraai the rain was coming down, excellent to test her on wet rails as well.

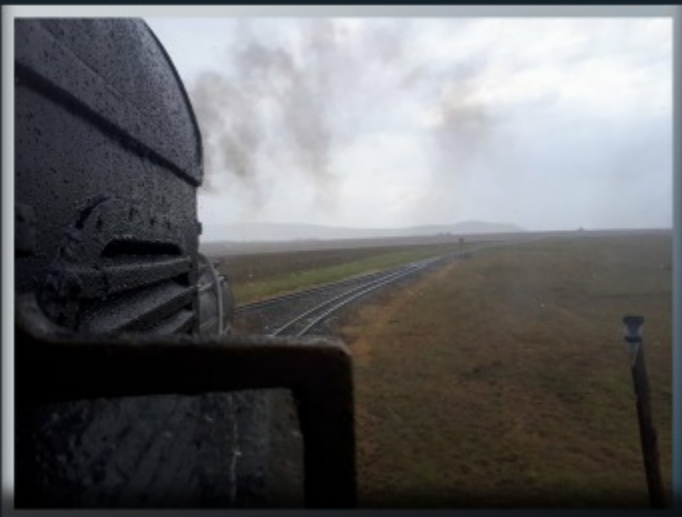
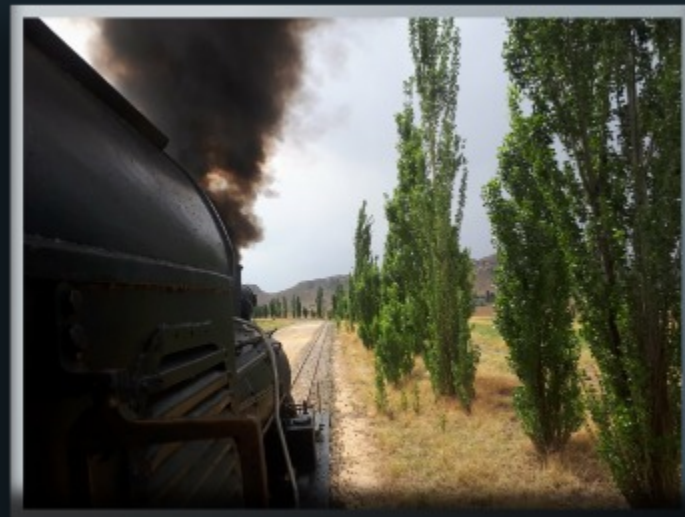
Below: We stopped at the points and the Ng 15 picked up her 8 wagons with no problems.. We then headed over to the Pandora embankment and tested her twice on the gradient.

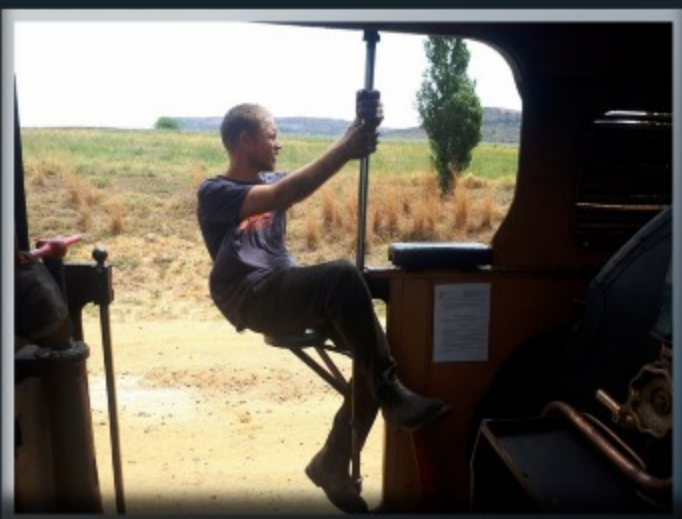
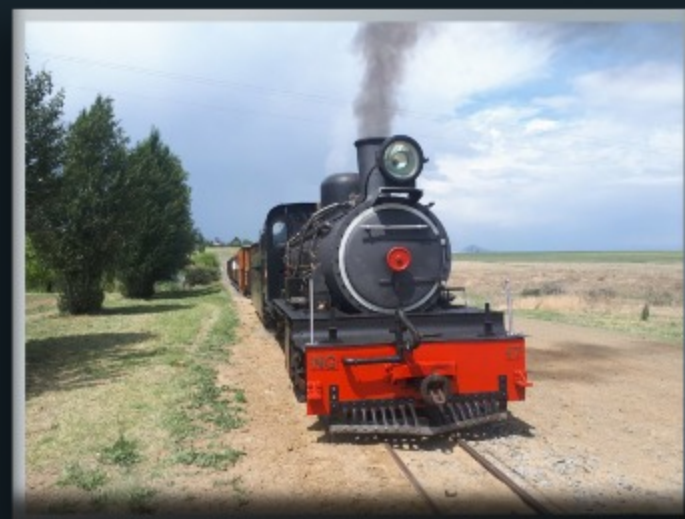
We made a stop at Pandora crossing and the NG 15 could pick up her load at any place on the Pandora embankment without a slip, just as strong as a NGG 16.

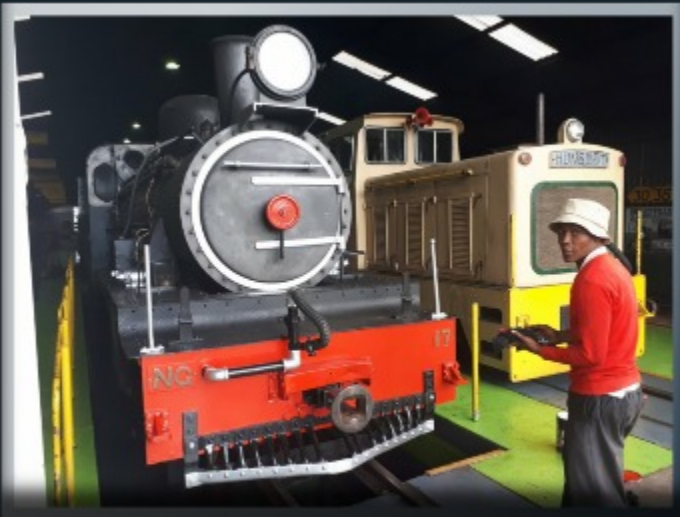
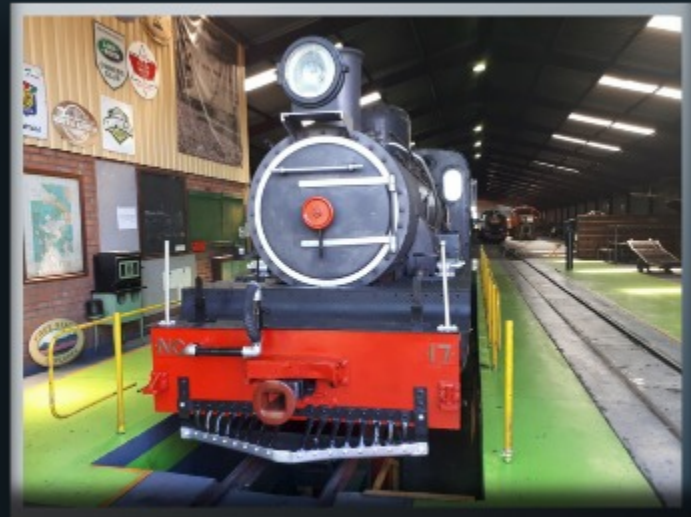
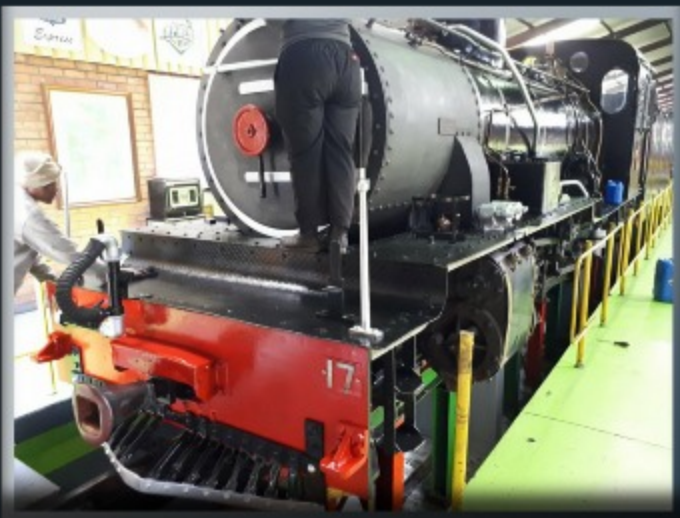
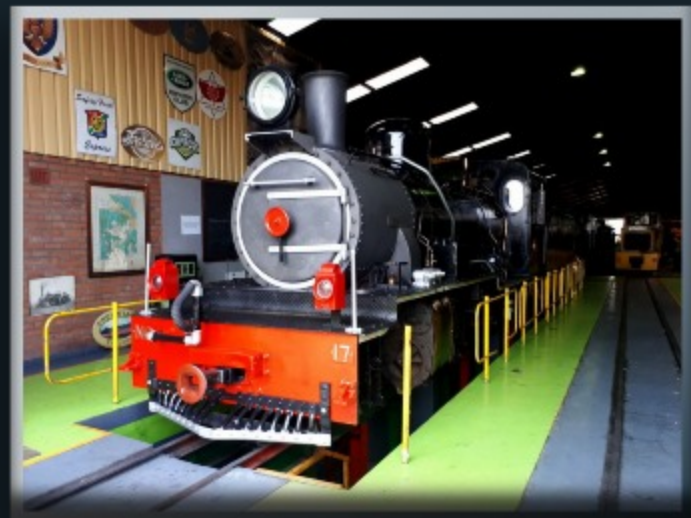
The NG 15 is the chosen locomotive to haul the annual Cherry Express trains and Brian is just the guy to do the beauty upgrade needed to have her in splendid condition for the coming Cherry Festival in Ficksburg.

Below: paint and polish!

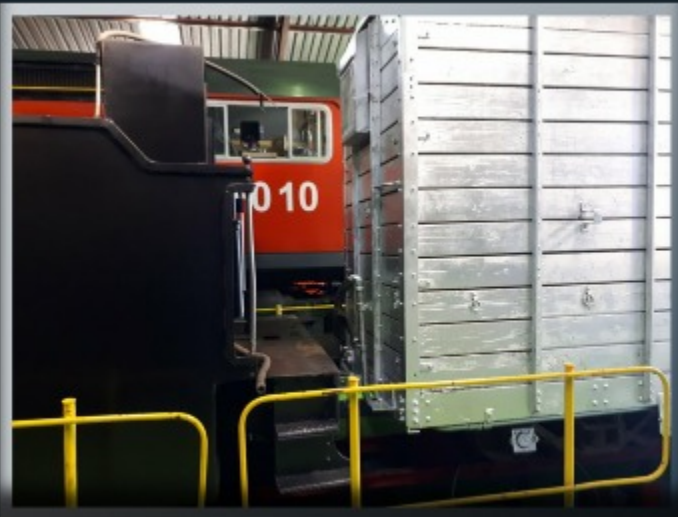
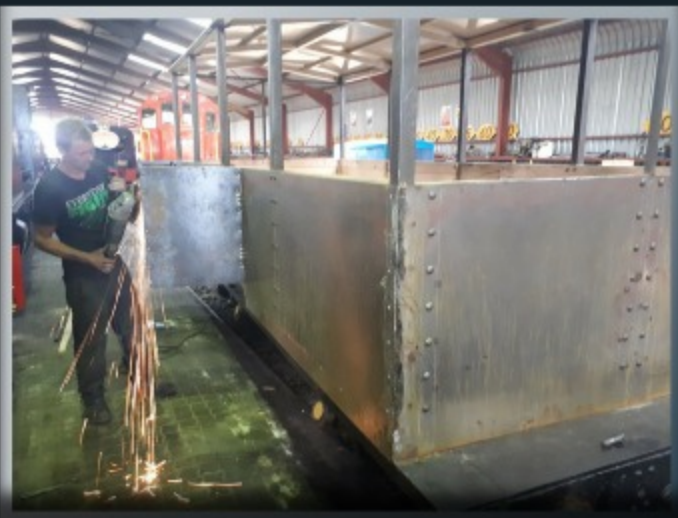
Sandstone Estates recently acquired another Ratanga wagon that was delivered a while ago. This Ratanga will soon be restored. The O wagon 3991 came to the pit and the under frame restoration was completed.
