## Highlights of the Month!

# 150 M Shed

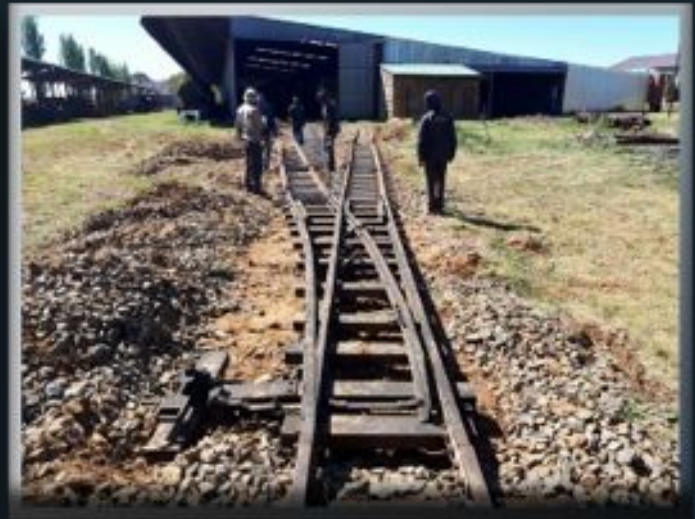
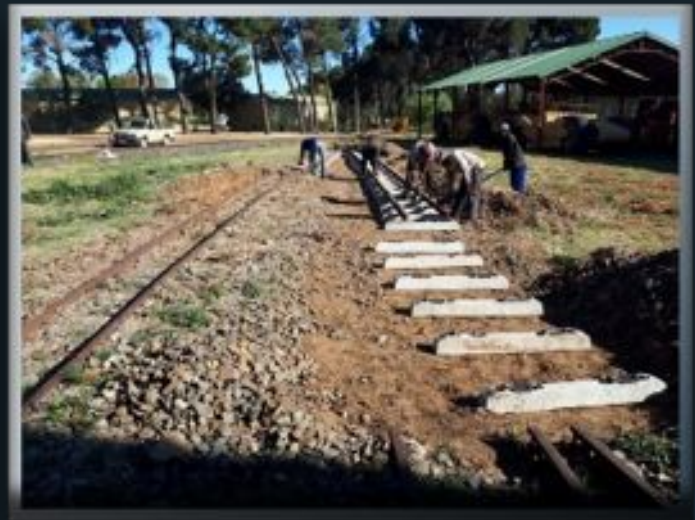
Our Track team have finished the construction work at the main points towards the 150M shed and started the track construction in front of the 150M shed. They have fitted a left hand point and connected 2 lines into the shed.

Below: Images of the track building at the 150M shed.

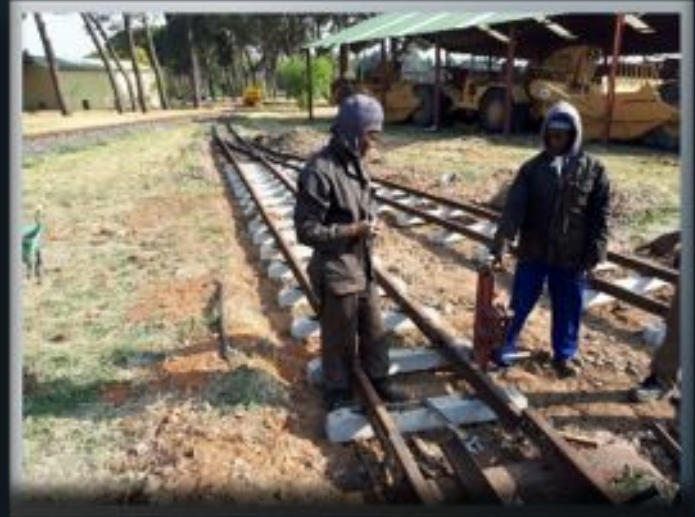
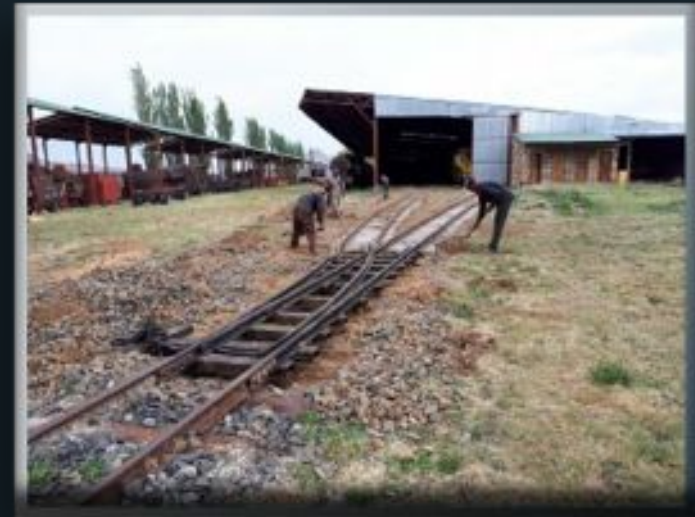
The tracks were re connected and the ballast was moved back to enable them to tamp the lines..

The 2 lines were finished and we could shunt back all the box wagons into the shed before the rain season starts.

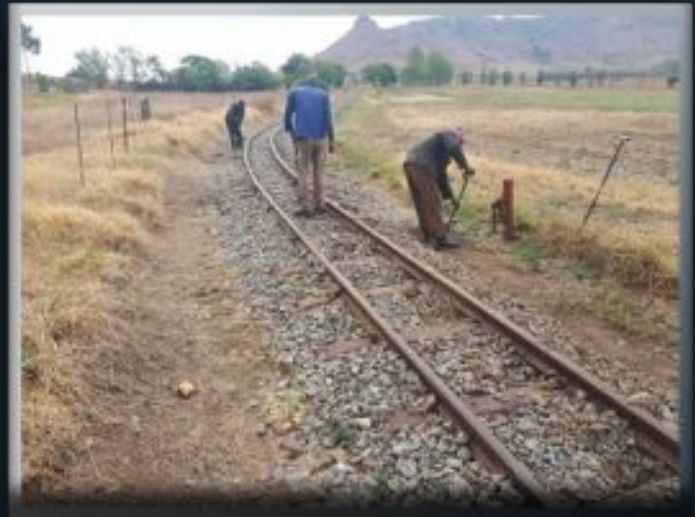
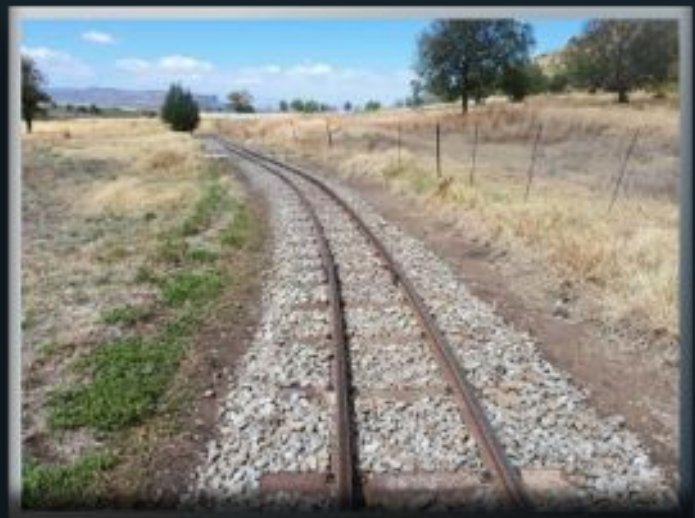
Our Track team lifted out the slacks on the section of line next to where the old Pandora house use to be. The Cant was adjusted on the curves and the straight line was levelled again.

The straight line here had a severe cant on it and we needed to rectify it. The track alignment was also done on this Section of the line and the ballast was raked neatly.

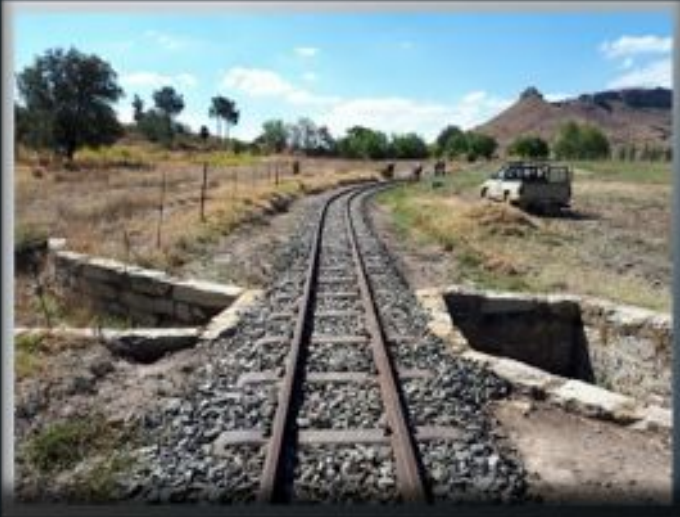
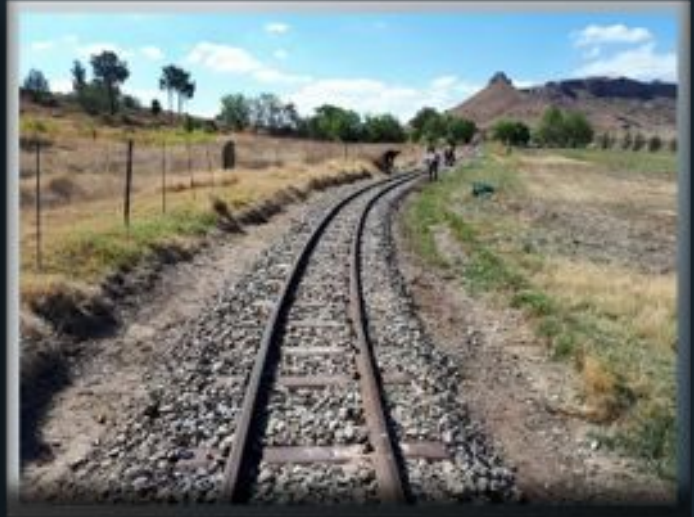
This section of line maintenance was completed this week and we now have moved on to the Vailima entrance points working our way up to Pandora Junction. This section has severe slacks and alignment problems.

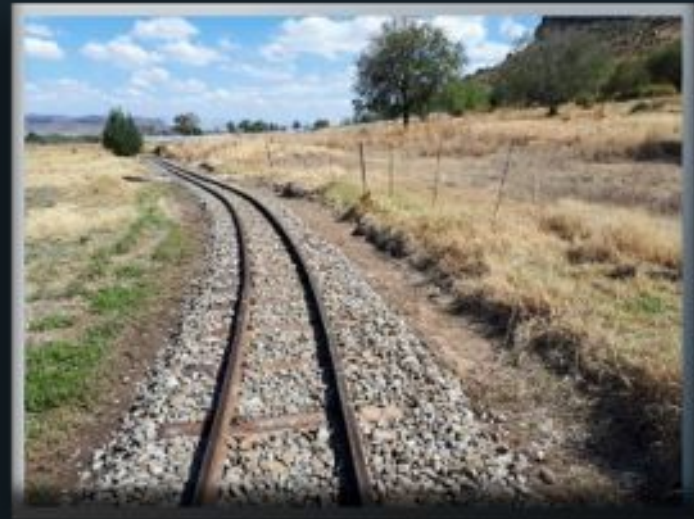
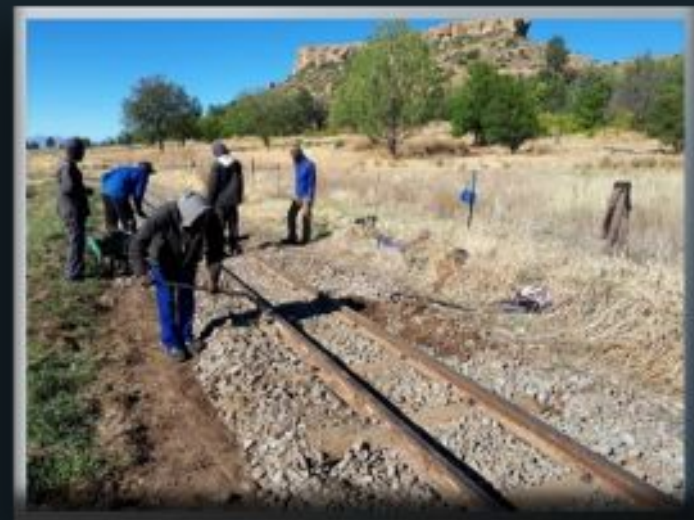
Below: Images of the section near the old Pandora house.

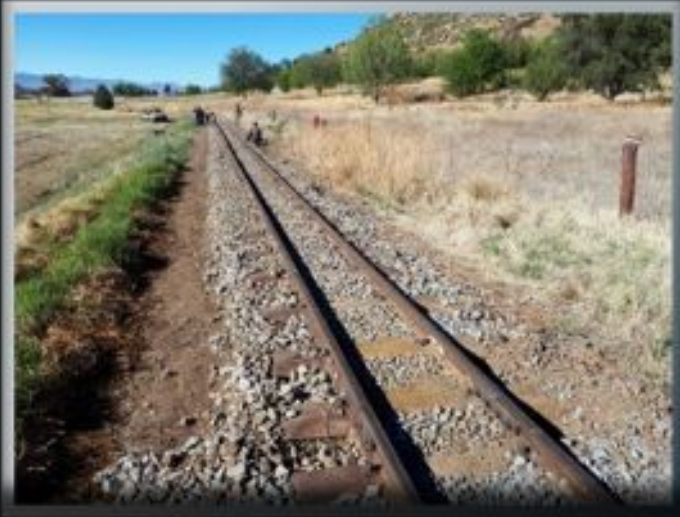
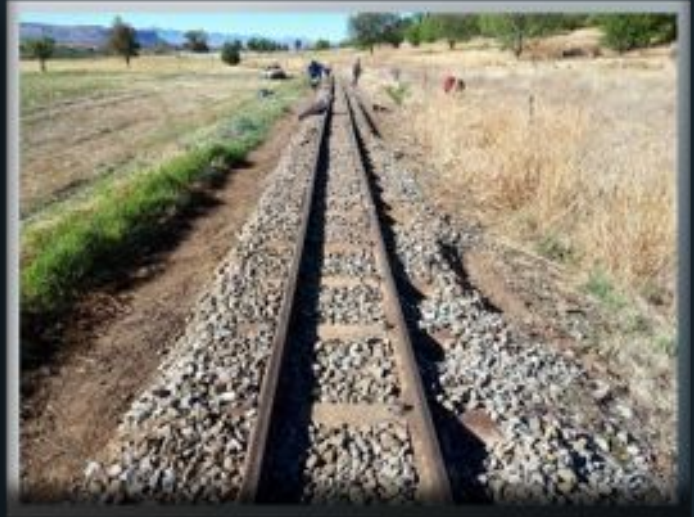
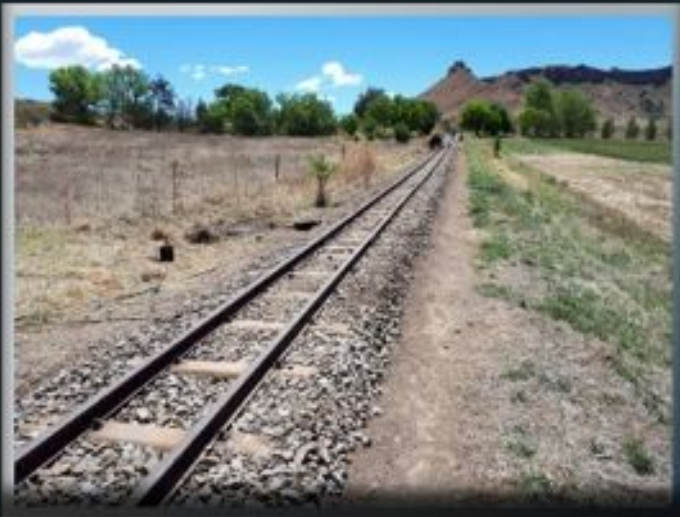
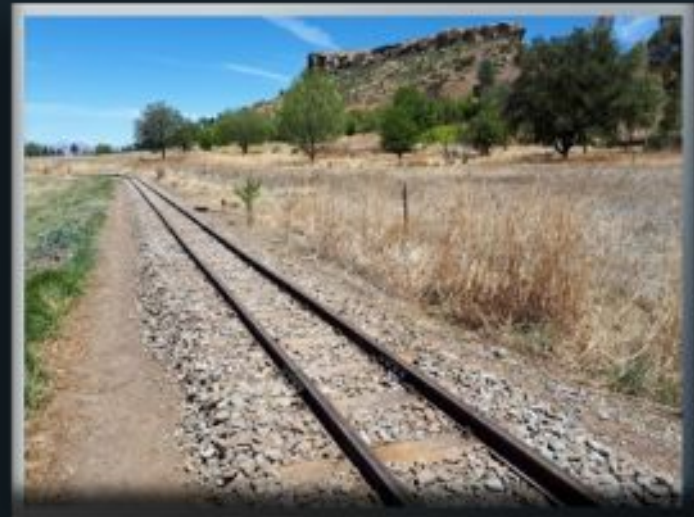
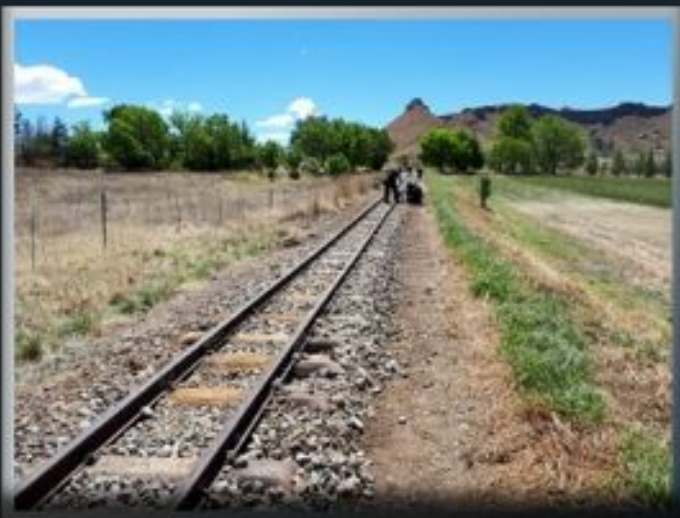
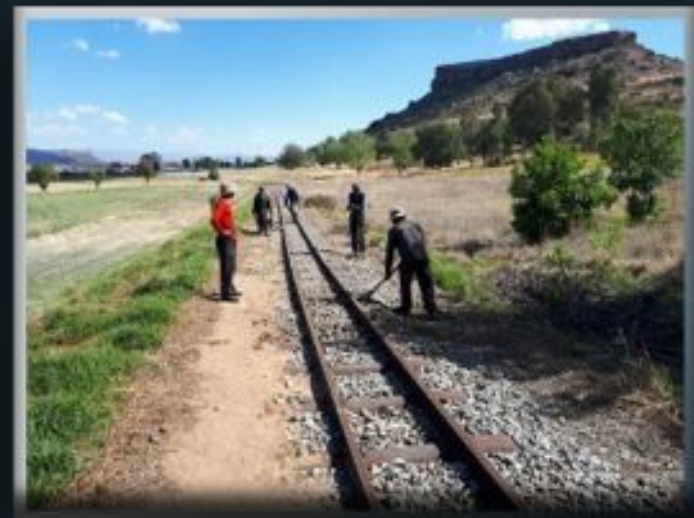
The maintenance on this section is now completed and we started on the Vailima side. We will first tackle the severe Sections and will later come back to do the maintenance on sections not so severe.

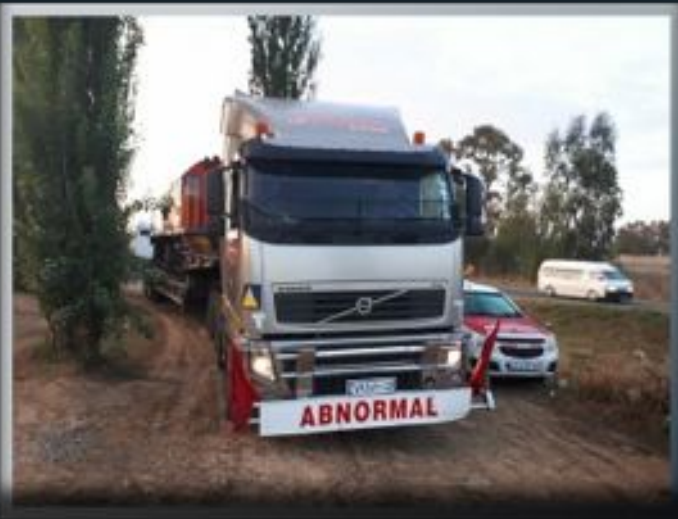
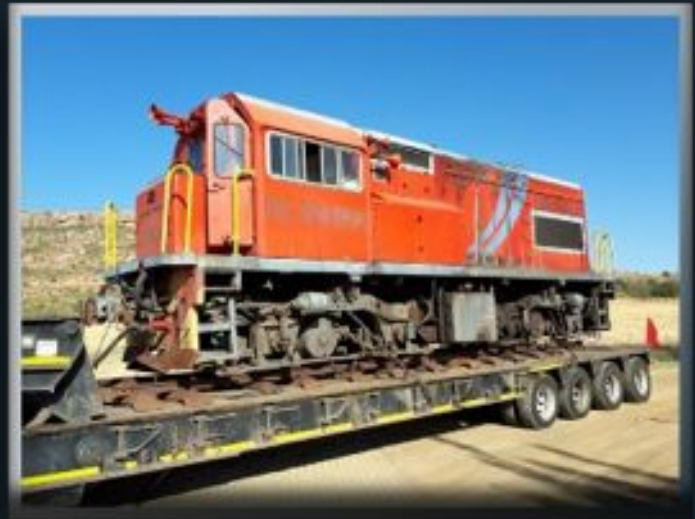
Sandstone Estates have acquired another class 91 from RRL Grindrod. Class 91-04 is seen below left in Bethlehem and A few hours later on the Farm.

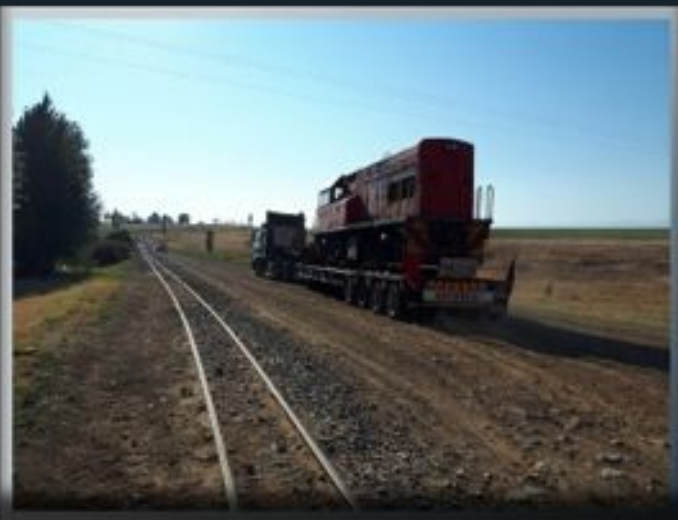
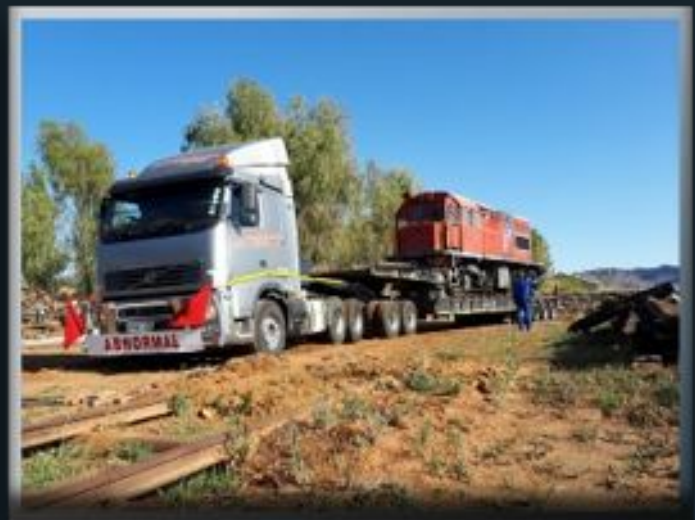
Below right: The class 91 arrived at the offloading area on Sandstone Estates.

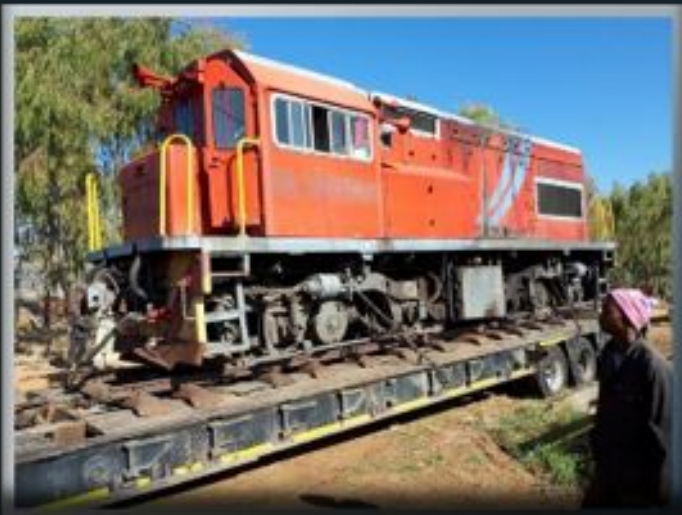
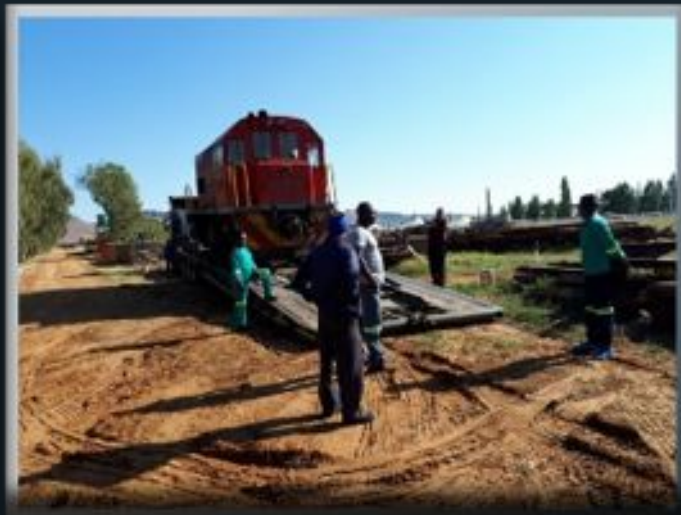
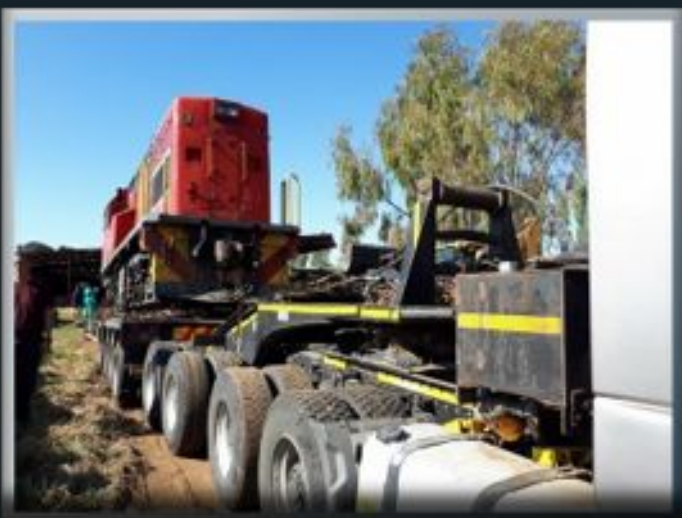
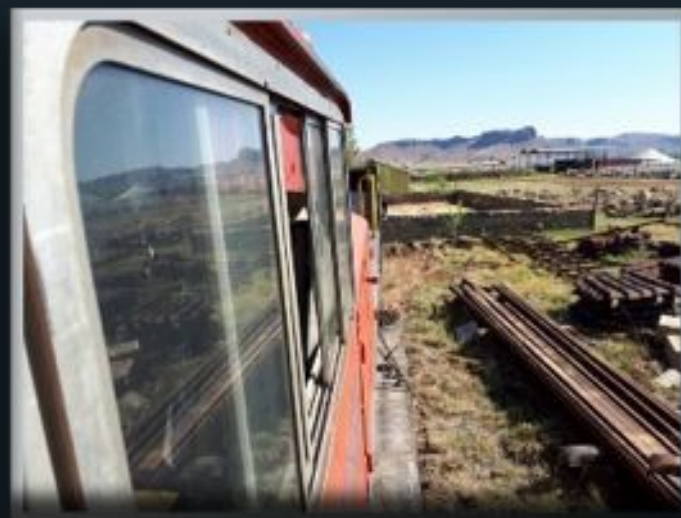
Below: Images of the offloading of 91-04. This 91 class is a 3'6" gauge and found a temporary resting place on a 3'6" storage line inside the 150M shed.

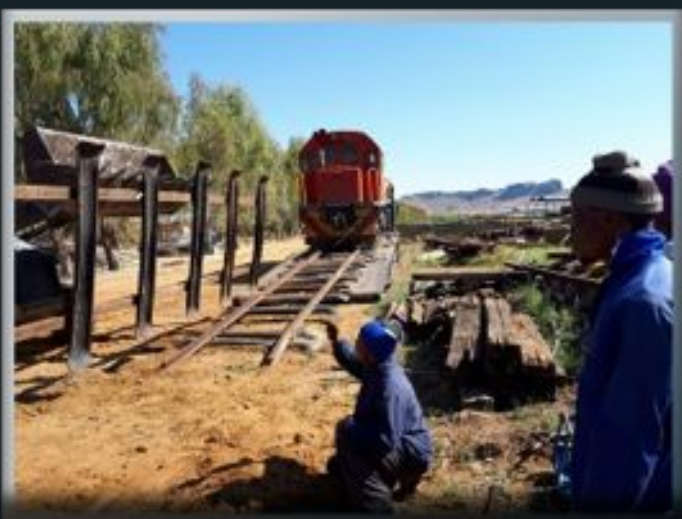
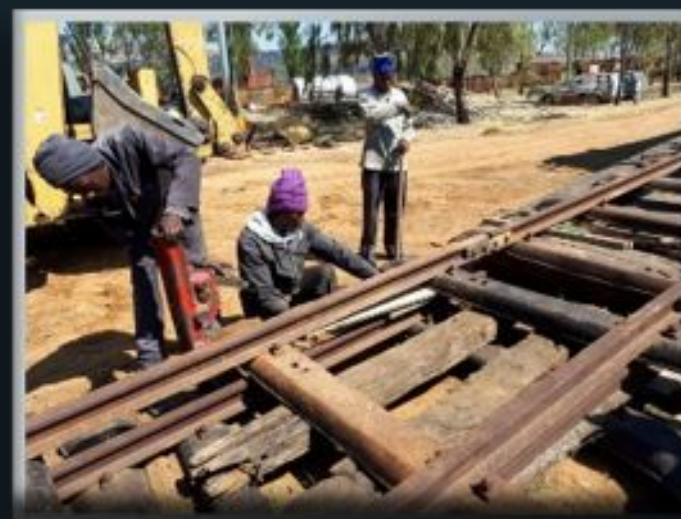
Below: Building a temporary track from the low bed connected to the existing 3'6" line inside the 150M shed.

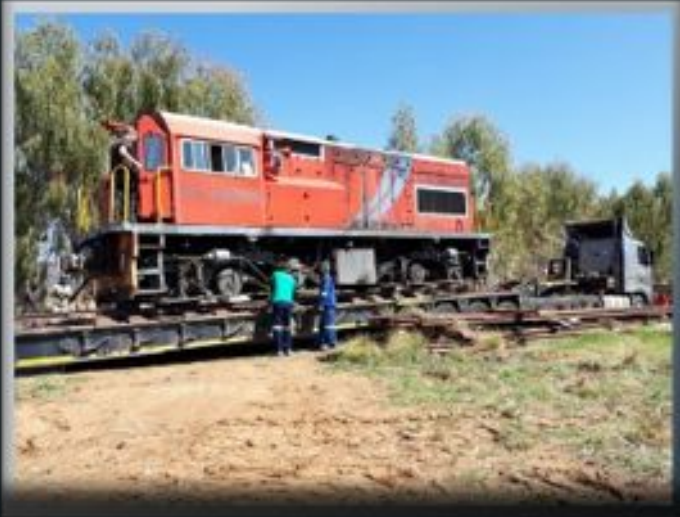
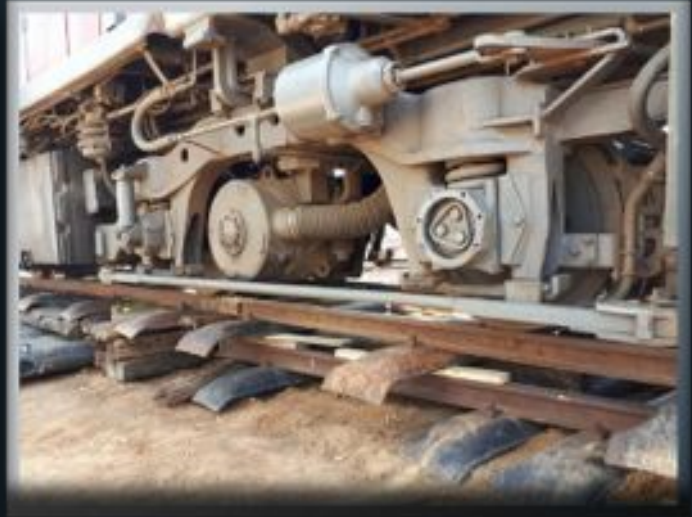
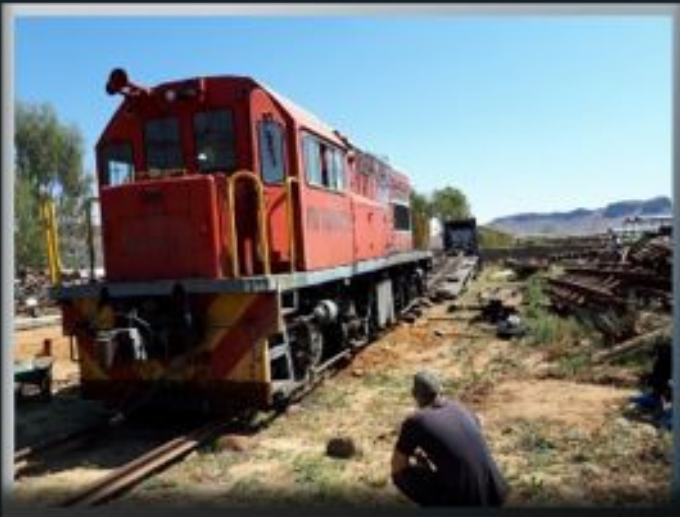
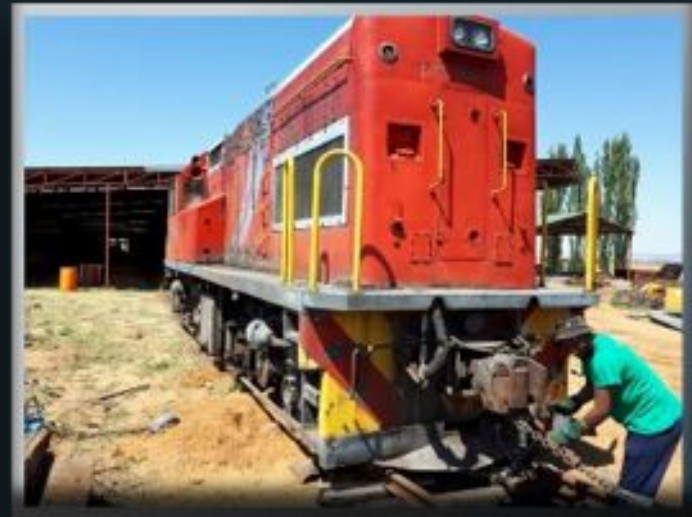
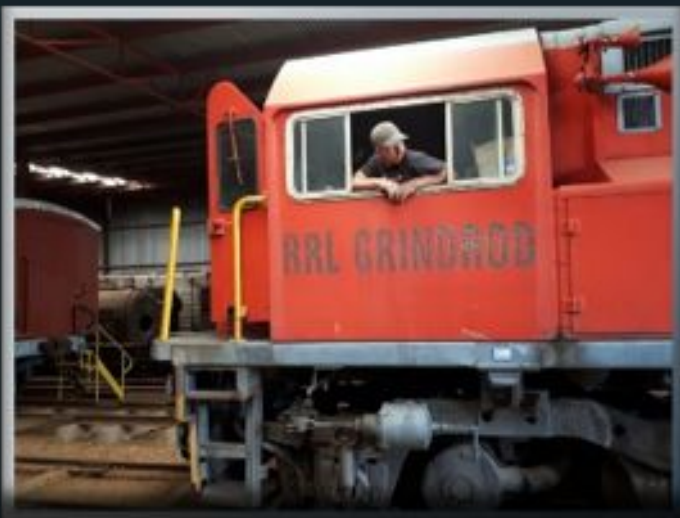
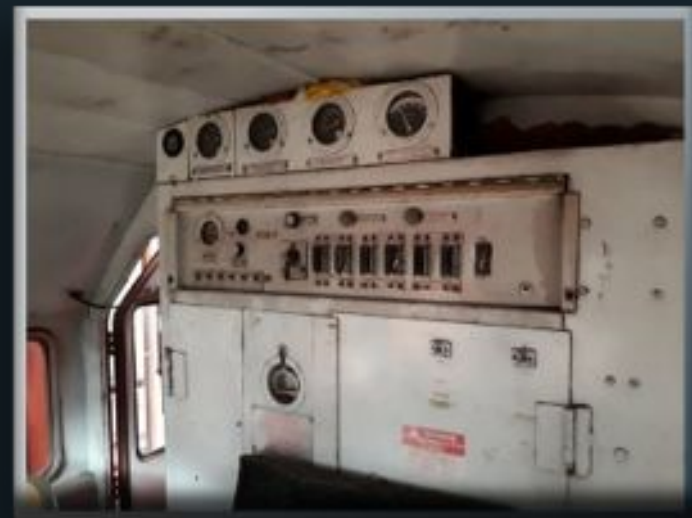
Below: The moment arrived and the 91 Class was rolled down the ramp.

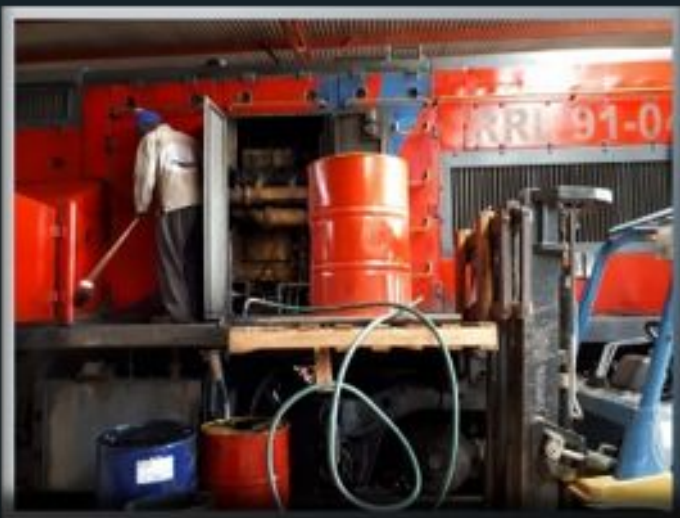
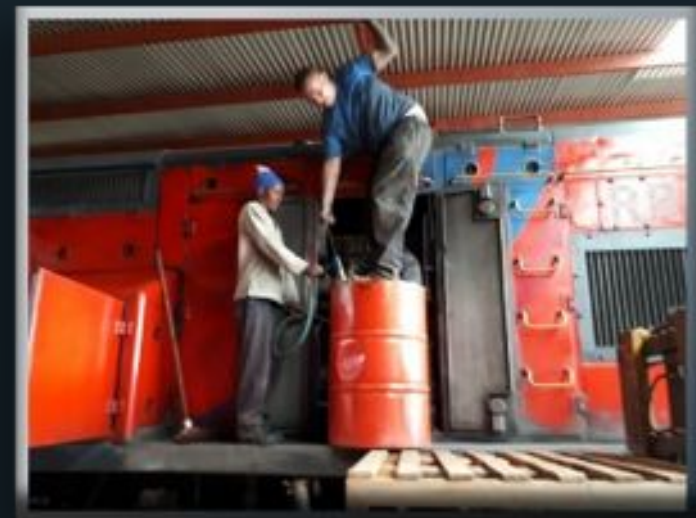
Below: The old oil was drained because of water leak into the sump and old oil was use to fill the engine that needs repair work to the head gasket.

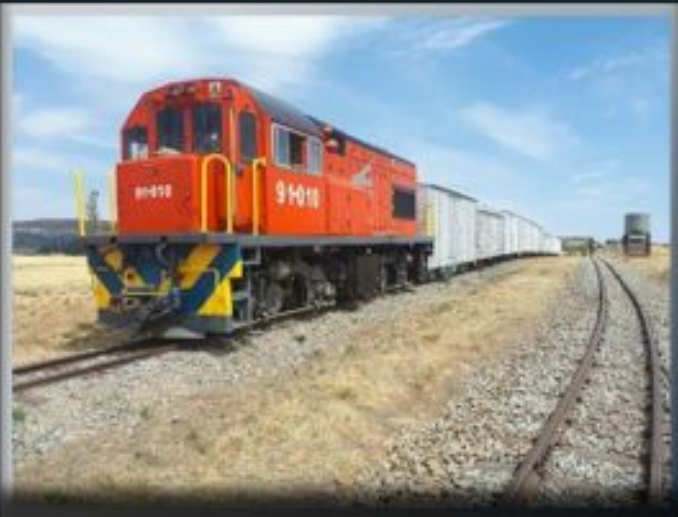
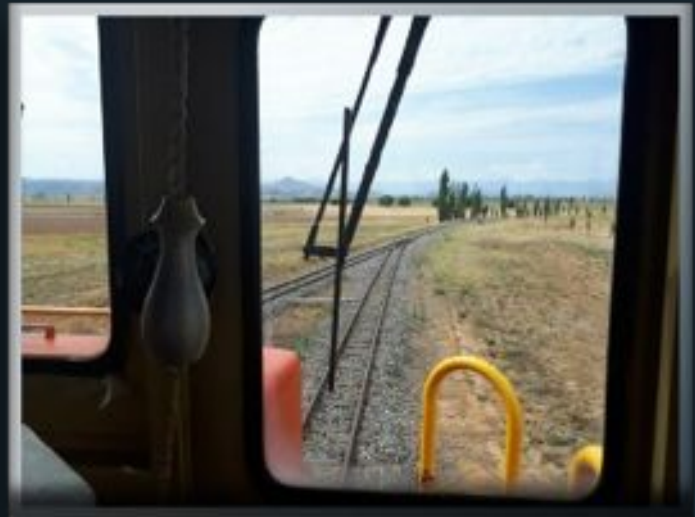
Below: Class 91-010 at Mooihoek siding. The box wagons were shunted back to Hoekfontein Station and then into the 150M shed.

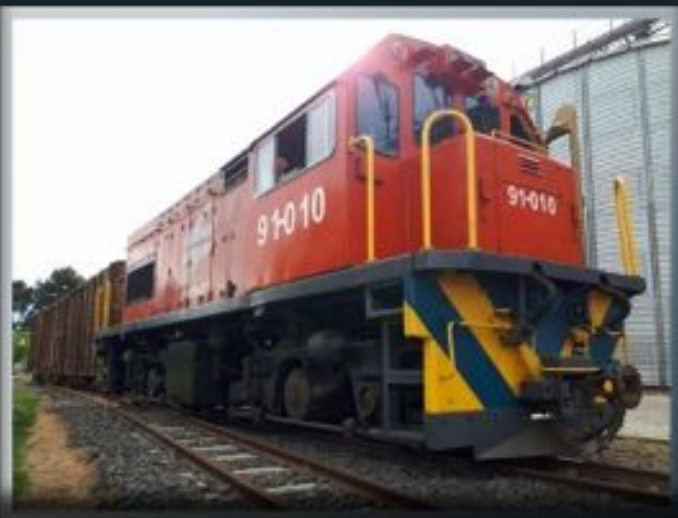
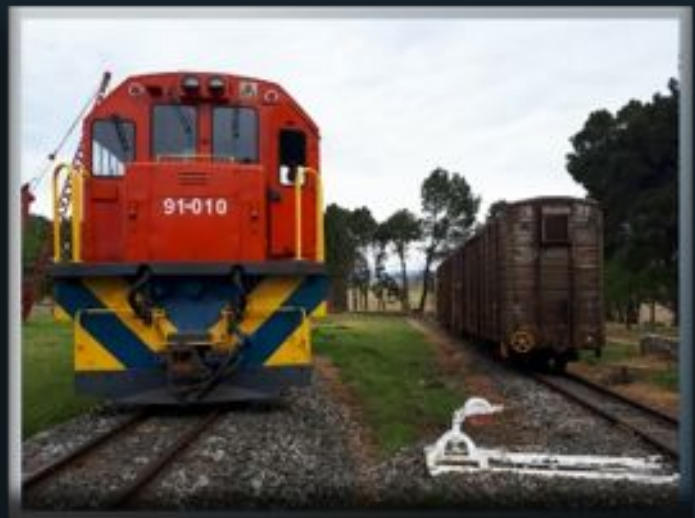
Below: The same day, 91-010 was used to do a reverse shunt to get 3991 to the steam shed for restoration.

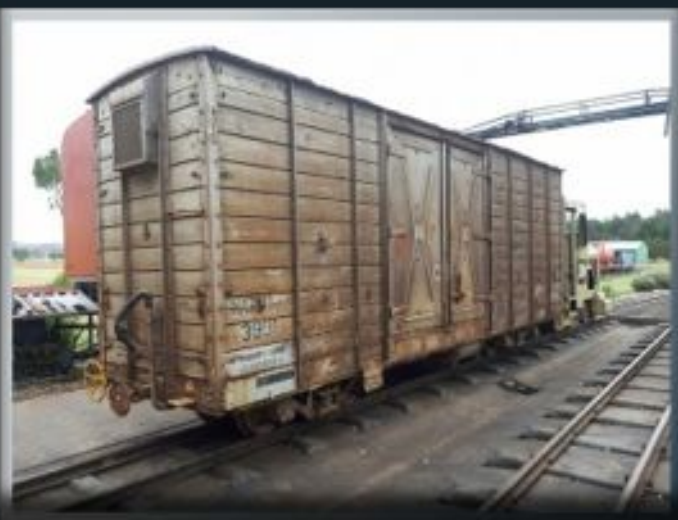
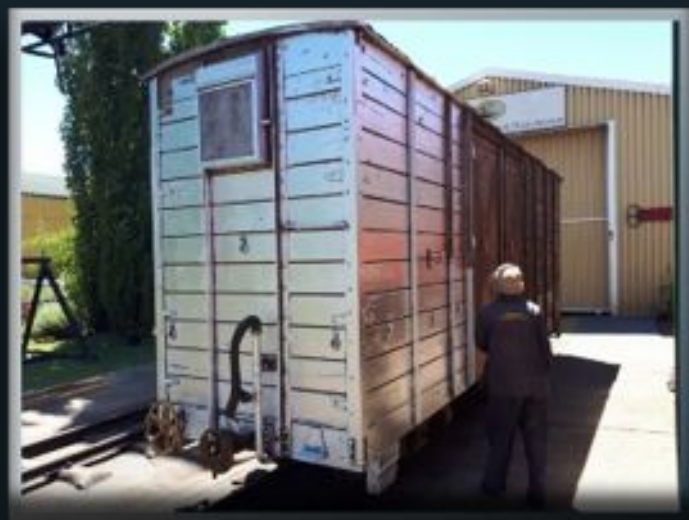
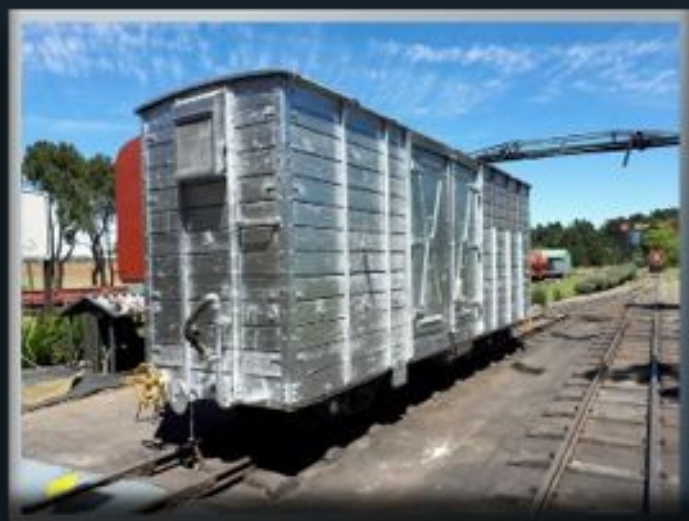
O wagon number 3991 was shunted to the shed, the brakes were tested and the vacuum system found in excellent Condition, a very easy restoration for our team. Brian painted the wagon silver again.

Wouter will now service the handbrakes and change the couplers to the normal bell type. The wagon will also be fitted with new chamber and vacuum hoses with couplers and washers.

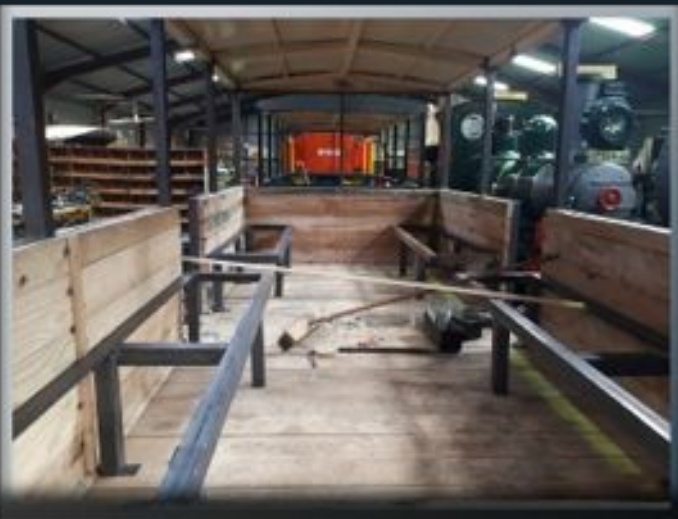
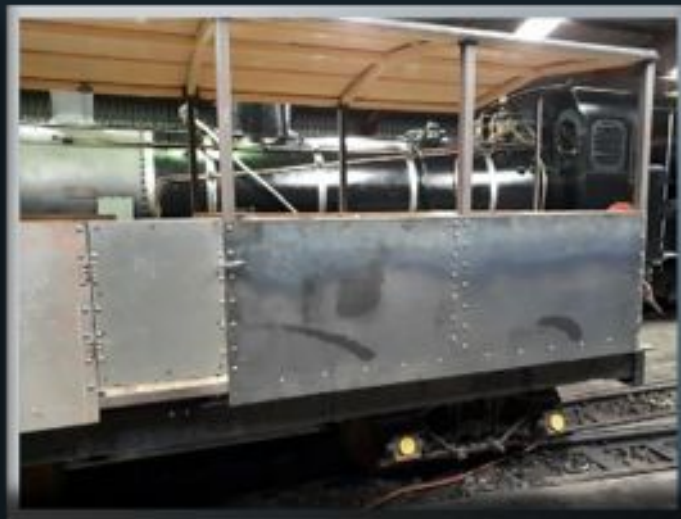
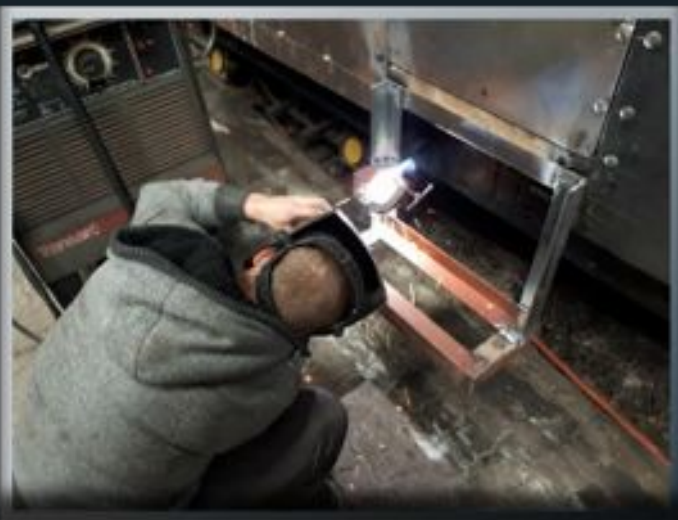
The restoration of the Little Bess coaches are still in progress in between all the other tasks we have. During the last Week or so Thinus made the one side door and the steps. He also fitted the steel frames for the seats.

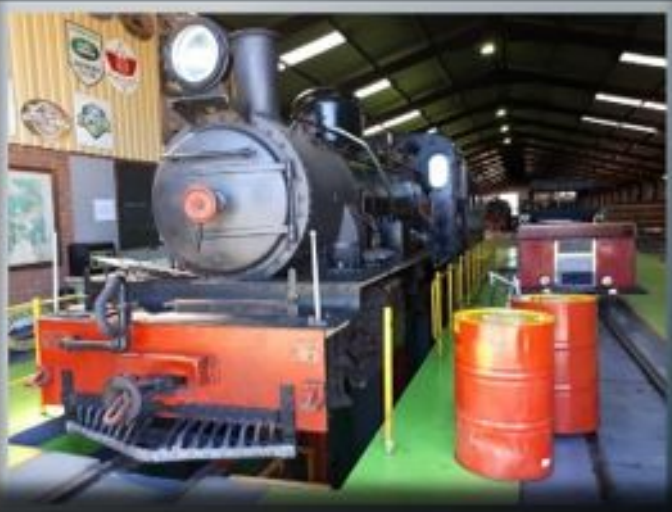
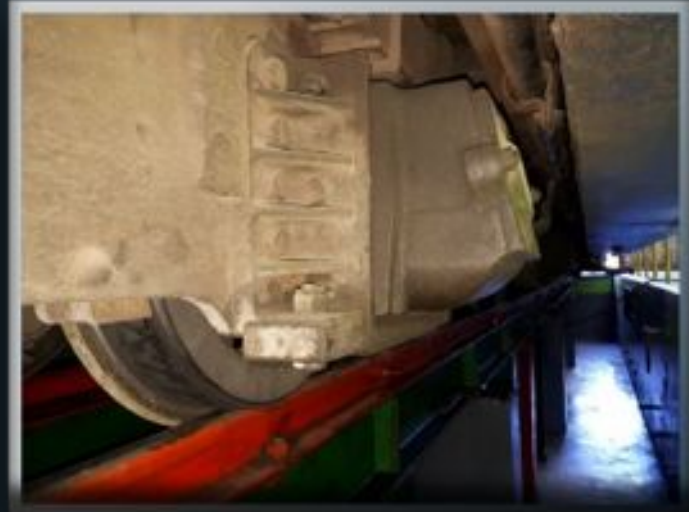
Our Class NG 15 number 17 was shunted to the inspection pit last week. The wheels were inspected and we Did find that the main locomotive frame is laying on the front pony frame. This is very dangerous as the front Pony wheel is the steering wheel of the locomotive.

We then decided to split the tender from the locomotive to enable us to do the necessary repair on the NG 15 to free The pony frame from the main frame.

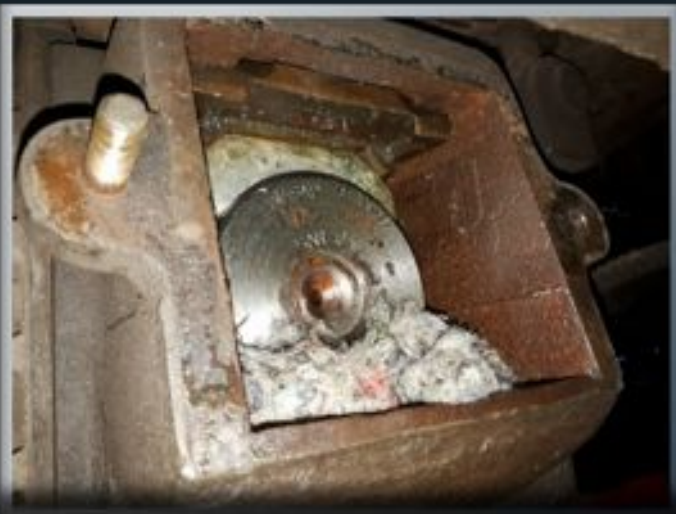
The tender axle boxes were inspected and all the old wool was removed.  
Below right: Showing the locomotive frame riding on top of the pony wheel frame.

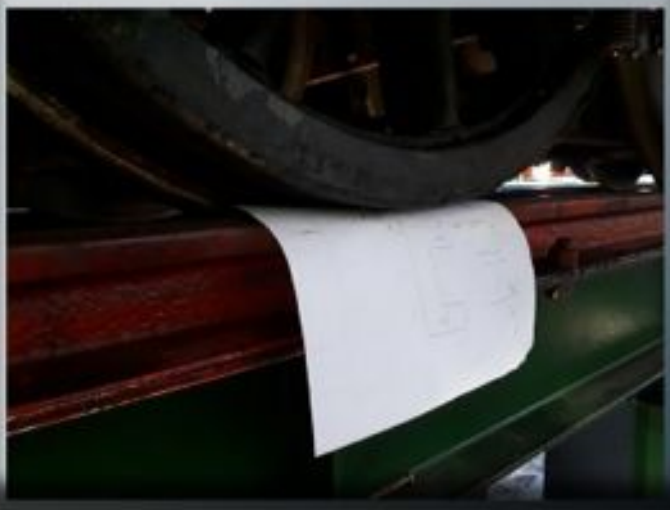
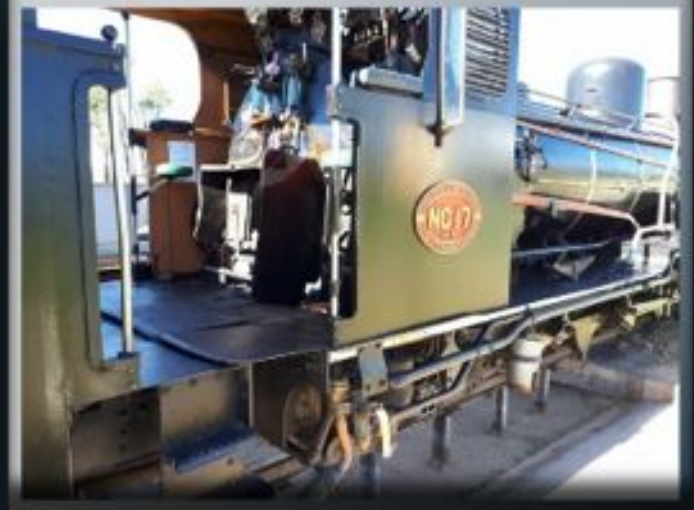
The left side of the locomotive driver wheels have some degree of hollow wear while the right side had no hollow wear, the weight of this locomotive was mostly on the left side with very little weight on the drivers on the right side. The paper below could be moved through under the right side wheels.

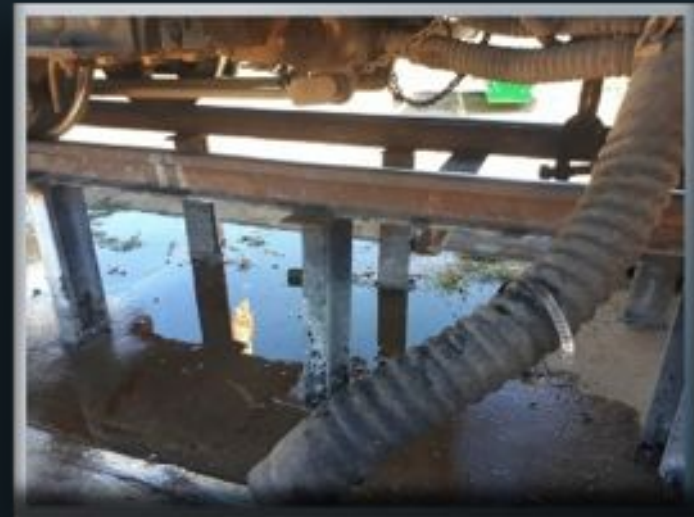
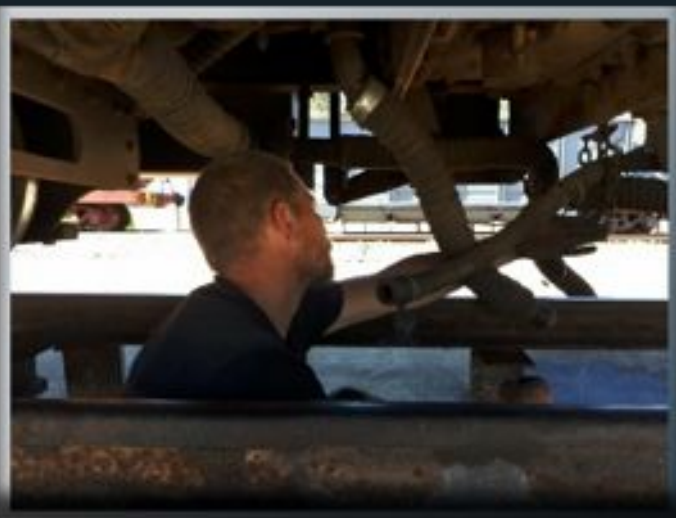
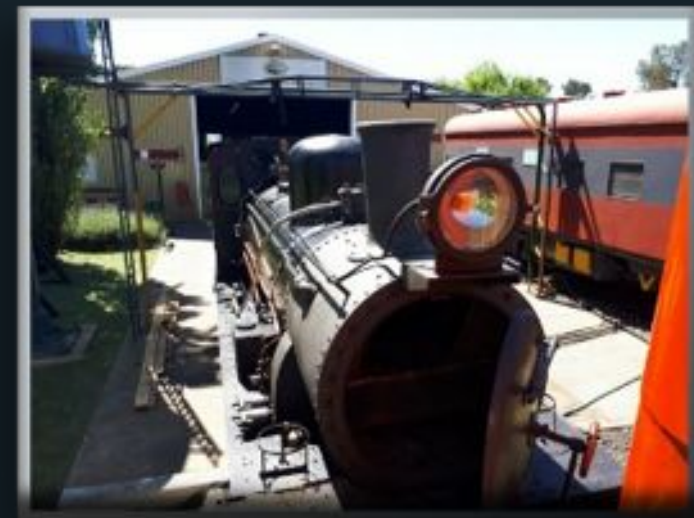
Below: Images of the tender being split from the locomotive.

The tender then was shunted back to the inspection pit for general maintenance and possible lifting from the bogies. New axle box wool is being prepared and the axle boxes will be packed within a day or 2.

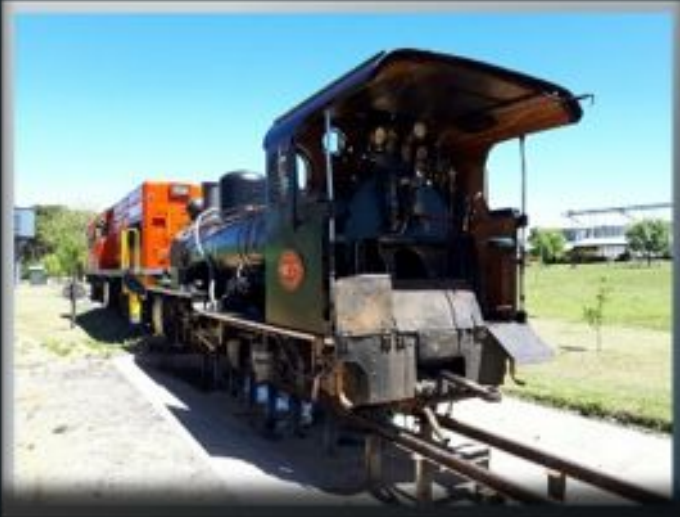
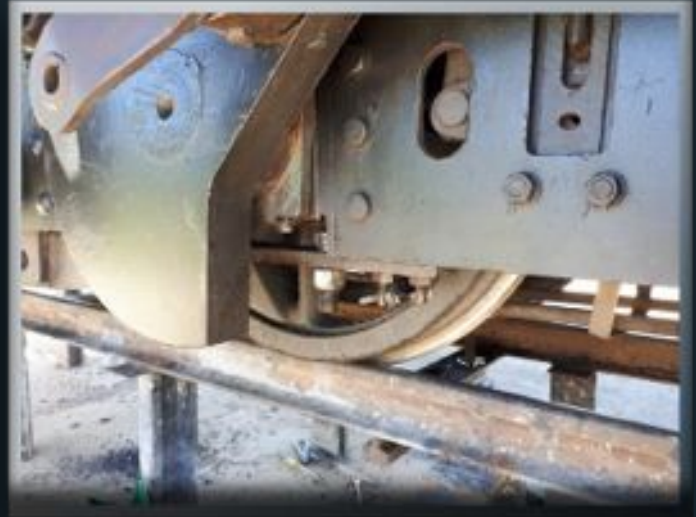
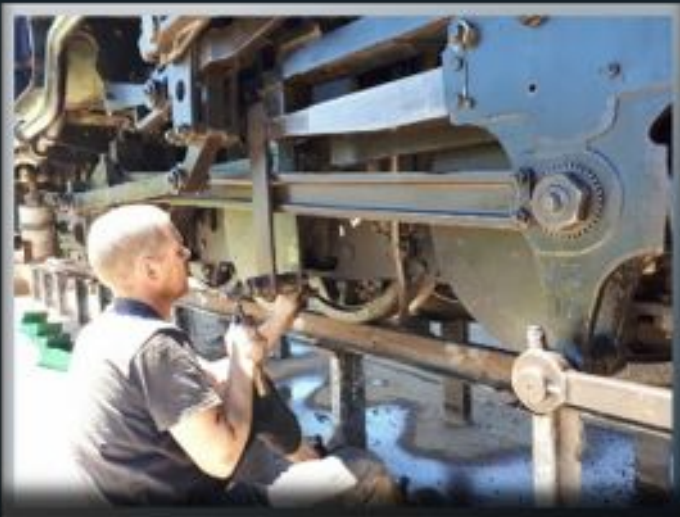
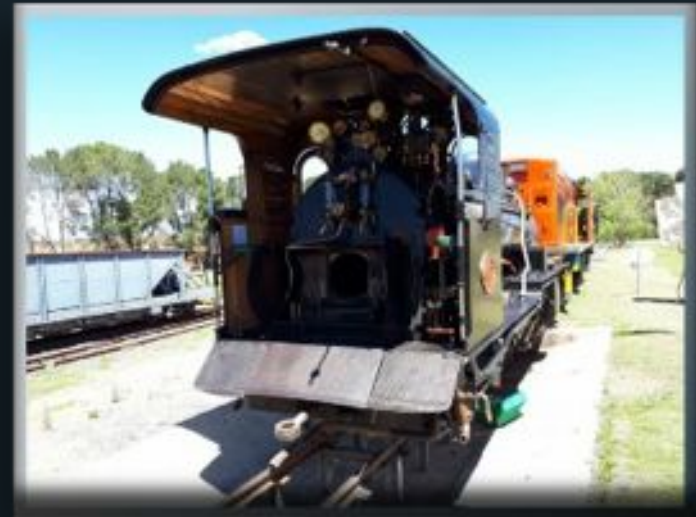
The next step was to loosen all the locomotive wedges so that the wheels and axle boxes could move down when we jack her.  
We jack her.

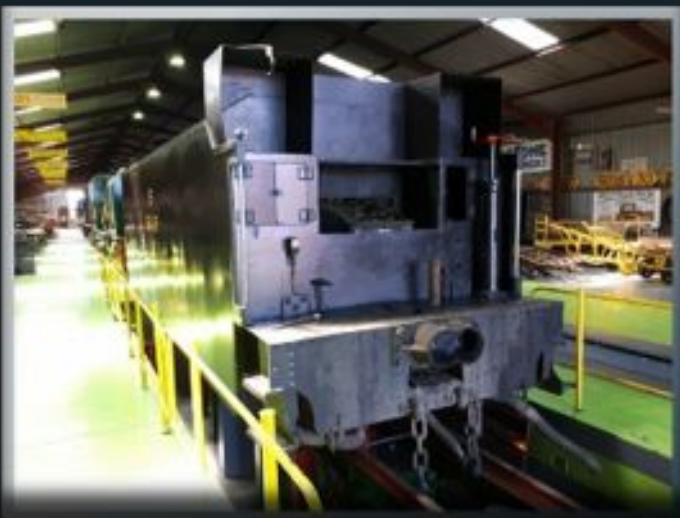
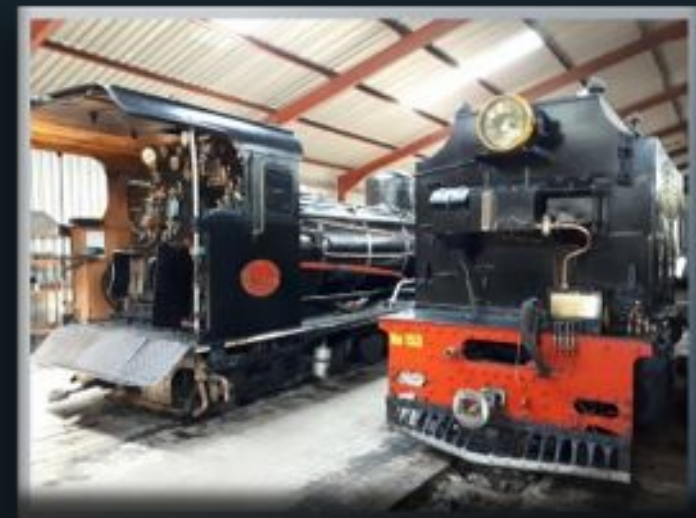
The locomotive then was shunted to the back of the shed where we could lift her to take the weight off the springs.

The pony and the bissel wheels on the right side are carrying all the weight while the driver wheels on the right side  
Hardly carried any weight, this is also the reason why the locomotive was slipping so much.

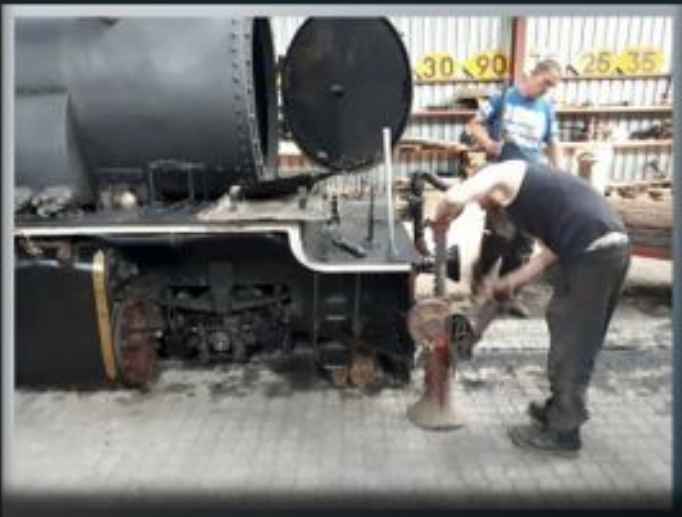
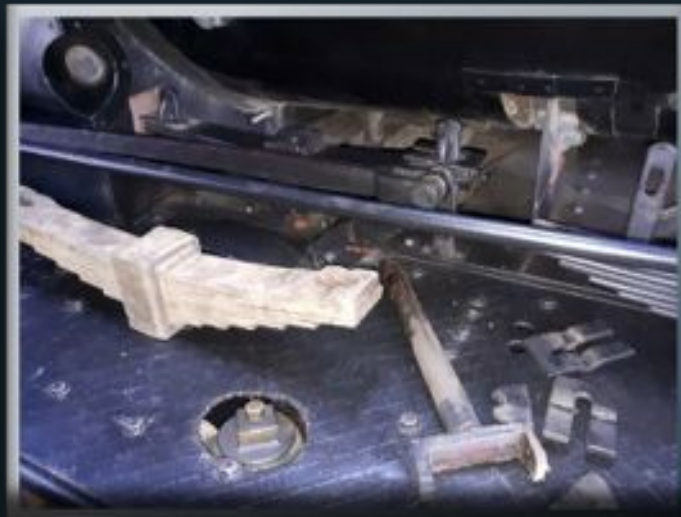
We then jacked the NG 15 and it was very interesting because we hardly took the weight off the right rear side and All the springs on the right side fell loose without jacking the front part of the locomotive.

Thinus is making spring spacers and will fit and test them before Friday this week.

Below: A new spring was fitted on the right side of the pony wheels.
