## Highlights of the Month!

# 150 M Shed

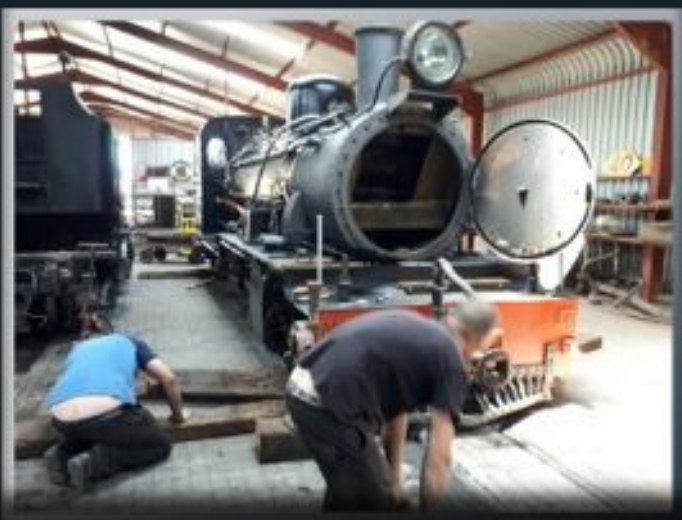
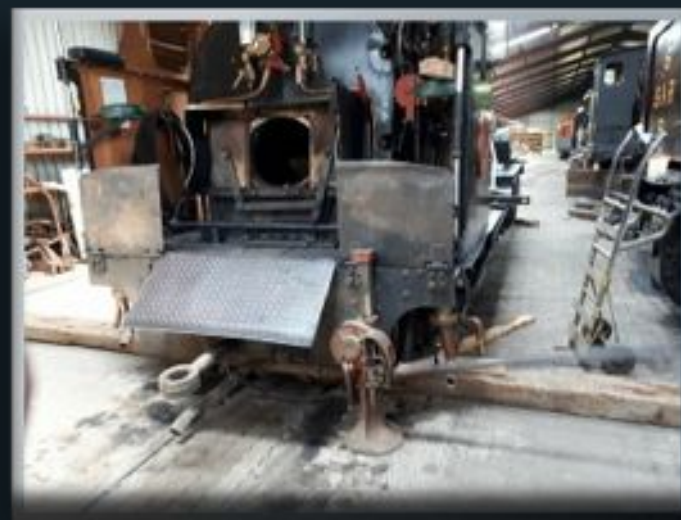
We then jacked the NG 15 and it was very interesting because we hardly took the weight off the right rear side and All the springs on the right side fell loose without jacking the front part of the locomotive.

Thinus is making spring spacers and will fit and test them before Friday this week.

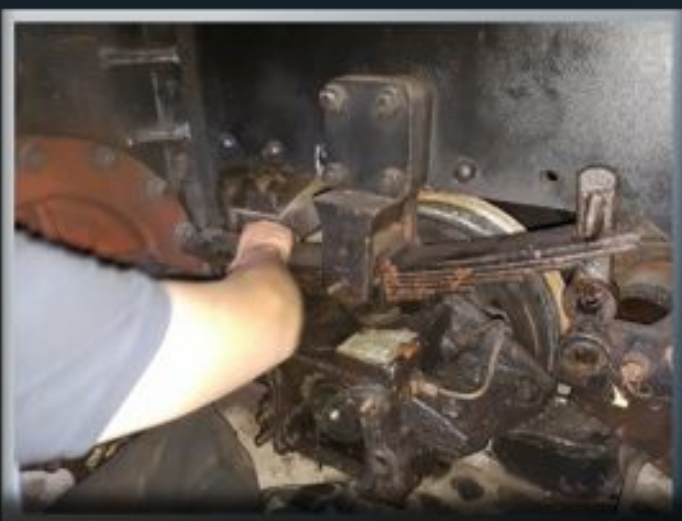
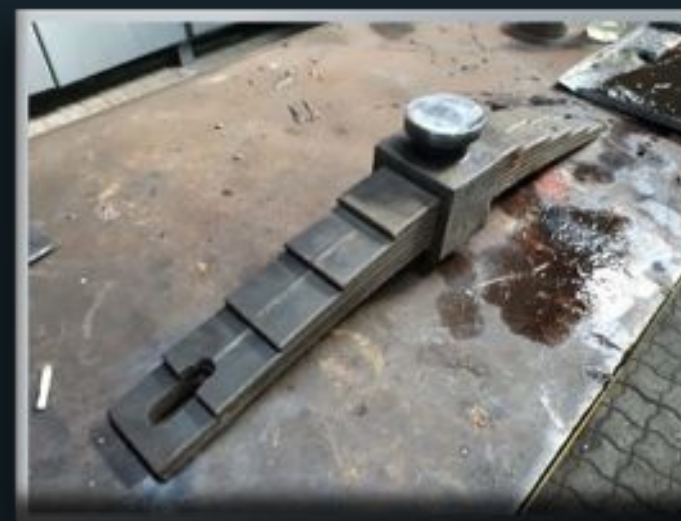
Below: A new spring was fitted on the right side of the pony wheels.

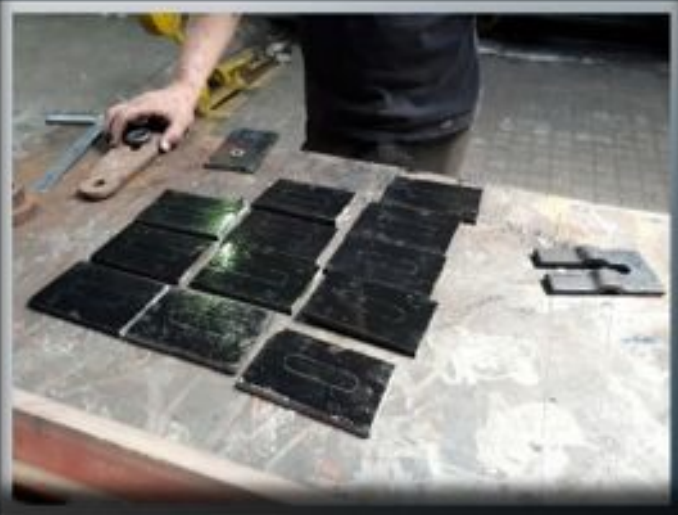
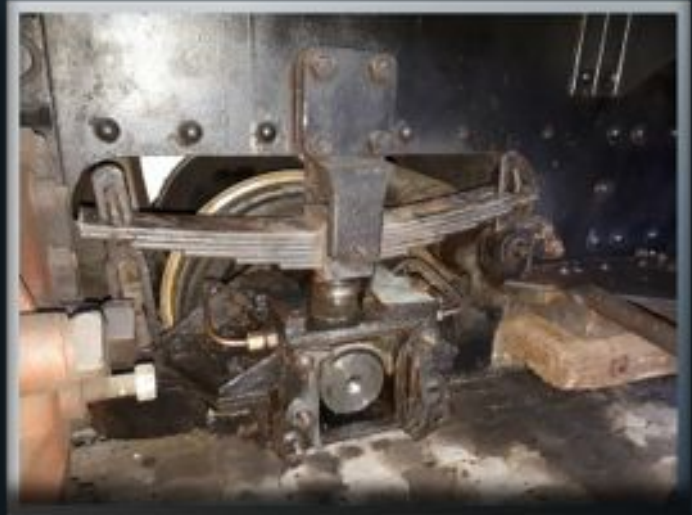
Below right: The new spring in place.

In the next report we will know if the spring spacing works, if not then we will have to send the springs for re tensioning or maybe use spares from another Ng 15.

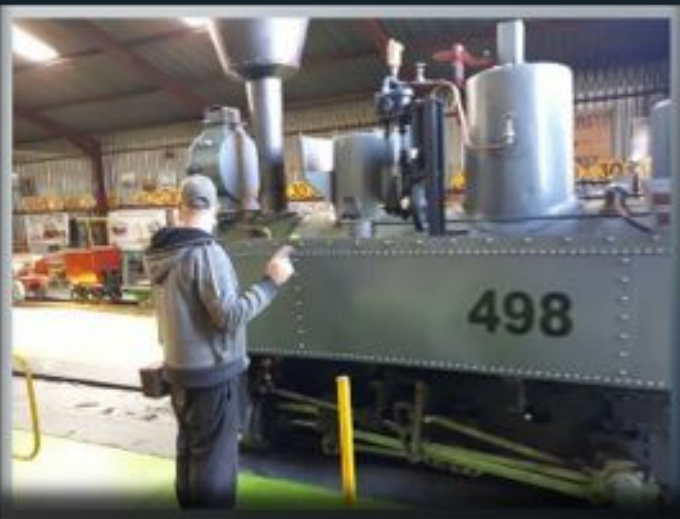
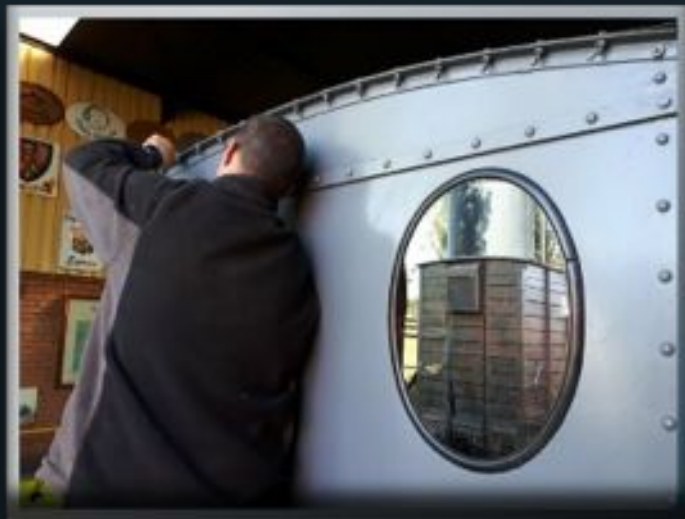
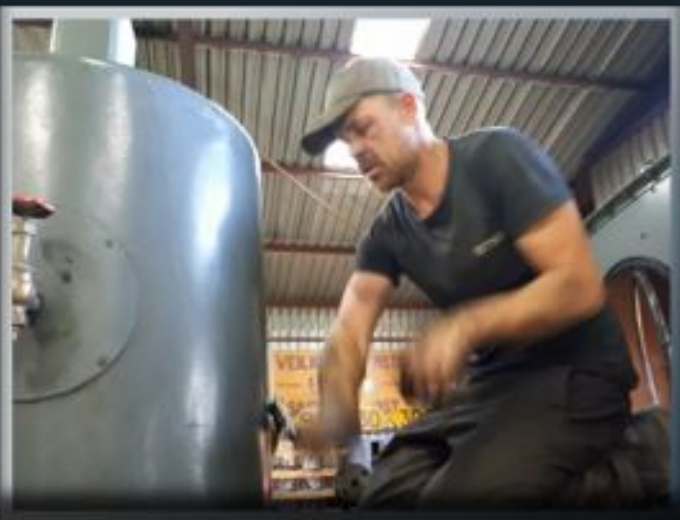
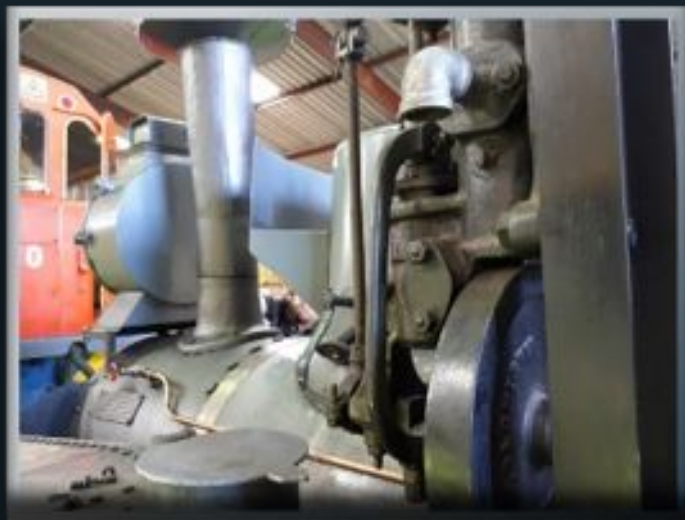
The Feldbahn needs boiler repairs by Stevens Mechanical and we have shunted her to the shed to strip and remove the Boiler.

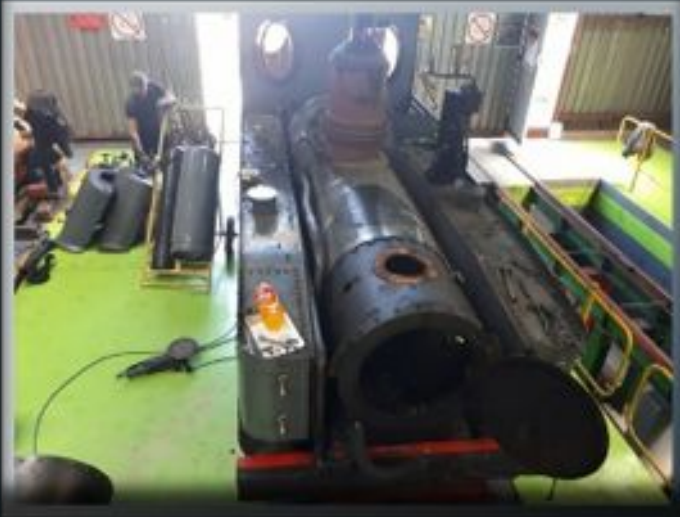
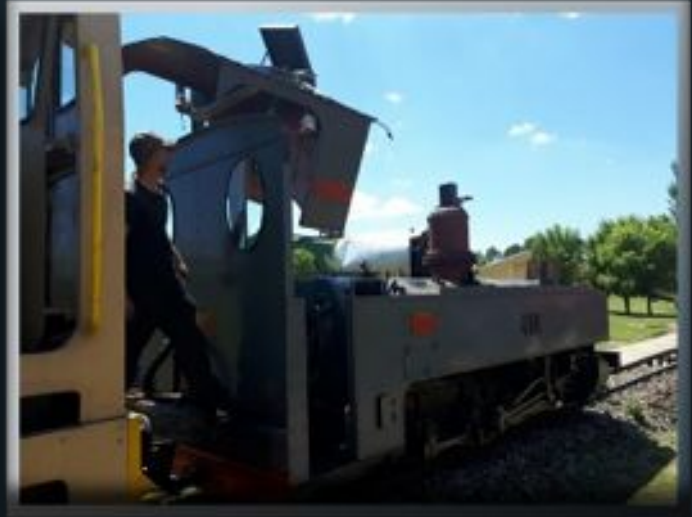
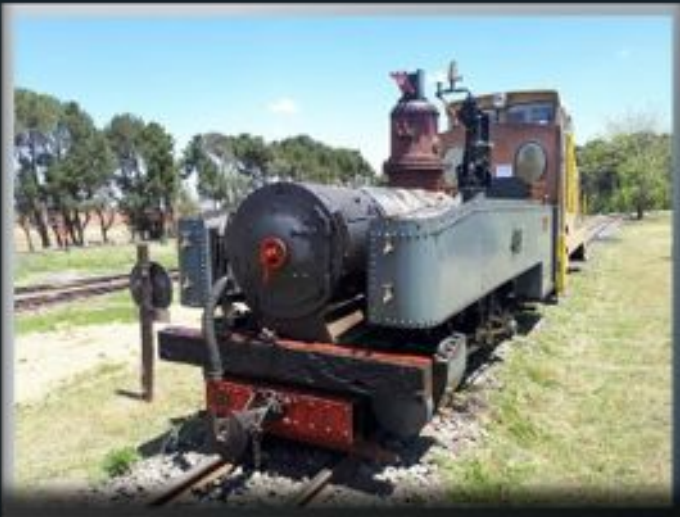
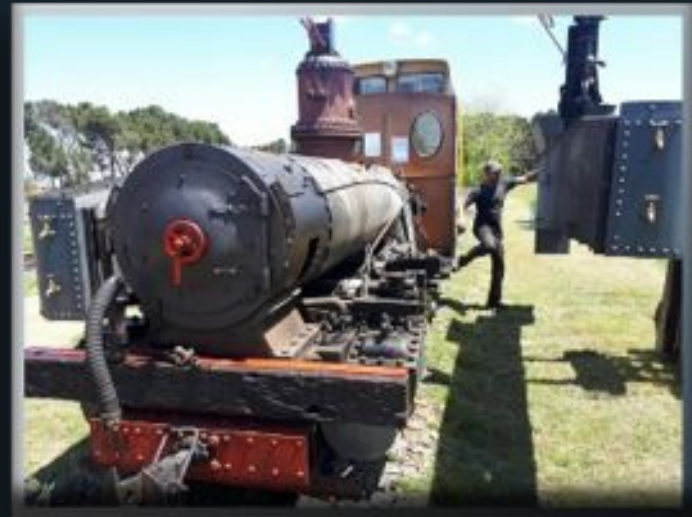
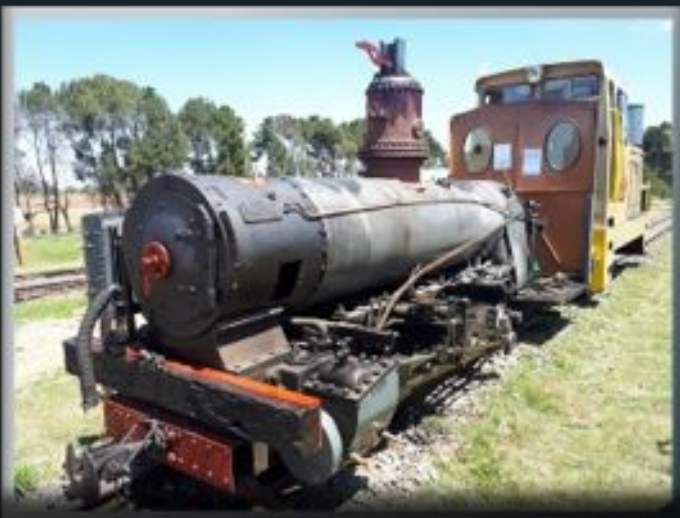
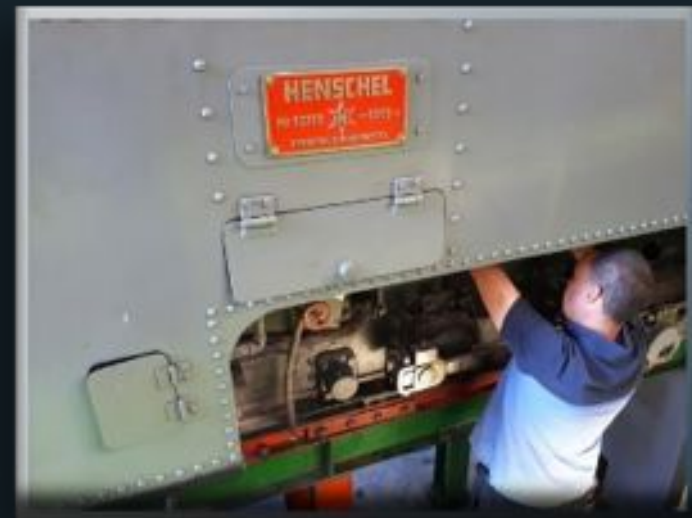
Below: Images of the stripping and removing of the Feldbahn boiler.

The cladding was removed and the boiler is now ready to be delivered to Keith Stevens for repair.

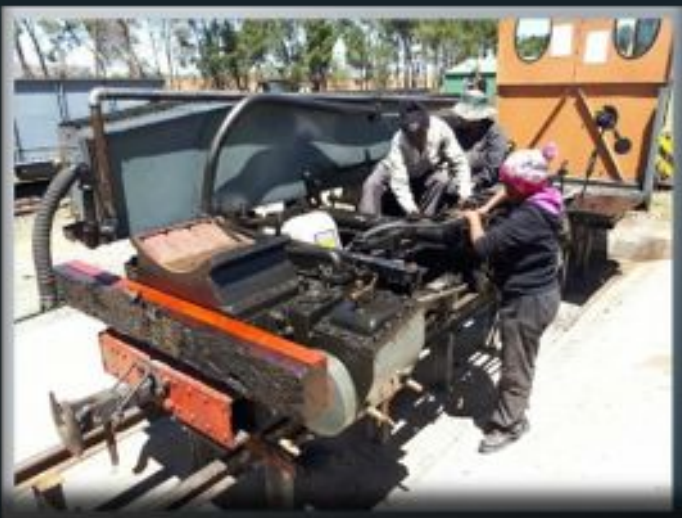
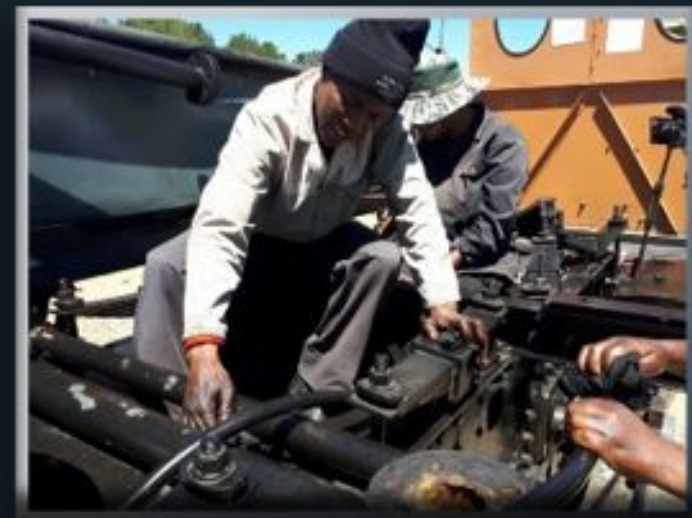
Below: Our cleaning team then cleaned the little Feldbahn and she will be stabled till her boiler returns.
