# Steam News From The Eastern Free State

# LOCOMOTIVE NEWS

## CLASS NG 15 Number 17

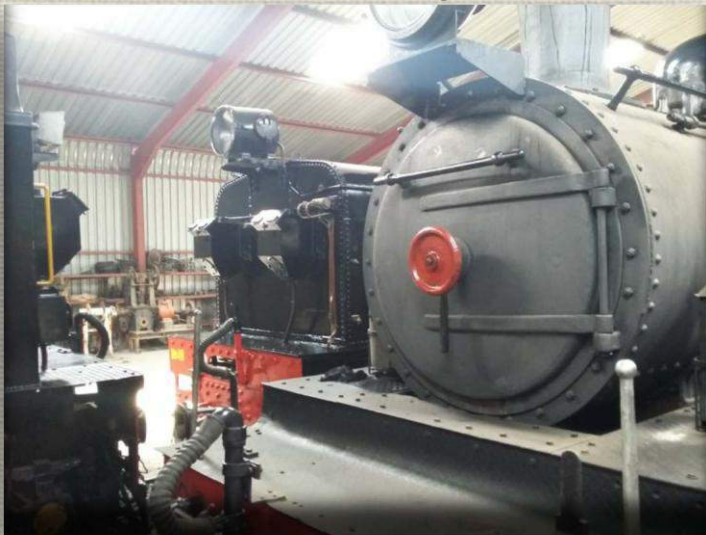
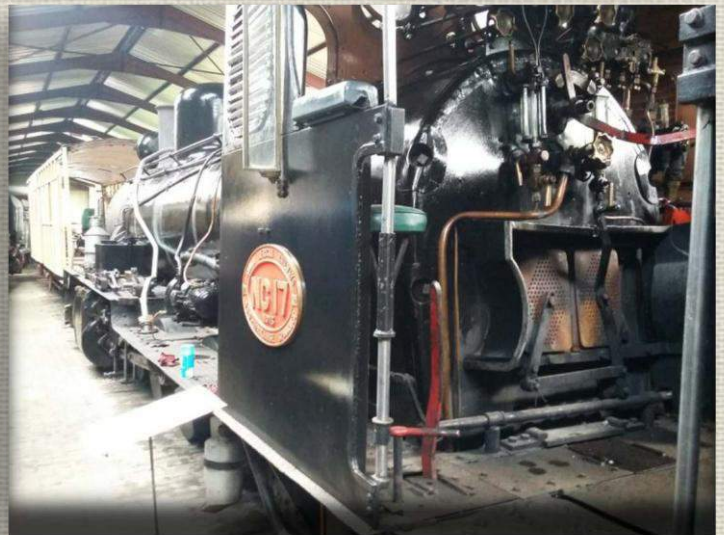
Our NG 15 Number 17 is due for more heavy repairs and the side and connecting rods  
Are being removed and new bushes will be machined

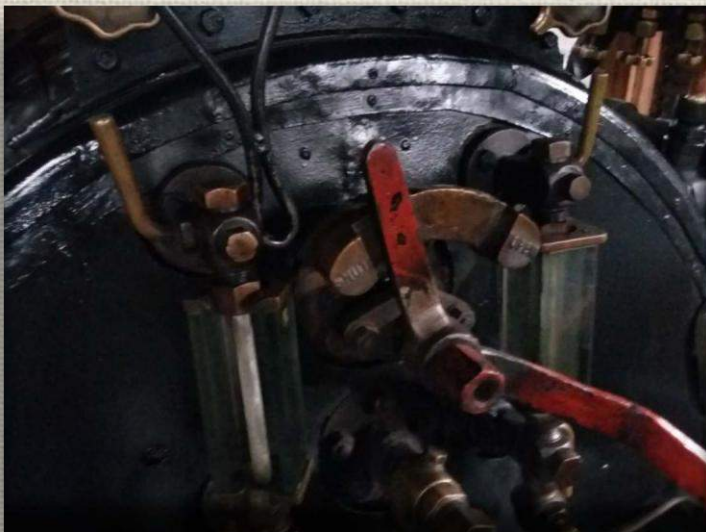
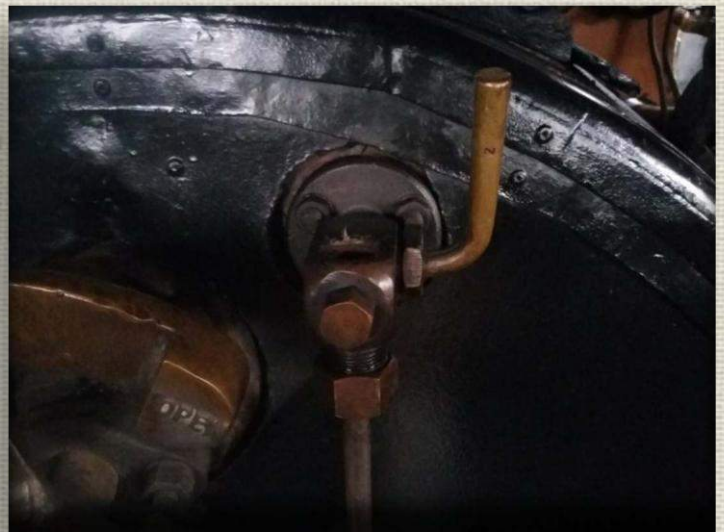
While this is scheduled we decided to service all the boiler joints. This week the  
Water gauges were removed as well as the regulator gland.

Signs of leaking gauge glasses is evident in the pictures.

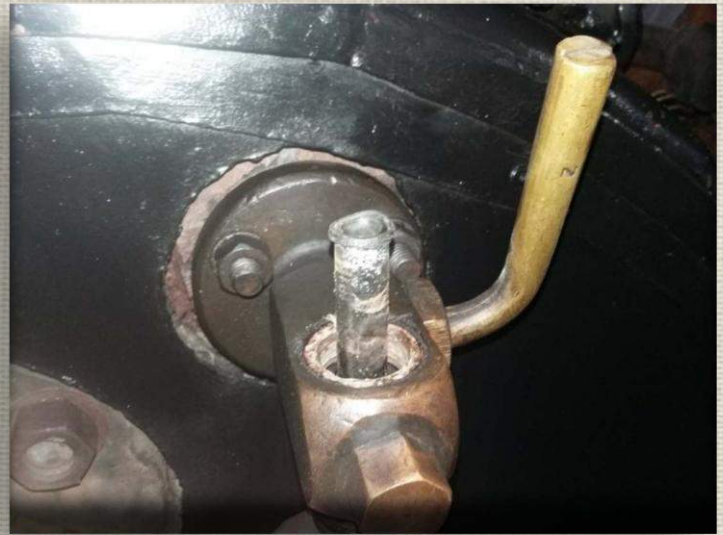
Below left: Gauge glasses removed

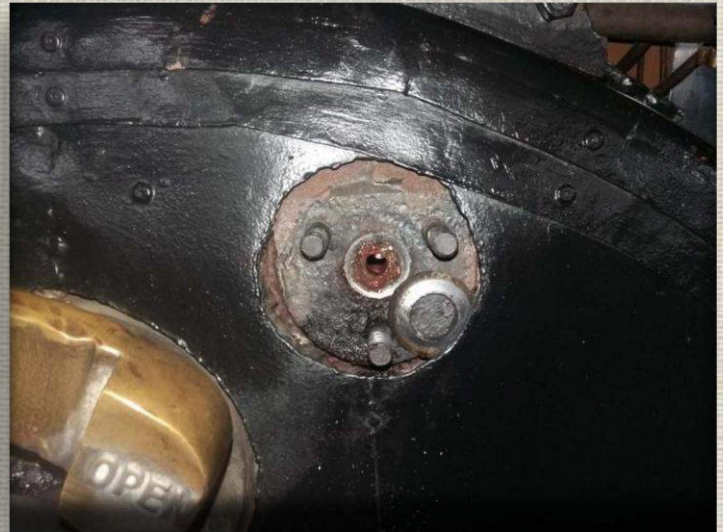
Below right: Steam port

All these corks were opened and old hardened asbestos packing were removed

This is the perfect time to inspect steam and water ports into the boiler and it is very important that these ports must be open and clean for accurate water level in the boiler. A blocked steam port is very dangerous, it will show more water in the boiler than there is. This is why it is important for crews to test steam and water ports before departure from the shed.

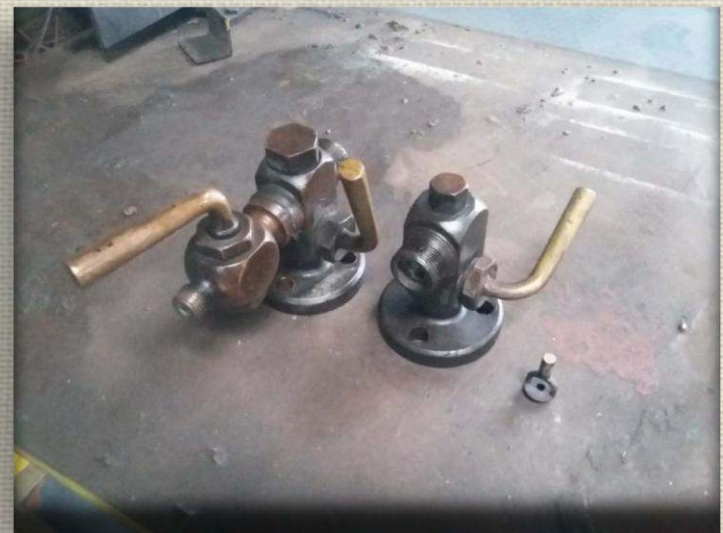
Below Left: Water port on the right side. A special tool will be made to clean the Mud out of these ports. Sometimes it is little things on a Steam Locomotive that Needs the most attention to ensure safe operations

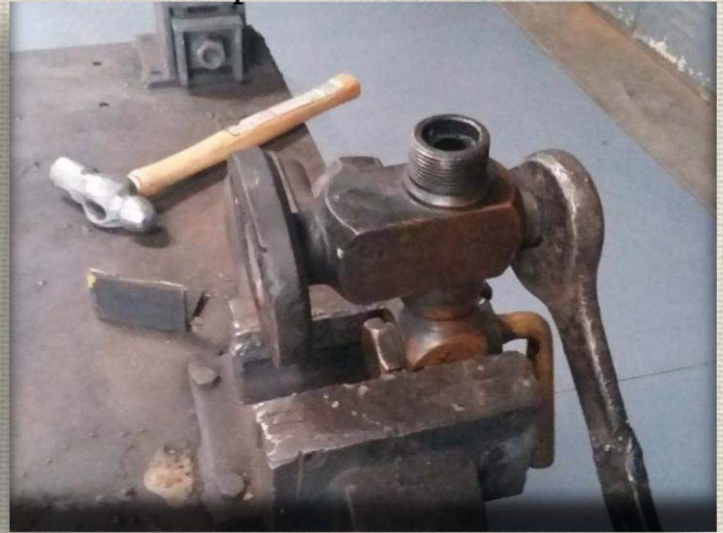
Below: Gauge corks being stripped and old asbestos removed.

Removing the old hardened asbestos is quite a time consuming exercise and special Care taken not to damage these corks. All these corks are now soaked in Diesel to Loosen all the asbestos I could not get out with my needle.

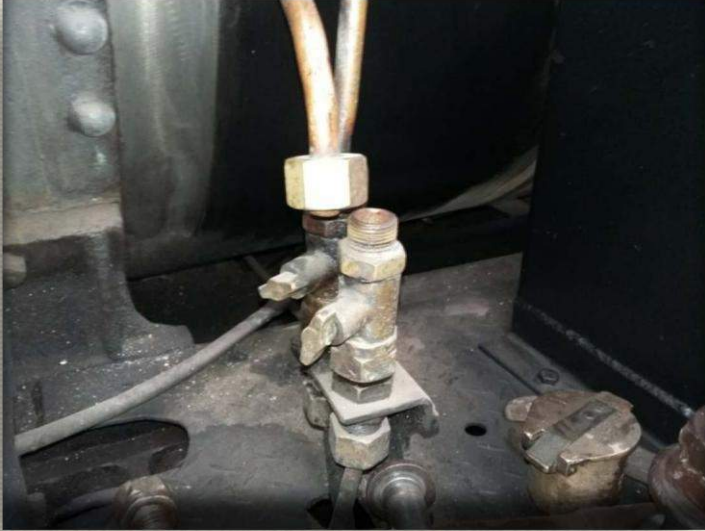
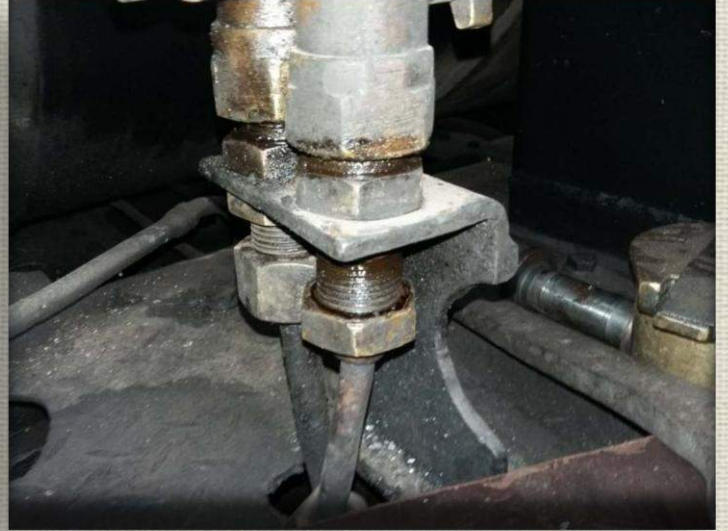
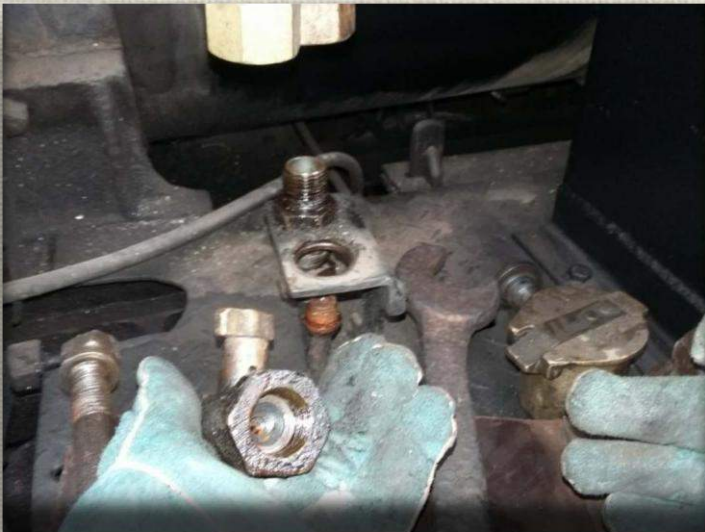
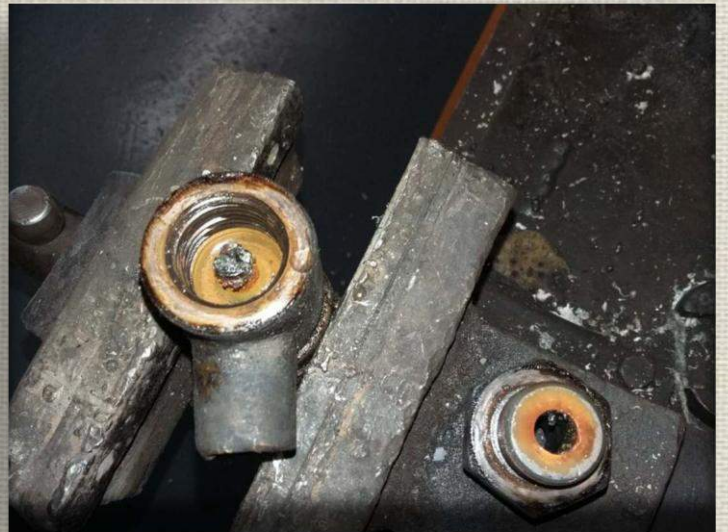
All 4 choke valves were removed from the NG 15 and was stripped to clean the Little choke valves inside but once I had stripped it I found that these valves are Due to retire. These valves are so important and if they are worn out it prevents the oil to Flow into the steam chest and cylinders while the regulator is open and will only feed Oil when the regulator is closed and then it is of no use, we need a constant oil feed To the front end when the regulator is open. Also oil leaks on the oil feed pipes are evident, And this is very serious, lack of oil to the front end will lead to valve and piston ring failure

The choke valves will be renewed and oil leaks repaired.

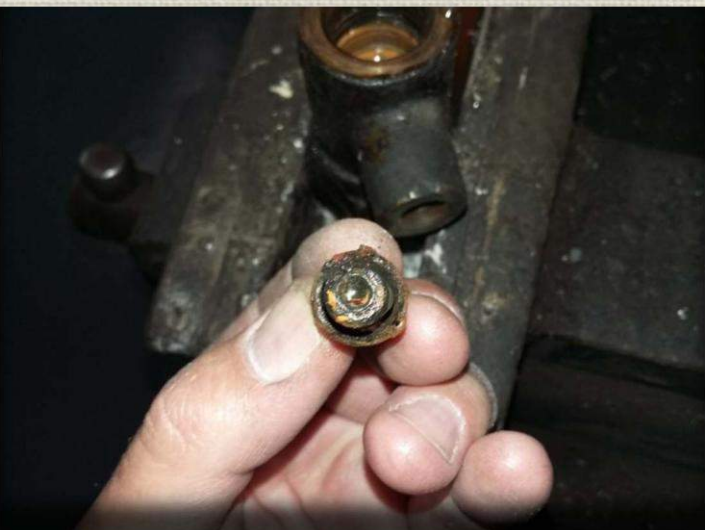
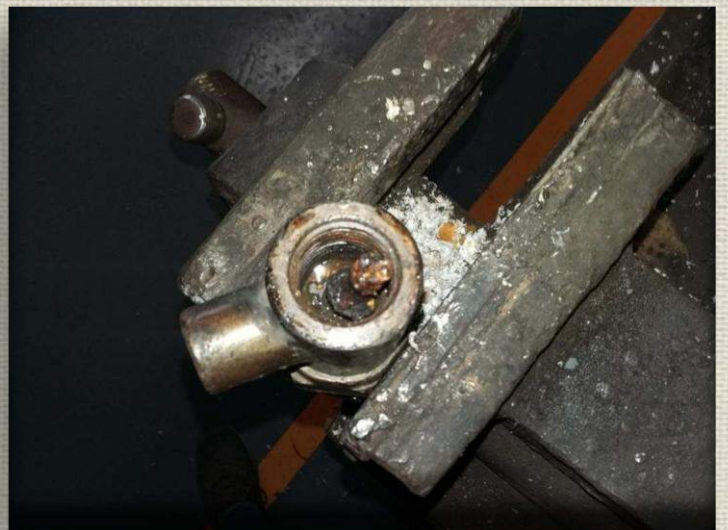
Below: The poor condition of the choke valves.

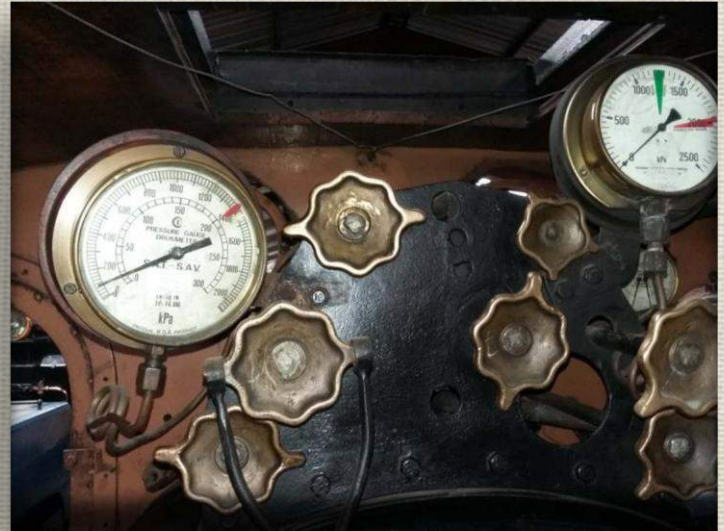
Both Steam gauges were removed as well and both calibrated, cleaned with brasso  
And will be fitted back after our NG 15 is washed out.

Each gauge will receive a unique number and calibration results will be logged.

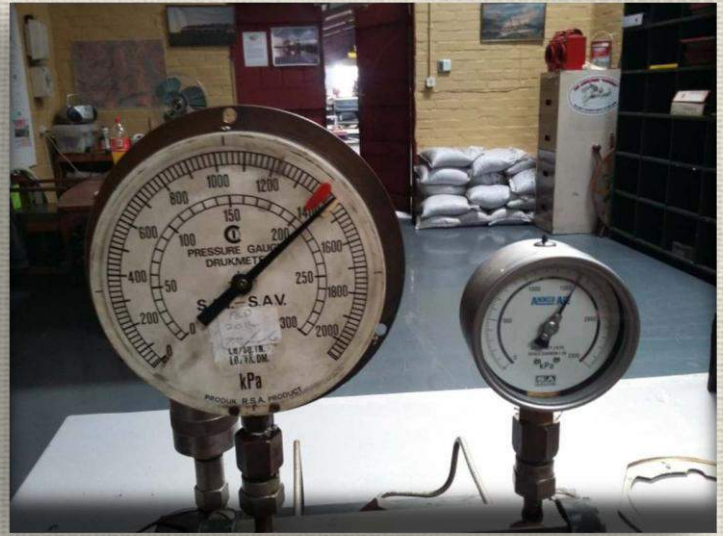
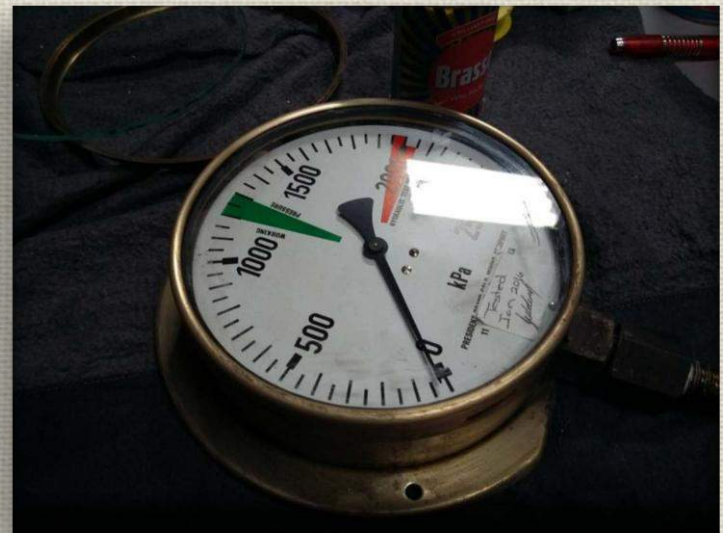
Below: The calibration of the Steam Gauges. The pressure calibrations is done every 100kpa and only by doing it this way it is possible to see that a slight difference at 100kpa Can result in a large difference at 1500 kpa. All these gauges were adjusted to be Correct at all readings.

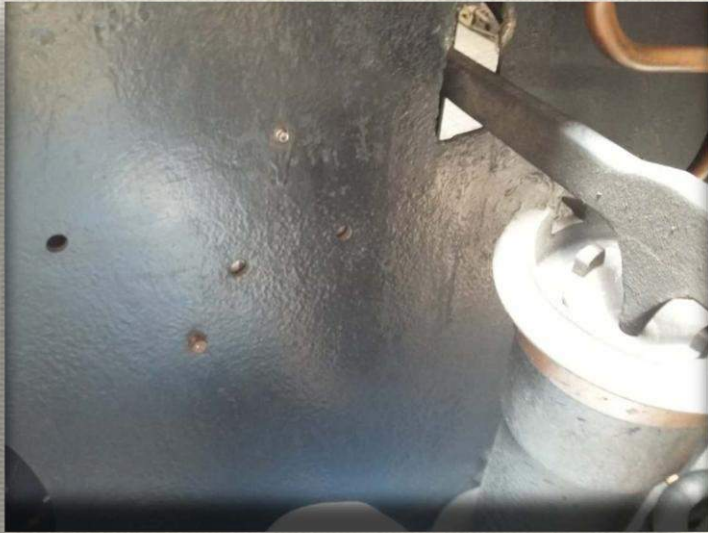
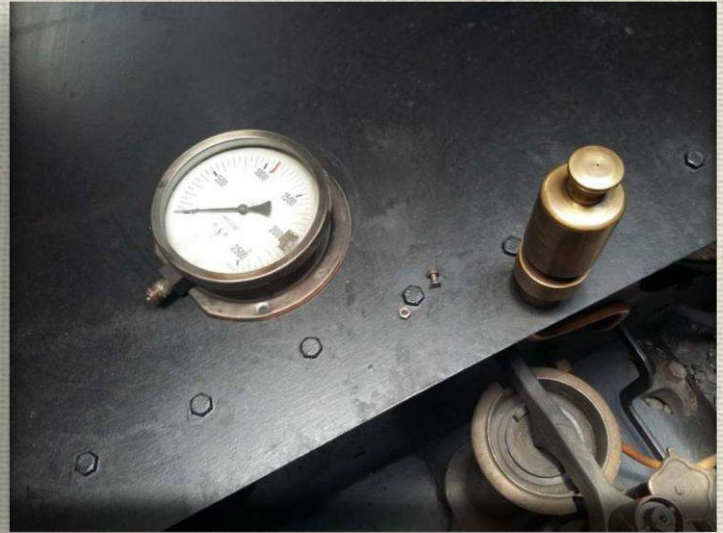
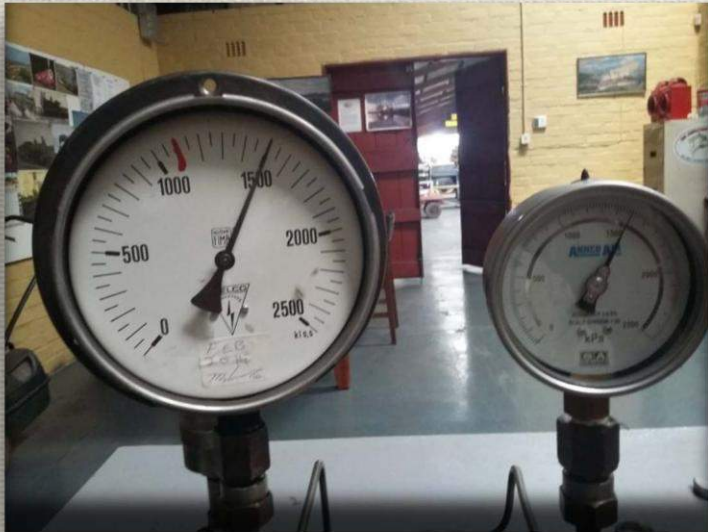
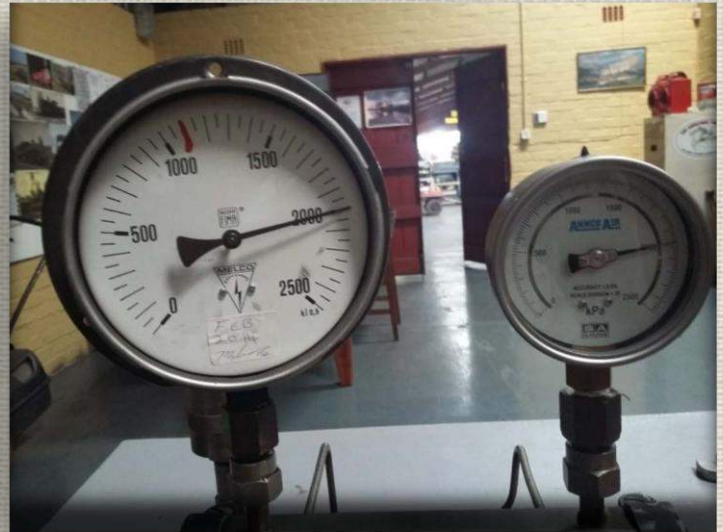
Below: The Steam Pressure Gauge of our NG 4 was also removed and calibrated and cleaned

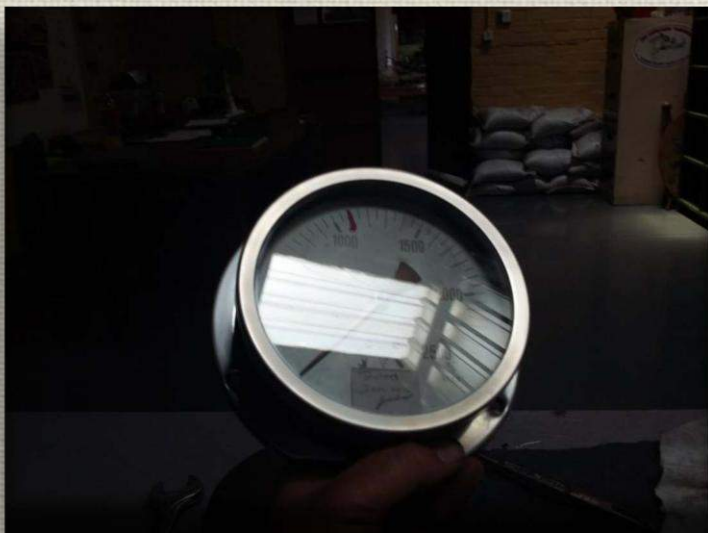
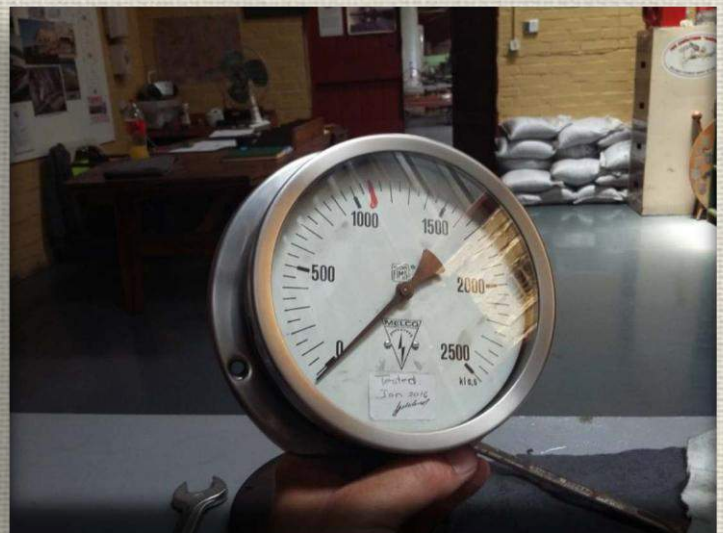
Below: The NG 4 Steam gauge after cleaning and calibration.

Our NG 4 is also due for some heavier repairs to bushes and will undergo the Same treatment as our NG 15.

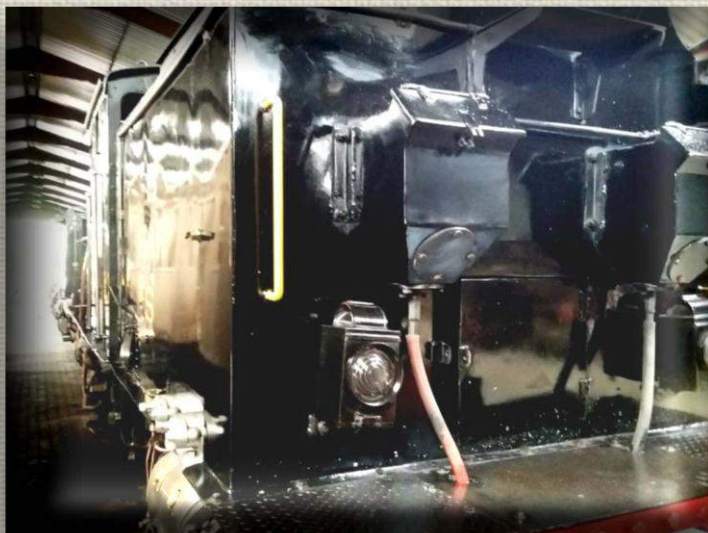
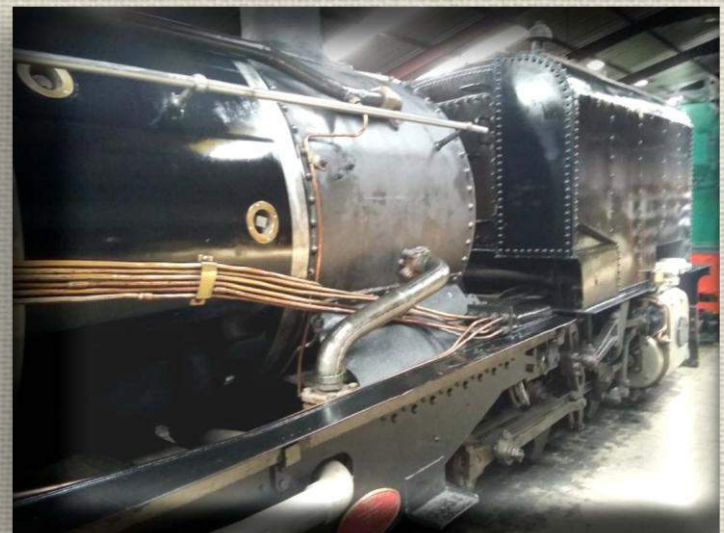
After all the major cleaning up of the Steam and Wagon Shed it was needed to clean our Locomotives Again. This time we attended to the smoke boxes and are treating the smoke boxes with a special mix Of graphite powder with valve oil. This prevents rust and also looks great

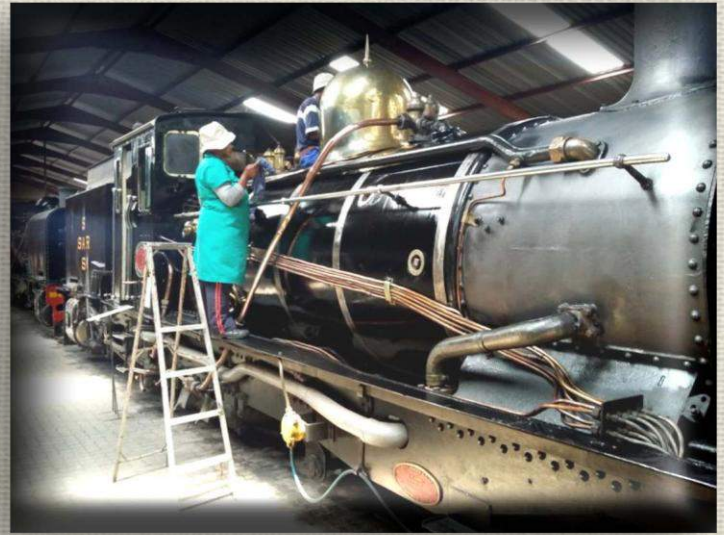
Below Right: The graphite effect of the smoke box of 113.

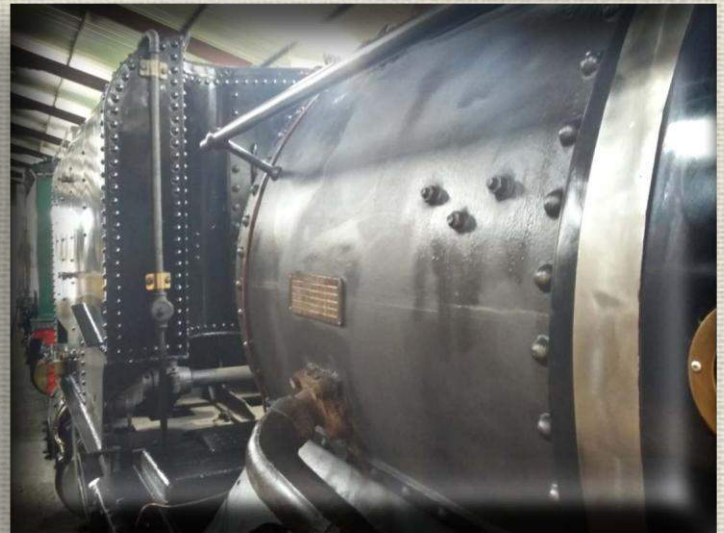
Below Left: The graphite effect of the smoke box of Number 88.
