# Steam News From The Eastern Free State

## Sandstone Estates Steam Railway News 5 February 2016

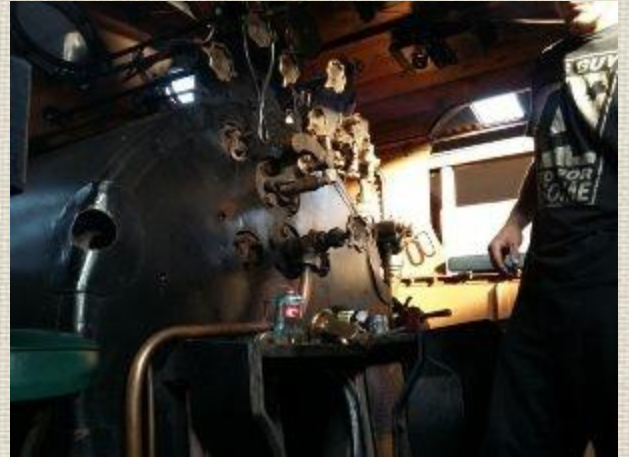
Below left: Isak facing the cone joints of our NG15 number 17

This week Isak fitted all the gauge columns and test corks that were removed to be serviced.

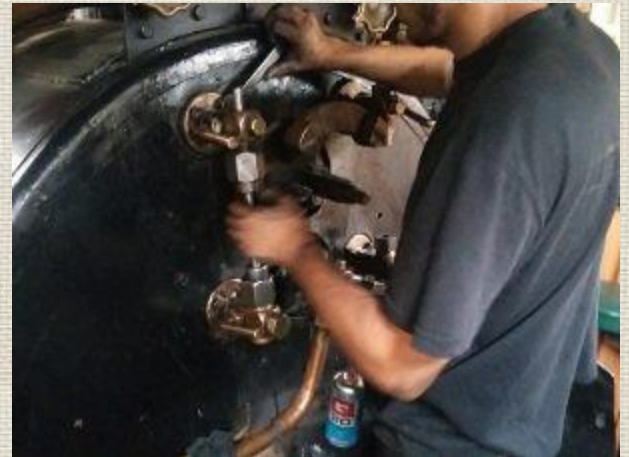
He then fitted back the gauge columns and plumb them to be perfectly aligned.

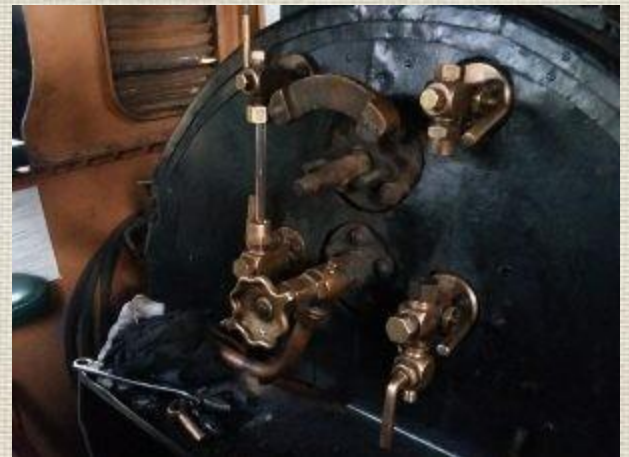
He then fitted back the gauge glasses after he was sure that all of them were aligned.

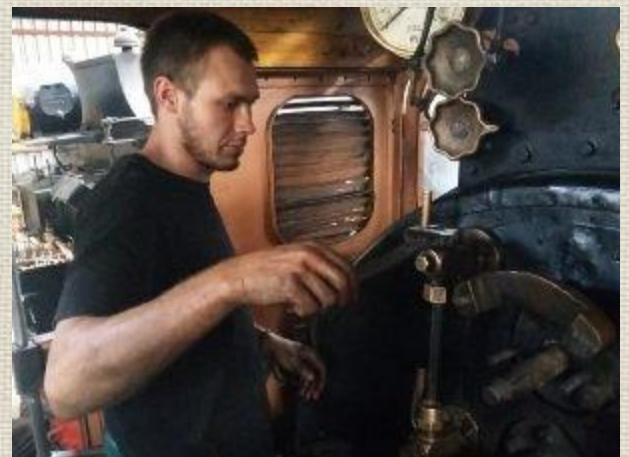
Isak also fitted the pressure gauges that were removed to be calibrated and cleaned.

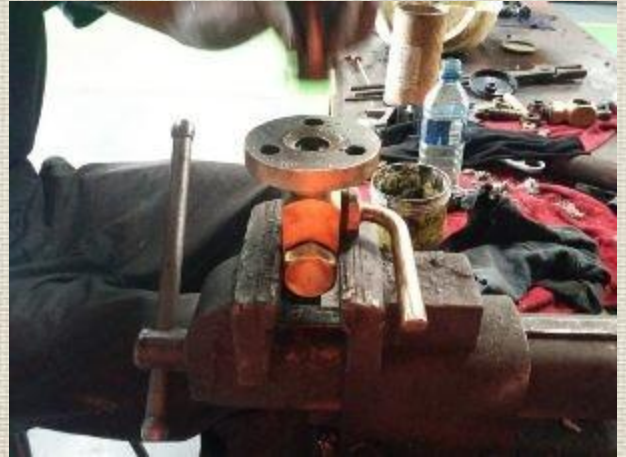
Below: Facing the cone joints on the gauge columns before he could fit them back.

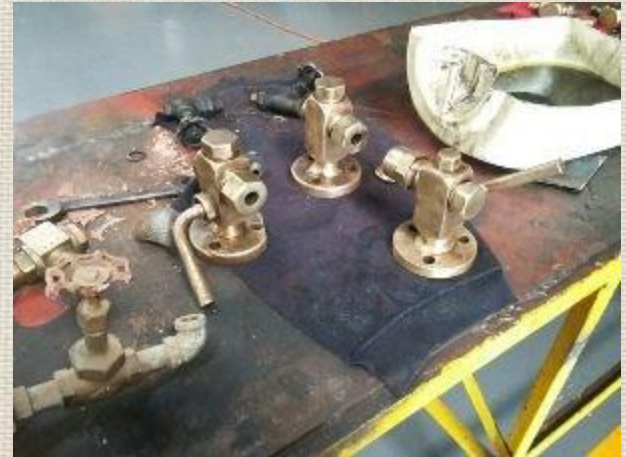
Below right: The cleaned NG4 gauge columns. Well done Isak!

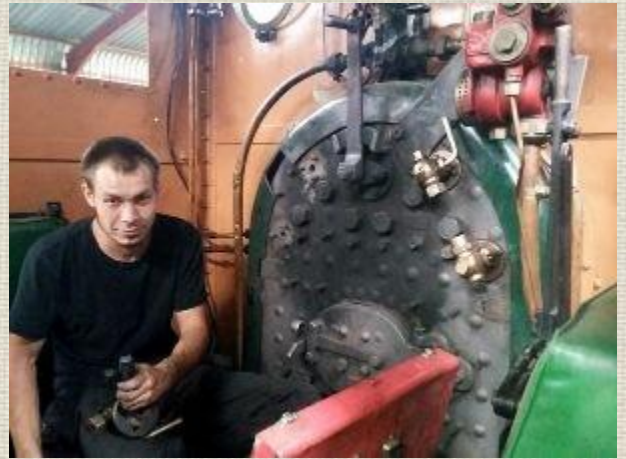
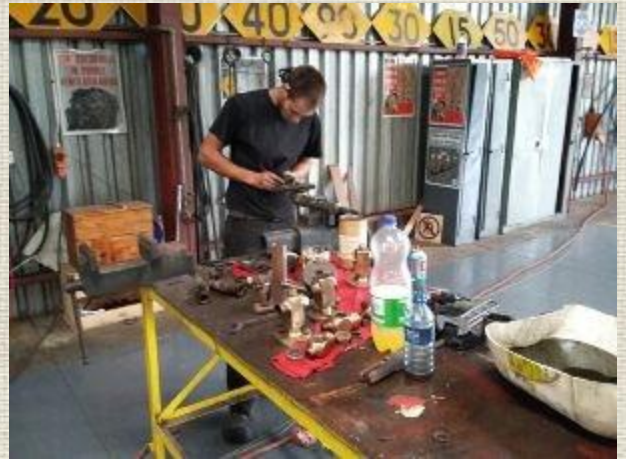
Below: Isak fitted the gauge columns of the Lawley and also fitted all the washout plugs that were removed for washout.

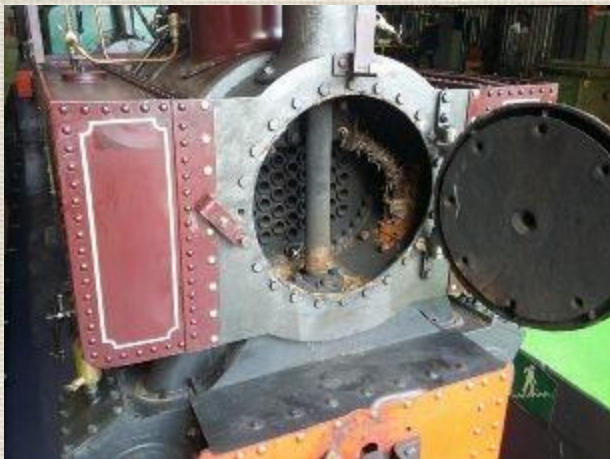
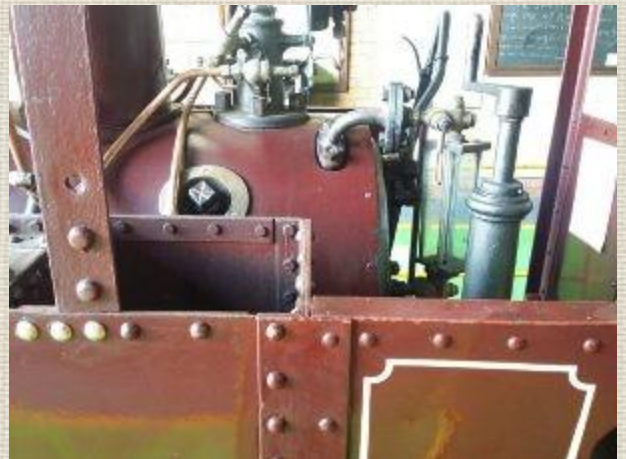
Below: All washout plugs are secured and marked with an X so that we know which were done.

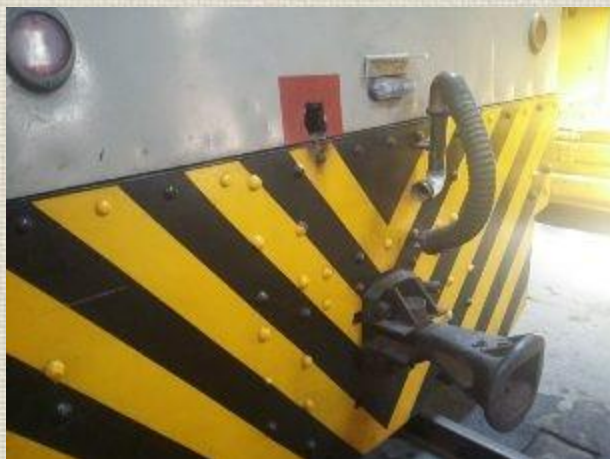
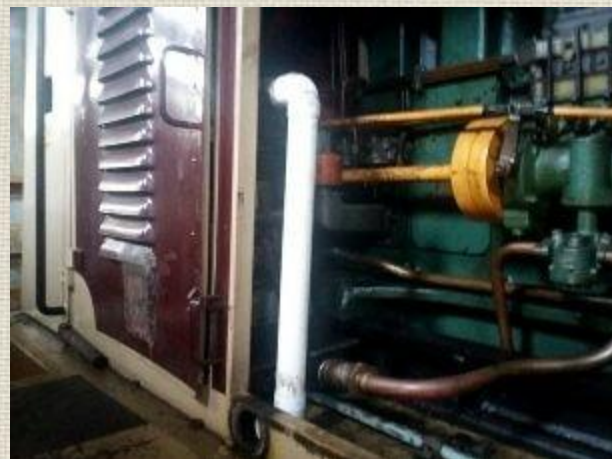
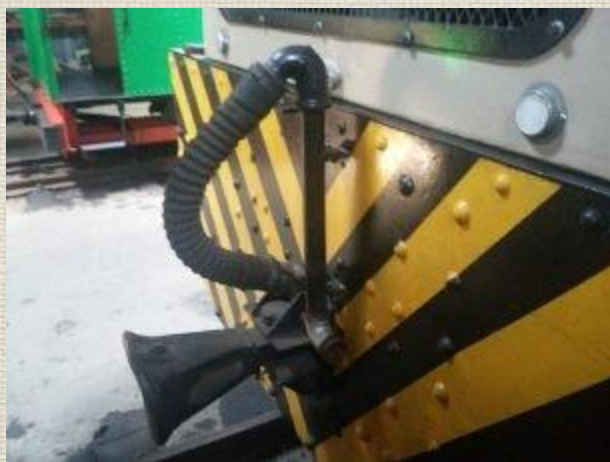
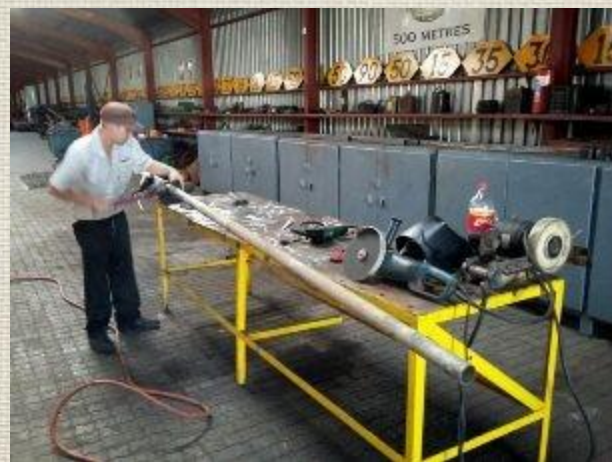
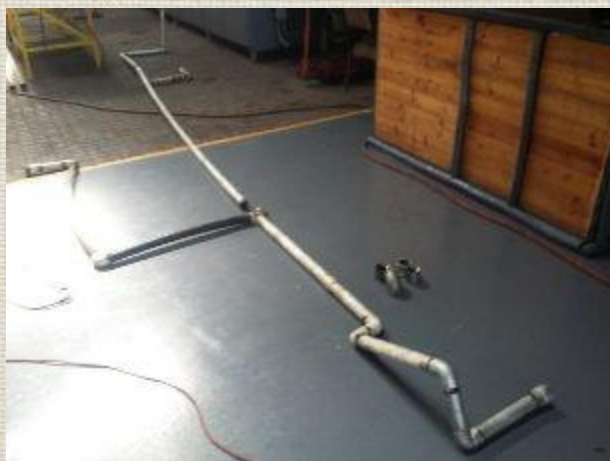
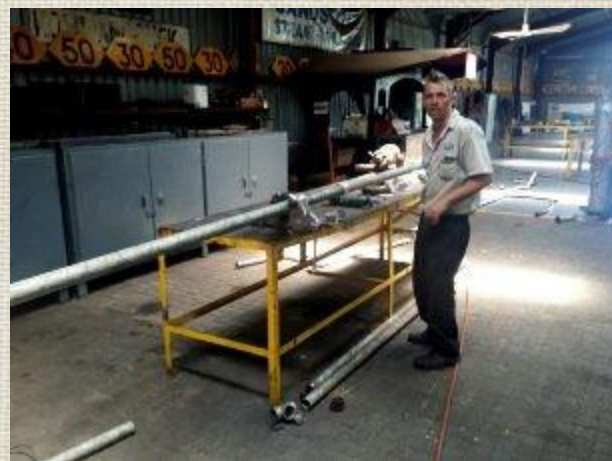
Our Bagnall Diesel Locomotive suffered from a defective vacuum train pipe and Thinus had to remove all the panels to remove the old vacuum pipe. He then assembled it again on the floor and is now making new 2" vacuum train pipes for the Bagnall. When he removed the panels he found a very serious defect on the driving shaft and it will be fixed soon

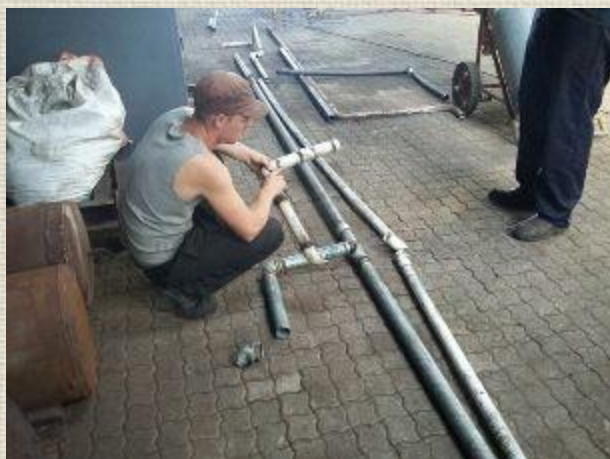
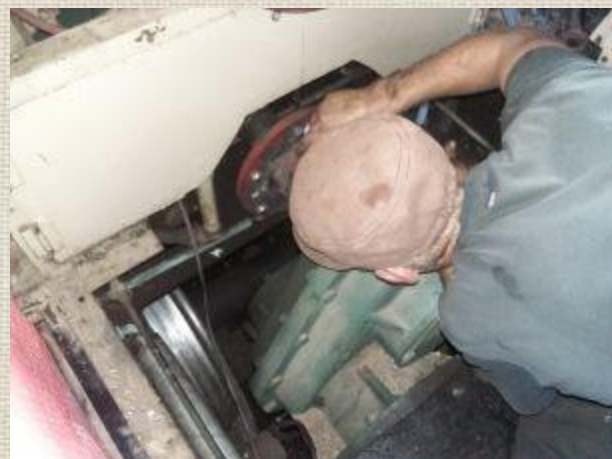
Below right: The driving shaft flange ( red ) has broken all bridges and was about to turn of completely.

Thinus will remove the shaft and fix it as soon as the vacuum pipe work is done.

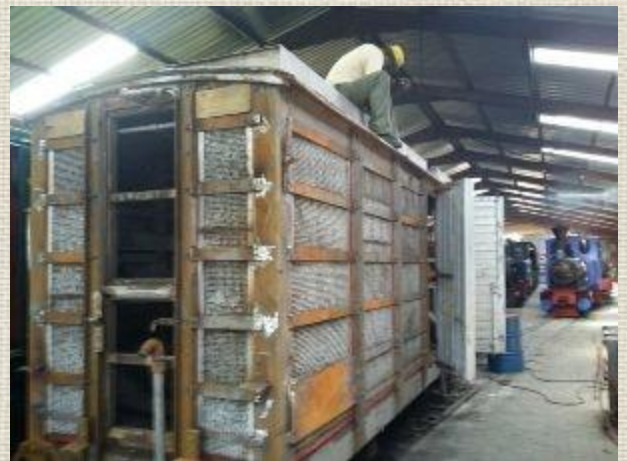
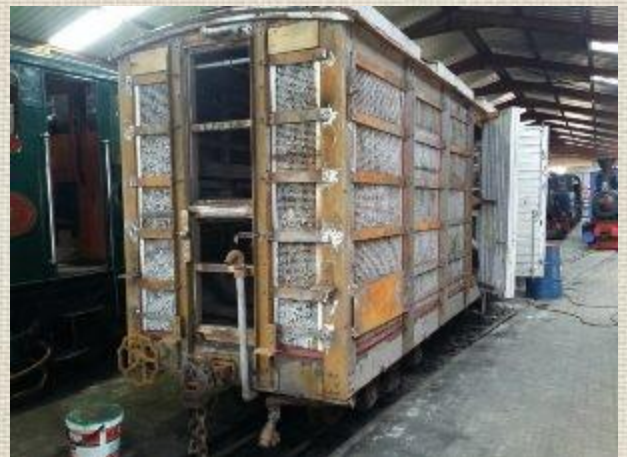
This week Petrus did the last Steel work needed on the TZ Cooler. We asked Thinus to help us with all the welding work needed on this wagon.

then grinded the rough sides away. It is now ready to be painted silver again.

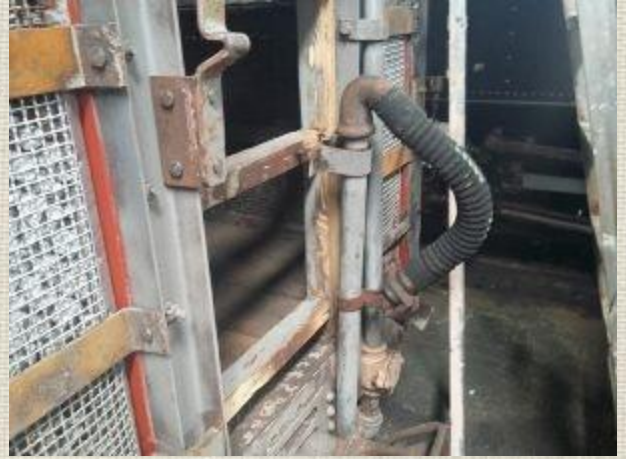
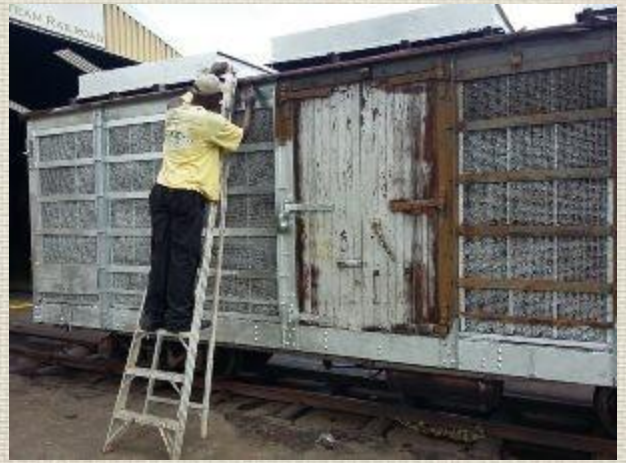
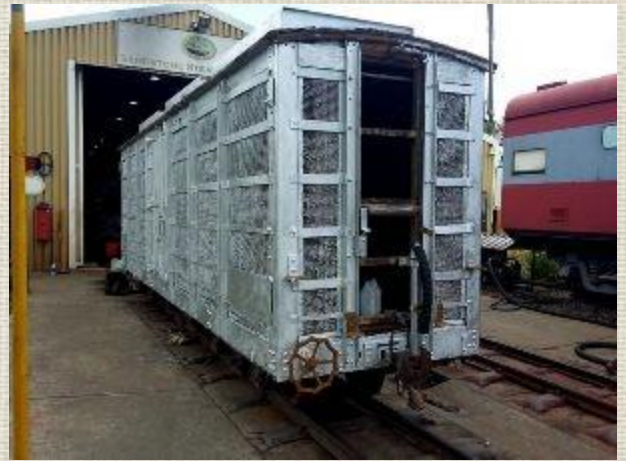
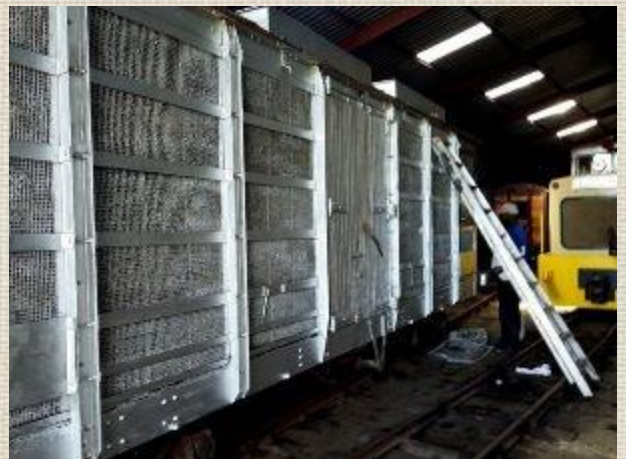
Thinus then fitted new dummies and vacuum pipes to the Cooler Wagon and the painting commenced.

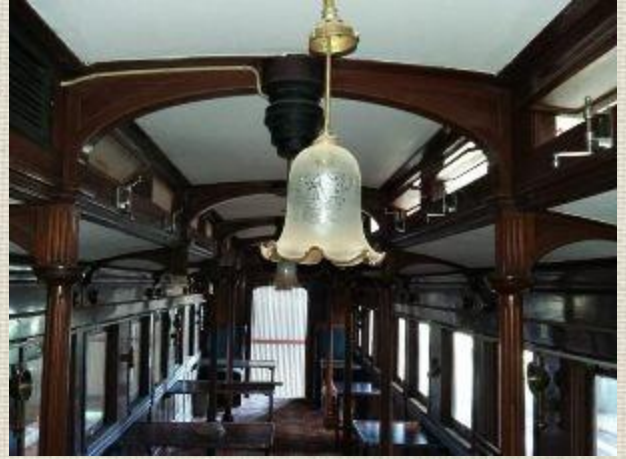
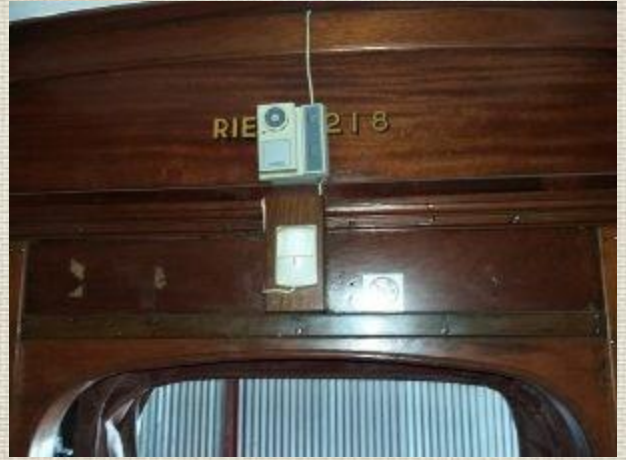
Below right: Small windows are fitted back.

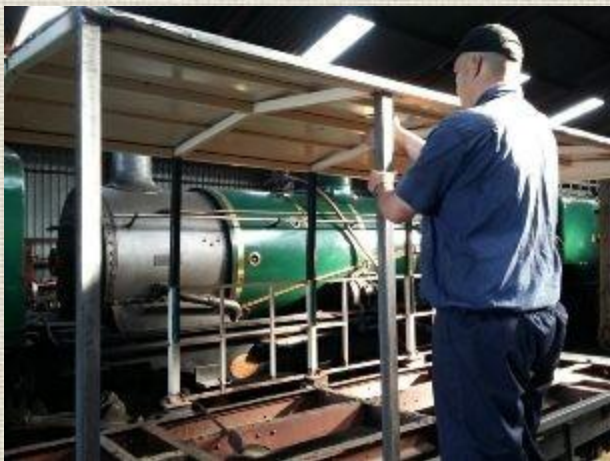
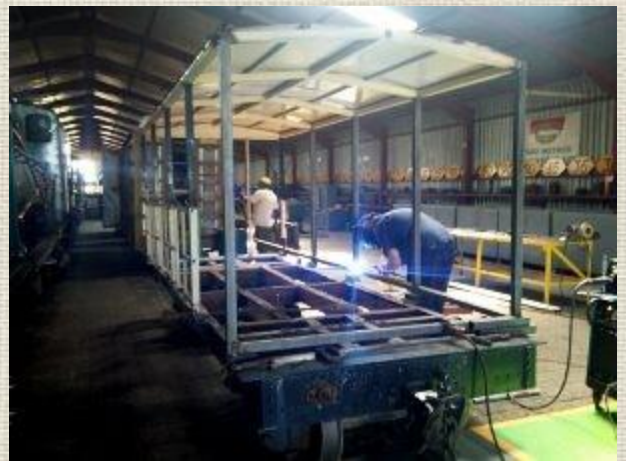
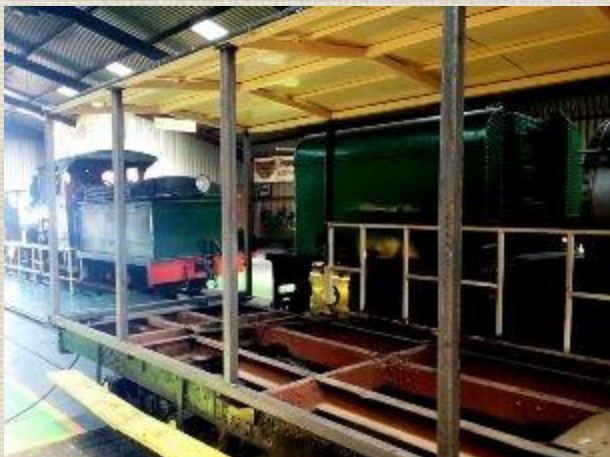
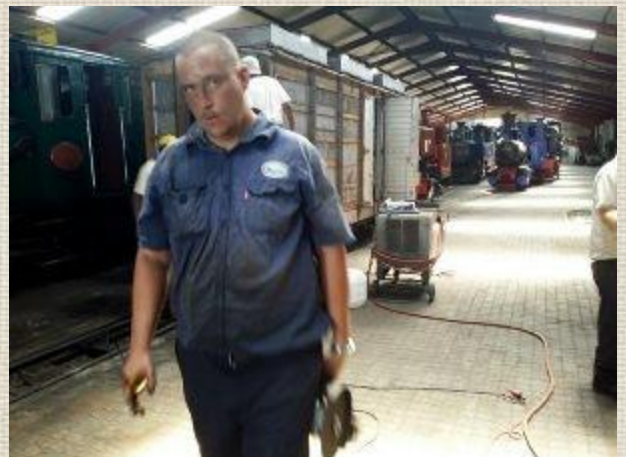
Below: Wouter was cutting out the corroded steel piece by piece, replaced square tubing at the same time until he was able to remove the rest without removing the roof. Thus saving time.

Last week we shunted the second Little Bess coach to the Steam Shed for the steelwork needed on it. Wouter then removed all the corroded steel and fitted new square tubing. The wagon steel restoration was completed and it was shunted out.

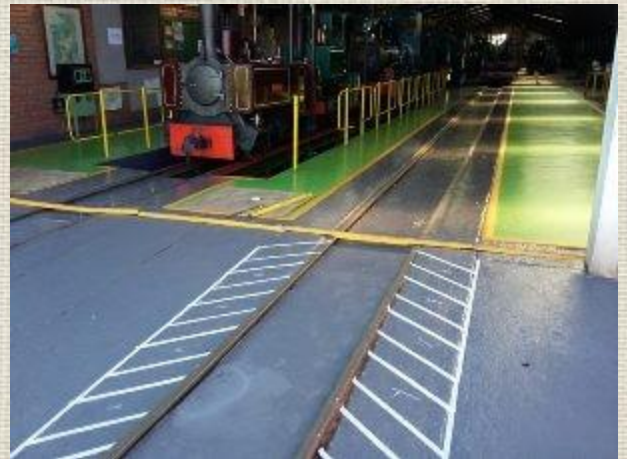
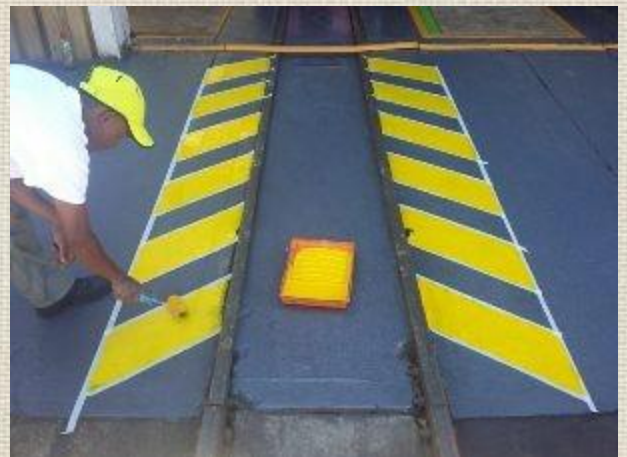
Below: A clean and very neat Inspection Pit.

This week we cleaned and painted the Inspection pit as well as the front of the shed. We also painted a second coat of green paint on the right side of the Steam Shed.
