**=== 15CA 2056 RECOM - CLEANING EXPOSED FRAMES ===**

**== 15CA 2056 RECOM - DRIVER AXLE BEARINGS REMOVED ==**

**= 15CA 2056 - PROFILE CUTTING ON LEADING DRIVER AXLE =**

=== 15F 3052 BRASS PLATES and BOILER RECOM WORK ===

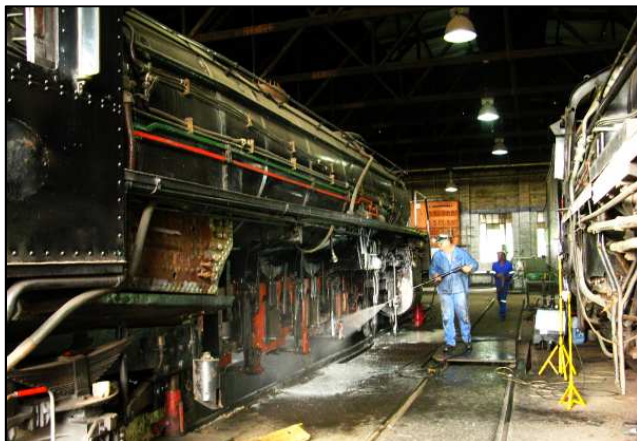
P01 - The 15CA 2056 project continued with the WAP-down (high pressure hot water + degreaser wash) of the now fully-exposed frames of the 15CA for inspection and to prepare for further paintwork. Hannes Bester, who is bound and determined to make this locomotive the show-boat of the Reefsteamers fleet, is seen at the spray nozzle.

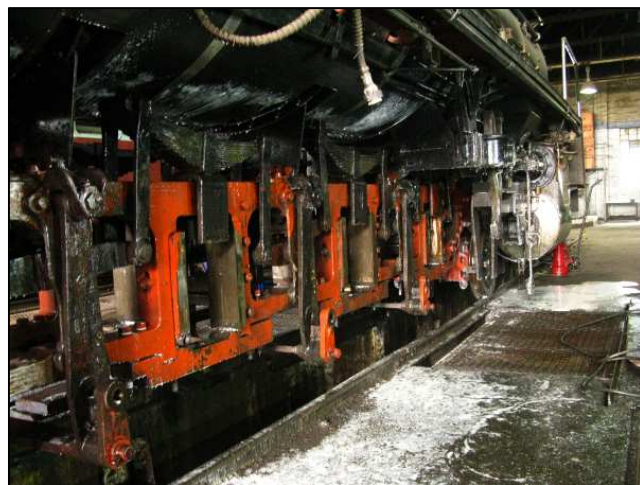
P02 - These are the exposed frames. All four sets of axles slots are bridged by their keeps and the locomotive is firmly jacked-up at all four corners. Hannes isn't going to have time to do the entire loco as originally planned, so he will focus on these inaccessible parts. The rest, we will do as a team at steam up time and during the running in period.

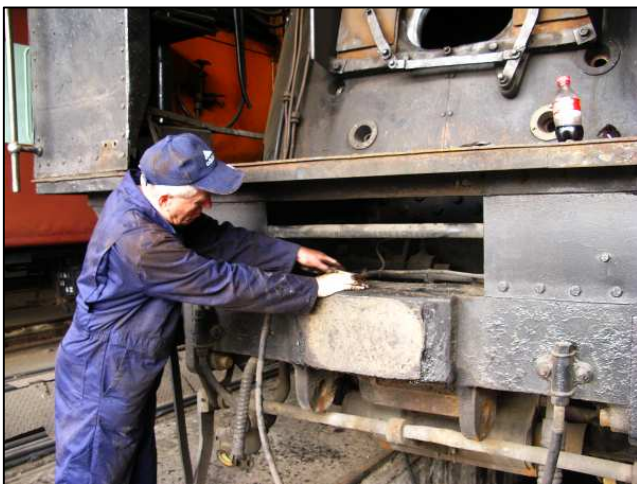
P03 - George, visiting from the UK, set to work to clean up the inter-buffer area and to scrape out the rubbish and crumbs out from under the cab floor. The paintwork at the rear end is poor, as new paint was applied over rust & dirt.

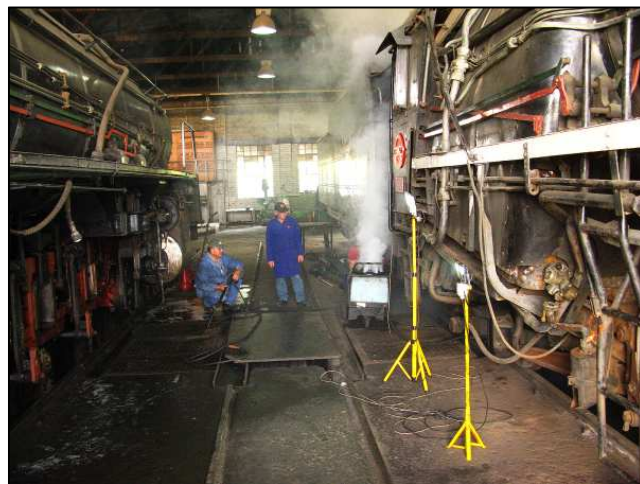
P04 - The WAP high pressure washer was misbehaving and smoking the place out. We lost a bit of time with fault diagnostics. While the water pump is electrically operated, the machine burns diesel fuel to flash-heat the jet water.

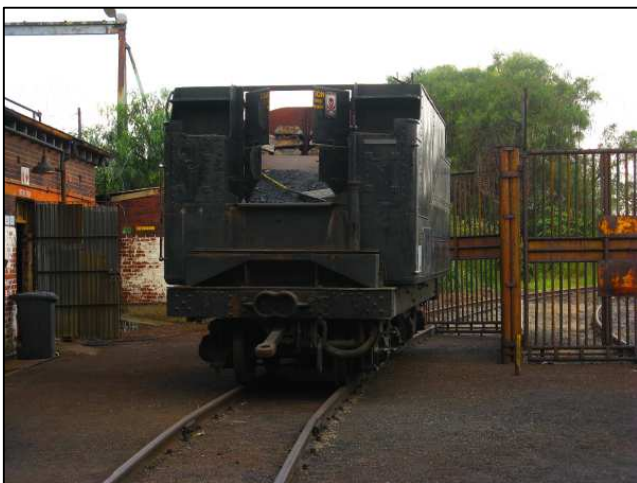
P05 - The 15CA's tender has been shunted out of the way for access to the 15CA track. It is on the 12AR track now but far back enough not to obstruct future boiler tube work.

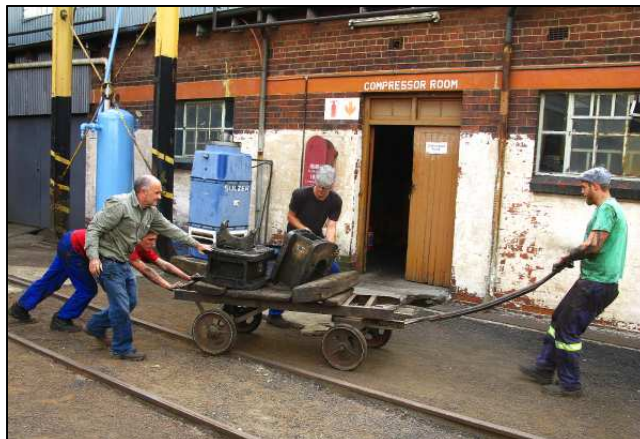
P06 - Cart horse duty - the heavy axle 'boxes' have all been marked and removed from the newly processed axles and hauled into the Fitters Shop. (Tough little ponies, these...)

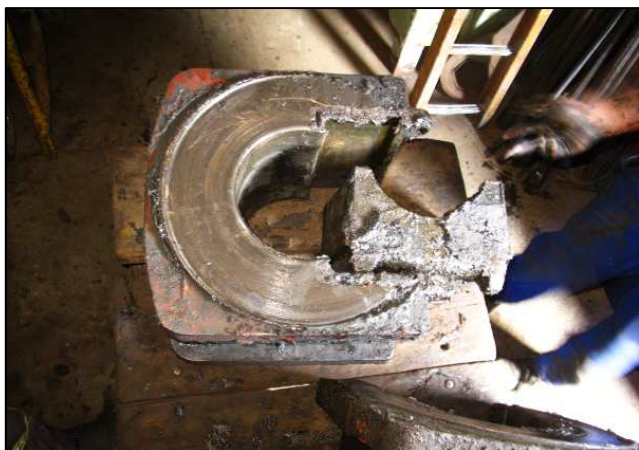
P07 - The axle bearings are worn at their crowns (left in the picture) which means the axles are not running true. The skew axles are imposing uneven wear on the thrust faces, and the small, but vital, driver axle side-play is reduced.

P09 - The axle boxes will be going to Valard Bearings to have their liners melted out and new white metal liners and thrust bearings cast. Valard Bearings do bearing work for us at no charge, and for which we are quite grateful.

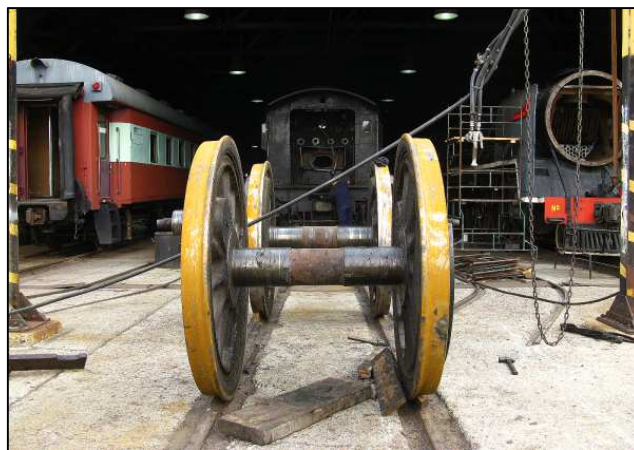
P08 - Just prior to putting a protective layer of grease onto the axle journals, the bare steel of the freshly-peeled wheels are already starting to rust with the morning dew-fall. (In the words of House Stark of Westoros, 'Winter is Coming.')

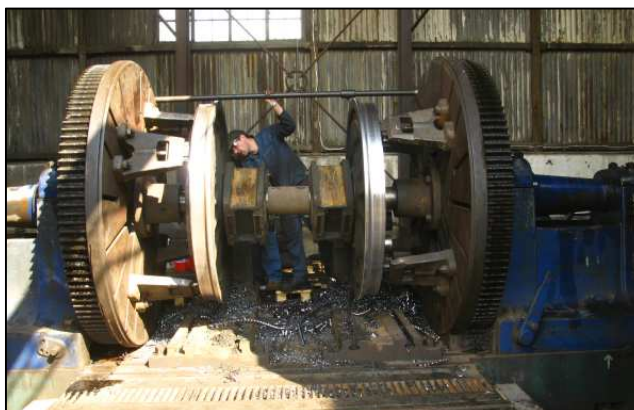
P10 - The fourth and final driver axle was being turned in the 1921 Craven wheel lathe for most of the day. The restored lathe is performing quite well both mechanically and electrically. The motor draws a steady 45 amps and the lathe doesn't strain on heavy loads.

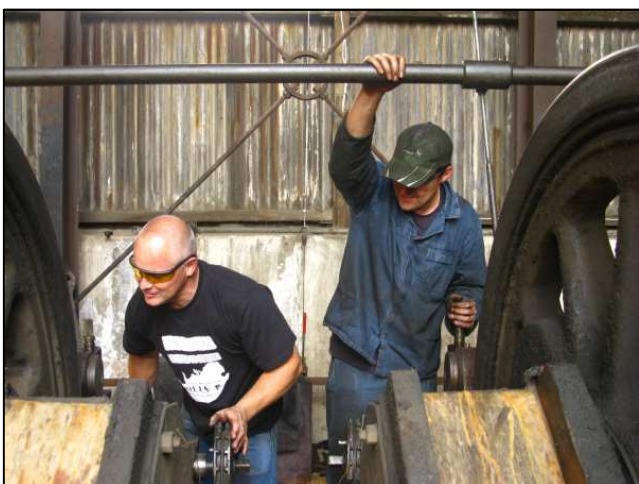
P11 - Dawie's pet fitter was here for the day too, a forlorn rescue picked up from the SATS Millsite Shops. Both gents are wearing safety goggles. We've found the lathe generally aims the spiral swarf towards the floor. But on the thicker cuts, you get the dangerous and unpredictable pings and chips that fly upwards towards the operator.

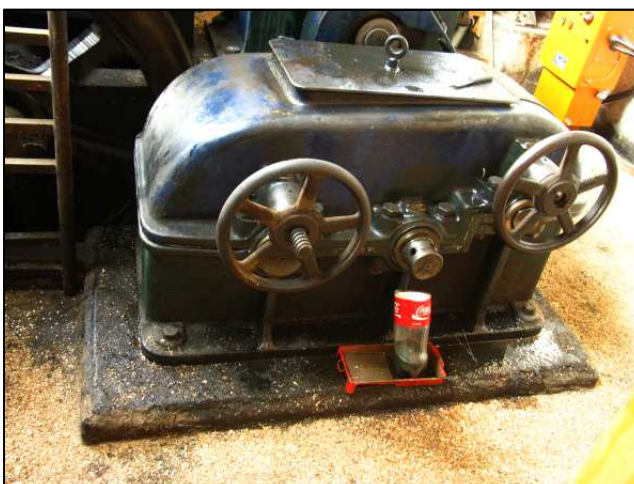
P12 - The idler shaft bearing continued to leak and a simple catch bottle was set up to capture the oil and chuck it back in through the top hatch. The bearing is about 0.5 mm oversize, letting the gear oil sneak through. It isn't a serious problem and it will be re-lined again once the 15CA project is completed. (Note the fresh sawdust on the floor.)

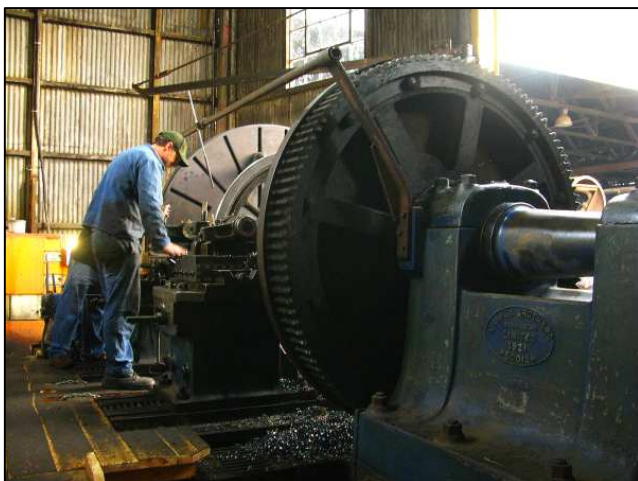
P13 - The big lathe picked up a bit of a chatter as it did during last week's session. The vibration from one side can feed into the other. The fault turned out to be simple – the tool tower racking bolts weren't tight enough. They need to be checked and tightened regularly. Lesson learned.

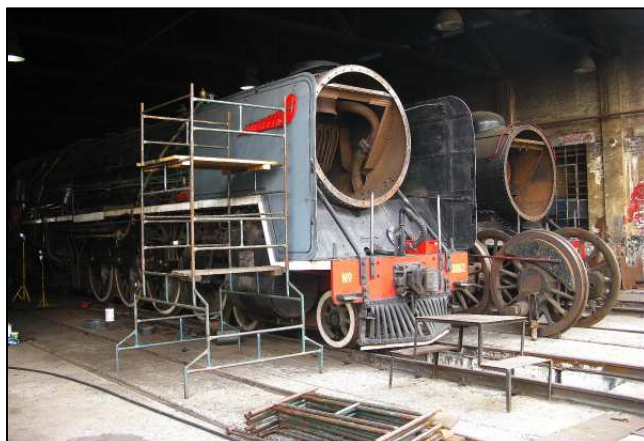
P14 - Sporting new cast wing plates, Sandstone's 15F 3052 has since had the boiler tubes all beaded over at the firebox end ready for the coded welding. Most of the boiler fixtures have since been reinstalled for the coming steam test, but many needed to have wasted steel studs replaced.

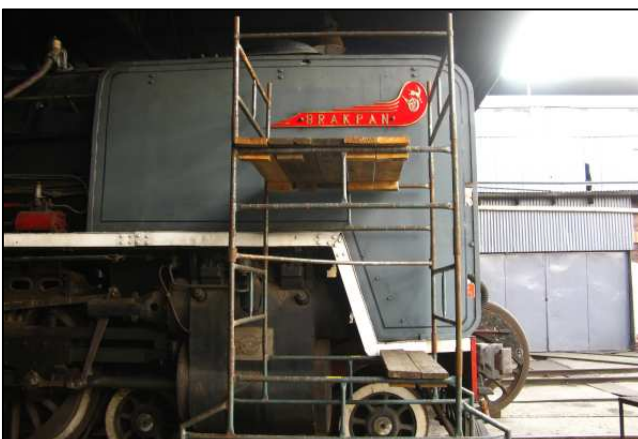
P15 - No.3052 was officially named 'Brakpan' by SAR&H back in 1945, when she was still a new engine. She ran as 'City of Germiston' for a while too. She is nowadays called 'Avril' after David Shepherd's wife, but she now bears her original SAR name as well, to commemorate her history.

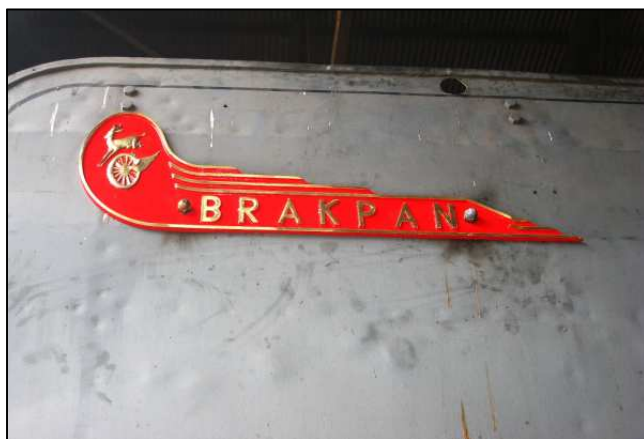
P16 - This photo shows why most SAR engines are black – other colours really show the dirt. 15F 3052 will retain her grey navy-blue lined deflectors and white wheel rims (not our standard) as per owner David Shepherd's request. This is the livery she wore when handed over to him in 1991.

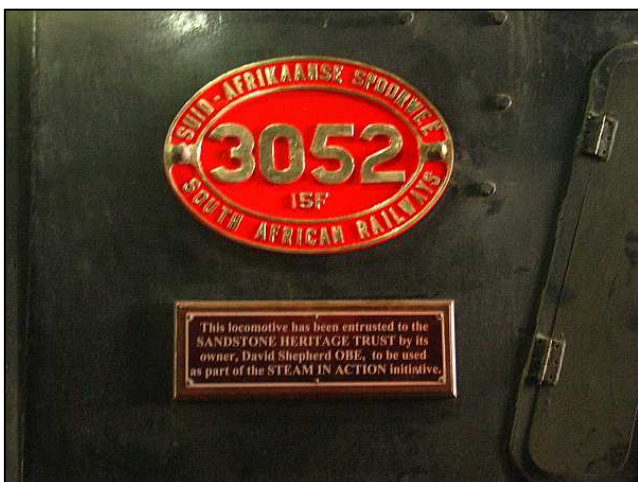
P17 - The 15F 3052 is now properly bolted in between a pair of newly baked brass name plates and no longer has an identity crisis. (She 'borrowed' 3046's plates for a while!)

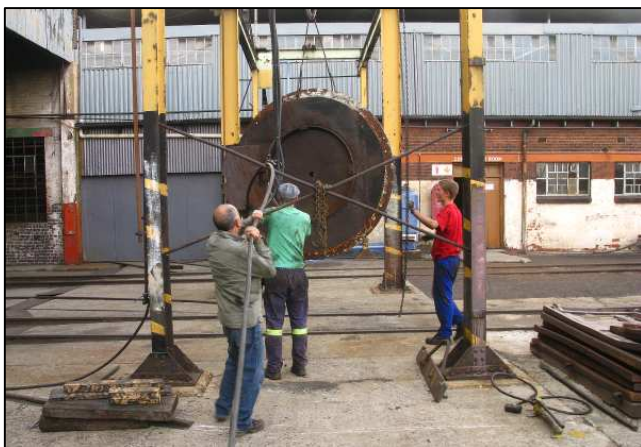
P19 - Traversing the smokebox front plate over that cruciform bracing was a tight squeeze and it JUST fitted. The plate needs to be descaled and repainted. We no longer use graphite paint, so this will be black etch primer,

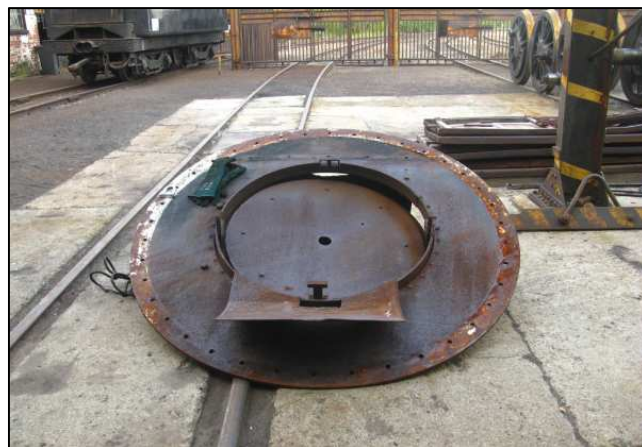
P20 - The rear of the smokebox plate, complete with cinder shield. The similar front plate that Hannes had been grinding down was for the 15CA show-boat project, not for this 15F 3052 locomotive, as I had earlier reported in error.

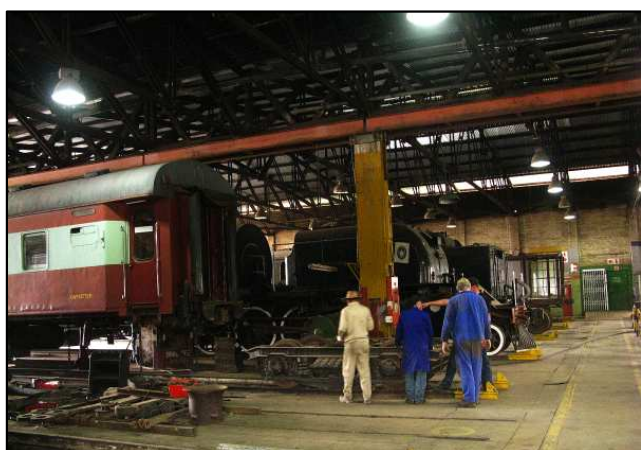
P21 - Coach lifting is underway on one of the Sandstone Day sitters. The old fashioned bar frame bogie had already been withdrawn from under the jacked-up and was undergoing inspection, lubrication and service.

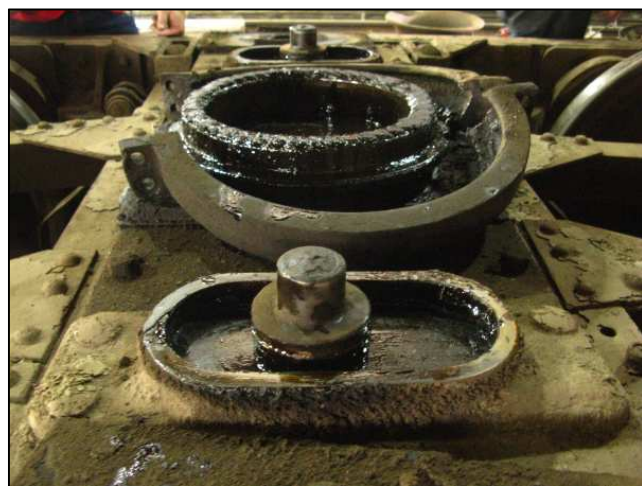
P22 - These old bogies have sliding pads on the shoulders of their bolster beams, and they need cleaning and lubrication. The collars around the bolster pin are nasty to uncouple at arm's length when starting the job

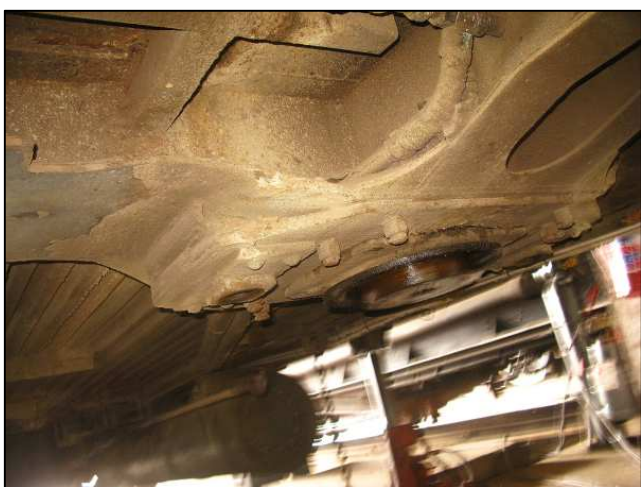
P23 - The bogie bolster pivot that has to be exposed and serviced at intervals. Notice the indented pads on either side, into which the sliding bearers of the previous picture engage.

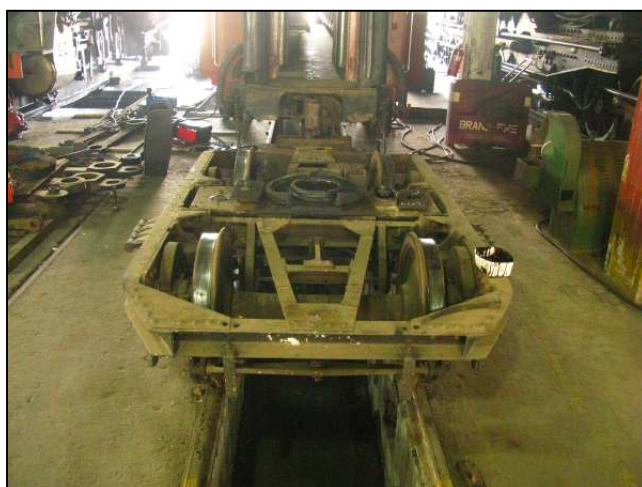
P24 - This coach needs axle work as there has been dragging damage to the wheel treads. So this isn't a one-day job. The wheel lathe CAN turn C&W axles but using two carrier dogs instead of four. (As per loco axles)

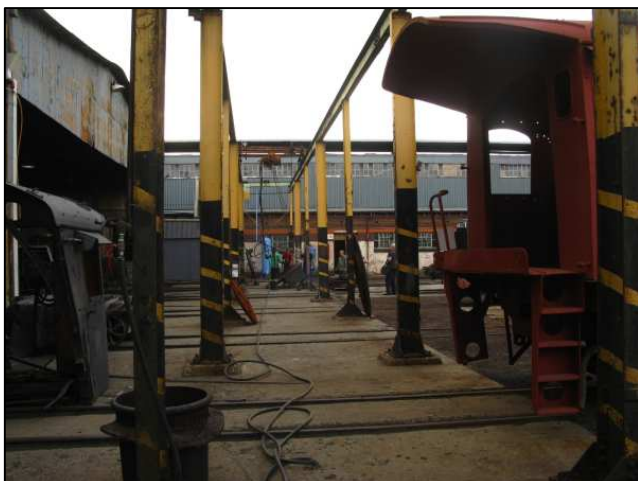
P25 - The gantry is booked for its own refurbishment project in the future. It needs descaling, repainting, new signage and removal of obsolete fixtures. The plinths need to be boxed in and recast. And Engineering Manager Ackerman is looking at various forms of powered traverser, as the chain is neither practical or safe for very heavy loads such as these axles. (The crawler shaft runs counter to the traverse, so the chain often runs awkwardly in a figure 8.)

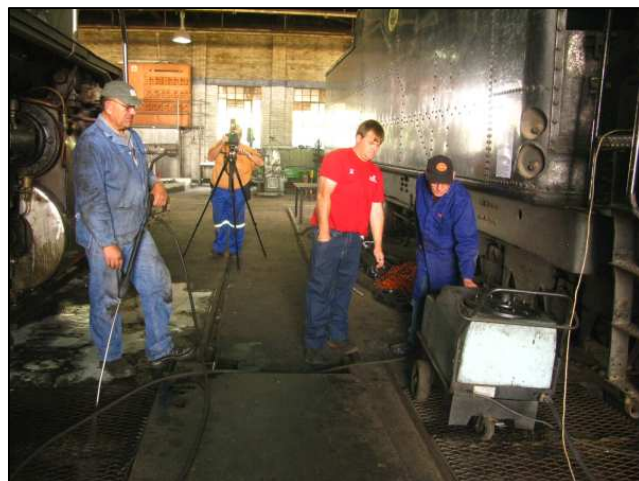
P26 - Talented photographer, Ian Morison (more talented than I) is now adding to my documentary photography with his own angles for the times I am absent and with the use of a better camera too. He quite enjoyed the smoky effects from that WAP machine.
