**=== 15F 3052 – PRE-STEAM TEST WORK ===**

==== 15CA 2056 –EQUALISER LINK REMOVAL ====

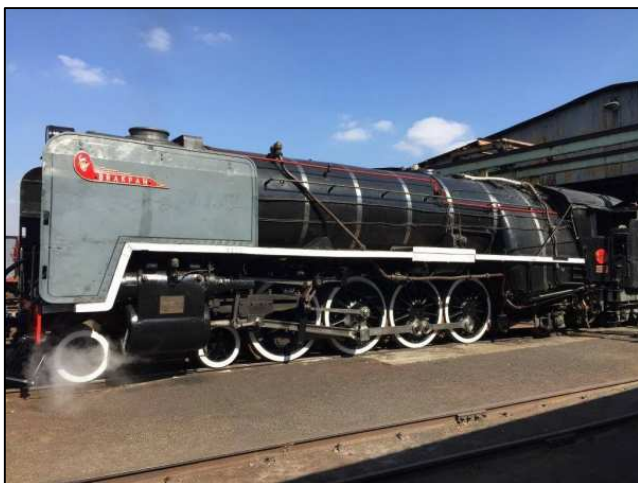
P01 - David Shepherd's Class 15F 3052 'Avril', entrusted into the care of Reefsteamers via Sandstone Heritage Trust in Oct. 2007, is formally in steam again and has received a three year boiler certificate.

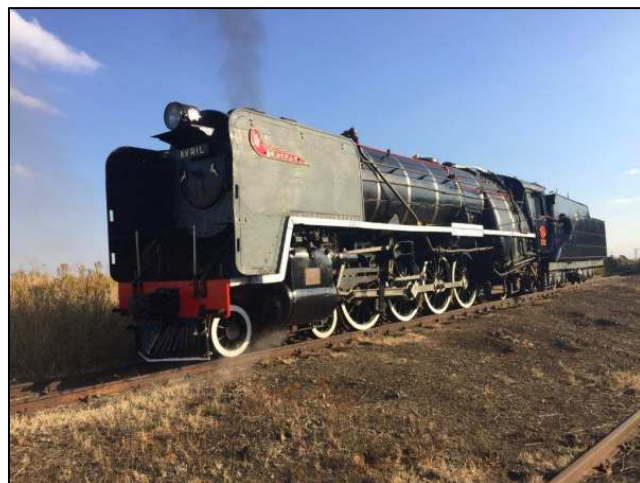
P02 - Seen backing up the incline outside the 15M approach yard, on her way to the Top Shed. The first mainline test run is planned for 28 May and a special 15F + 15F double-header revenue trip is planned for the 4<sup>th</sup> June.

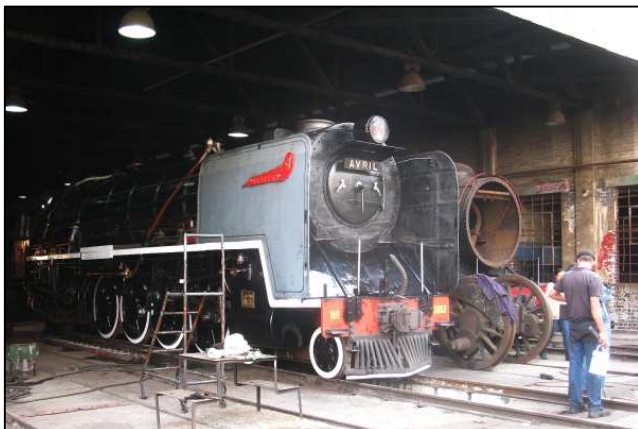
P03 - The first coat on the front end is done. She will be receiving a second coat of paint on the smokebox at a later date, while the cow-spreader and buffer beam would be painted by hand the following week.

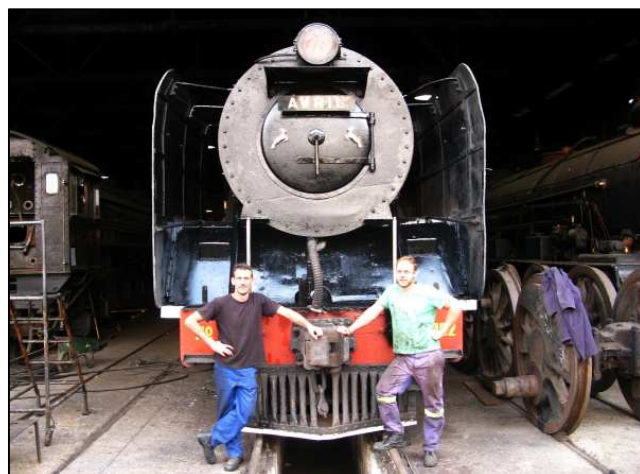
P04 - The newly reassembled front end at the end of the work day, with all of the external fixtures bolted back on. Just missing a nose wheel, which was left off in case access was needed to the smokebox on test day.

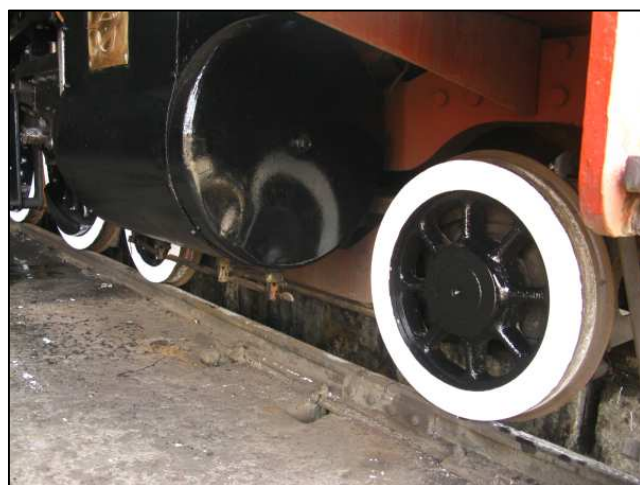
P06 - The cylinders were cleaned and the cylinder head covers were repainted as well. Interesting 15F fact. The cylinder bore and stroke (24 in x 28 in) matches that for the rebored 15CAs and the Class 23s as built.

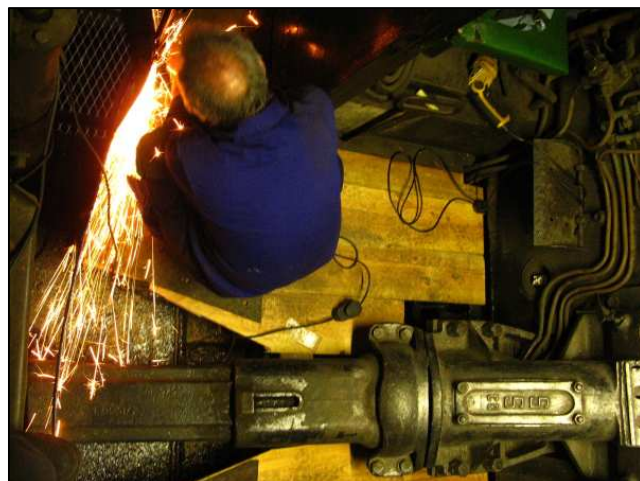
P08 - The entire cab floor was stripped and re-laid from aircraft packing timbers. (!) It wasn't part of the contract, but the cab floor was too rotted to be safe. Gordon is seen grinding down the old welds on the toe plate and the nosing caps before the tread plates could be reinstalled.

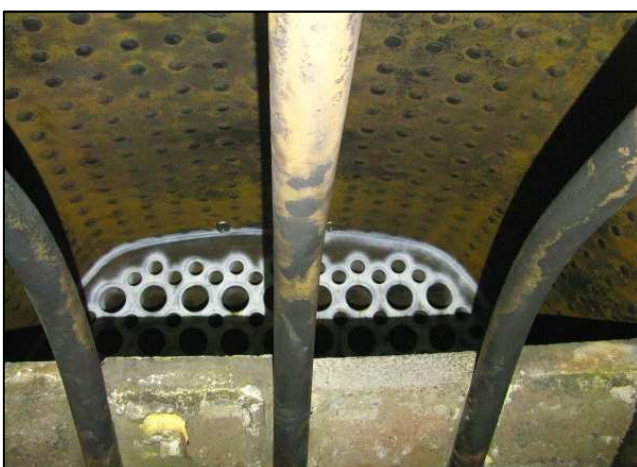
P11 - The firebox is done. The tube beads were welded during the previous week. If you look carefully, you'll see two of the fusible plugs screwed into the crown sheet at the front center.

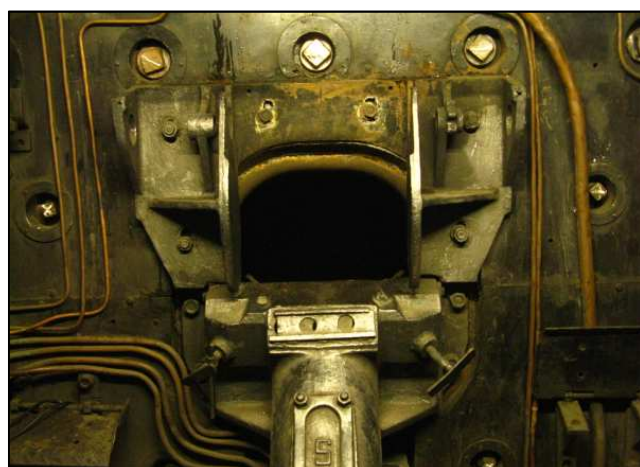
P12 - The firebox door and latch was removed to allow the coded welder access to the firebox. It was replaced on Saturday evening.

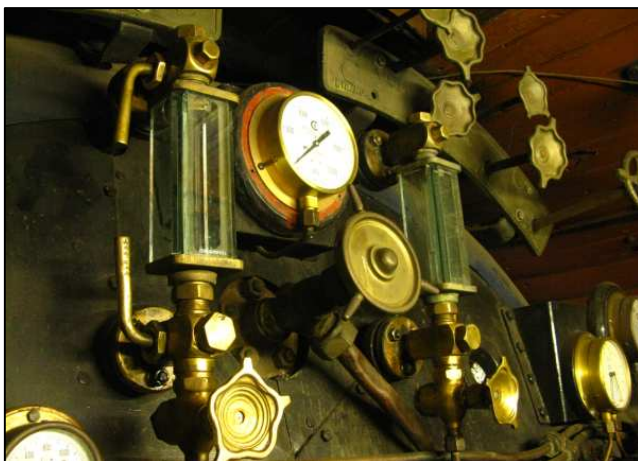
P13 - The cab is coming back together. Both the main pressure gauge and the duplex vacuum gauges were SANAS calibrated and certified. The turret spindles and their universal joints still need some work. We plan to move the speedometer a few inches to the left, as it is obstructed by the brake ejector's steam pipe.

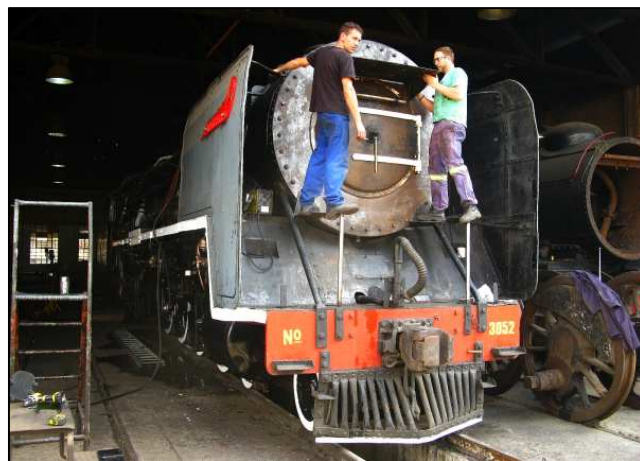
P14 - 15F 3052 was gifted a deeper headlamp bracket to accommodate a classic Pyle Chicago-style headlamp. As the smokebox front plate's mounting holes had been drilled skew in the past, it is rotated to the right slightly. The fellows dismantled the brackets and put shims on the right side to level the headlamp relative to ground level.

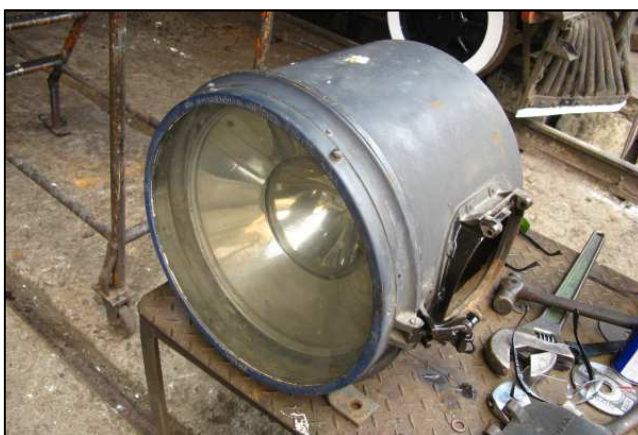
P15 - A closer view of the classic style Pyle National headlamp. This particular example is interesting as it has a retro-fitted GE sealed-beam unit in the middle, rather than the very obsolete Romania-made incandescent globe.

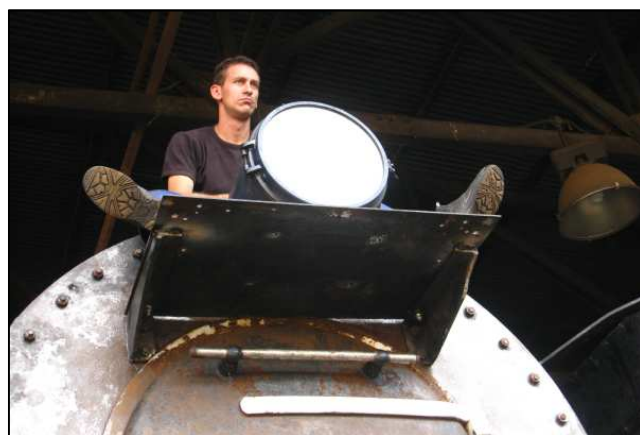
P16 - Test-fitting the 'new' headlamp. The name plate was later mounted on the forehead rail instead of from under the bracket (as is usual practice.) The problem with the easier bracket mount is that the name plate then has to be removed whenever the smokebox door is opened.

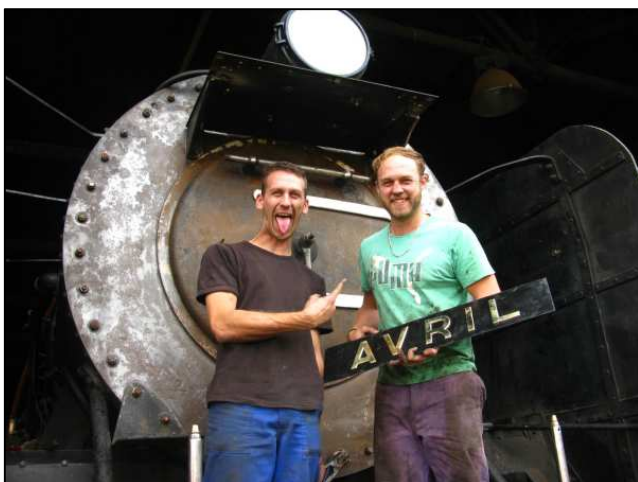
P17 - Darryn had been de-greasing and polishing the name plate, and making up brackets for the rear. Excuse the funny faces – if we were all 'normal' we wouldn't be spending our free time working with these lumps of iron.

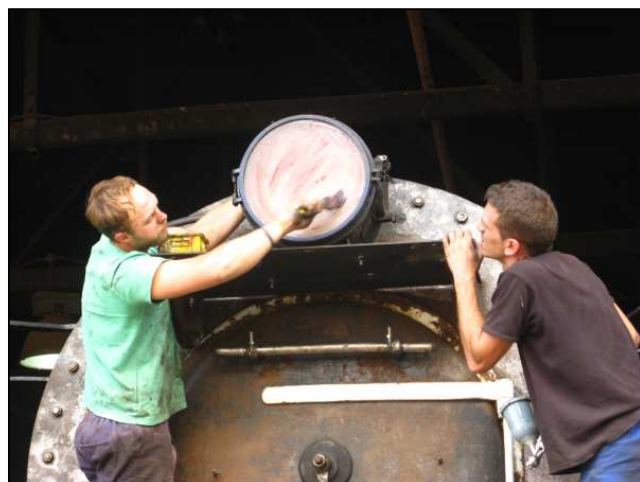
P18 - Painting the headlamp glass with grease to protect it from paint gun over-spray. The paint overspray then comes off with a paraffin rag. This is much easier than using masking paper on a circular surface!

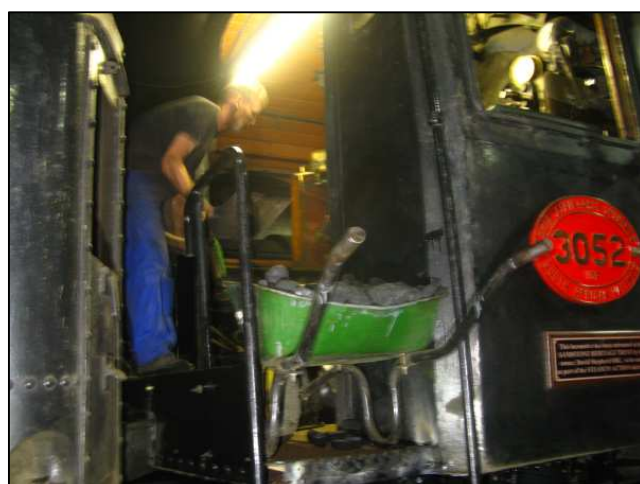
P22 - Coaling from a wheel barrow. The service guys decided to pre-lay the fire for Monday morning fire lighting for the impending live steam test.

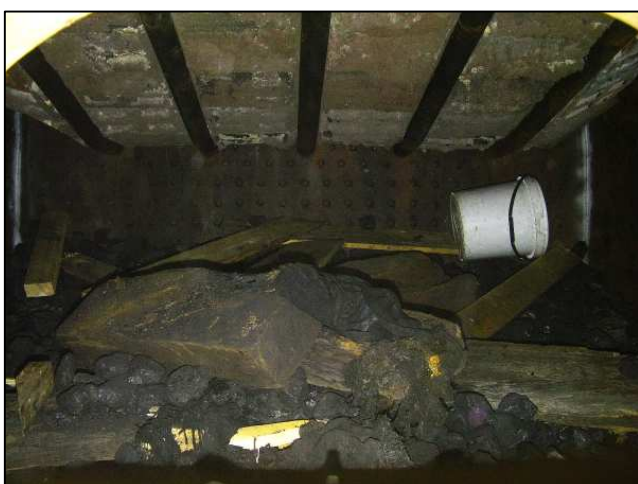
P23 - Not a conventional fire bed. It had been laid to get rid of scrap timber as well. Kindling still needs to be put in but that's a Monday job. Somehow, Michael Thiel's lunch bucket ended up in there as well.

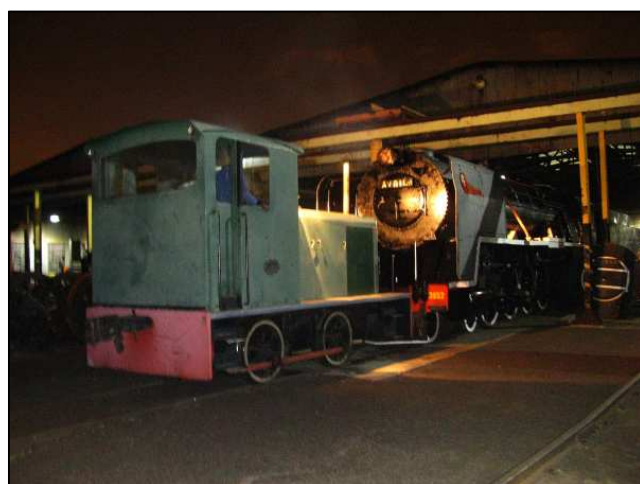
P24 - The last job of the day was to shunt the loco out so the chimney would be clear of the unventilated workshop roof. The safety valves also needed to be clear of the roof as they would be allowed to blow-off for calibration.

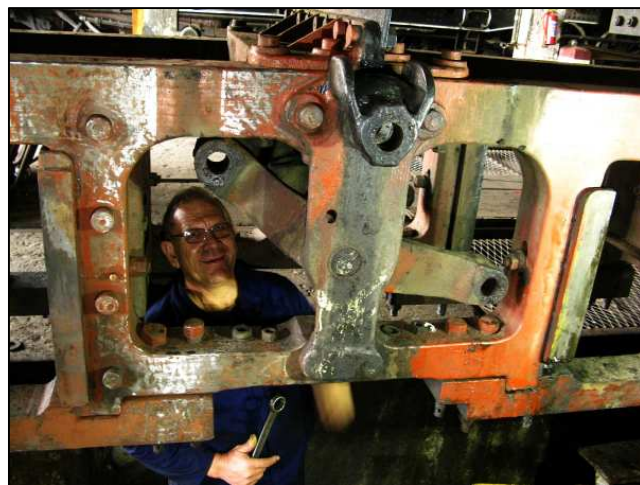
P26 - The inter-axle equaliser links were all removed with the aim of cleaning, inspection and rebushing if necessary.

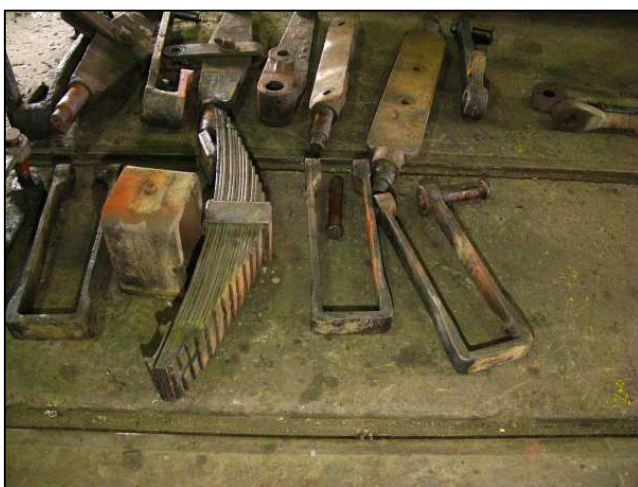
P27 - A growing collection of suspension and brake parts. All of them have been stamp-marked with their wheel allocation to be able to be returned from whence they came. Bushes may need to be custom fitted per component.

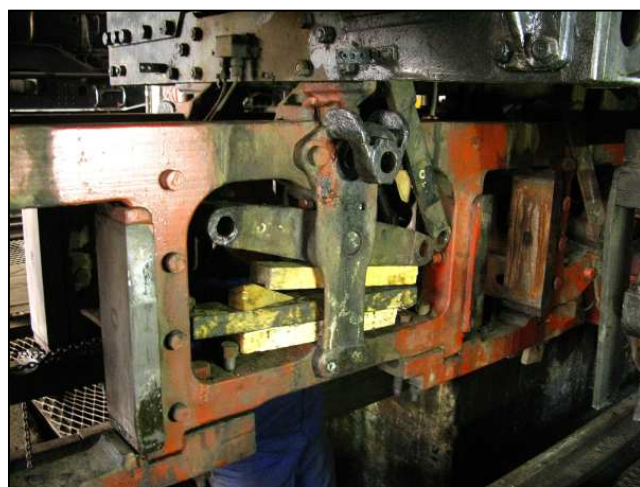
P28 - If time permits, greasing facilities will be added to the equaliser link pivots (center) and to the brake beam hangers. Due to their inaccessibility behind adjacent wheel rims, they are prone to not being lubricated on a regular basis, and have no engineered lubrication points anyway.
