**Sandstone Steam Railway. Types of Narrow Gauge Wagons.**

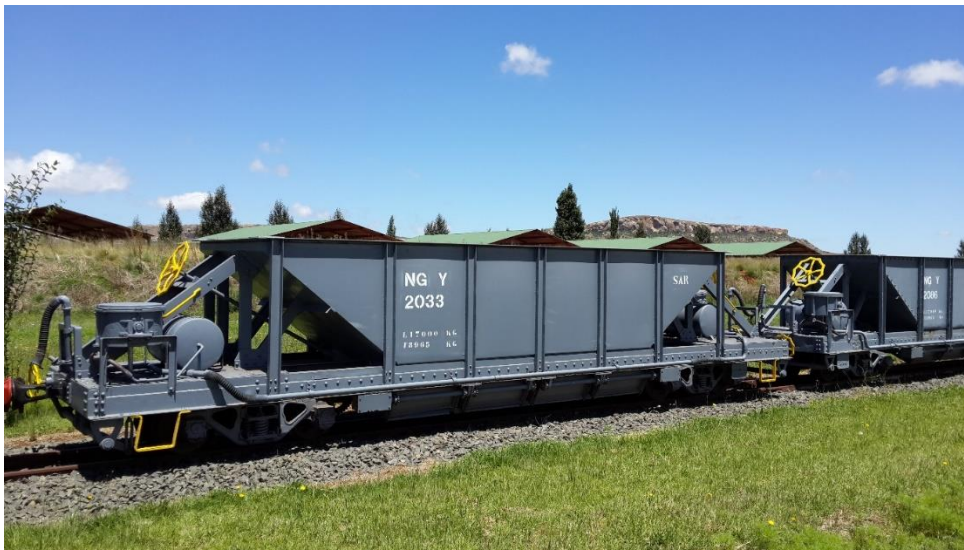
**Acquired from the Port Elizabeth to Avontuur line, Y wagon number 2033, built in 1976, has been fully restored at Sandstone. Photo by David Richardson.**

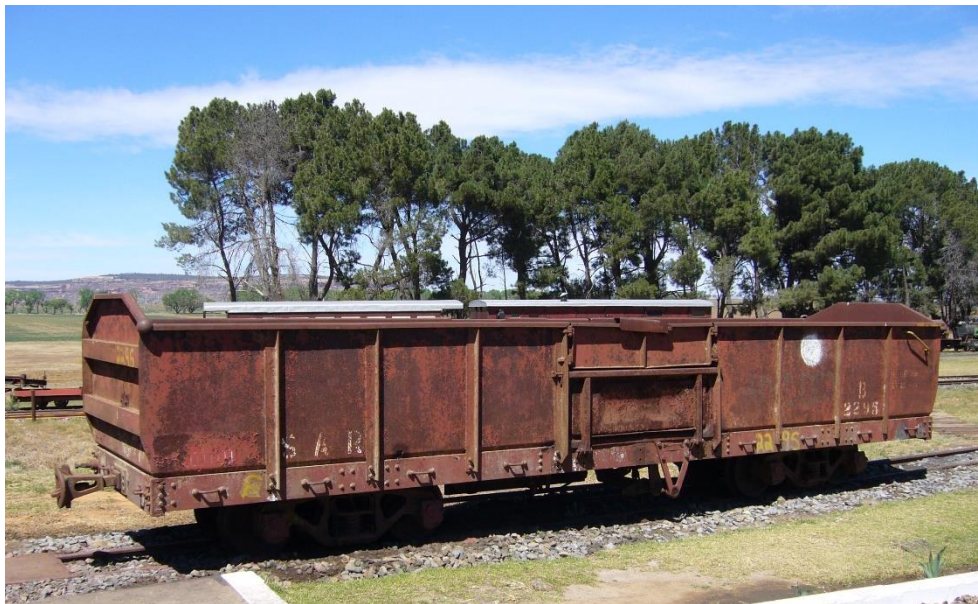
**This 1966 B6 type B wagon, number 2295, was acquired from the Port Shepstone area. Photo by David Richardson.**

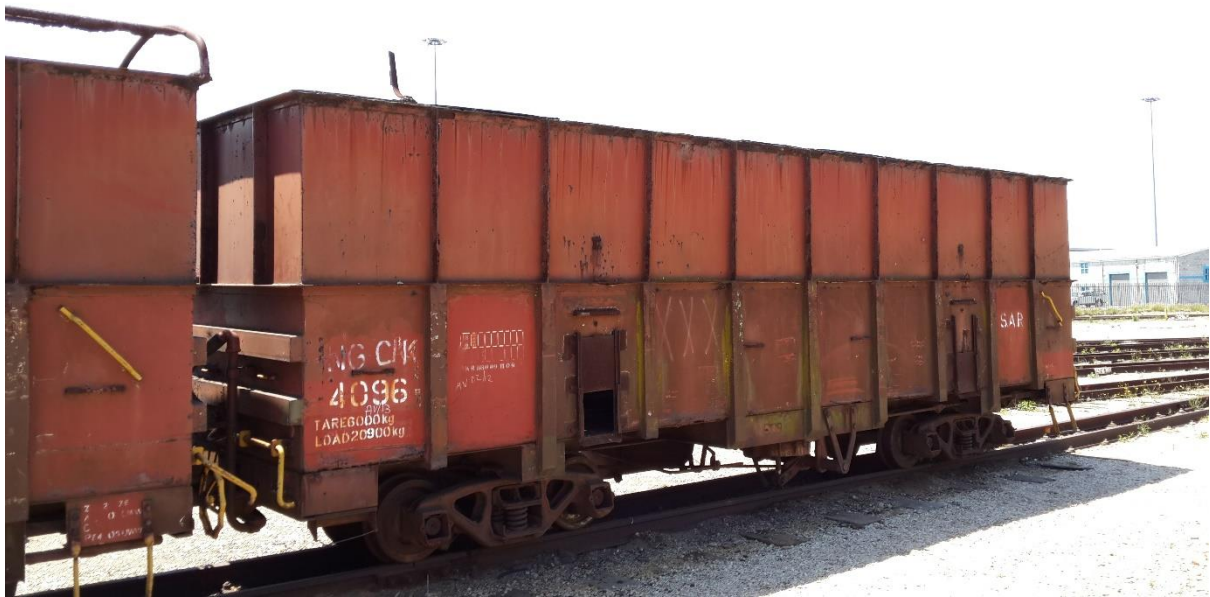
A high sided C3 type, number 4096, modified from an original C1 type stands at Baakens River in Port Elizabeth before being moved to Sandstone. The original lower sides of the C1 can be seen plus the added sliding doors for the discharge of cargo. Photo by David Richardson.

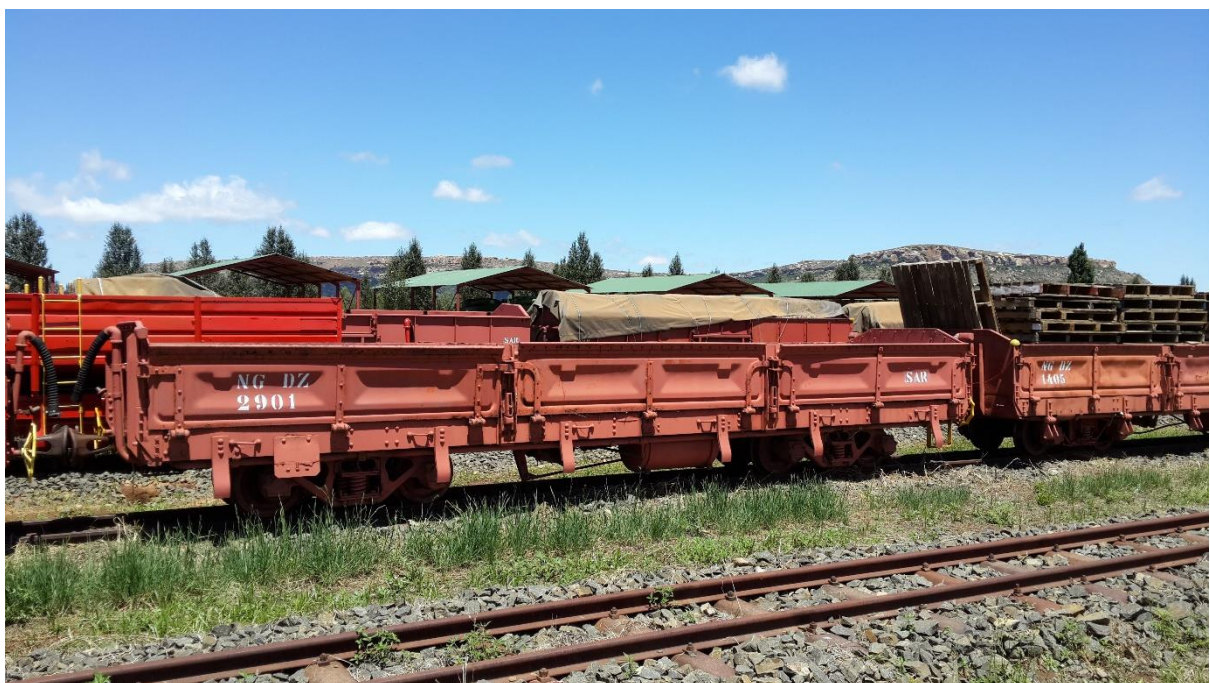
NG DZ number 2901 at Sandstone, this is a DZ9 type built in 1972. Photo by David Richardson

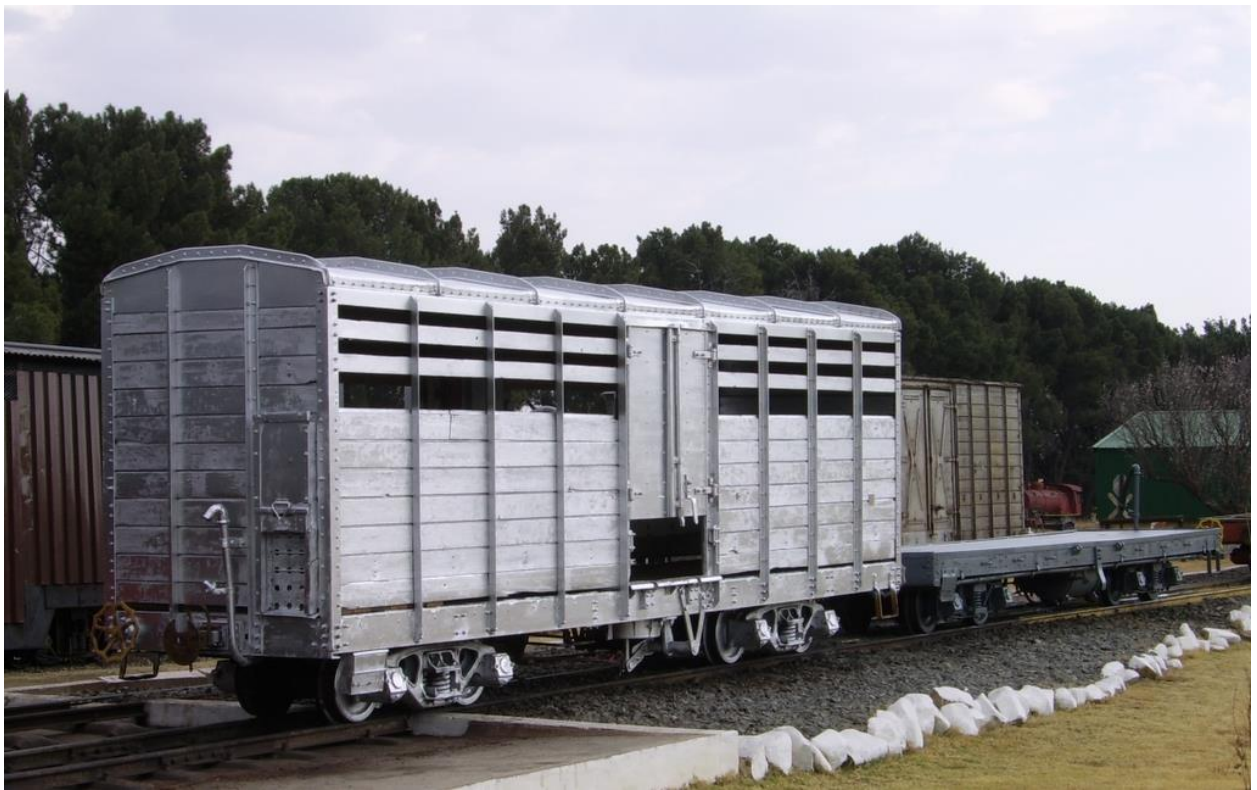
**A G type fruit van. Photo by David Richardson**

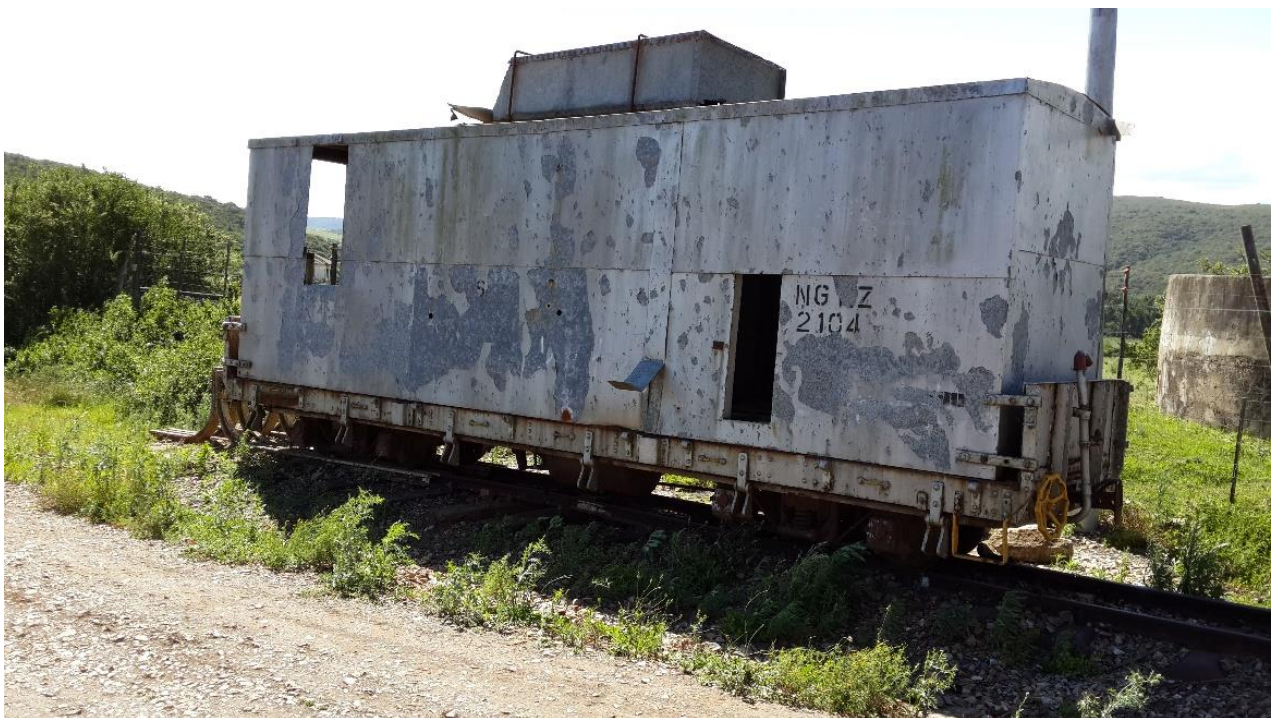
**NZ 2104, originally used as a Platelayers Van, stands at Lorie before being moved to Sandstone. Photo by David Richardson**

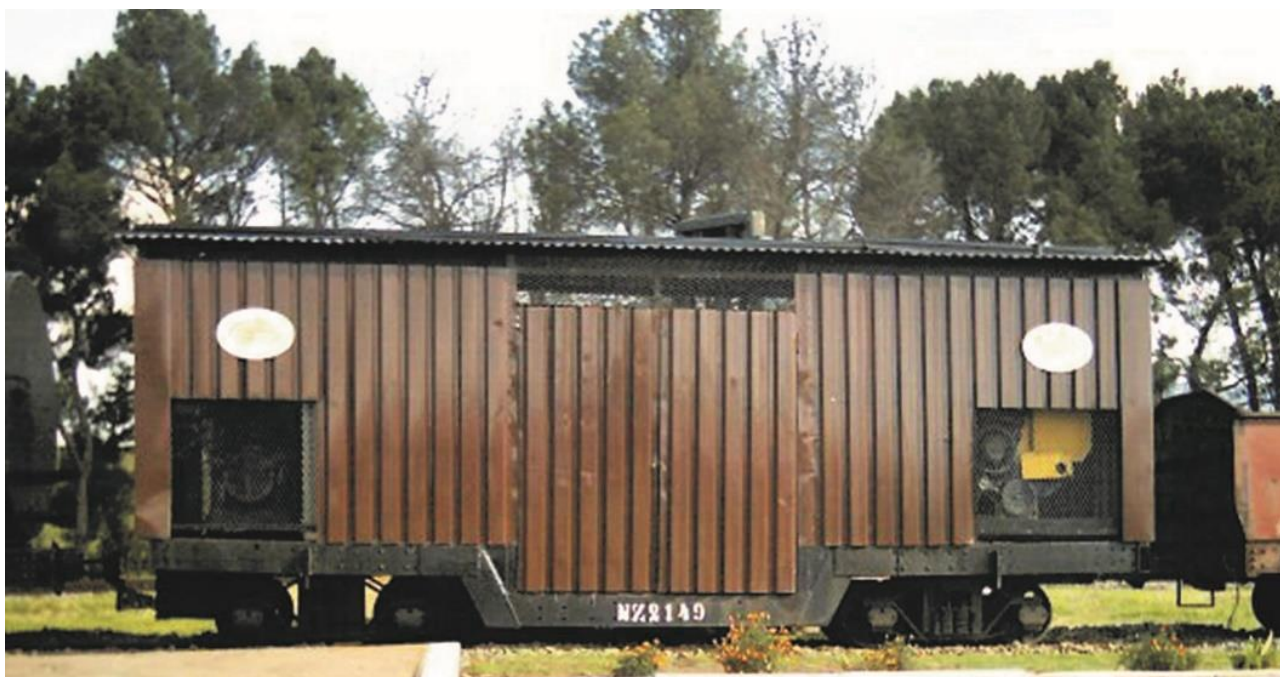
**NZ 2149, the Tool & Mess Van, awaits its next turn of duty at the locomotive workshop.  
Photo by David Richardson.**

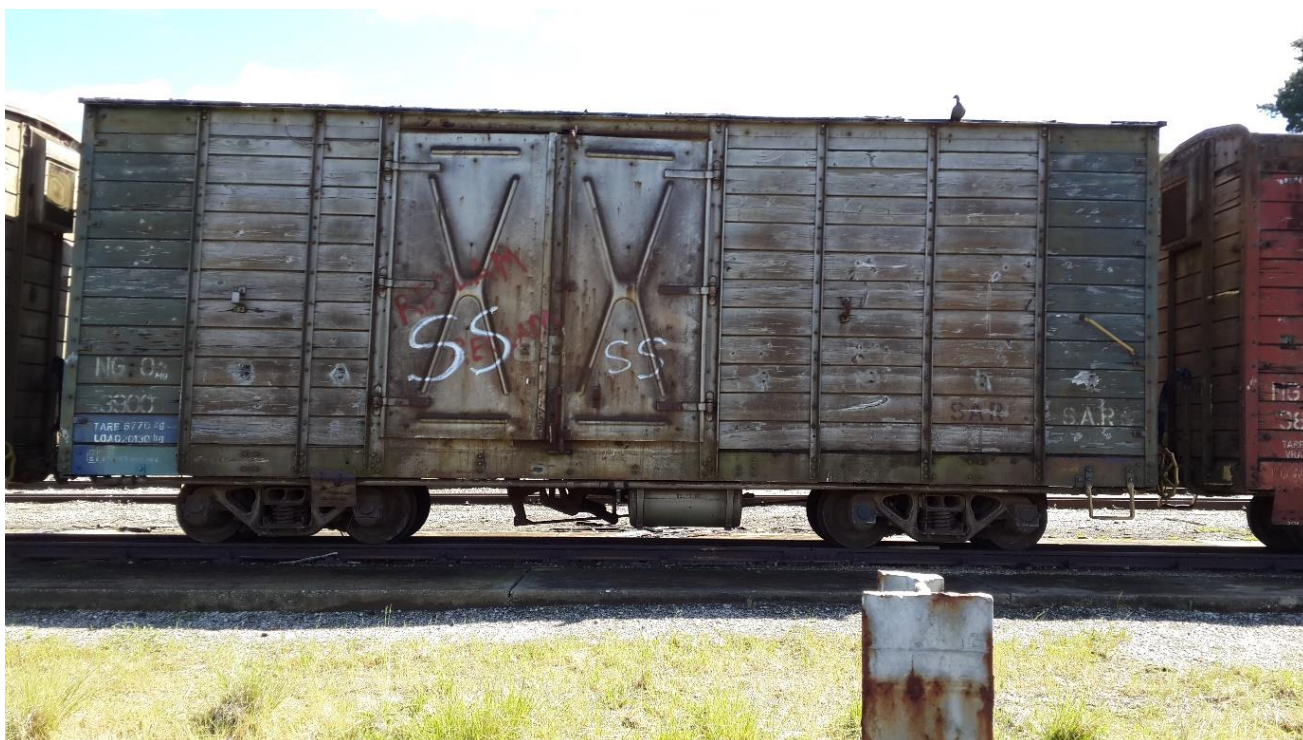
**A 1966 built O3 type fruit van stands at Assegaaibos on the line to Avontuur. Photo by  
David Richardson.**

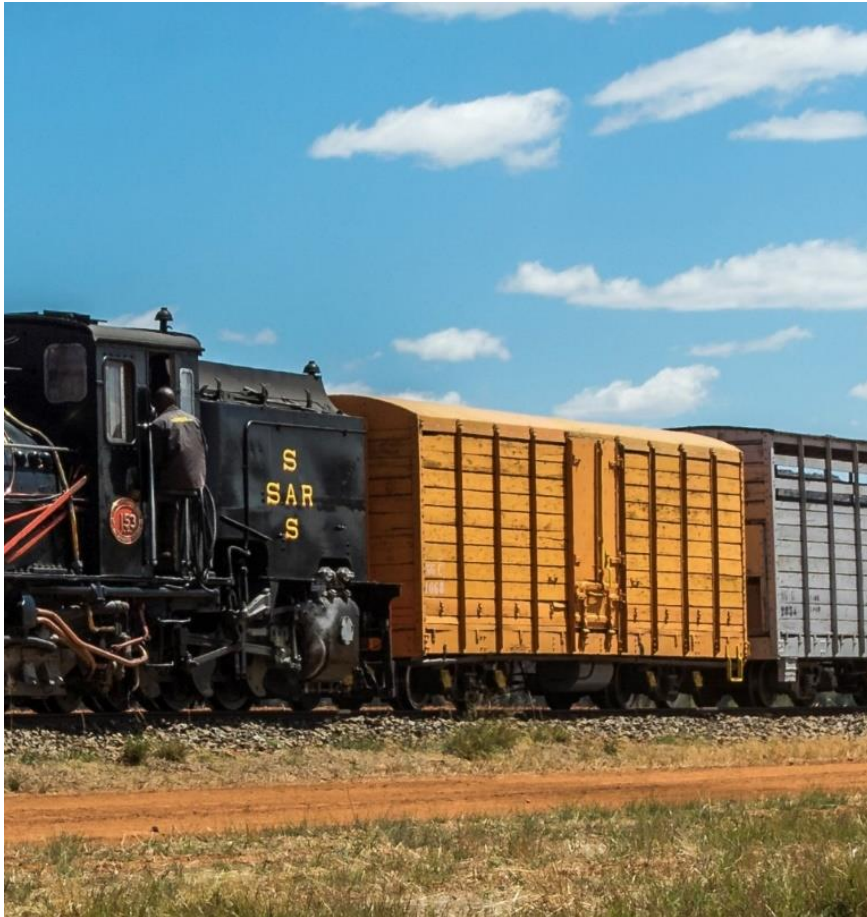
**The sole surviving OZ freight van number 1068, built in 1957, heads a consist powered by NGG16 number 153. Photo by Rod Hering**

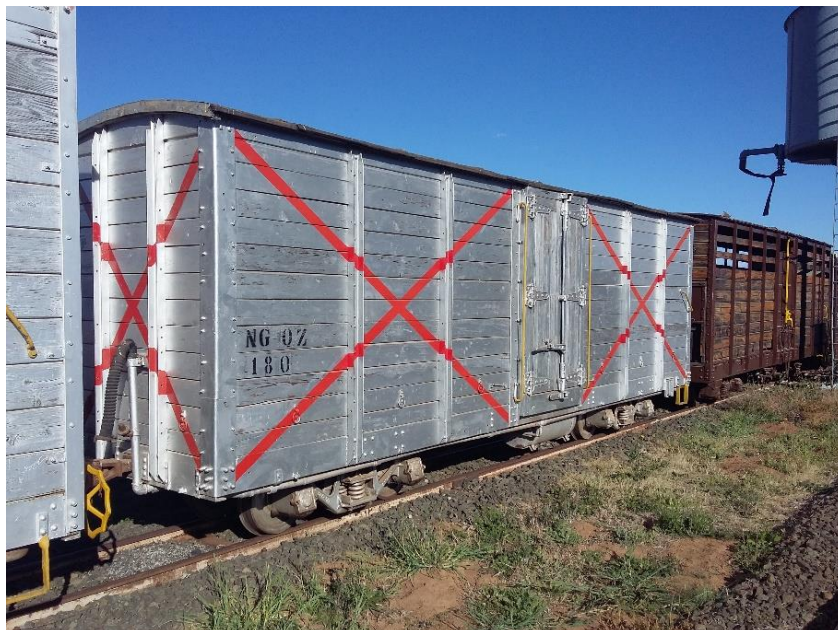
**Another sole survivor QZ number 180, marked with red crosses for explosive transport. Gert Jubileus**

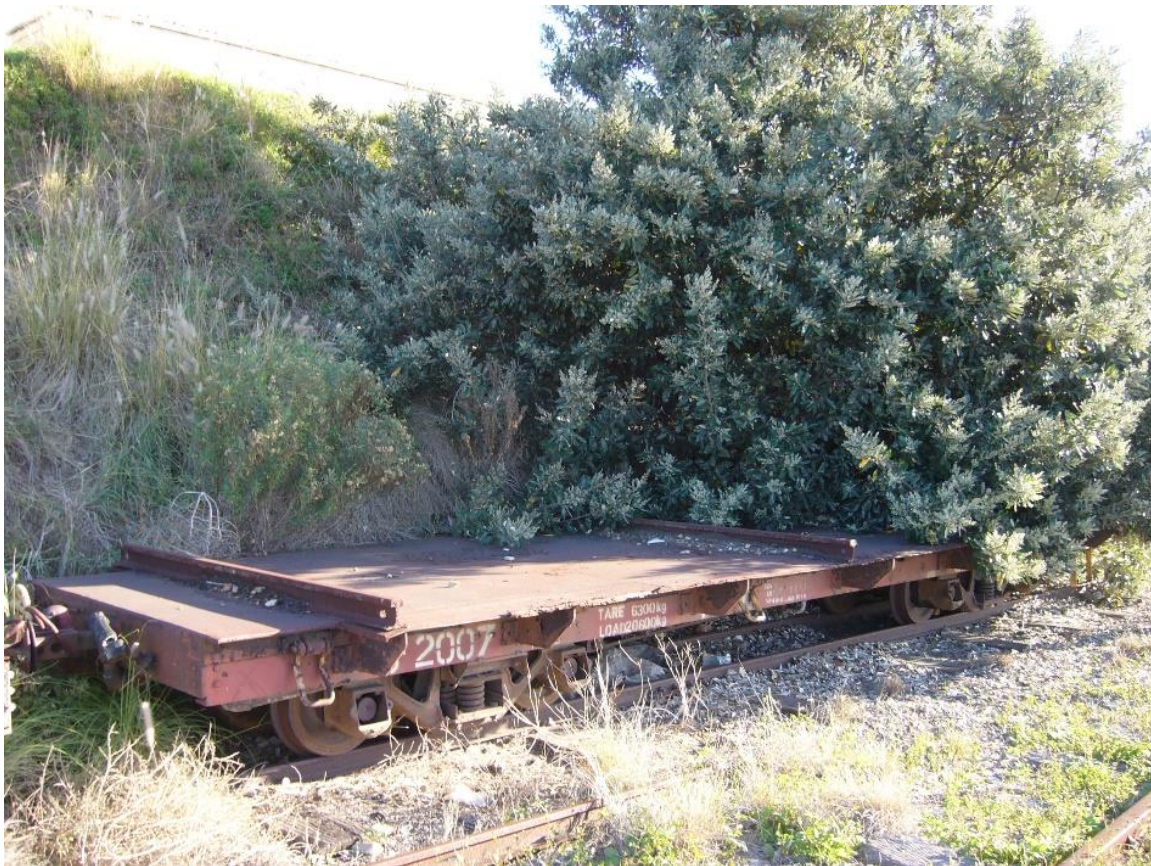
**An abandoned S type flat in the heart of Port Elizabeth, number 2007. Sandstone has a number of unrestored examples. Photo by David Richardson**

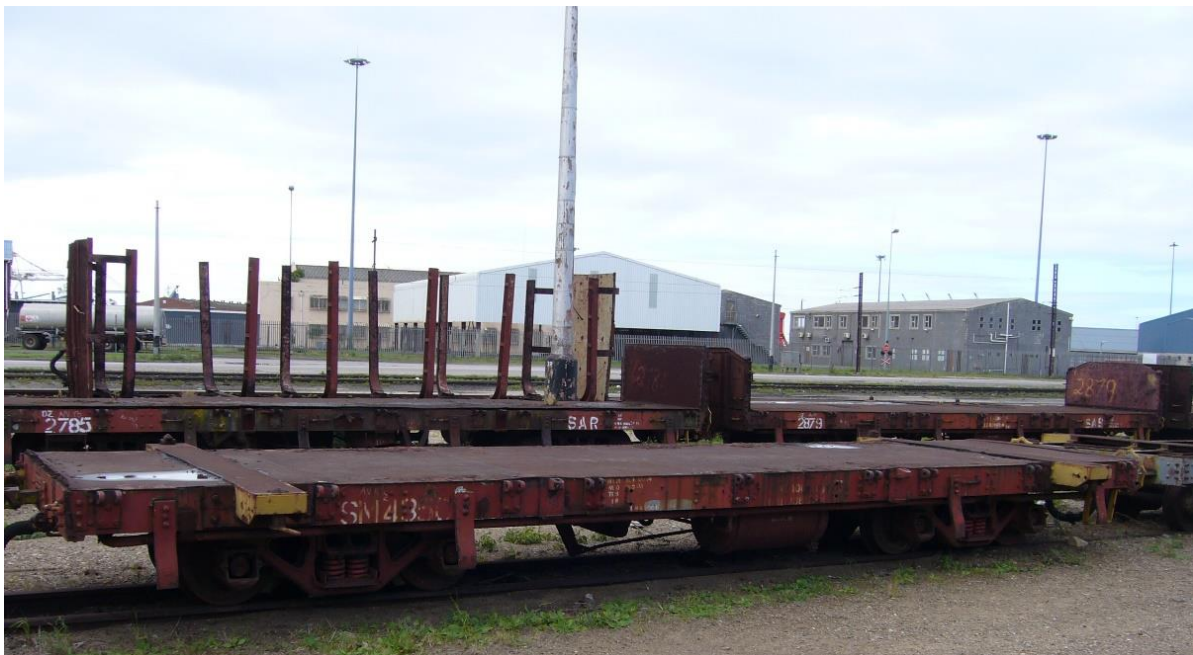
**SM Container Flat number 4350 stands at Fleming Street sidings in Port Elizabeth before being moved to Sandstone. Photo by David Richardson.**

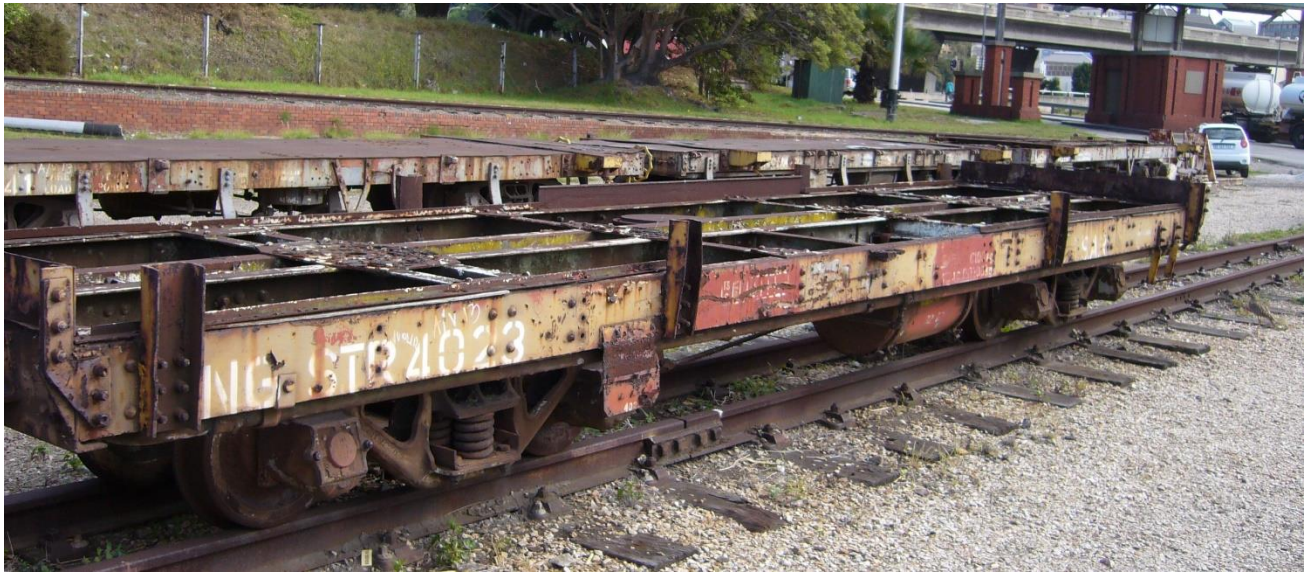
**ST 4023 at Port Elizabeth. Photo by David Richardson**

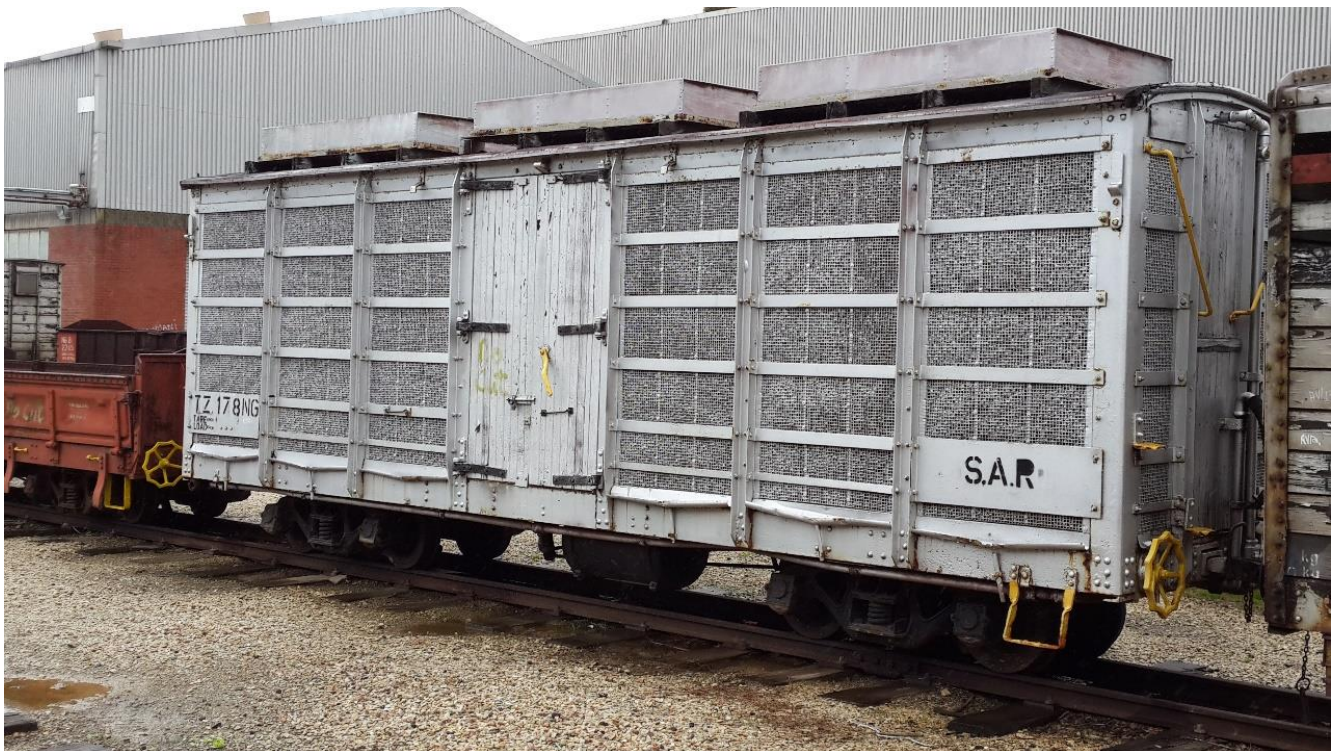
**The last survivor of the TZ Cooler Vans, number 178, awaits transport to Sandstone from Port Elizabeth in 2016. Photo by David Richardson.**

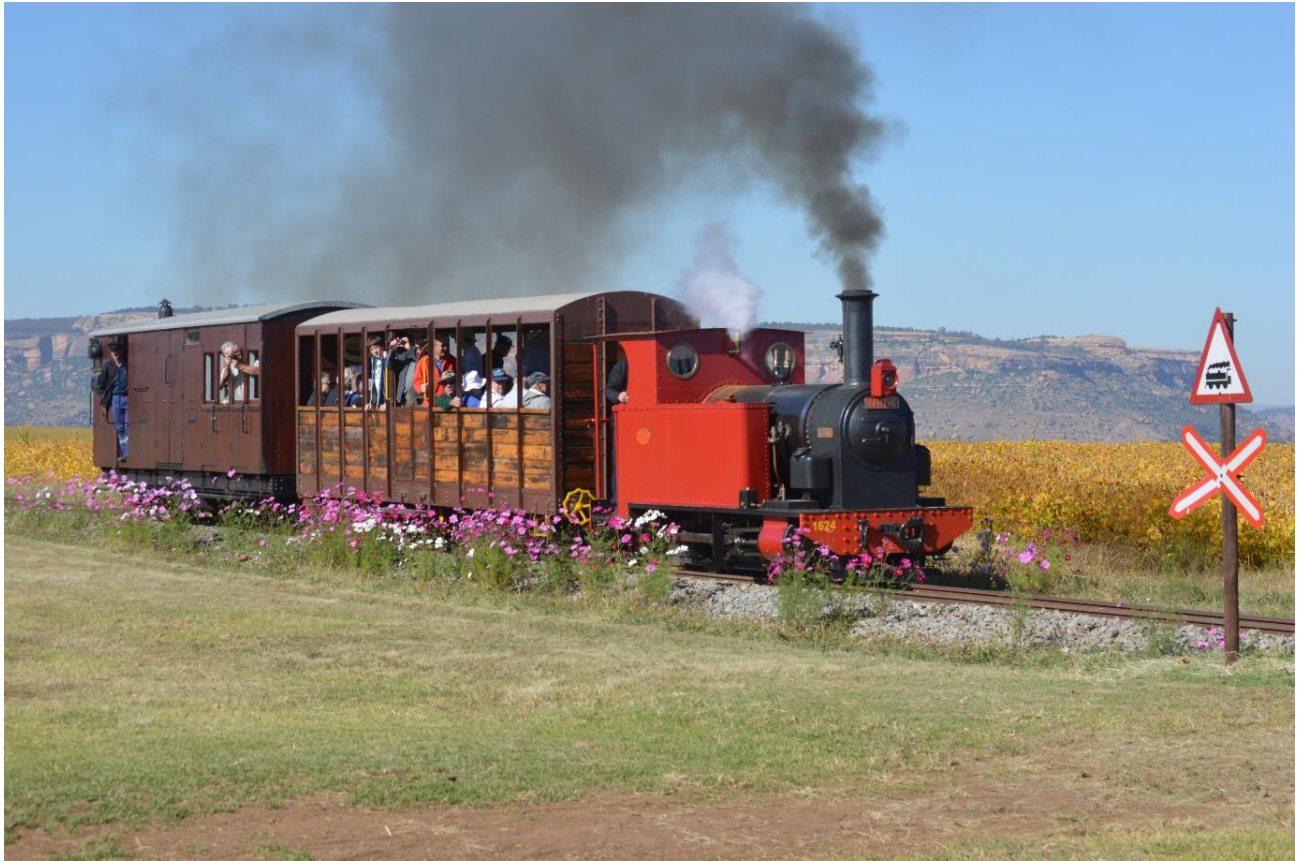
**Avonside 1624, Xanthe, rolls past the airport with a Ratanga coach and V15 Guards Van number 2814 at the rear. The two passenger compartments can be clearly seen. Photo by Gary Barnes.**

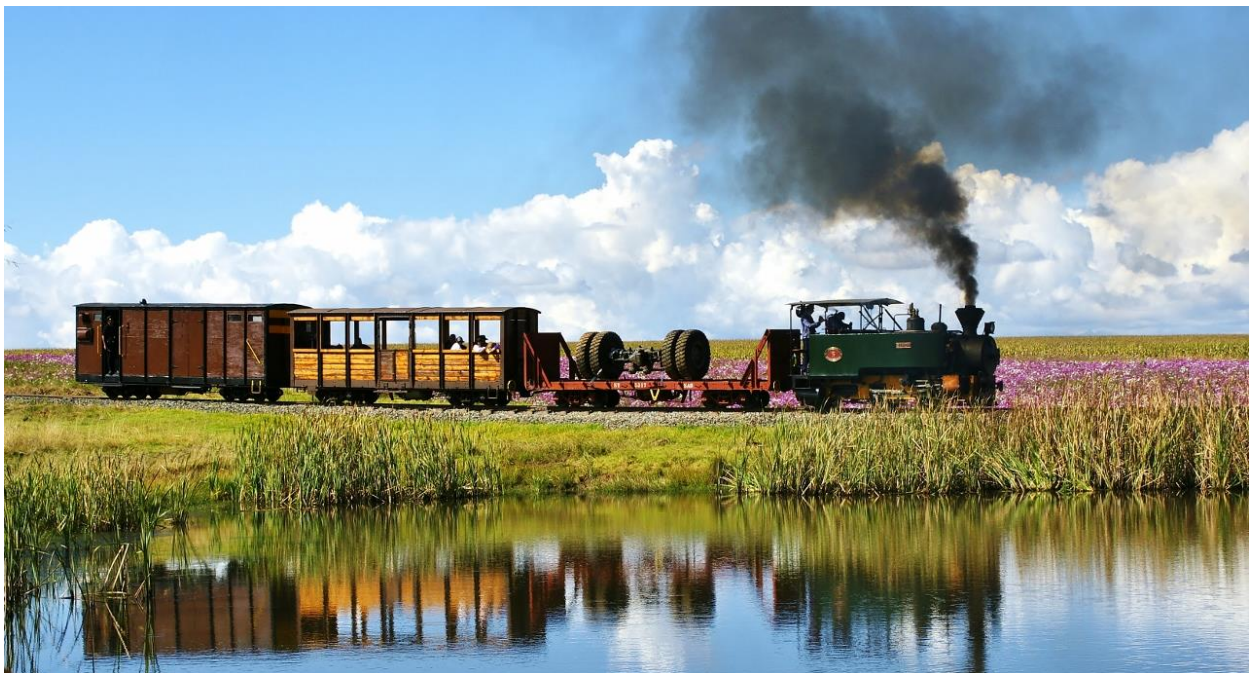
**A V16 Guards Van brings up the rear of a short train hauled by Fowler 0-4-2T, Sandy, as it passes Pandora Dam. Photo by Hannes Palin**

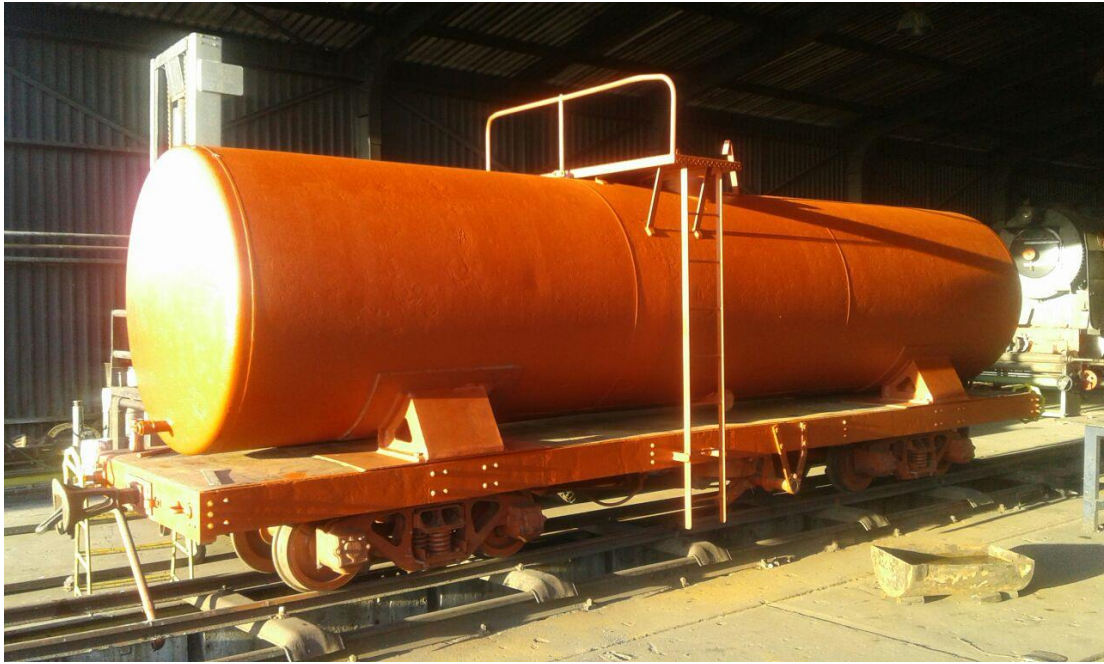
**X type tanker number 2197, built in 1952, was restored alongside NGG11 number 52 at Bloemfontein to act as an additional water supply for the locomotive. Photo by Lukas Nel.**

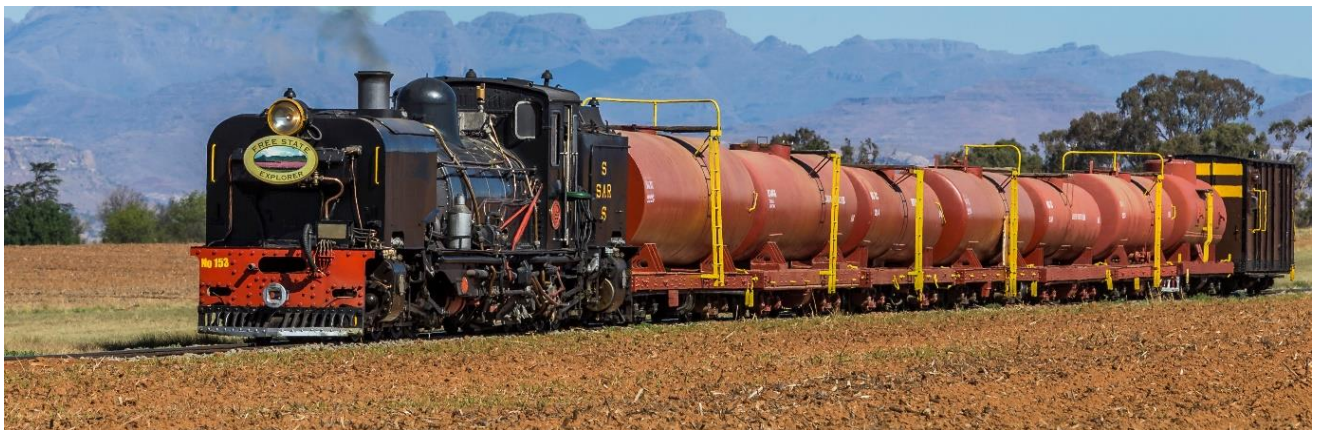
**A tanker train behind NGG16 153, two XC type tankers are immediately behind the locomotive. Photo by Rod Hering.**
