# SANDSTONE STEAM RAILWAY

# LOCOMOTIVES

## REPAIRS

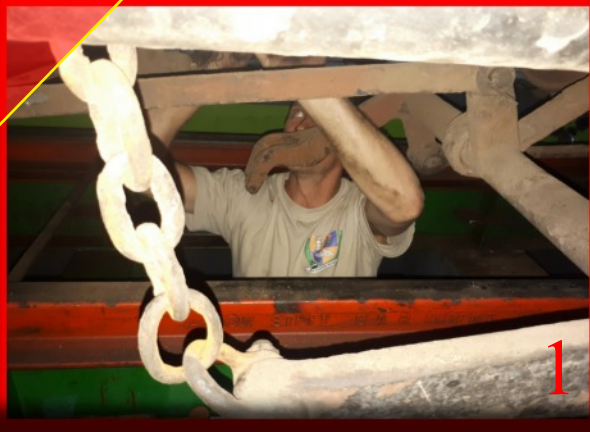
Image 1: A new piston rod fitted to the PE coach

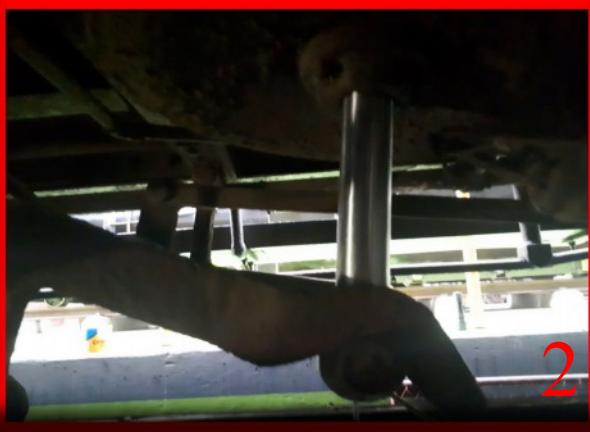
Image 2 : The new piston rod fitted after the nylon bush and neck ring were replaced.

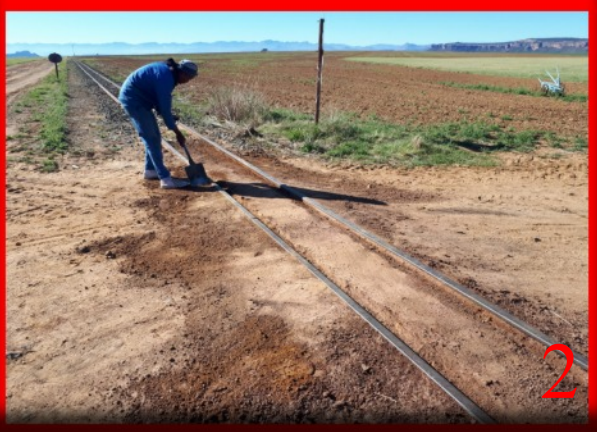
Image 2 : Crossing being cleaned prior to departure.

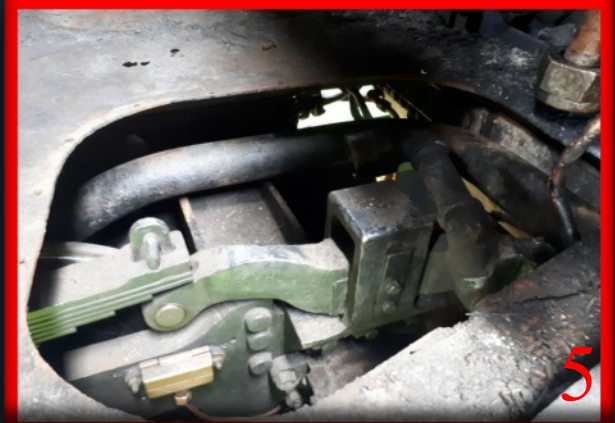
Image 1: NGG 16 number 153 on the inspection pit. Fitting the steam pipes is not a easy task.

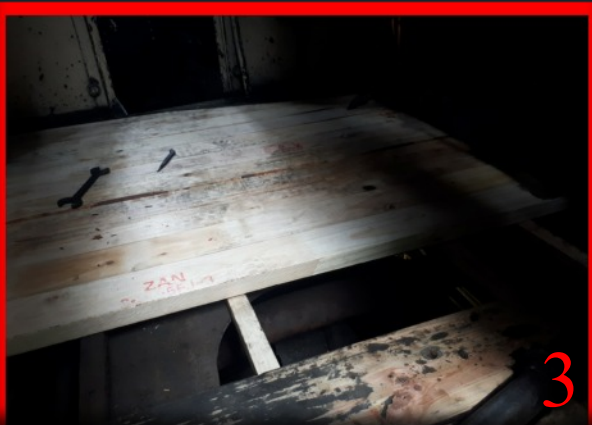
Image 2 : 153's rotten wooden floors removed.

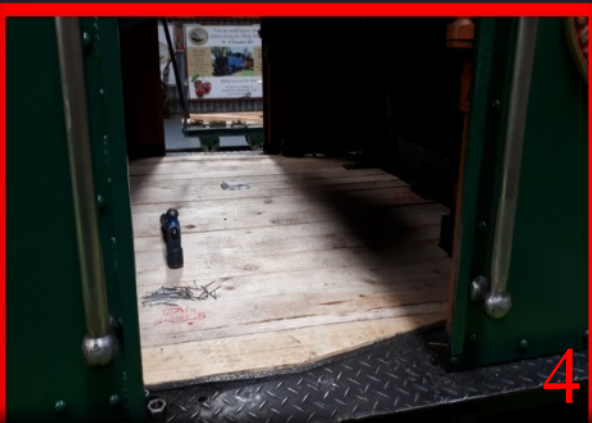
Image 4 : Wooden floor completed.

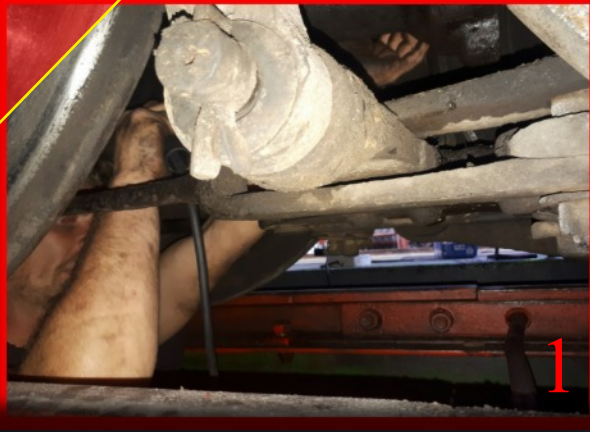
Image 1: Fitting back the main steam pipes under 153.

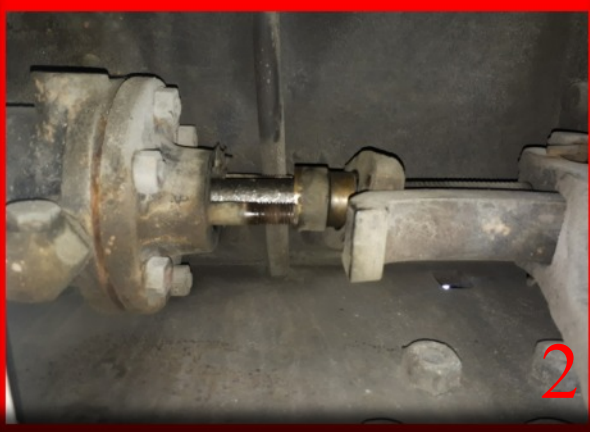
Image 2 : Steam shaker piston gland being packed under 88.

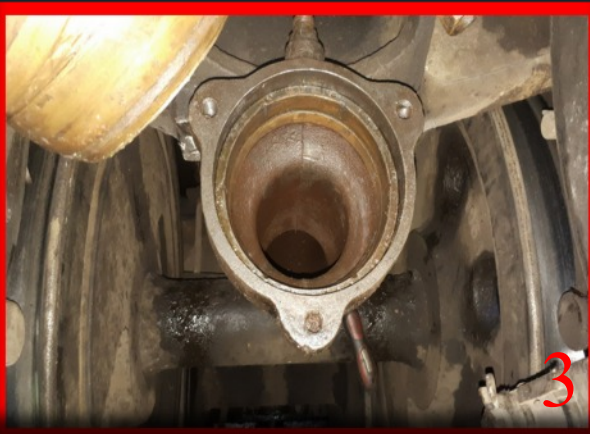
Image 3 : The steam ball joint.

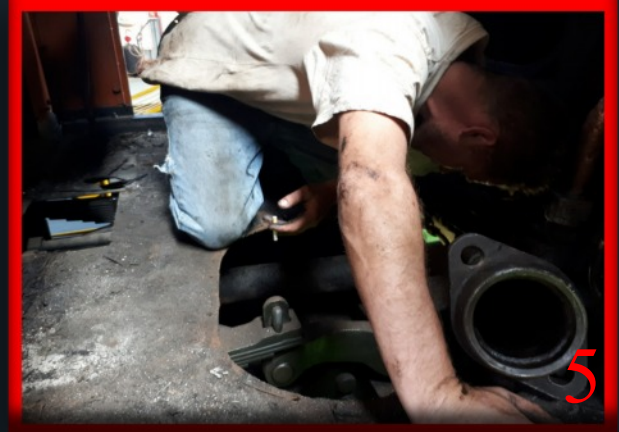
Image 5 : Thinus busy with the fitting of the rear engine steam pipe.

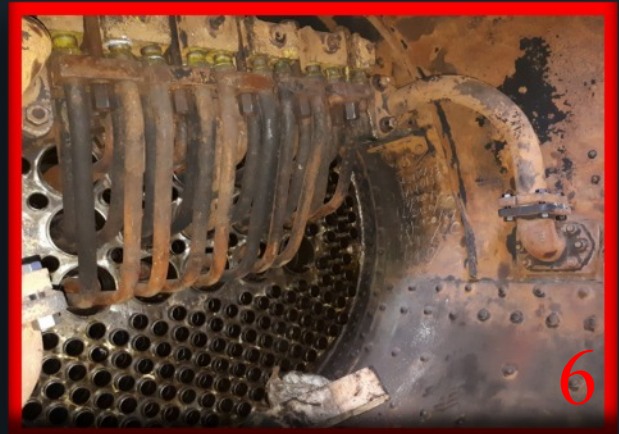
Image 6 : 113's smoke box with the elements tested, fitted and ready to fit back the blast pipe and spark arrestors.

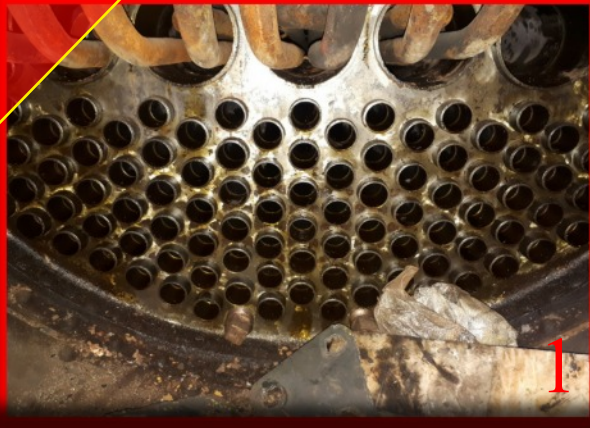
Image 1: The Class NGG 16 number 113 after re tube.

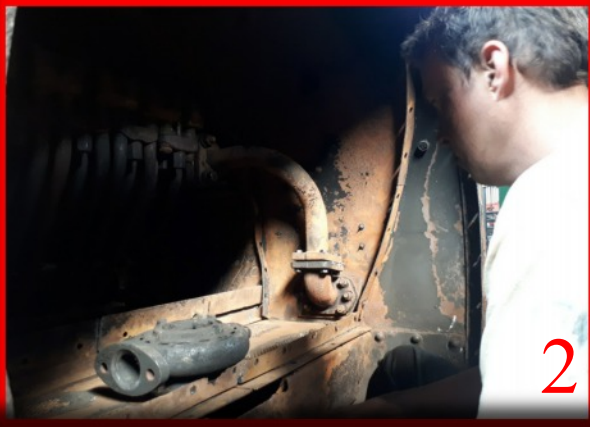
Image 2 : Wouter fitted back all the pipes and arrestors.

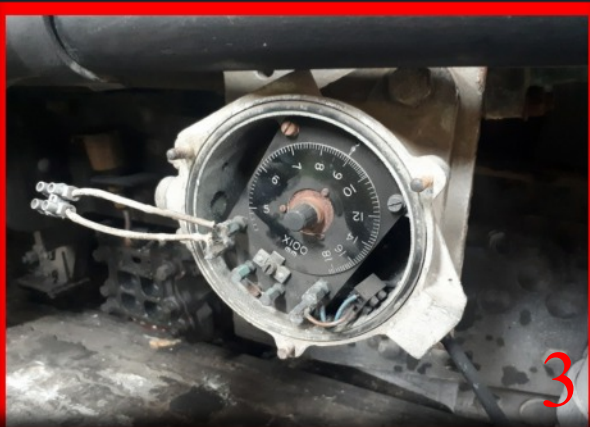
Image 4 : Final adjustments to the speedometer before we tested and calibrated it.

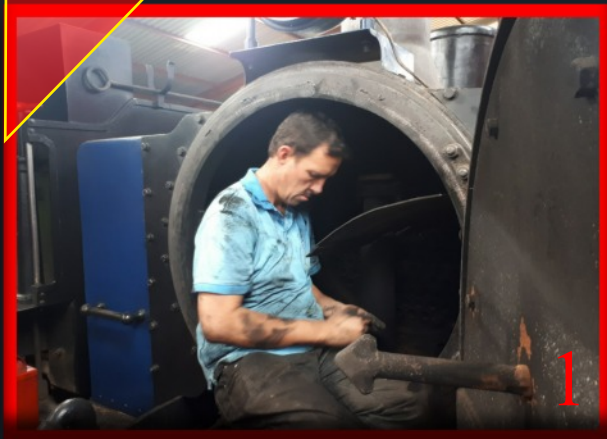
Image 1: Wouter fitted back the branch steam pipes inside the smoke box of the NG 4 and then fitted back the spark arrestors.

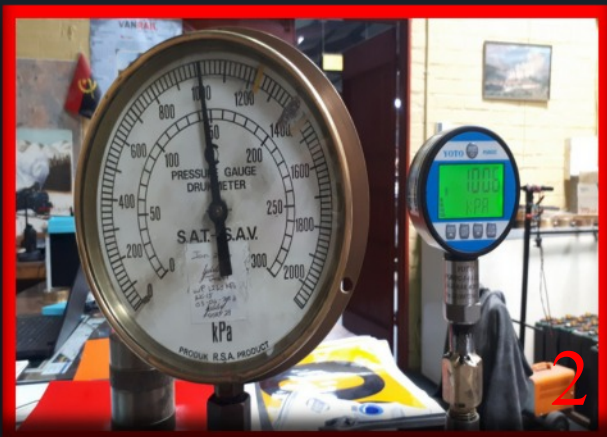
Image 2 : Gauge calibrations.

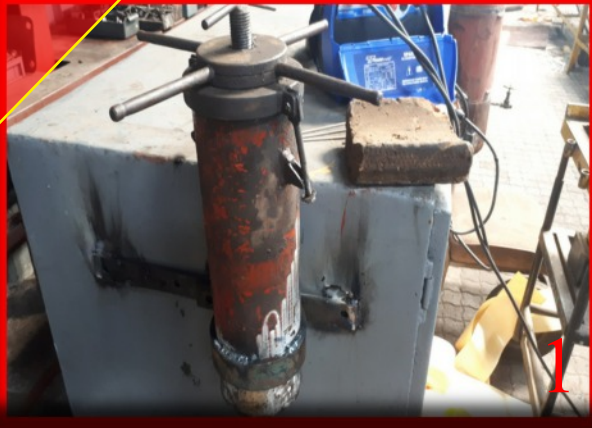
Image 1: Thinus made us a stick grease maker as we needed stick grease for the NG 15.

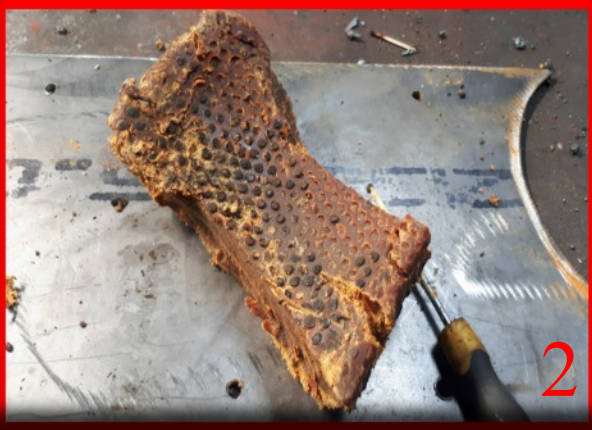
Image 2 : Pieces of grease pads were used.

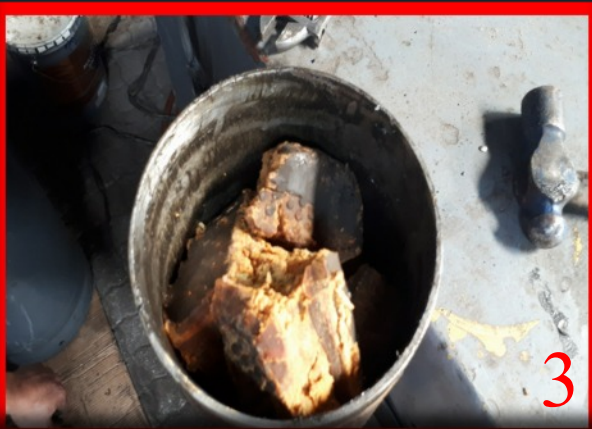
Image 3 : The grease pieces inside the grease press.

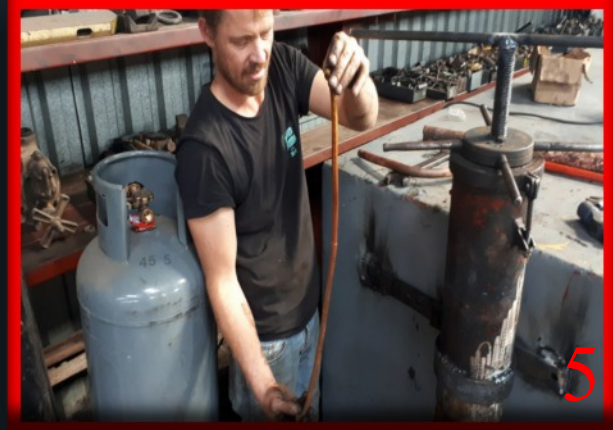
Image 4 : Perfectly shaped grease sticks.

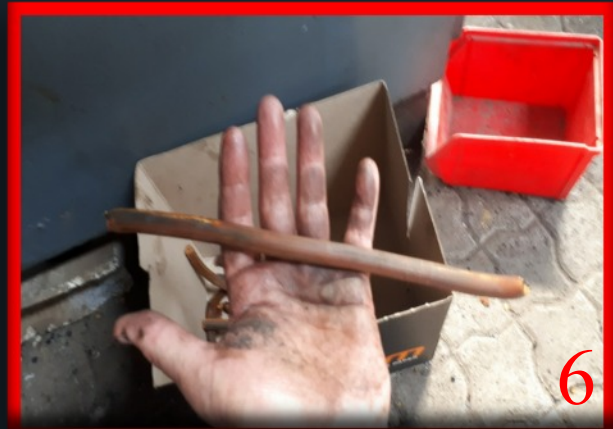
Image 5 : The longest piece of stick grease ever made.

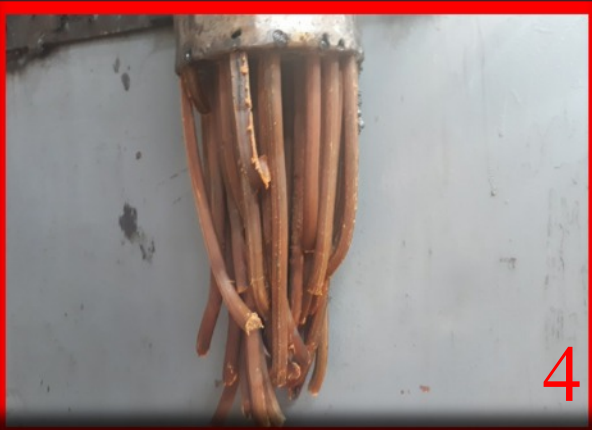
Image 6 : We made one box full of stick grease and this should last us a few years.

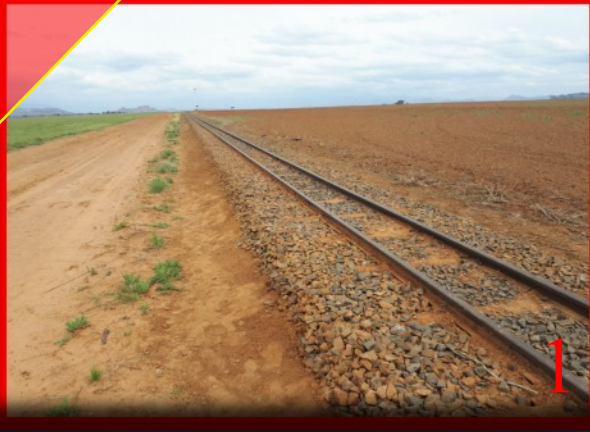
Image 1: Track work done on the section from the airstrip curve towards the level crossing near Hoekfontein South.

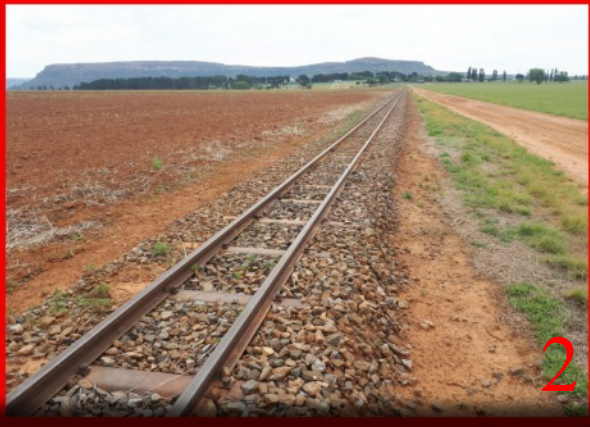
Image 2 : A view towards the South Gate.

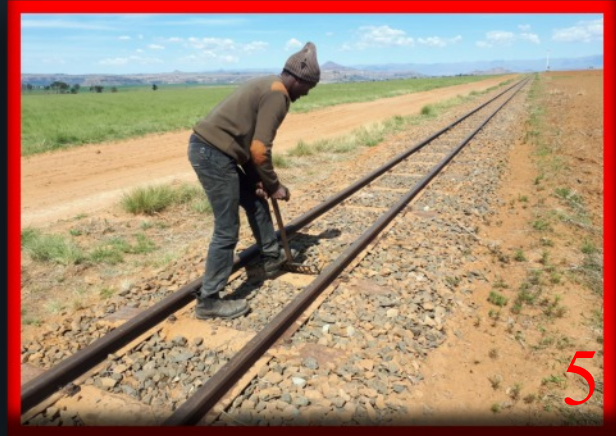
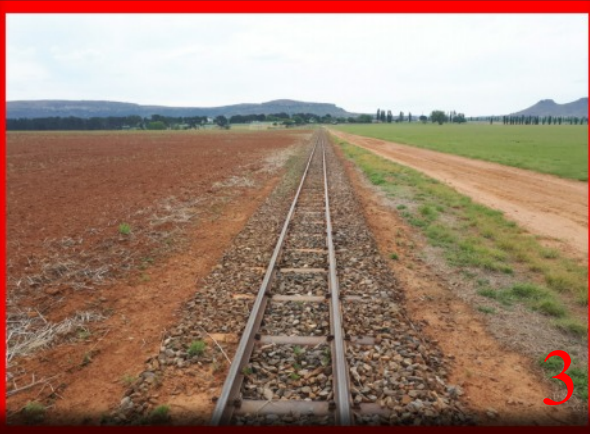
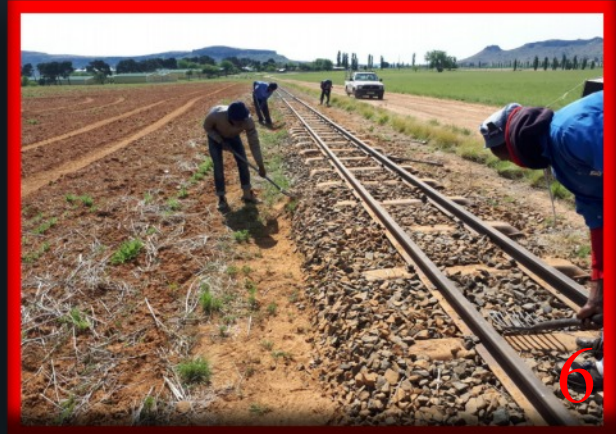
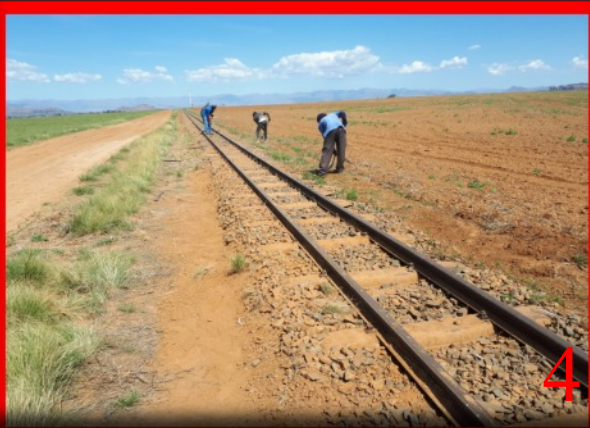
Images 3 to 6 : Track work on this section of the line.

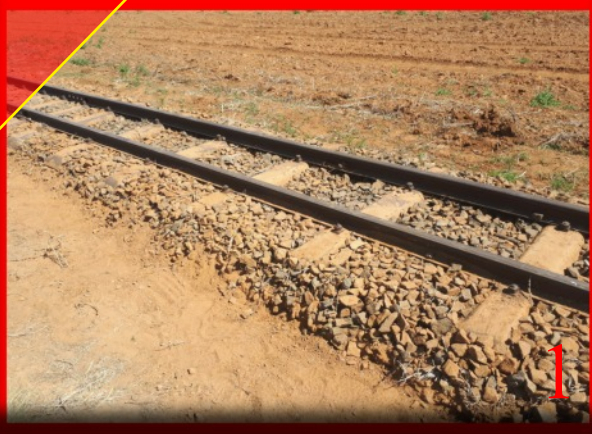
Image 1: Track work on the section Hoekfontein to Grootdraai.

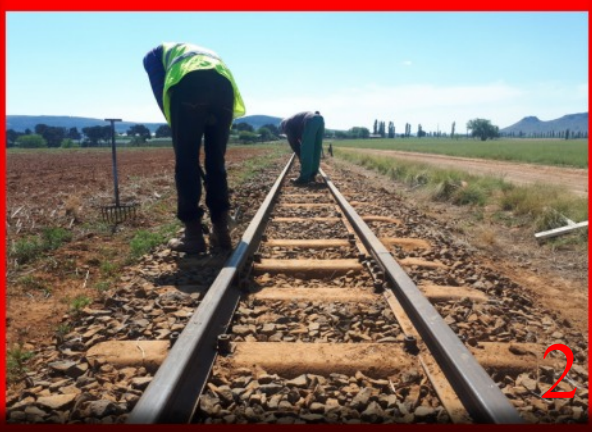
Image 2 :Removing the last slacks towards the level crossing.

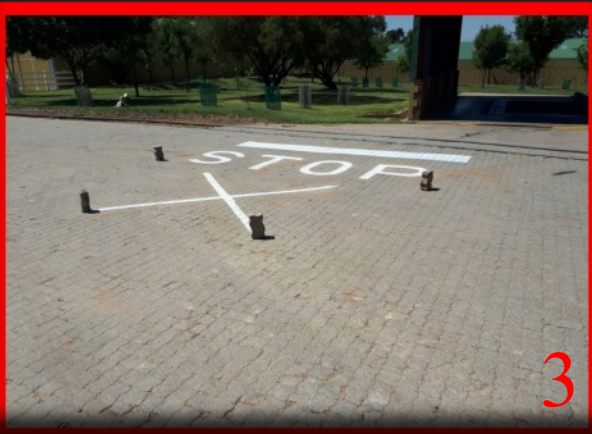
Image 3 : The road signs being painted.

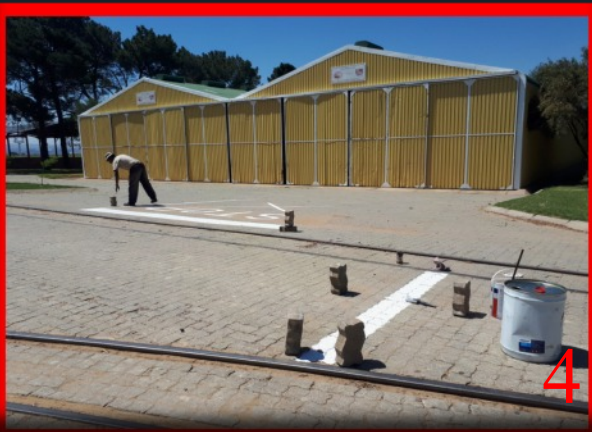
Image 4 : The road signs being painted at the Military shed.

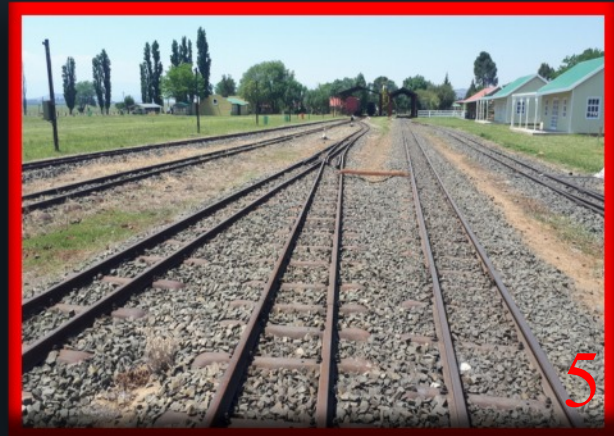
Image 5 : New clearance marks fitted.

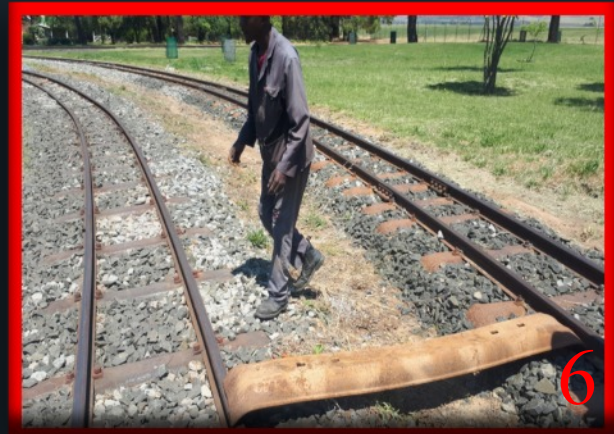
Image 6 : New clearance marks fitted and then white washed.

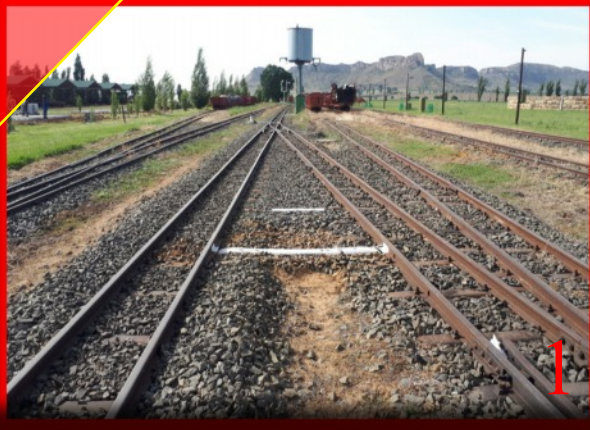
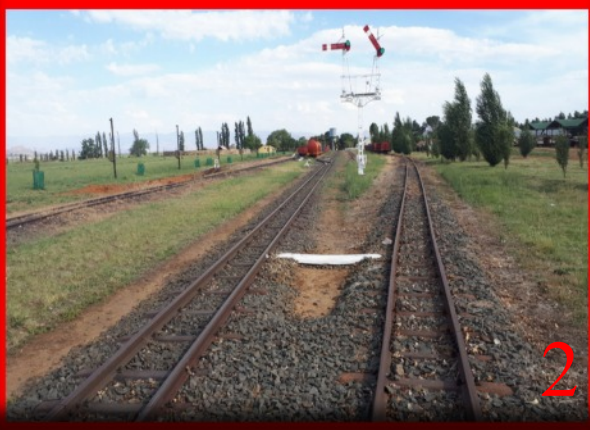
Image 1 & 2 : More clearance marks.

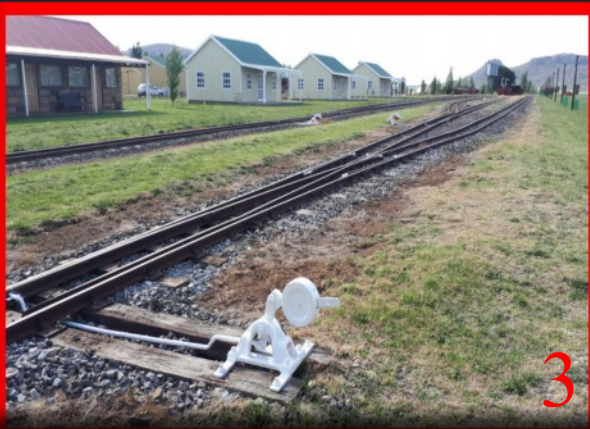
Image 3 : All the points were painted

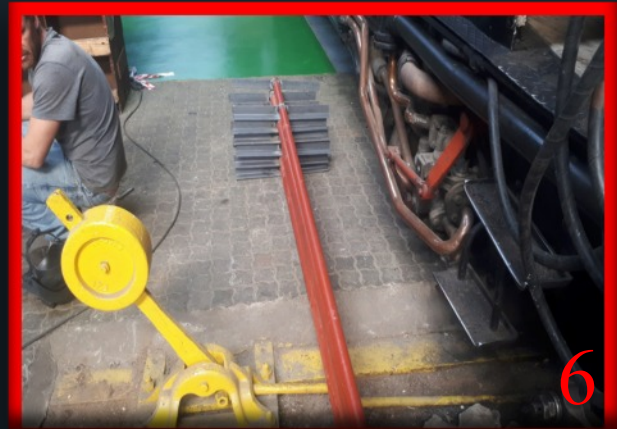
Image 5 : Road signs painted.

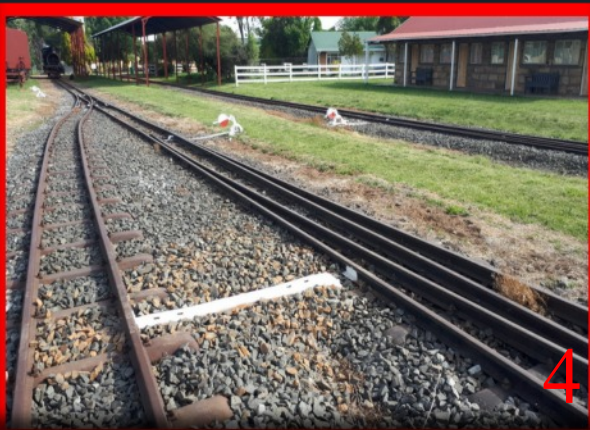
Image 6 : Thinus and Wouter made all the new whistle and speed posts and repaired all the road signboards.

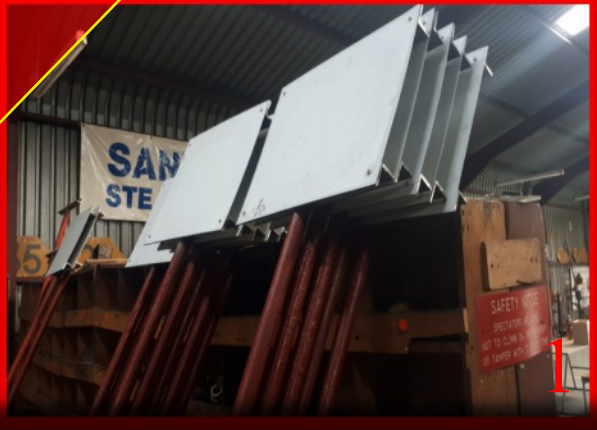
Image 1: The new whistle posts.

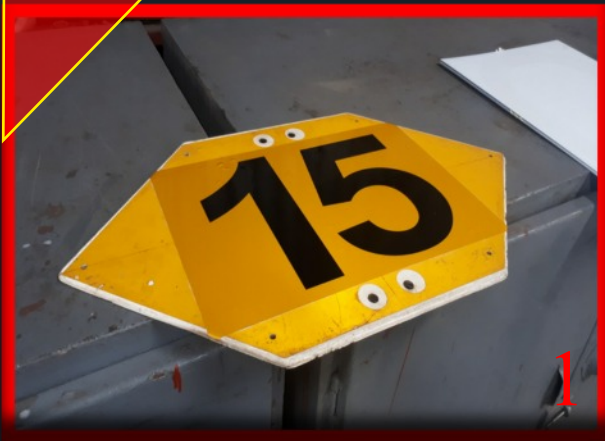
Image 1: New speed posts were made.

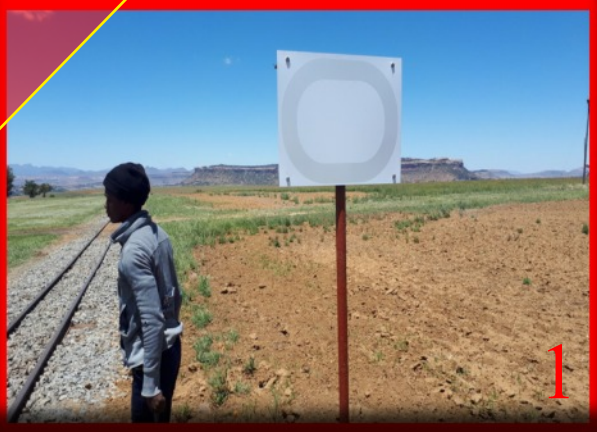
Image 1: All the whistle posts at the airstrip crossing were planted on the opposite side so it will not bother the planes.

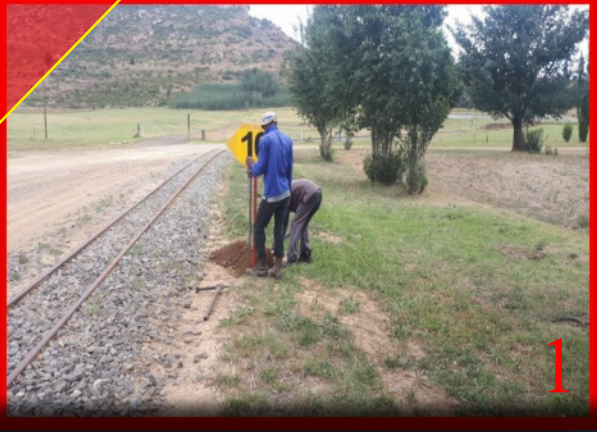
Image 1: Speed post fitted near Pandora crossing.

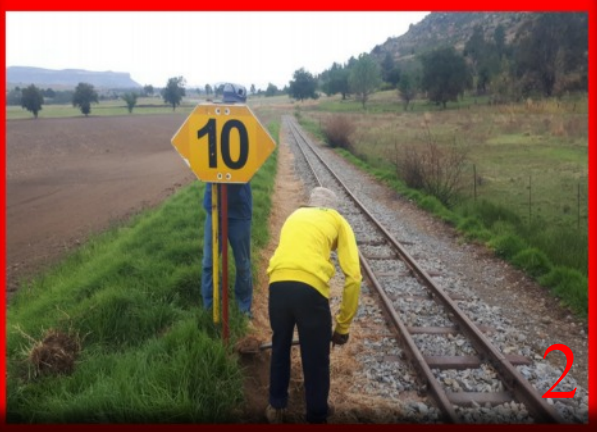
Image 2 : Speed post fitted near Pandora house.

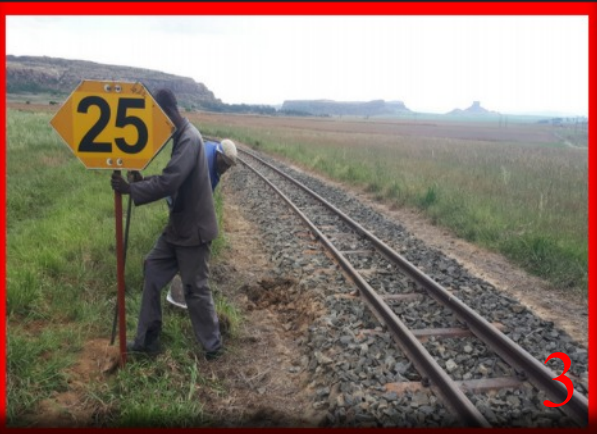
Image 3 : Speed post fitted at Pandora Junction.

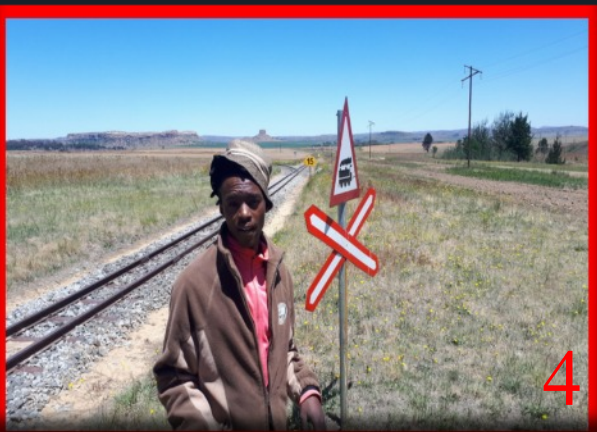
Image 4 : Crossing signboards fitted at Pandora Junction crossing.

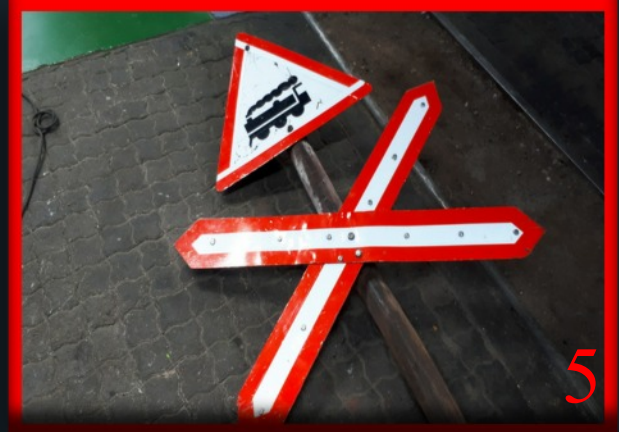
Image 5 : Road signboards repaired.

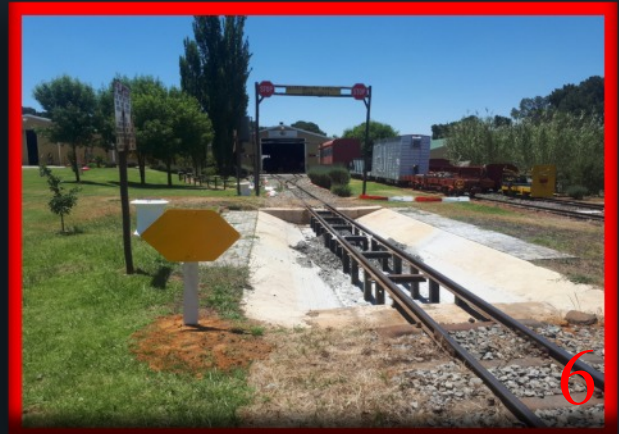
Image 6 : 5 km/h speed post at the Steam shed fitted.

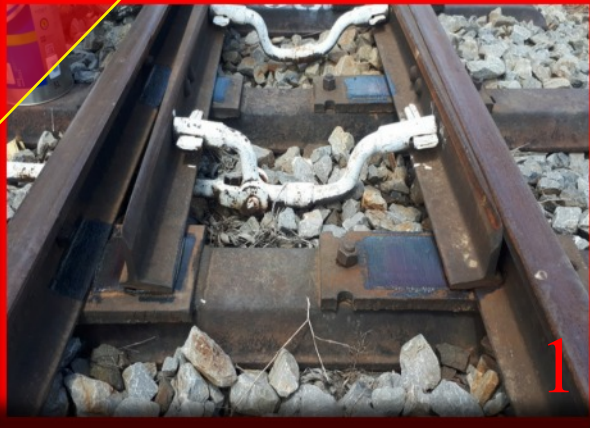
Image 1,2,4 and 5: All the points were serviced.

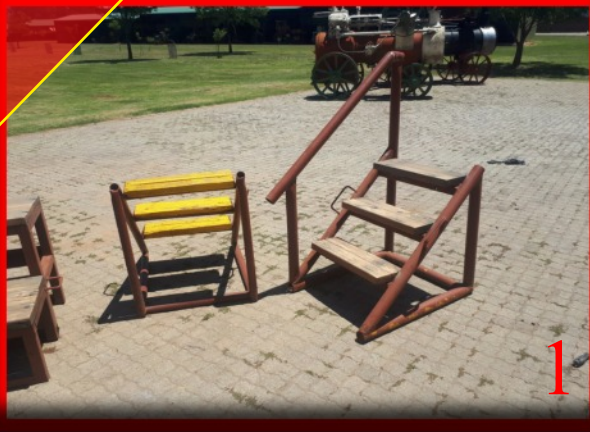
Image 1&2: All the Station steps were take to the shed where we fixed them and all were painted.

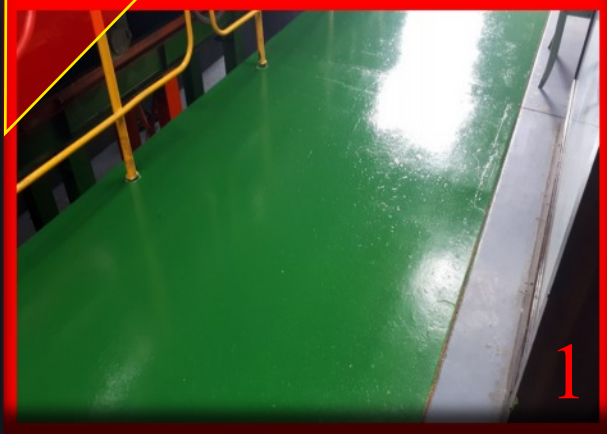
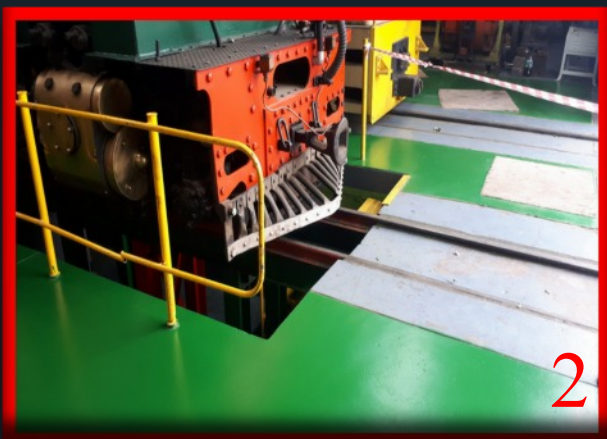
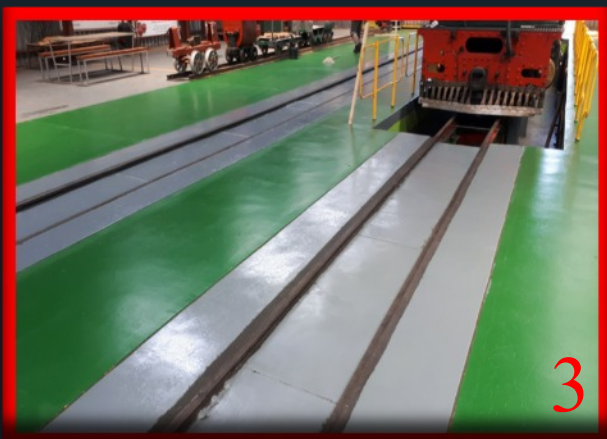
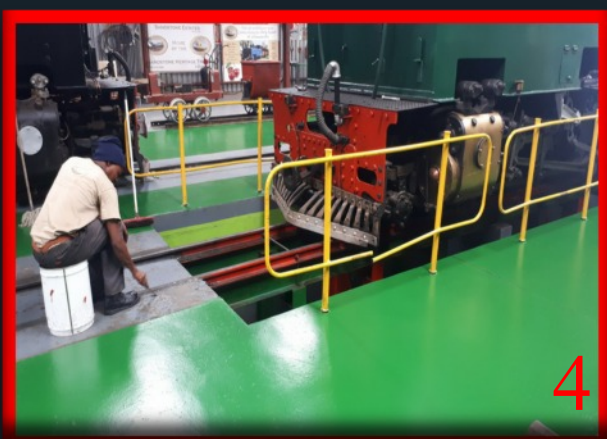
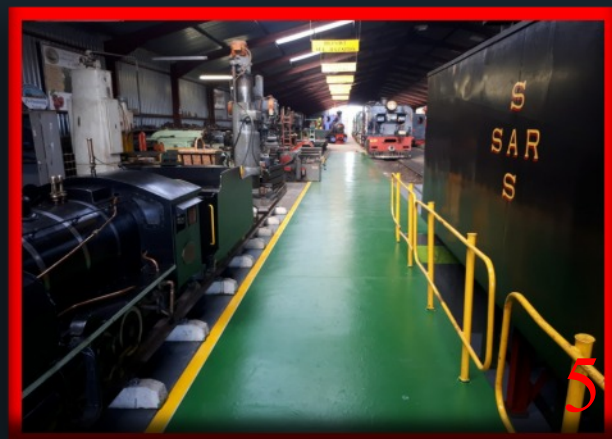
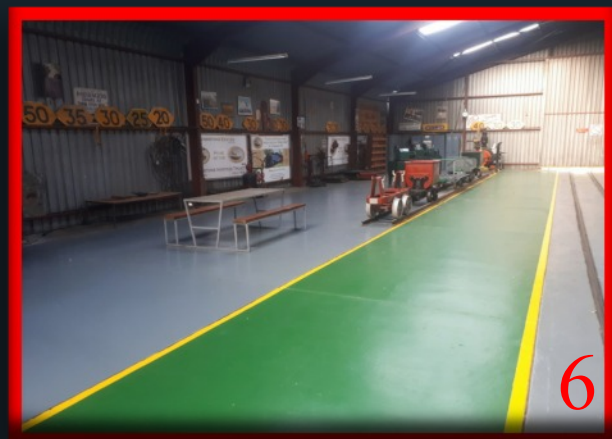
Image 1 to 6 : The shed floors were painted.

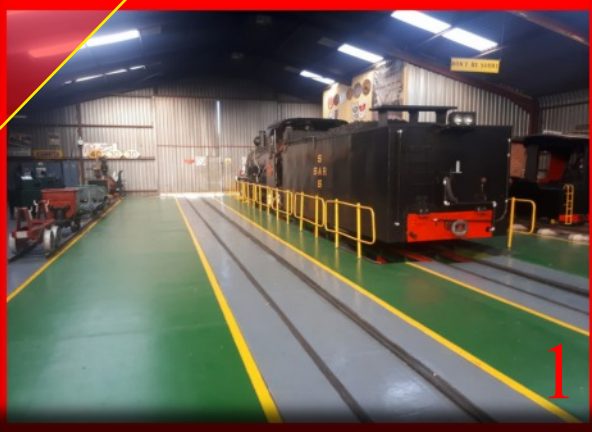
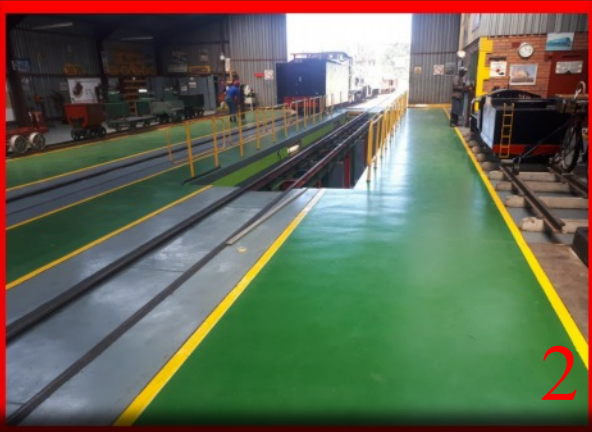
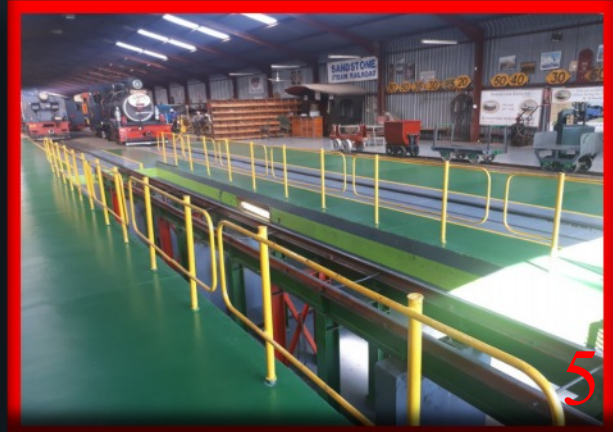
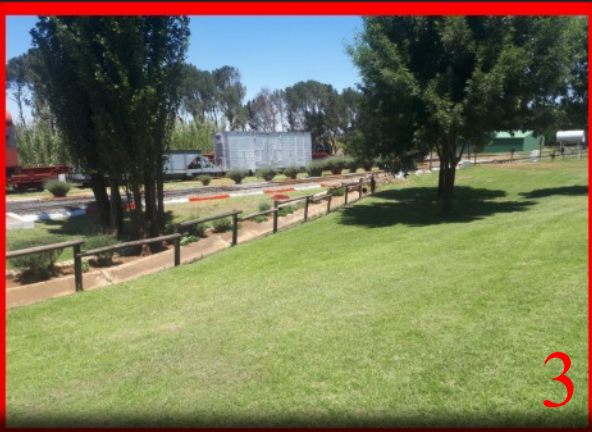
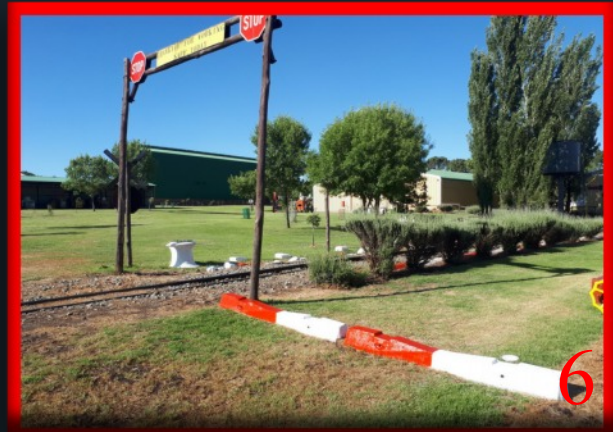
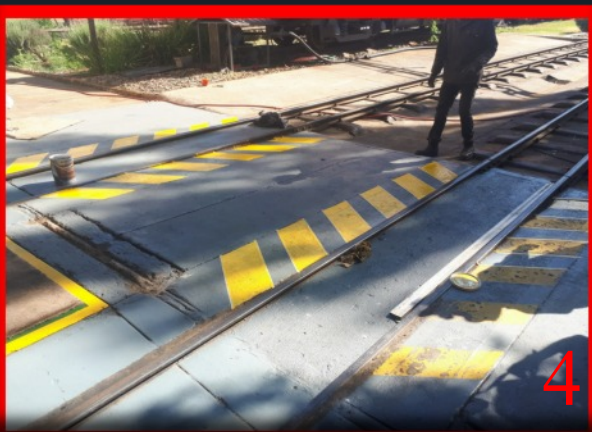
Image 1 to 6: The shed floors were painted and the paint work outside was attended to.
